**Arboricultural Report**  
**composed of**  
**Arboricultural Impact Assessment**  
**Arboricultural Method Statement**  
**& Tree Protection Plan**

Bowood  
Bashurst Copse  
Itchingfield  
West Sussex  
RH13 0NZ

Written by  
Barry Holdsworth Ltd

10th April 2025

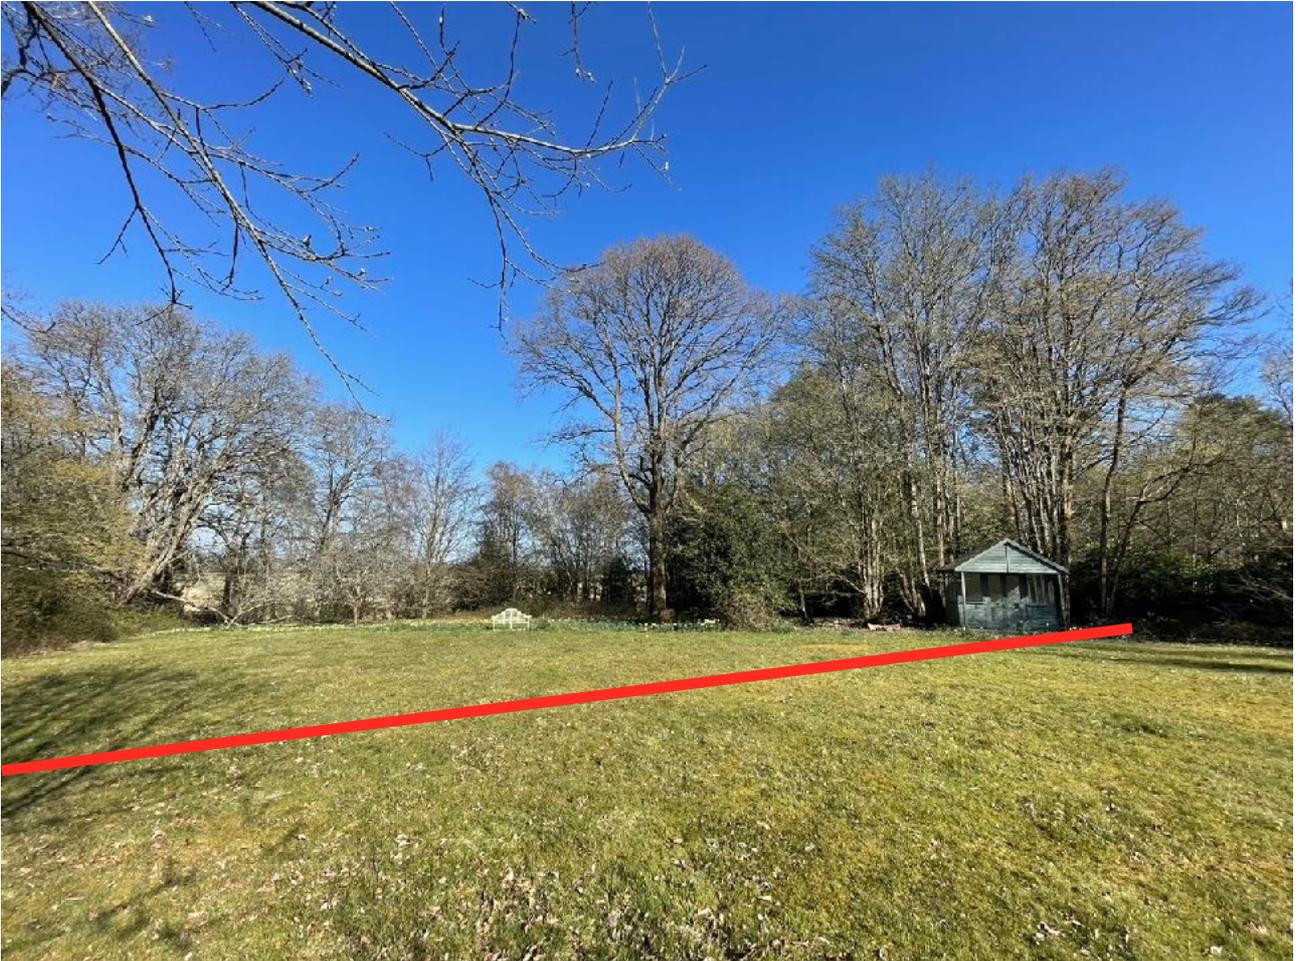
The Ancient Woodland boundary runs across the garden from the Summerhouse in the east

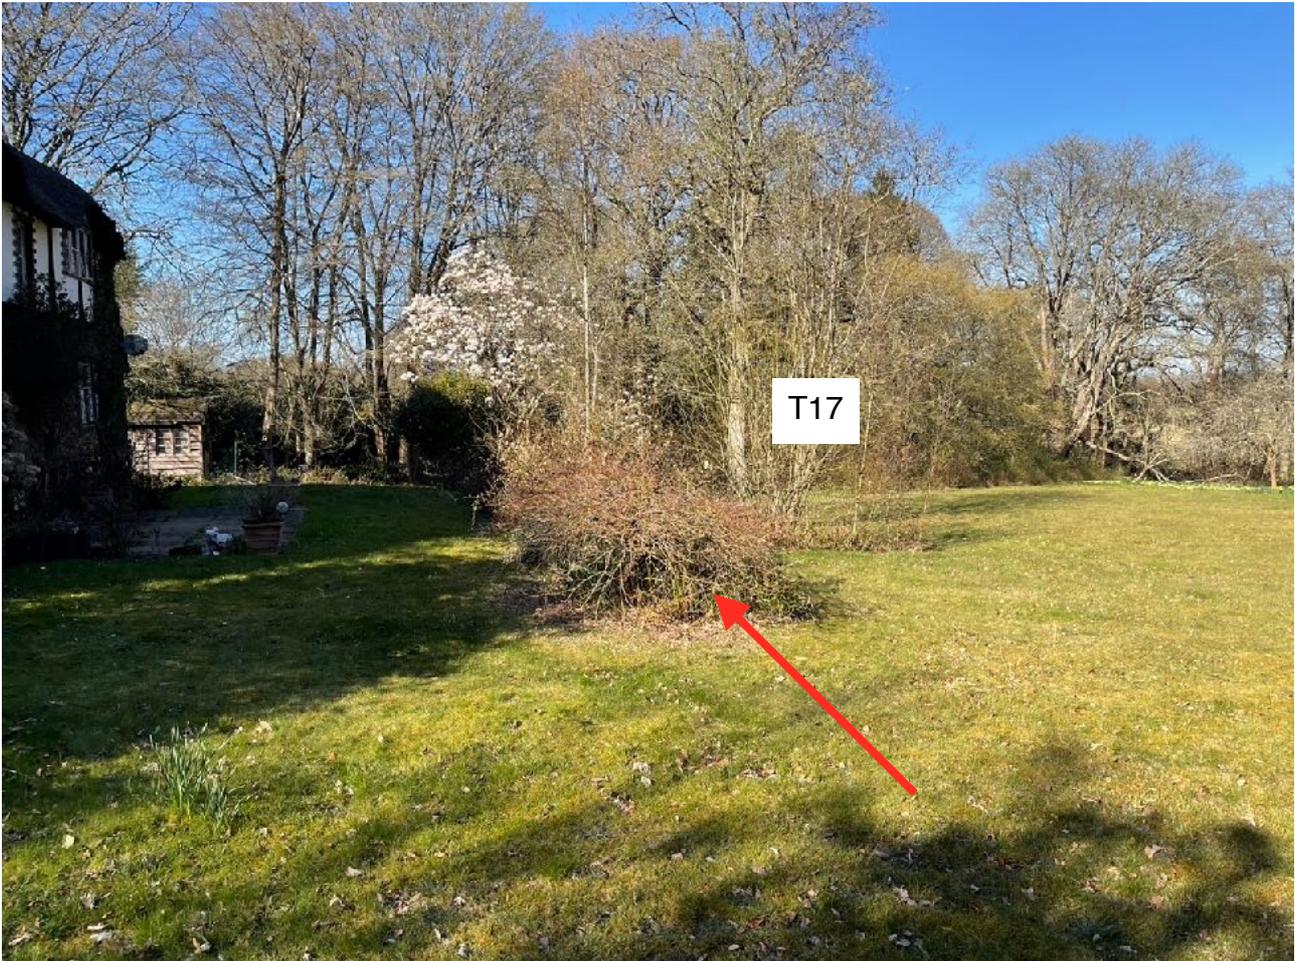
The Ancient Woodland boundary runs across the garden from the Summerhouse in the east to T17 the Oak tree.  
The proposed house will be brought back eastwards to be in line with the shrubs shown

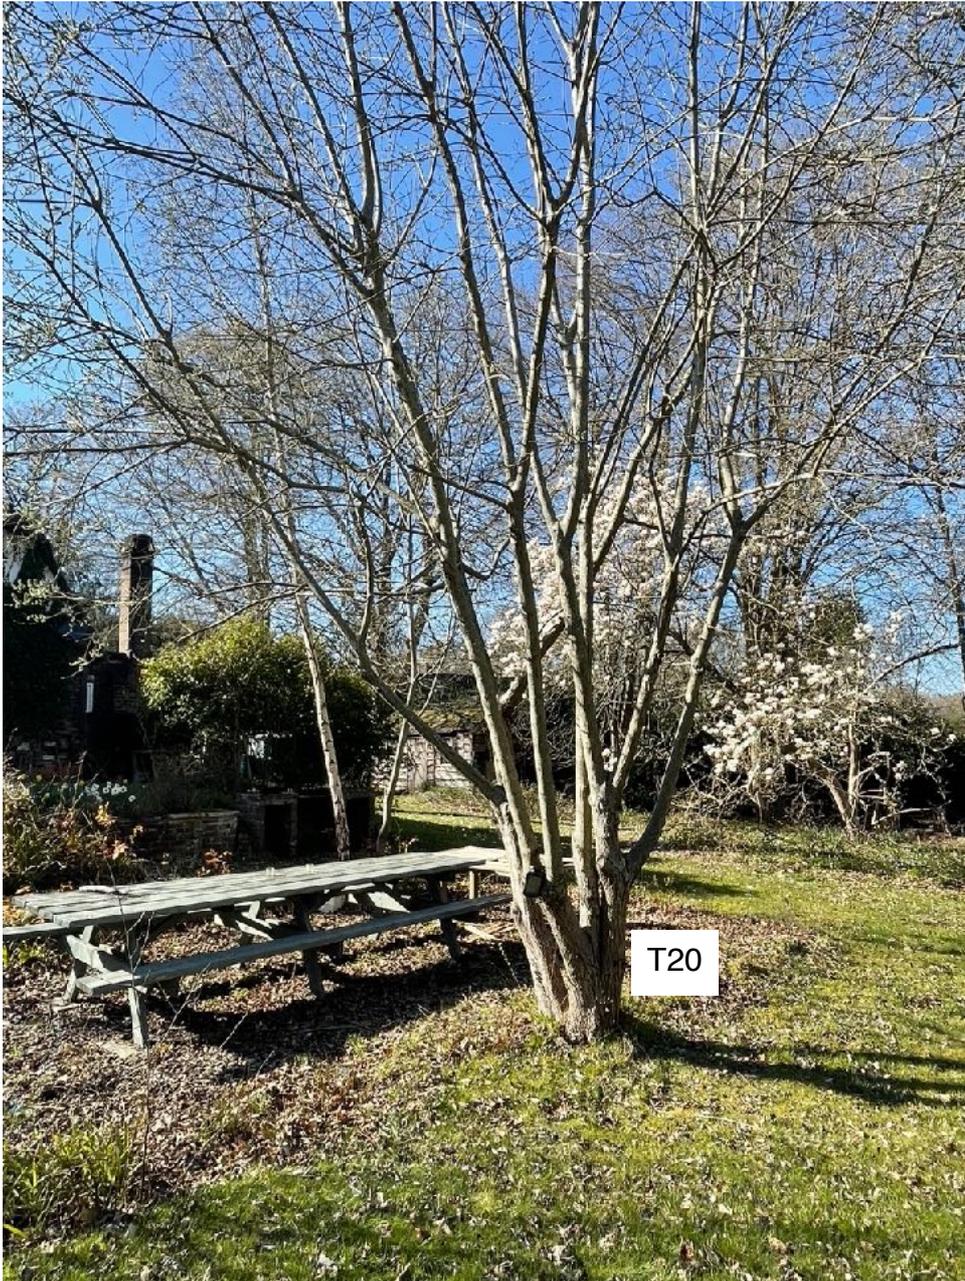
Shown are the small Class C trees that are self sown to be removed in the rear garden. T18/19/20

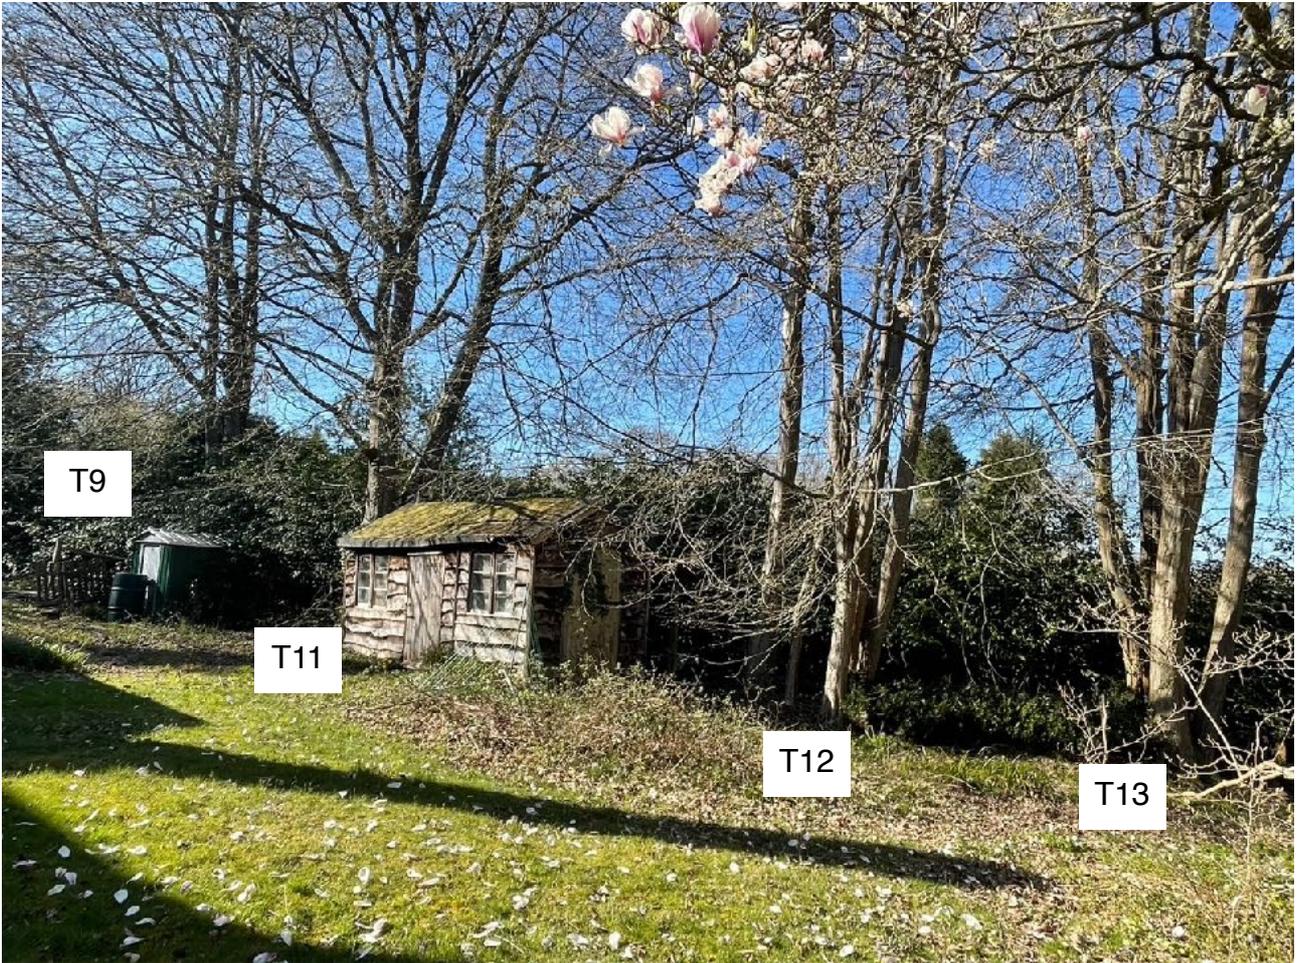
The bank of large established trees found along the north western boundary of the site T7-T11 have root zones that require protection for the duration of the works. See below 3.7 Requirement for Tree Barrier Fencing and Ground Protection for details.

Shown are the cluster of boundary trees that require ground protection in addition the tree protection fencing T9/11/12/13

3.7.3. In order to protect the ground conditions and the roots with the RPA of trees T7- T11 ground protection is required to be installed prior to the installation of the tree protection fencing. It is advocated that heavy duty mats such as Hermes **Safe Trak Mats** are used that can take weights up to 80 tonnes on medium to soft ground. *These mats have a unique surface with one side being non-slip for pedestrians and the other side being a non-skid deep traction surface for vehicles. They are commonly used for moving large machinery and vehicles over soft ground in construction environments.*

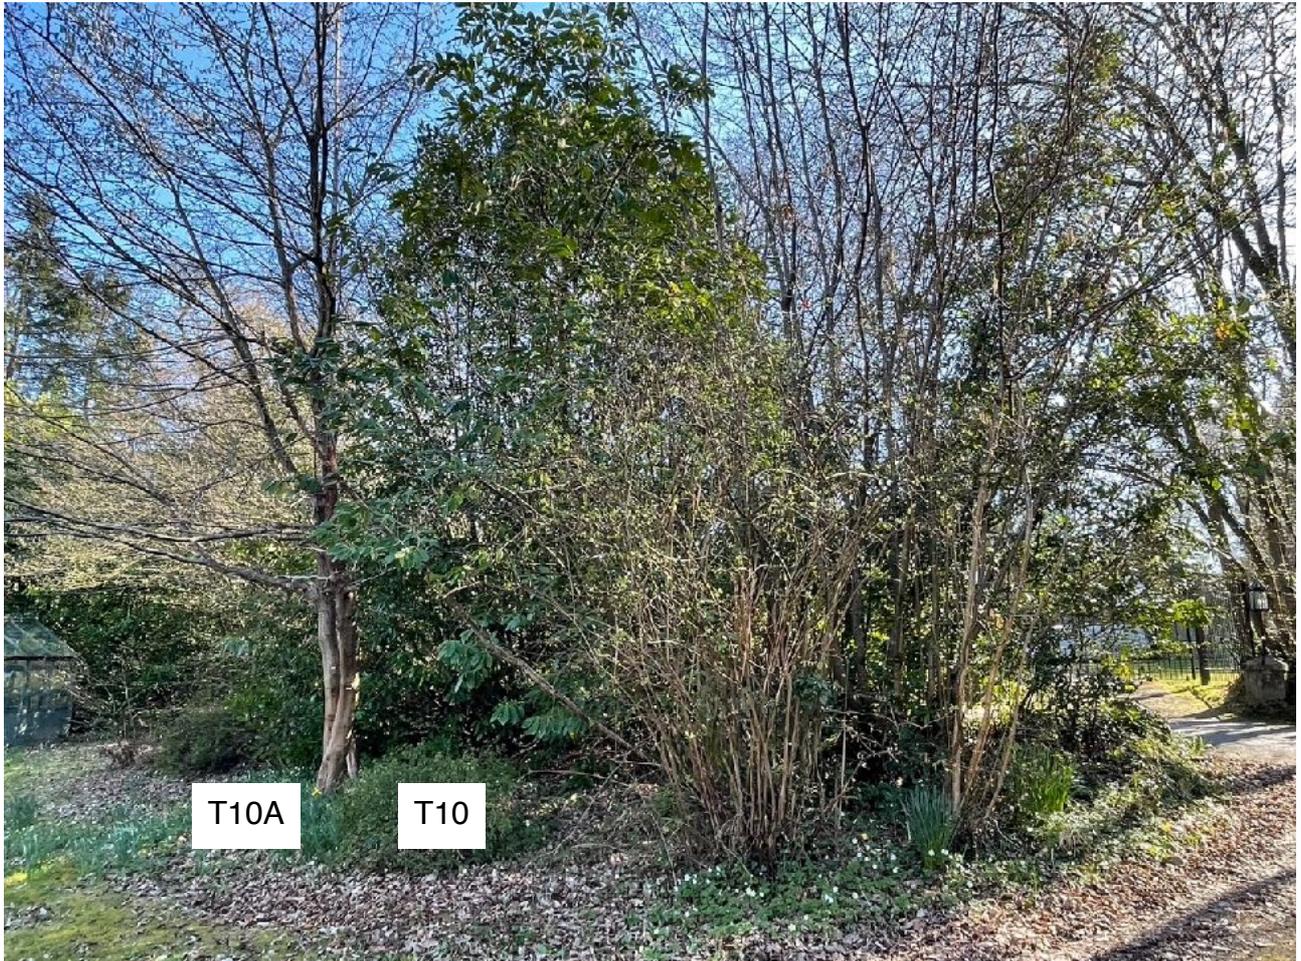
Additional tree work is required is to reduce the front boundary vegetation upon entering the property. This has become overgrown and is restricting normal access. All the trees and shrubs growing here are to be retained for privacy, but require pruning as regular maintenance has lapsed.

Two small trees T10/10A to be removed and the vegetation pruned back to allow improved access
