## HORSHAM DISTRICT COUNCIL CONSULTATION

<b>TO:</b>	Horsham District Council – Planning Dept
<b>LOCATION:</b>	Land to the South of Broadbridge Way Broadbridge Heath
<b>DESCRIPTION:</b>	Full Planning Application for the erection of 89no. residential dwellings comprising dwellings (54no.) and apartments (35no.), 36% affordable homes, creation of new vehicular access on to Sergeant Way, provision of public open space, landscaping and drainage solutions
<b>REFERENCE:</b>	DC/25/0894
<b>RECOMMENDATION:</b>	<b><del>Holding objection / modification</del></b>
<b>RECOMMENDATION: 2<sup>nd</sup> Response in Red</b>	<b><del>Objection maintained, as modification is still needed to address Root Protection Area conflicts and concerns.</del></b>
<b>RECOMMENDATION: 3<sup>rd</sup> response in green</b>	<b><del>Advice / Holding objection withdrawn</del></b>
<b>RECOMMENDATION: 4<sup>th</sup> response in orange</b>	<b>Advice</b>
<b>SUMMARY OF COMMENTS &amp; RECOMMENDATION:</b> <b>The submitted Arboricultural method statement and Tree protection plan are a fair assessment of the tree-related impacts of the development proposals at the site. However, some modification to the site layout is needed to addr

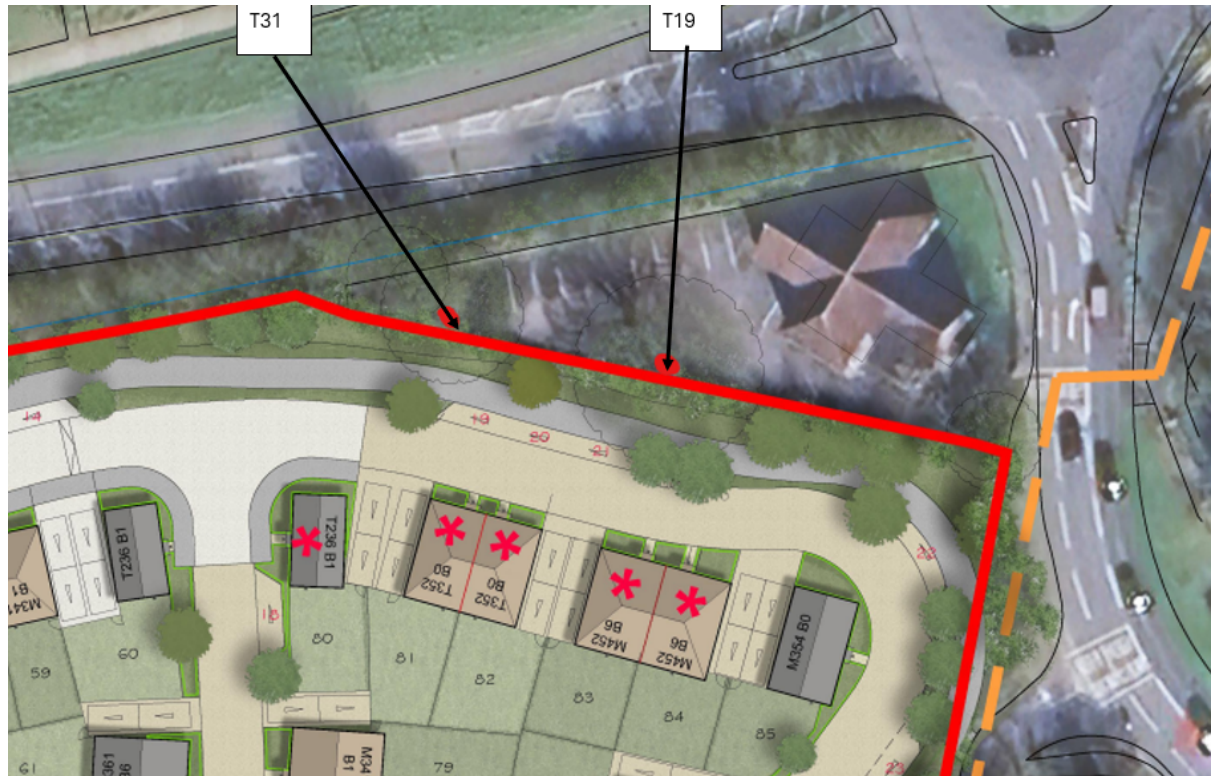
For both T31 and T19, nearly half of the theoretical RPA is currently shown extending beneath an impermeable car park surface to the north. This means that any additional encroachment into the remaining functional (southern) portion of the RPA becomes significantly more critical. As such, based on the current assessment the proposed cycle path, to the south of the trees, in particular, would in my opinion, increase development within the RPA as is currently shown well beyond the 20% threshold generally accepted within BS5837, further exacerbating non-compliance with the BS.

PROPOSED SITE LAYOUT showing the carpark to the north of T31 & T19

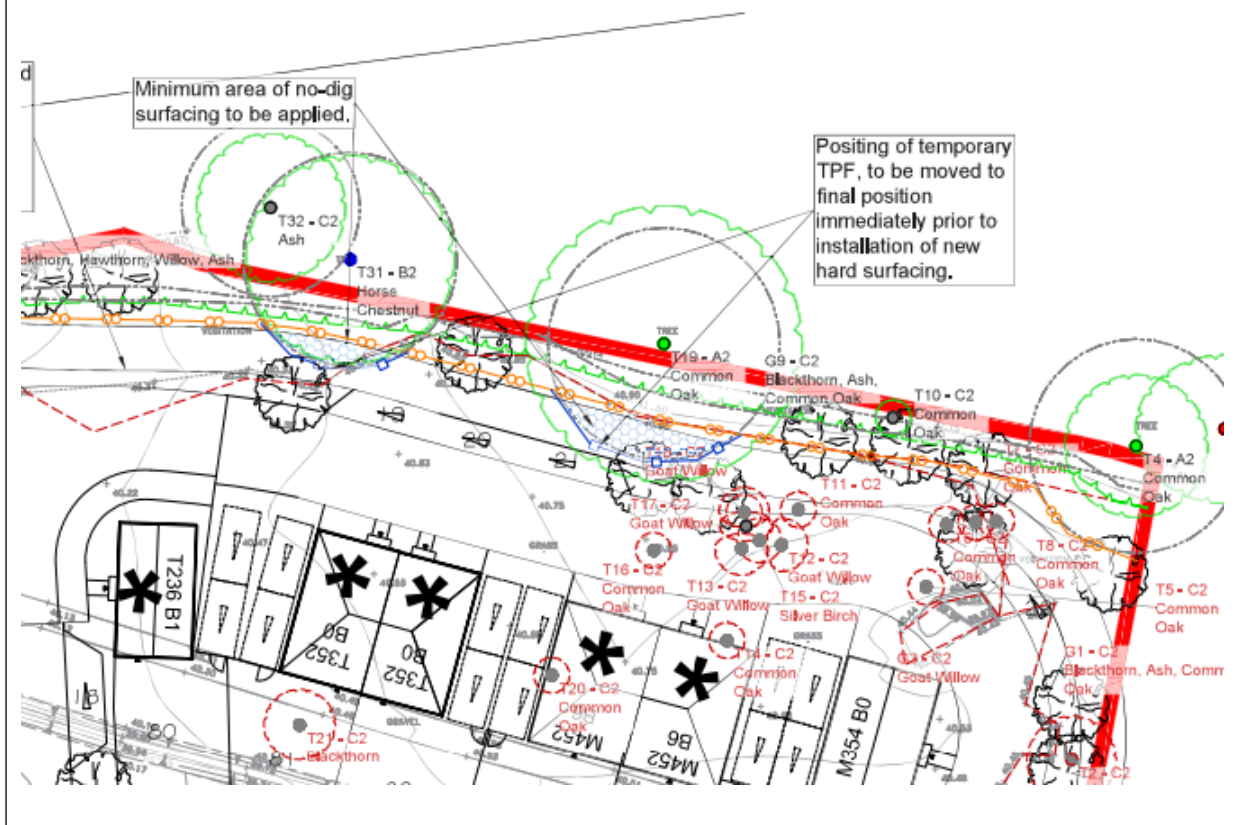
Tree Protection Plan DWG NO: VYH24657-03A Sheet 2 of 2. It should be noted that the date on the new TPP has not been updated from the 17/04/2025 submission, despite the plans and site layout having been altered.

Given the likely southward rooting bias for T31 and T19, caused by the existing hardstanding, the proposed new road to the south is expected to lie partially or wholly within the functional RPAs of T31 and T34. No mitigation measures have been proposed to address this conflict. As such, the scheme is not considered to be compliant with BS5837 and is likely to result in significant, delayed-onset harm to these trees over the next 5–10 years, due to construction activity and root loss/damage within their key rooting areas, unless the layout is amended accordingly.

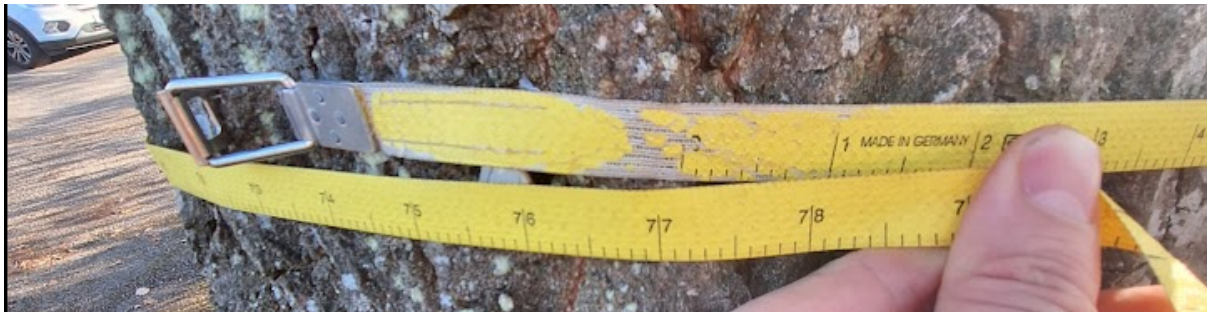
In the case of T19, surface rooting was evident within the car park to the north, with clear signs of root disturbance in the surface of the car park, and evident patch repairs. As such my earlier concerns regarding the apparent absence of rooting to the north beneath the car park have been mostly addressed by on-site observations. However, the original stem diameter recorded in the tree survey is incorrect. It was recorded in the tree survey as 650 mm given the tree an RPA of 7.8m, whereas the true measurement is 770 mm, which, although seemingly modest, this equates to an RPA of approximately 9.2m and an additional 1.4m to the circumference of the calculated RPA, as is presently shown.

T19	Quercus robur (Common Oak)	15(4)	650(1)	9	9.3	9.3	9.3	EM	40+	Offsite tree, diameter estimated. Deadwood visible in western aspect of Crown.	A2
-----	-------------------------------	-------	--------	---	-----	-----	-----	----	-----	--	----

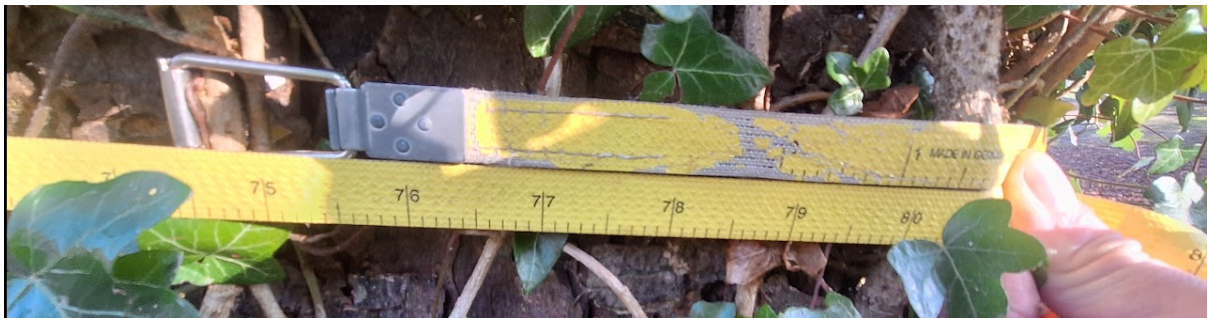
In addition, for the Horse chestnut T31, a stem diameter at 1.5 m could not be measured due to bifurcation and stem bulging, so a measurement was instead taken at 1m above ground level (over ivy), recorded as being just under 790 mm compared to the 600 mm stated in the tree survey, which equates to an RPA of approximately 7.2m. However, if the RPA is based on my measurements, there is a discrepancy between the measurements, and results in an approximate 2m increase in the RPA compared with what is currently shown on the TPP. Whereby, the RPA of T31, presently shown as 7.2m would in fact be 9.2m when the ivy on the stem is considered.

T31	Aesculus hippocastanum (Horse Chestnut)	14(4)	600(1)	7	7	7	7	M	20+	Ownership of tree unclear. Tree situated behind dense group and undergrowth. Adjoining Ash tree on western aspect, location and impact to site uncertain.	B2
-----	---	-------	--------	---	---	---	---	---	-----	--	----
