HORSHAM DISTRICT COUNCIL CONSULTATION

TO:	Horsham District Council – Planning Dept
LOCATION:	Land East of Tilletts Lane Warnham
DESCRIPTION:	Erection of 59 dwellings with associated open space, landscaping, parking, access, and drainage infrastructure.
REFERENCE:	DC/25/1155
RECOMMENDATION:	Advice / Modification / Holding Objection to the current position of the access road within the RPA of T59, and the foreseeable impact this will have on the tree's viability for long term retention.
SUMMARY OF COMMENTS & RECOMMENDATION: The application has been supported by a detailed Arboricultural Impact Assessment and Preliminary Methods Statement, and a Tree Protection Plan, however, concerns are raised with the site access and the foreseeable impact this will have on the off-site Oak T59 with regards to tree's viability for successful long-term retention.

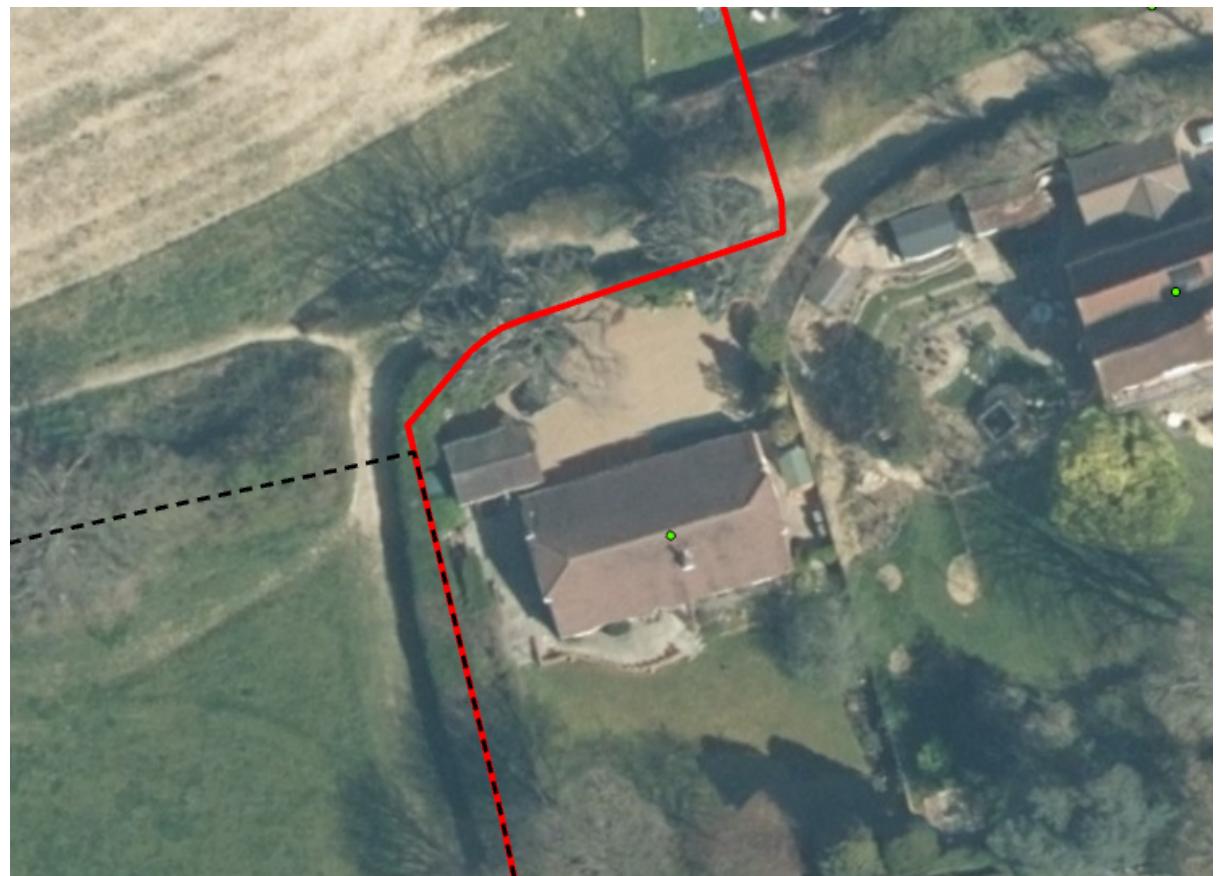
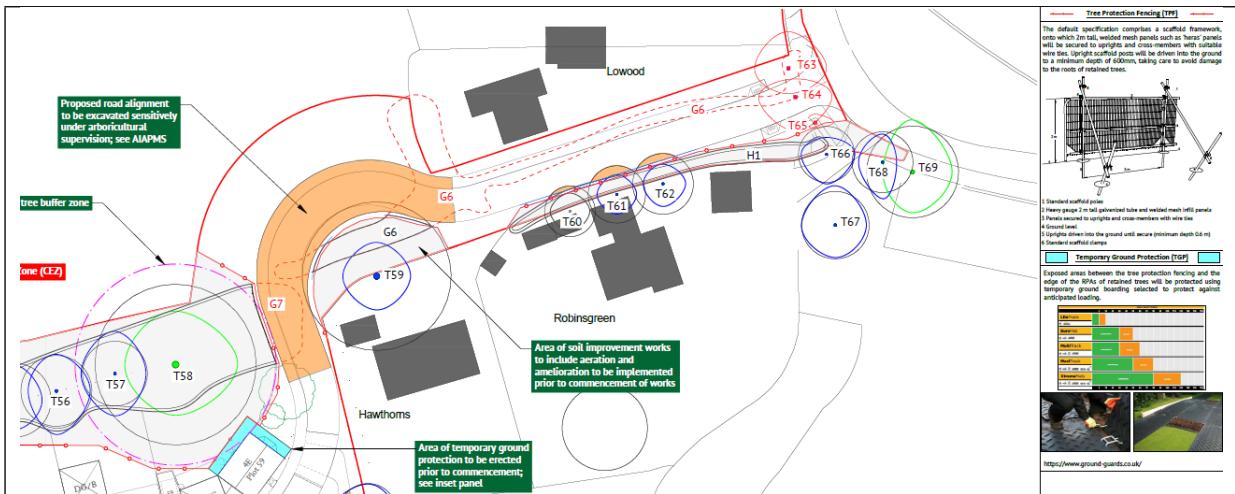
The area immediately south of T59 is occupied by the property's principal parking area and garage. The tree sits on slightly elevated ground relative to this area, possibly due to excavation works undertaken to create a level surface at the time of property construction. The parking area is predominantly surfaced with shingle, please see below

Due to the constraint posed by the change in land levels and the parking area to the south of T59, it would imply that the tree’s principal rooting area lies to its north, beneath the compacted trackway/PROW, where the new site access is shown. Whereby, the long-standing parking area to the south has most likely impeded any significant root development in that direction and, in itself, constitutes a significant proportion of hard surfacing within T59’s RPA, as indicated on the Tree Protection Plan. When combined with the proposed 8.8% incursion, the cumulative extent of hard surfacing within the RPA would exceed the tolerable limits of 20%, as advised in the BS.

As such, even with the proposed mitigation, the excavation required for the road would almost certainly result in the loss of a significant proportion of T59’s key rooting area and rooting volume. This action would be detrimental to the trees health and compromise its long-term retention potential.

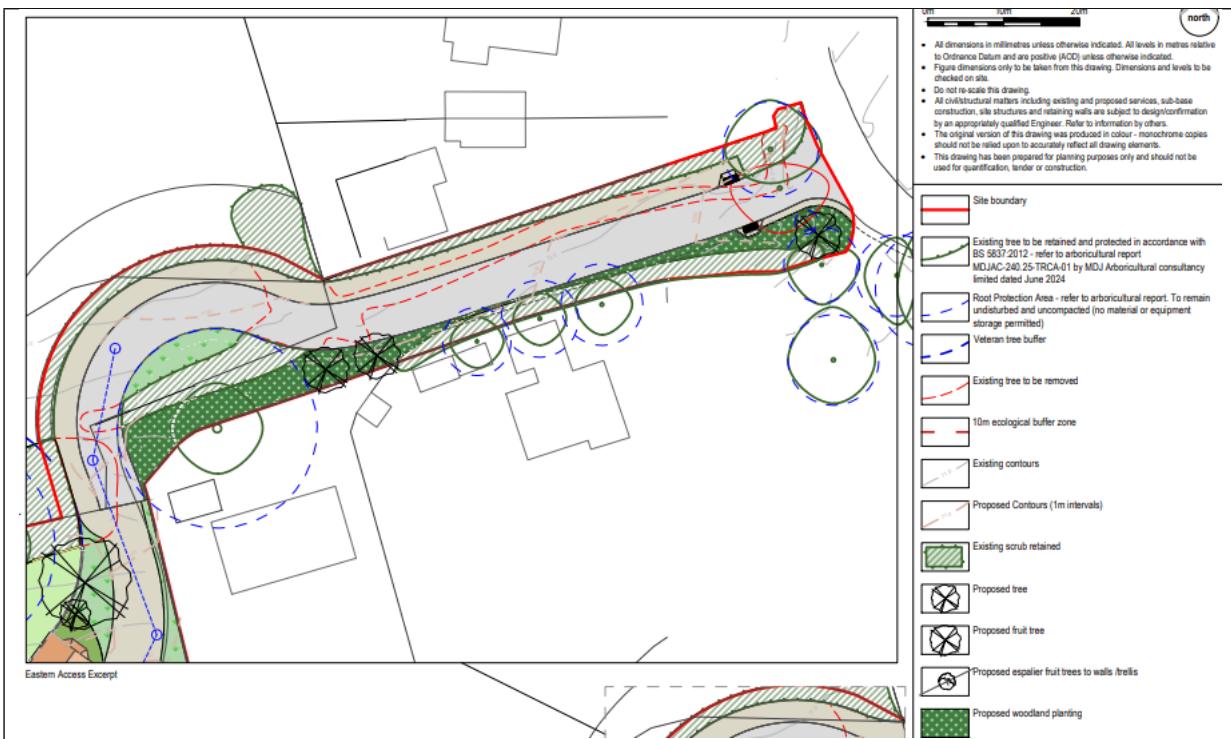
Furthermore, the proposed drainage strategy indicates that underground services requiring open trenches would also fall within T59’s RPA, as with the building of the road, this action and the root severance that it would entail have the capacity to significantly impact T59’s condition and long-term retention potential and is unsatisfactory.
