Arboricultural Report
composed of
Arboricultural Impact Assessment
Arboricultural Method Statement
& Tree Protection Plan
for
Haynes, Littleworth Lane
Partridge Green Horsham
West Sussex RH13 8JF
Written by
Barry Holdsworth MBA, RHS. Dip, MCI Hort, M.Arbor.A, MCMI
Horticultural Consultant
12th August 2025

Site Location: Haynes, Littleworth Lane Partridge Green Horsham West Sussex RH13 8JF

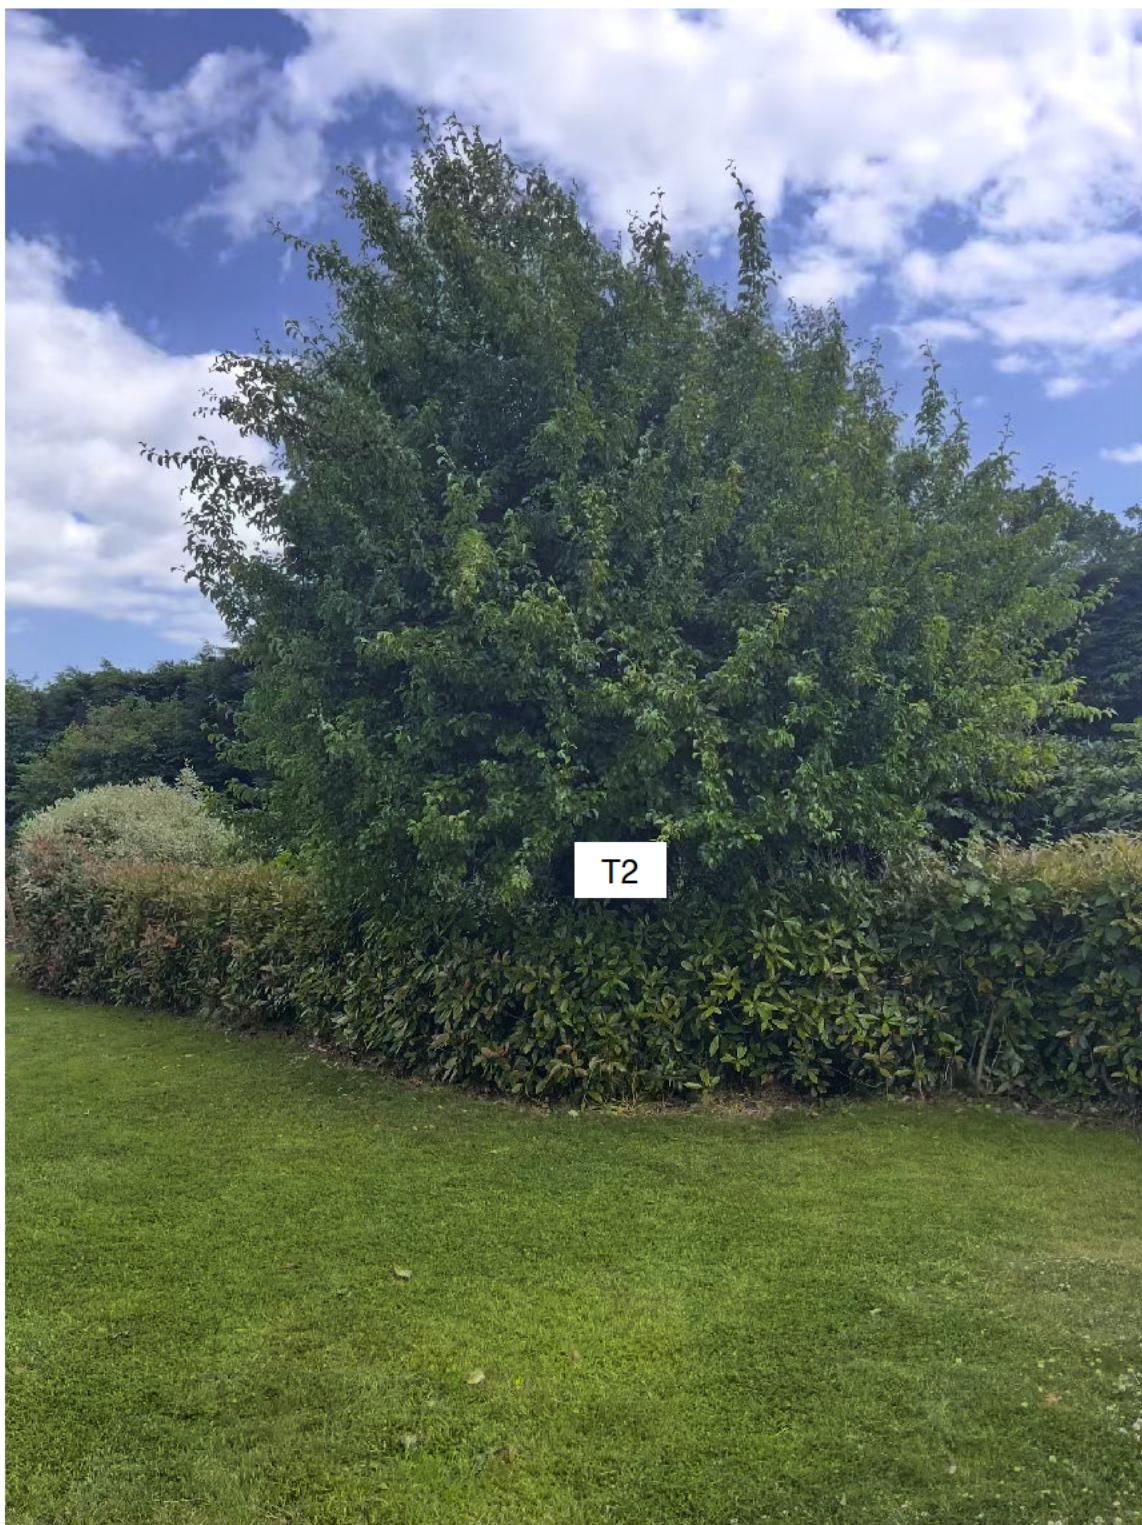
Site of access drive requiring the removal of the Photinia hedge and T2

The small group of trees G1 (Category C) being a mixture of Elm and Wild Plum is to be removed for the drive along with the Pear tree T2 (Category C), the Photinia hedge H3 (Category C) and shrubs within the footprint of the drive.

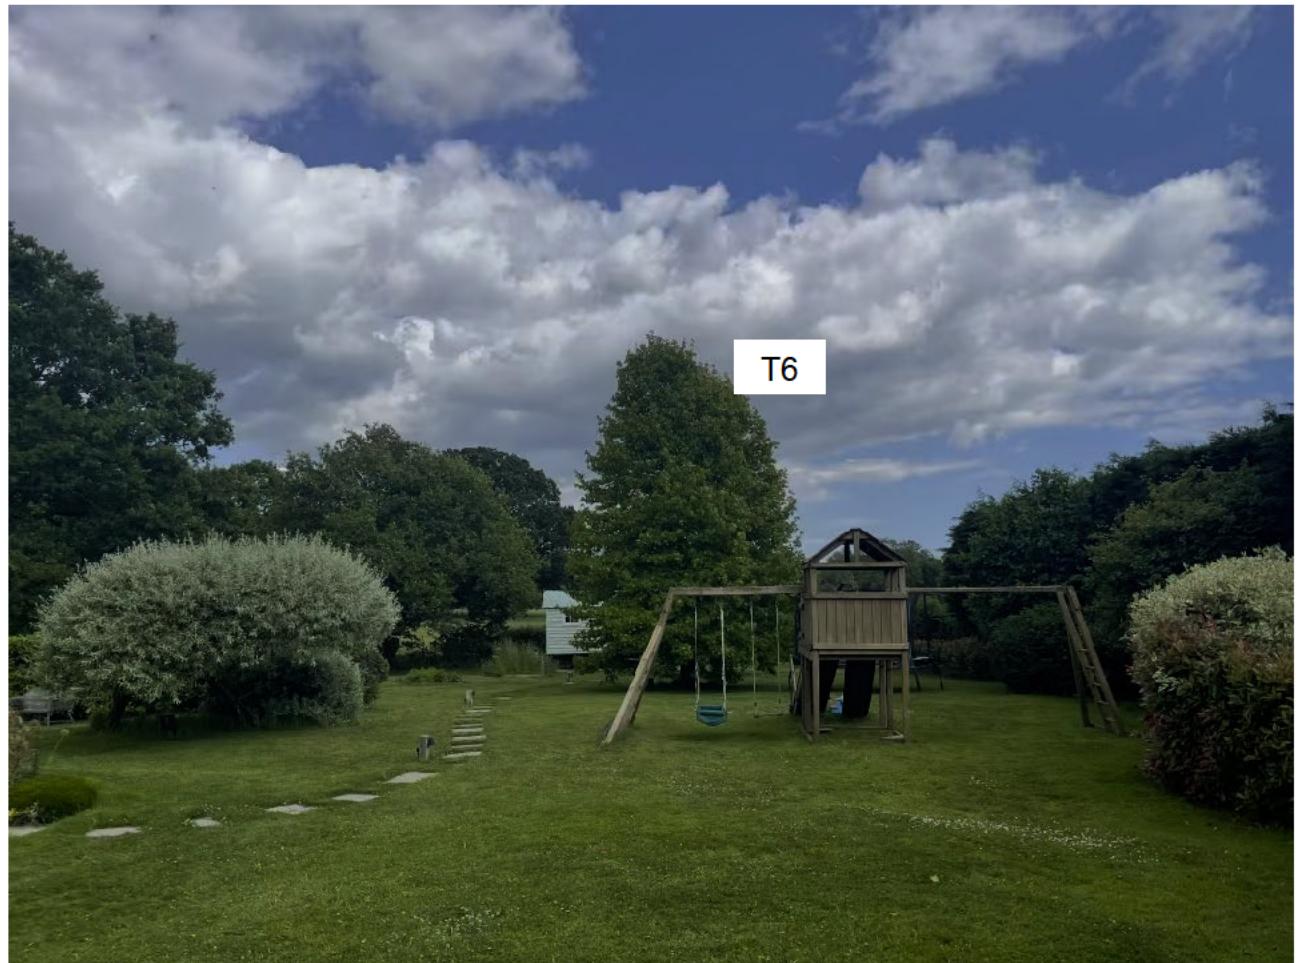
Access drive on right of picture with parking and turning where playground is sited. T6 to be removed to site new house

The house footprint will require the loss of the Sweet Gum T6 (Category B).
