**Arboricultural Report**  
**composed of**  
**Arboricultural Impact Assessment**  
**Arboricultural Method Statement**  
**& Tree Protection Plan**  
for  
3 Station Road, Billingshurst,  
West Sussex, RH14 9RF  
Written by  
Barry Holdsworth MBA, RHS. Dip, MCI Hort, M.Arbor.A, MCMI  
Horticultural Consultant  
12th September 2025

Site Location: 3 Station Road, Billingshurst, West Sussex, RH14 9RF

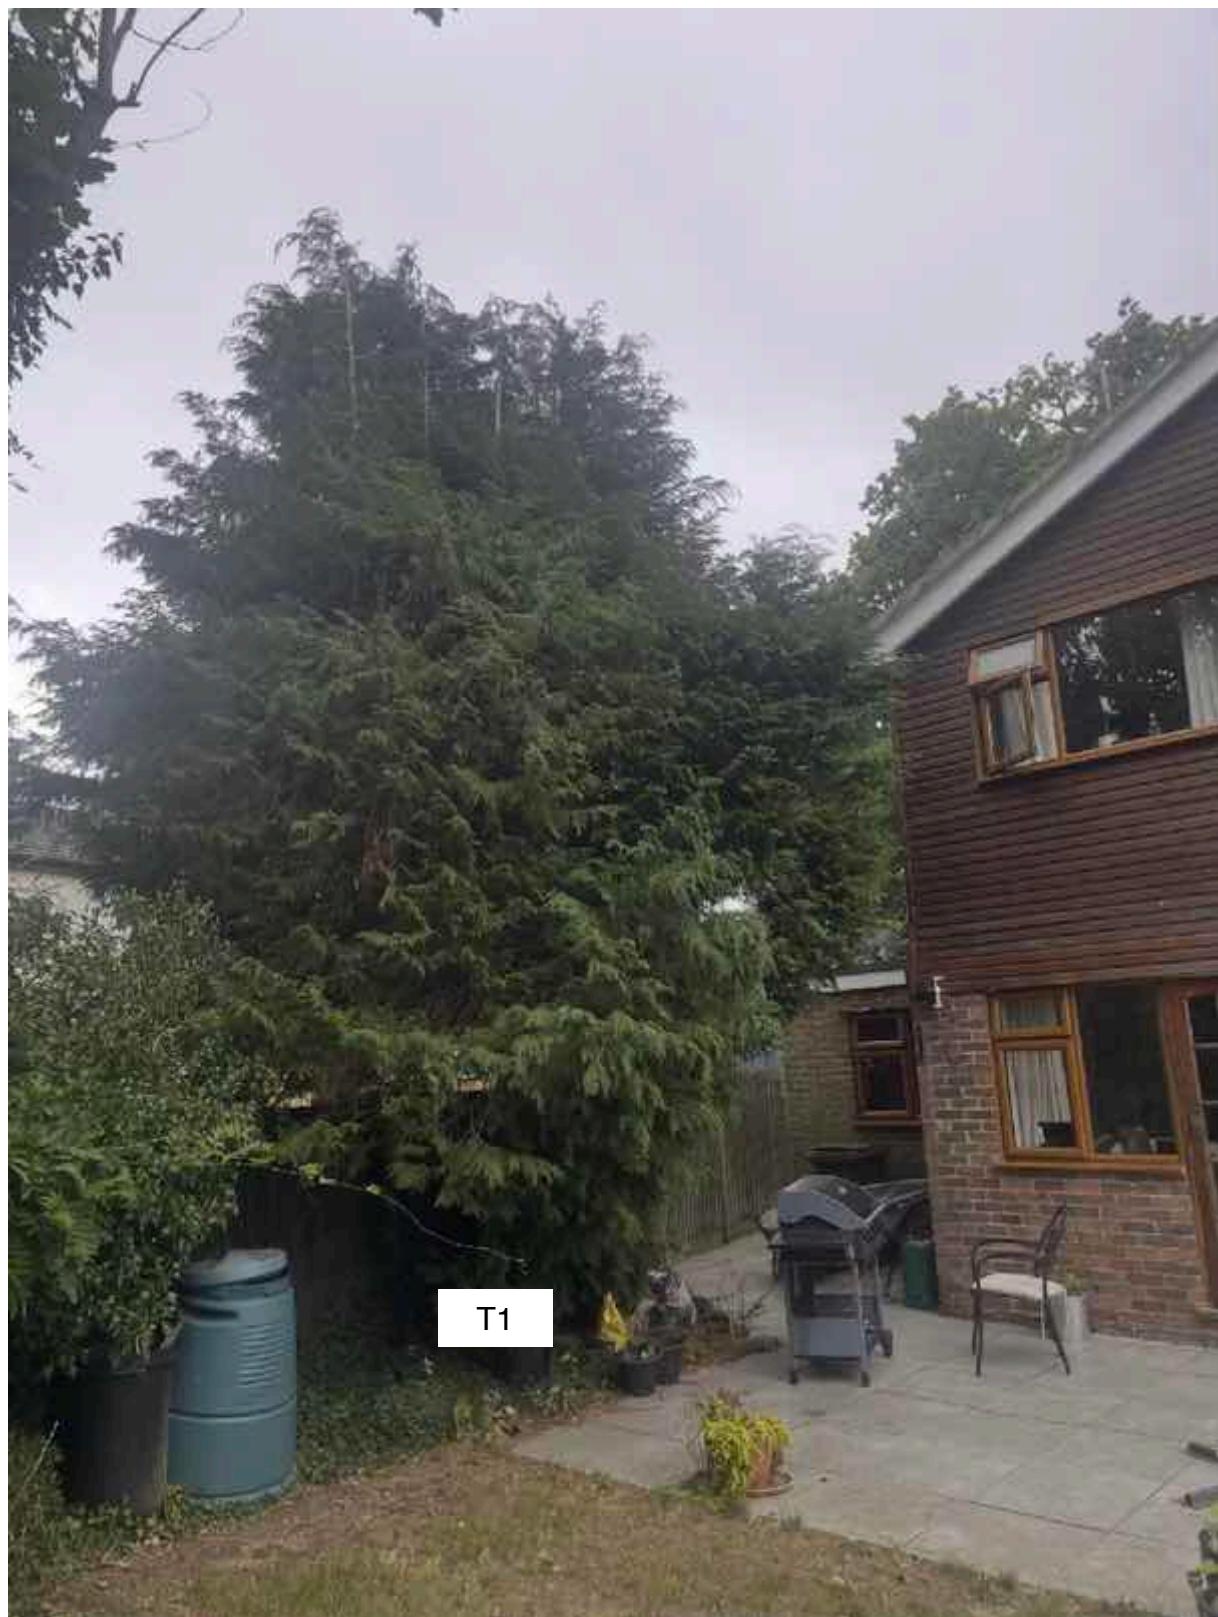
3.5.2. The trees that have been selected for removal are T1 Conifer tree (Class C - tree of low quality) and T2 Tulip Tree (U Class - trees unsuitable for retention).

T1 Conifer to be removed

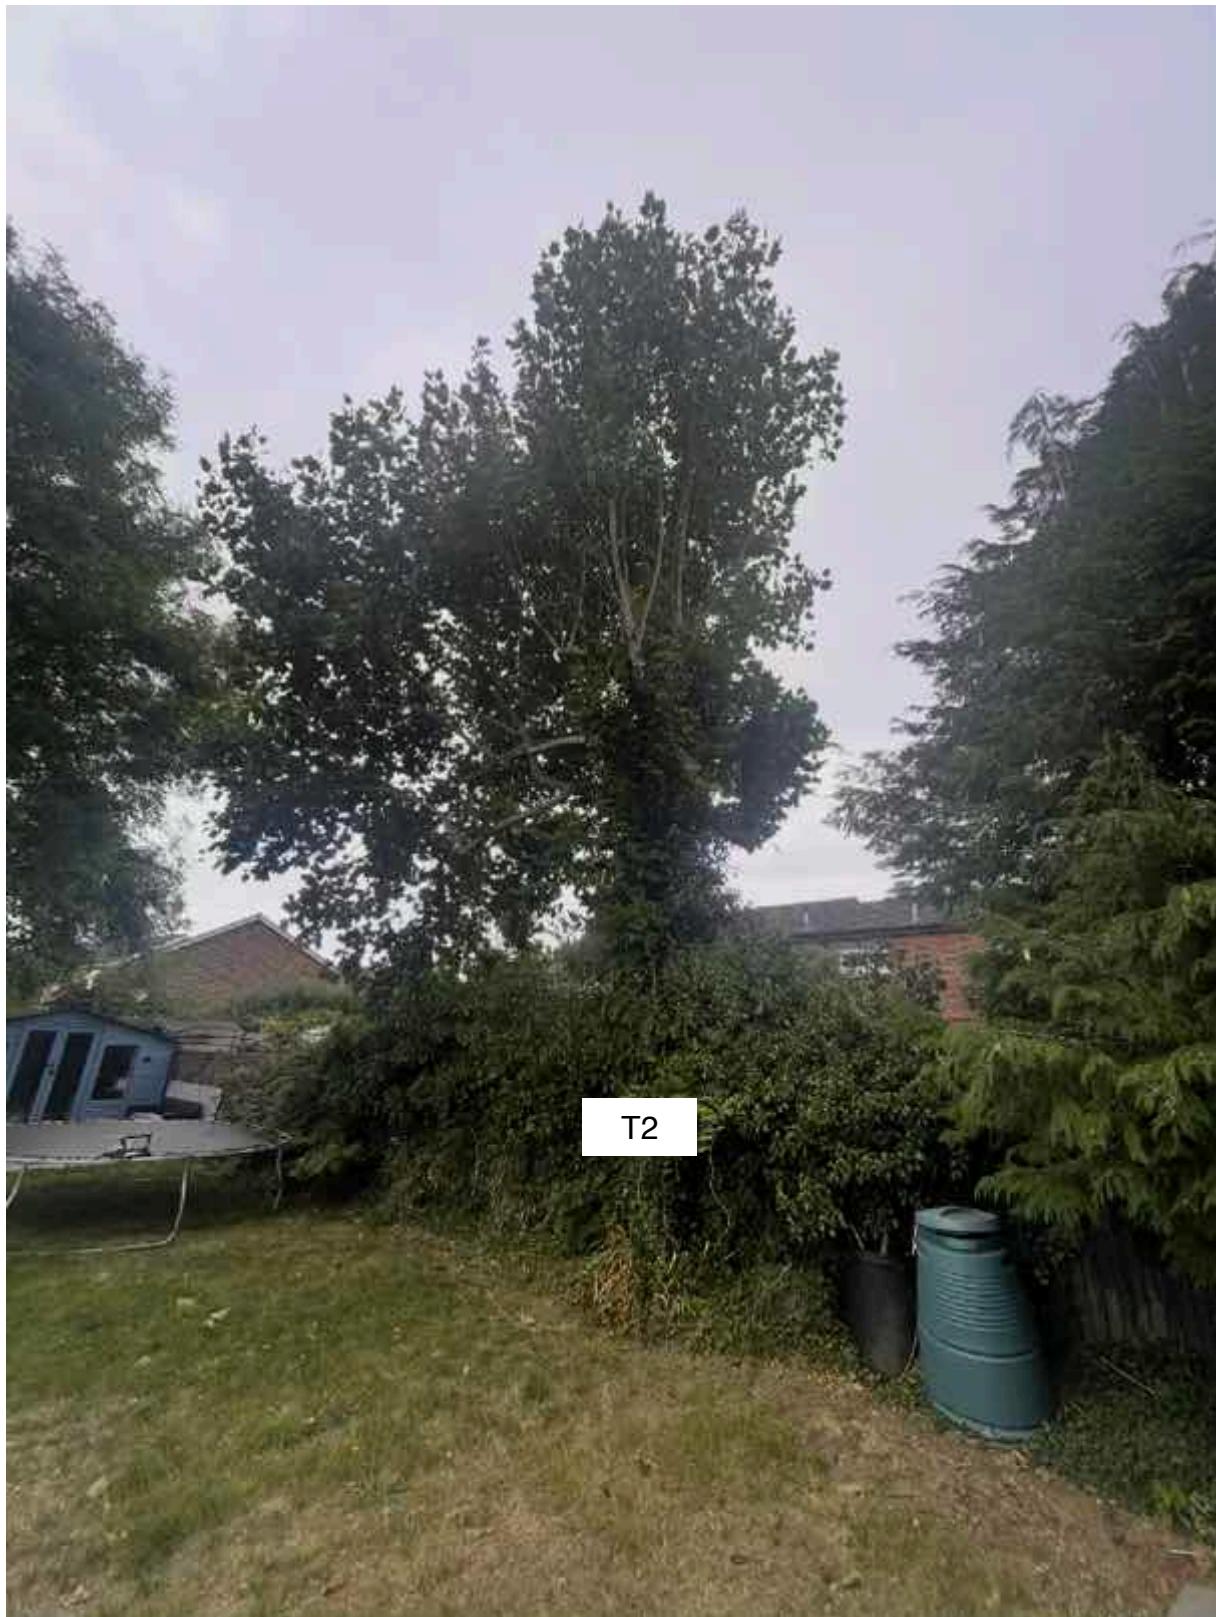
T2 Tulip tree to be removed

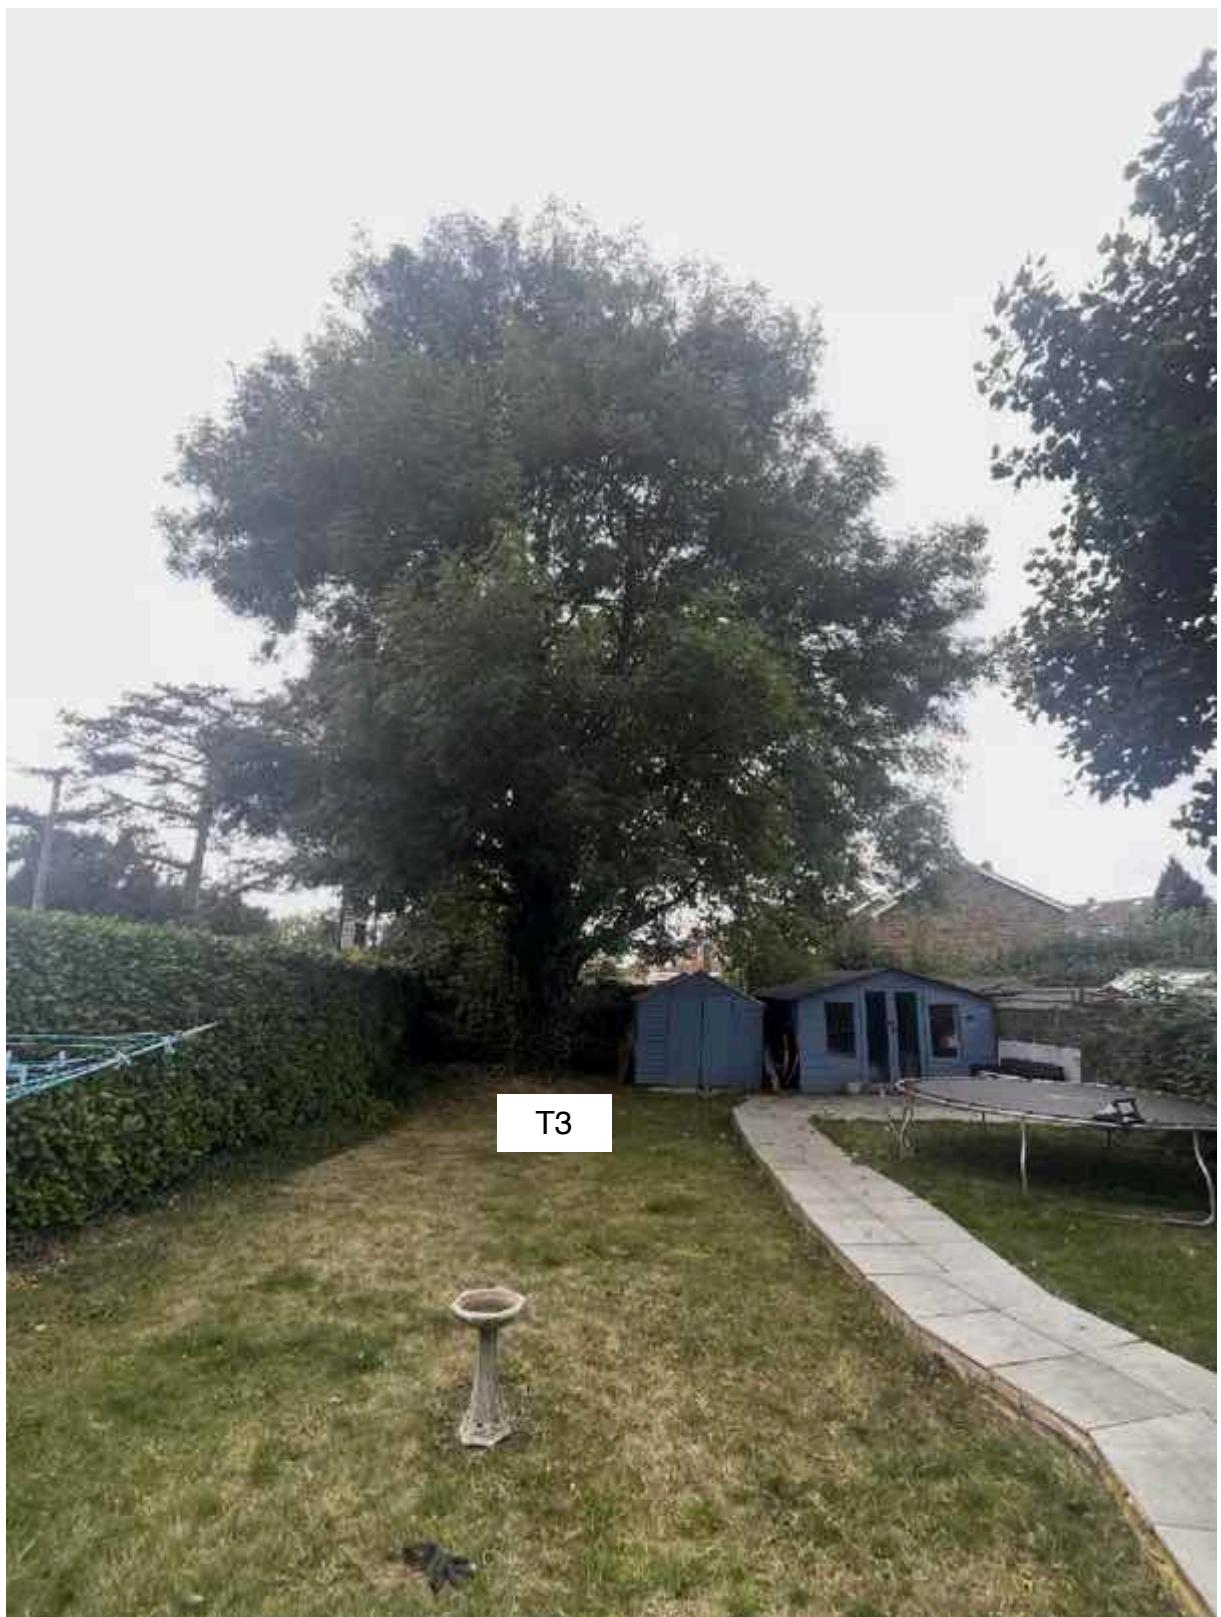
T3 Ash tree - TPO tree

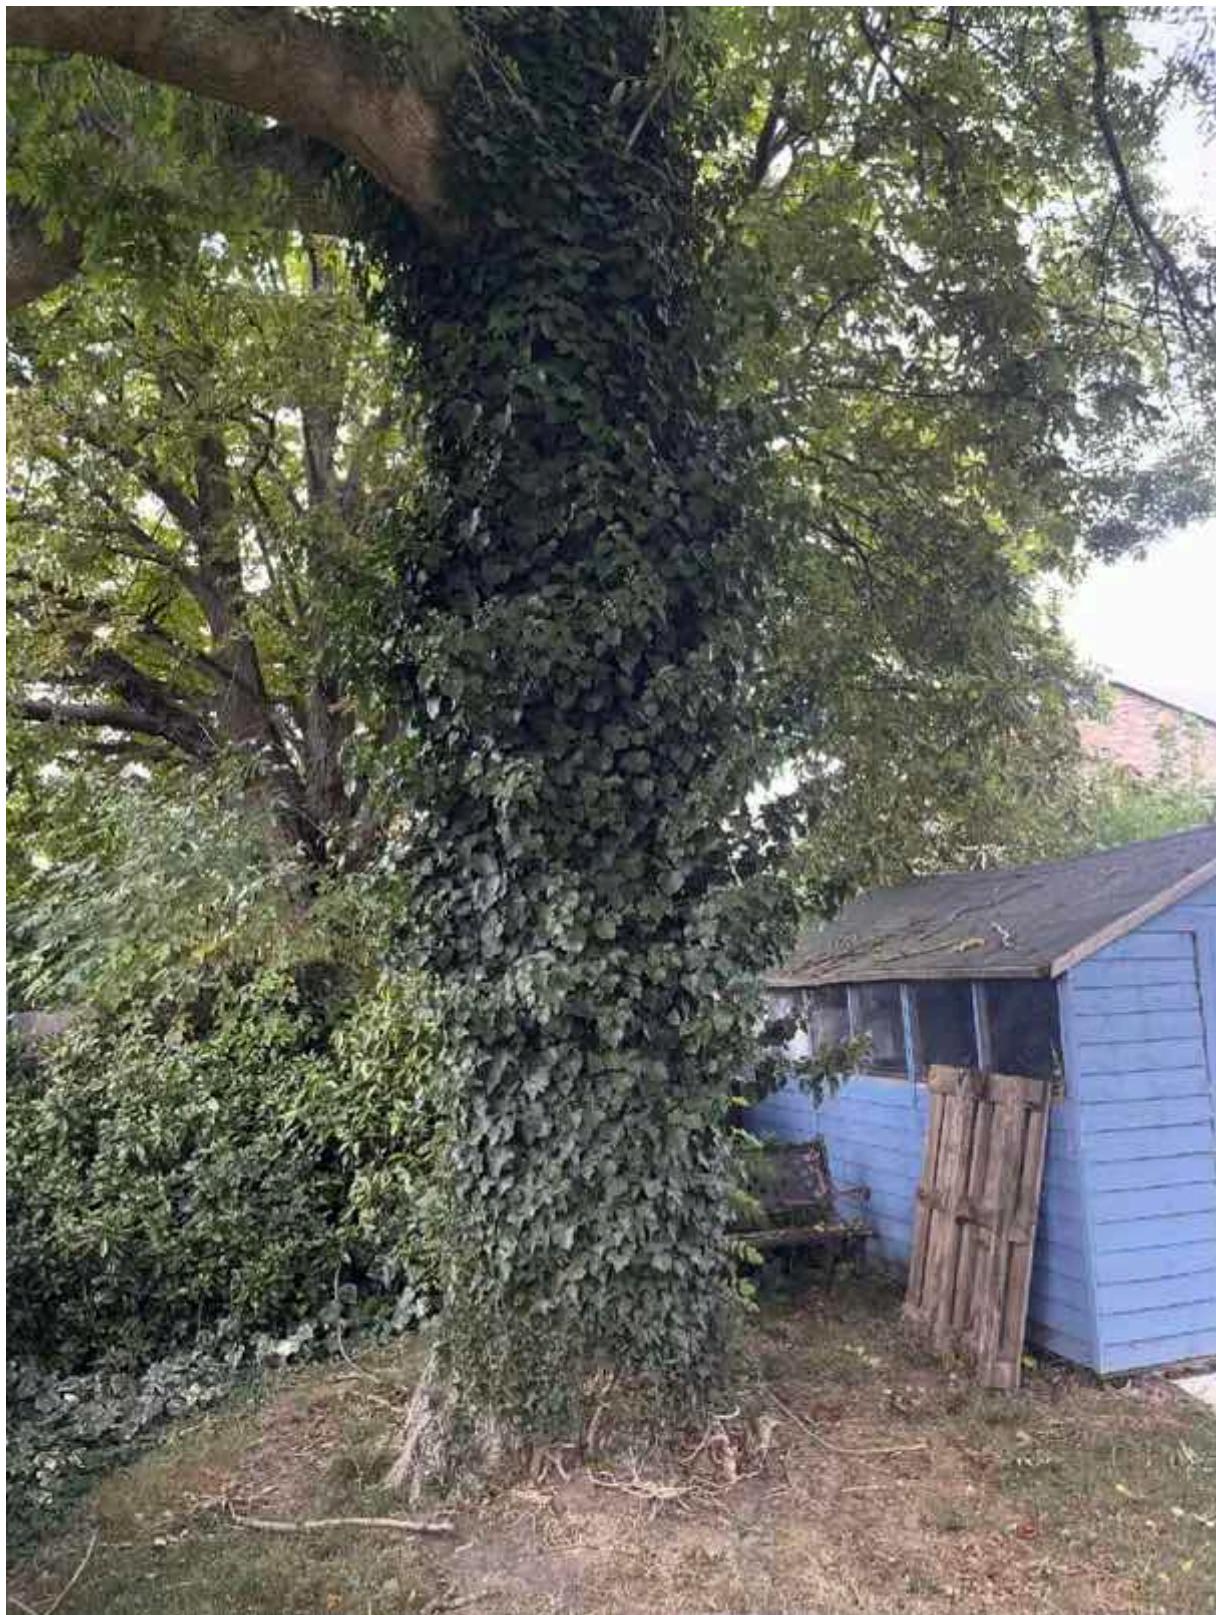
T3 Ash tree - remove ivy and wooden sheds around baser of tree

An improvement to be gained with this scheme is the removal of the sheds and pathway found within the rear garden at present. The removal of these items will allow the Ash tree T5 improved ground conditions for the roots of the tree. It is recommend that no sheds or paths are re-instated after the works have concluded to provide a permanent improvement in this regard.

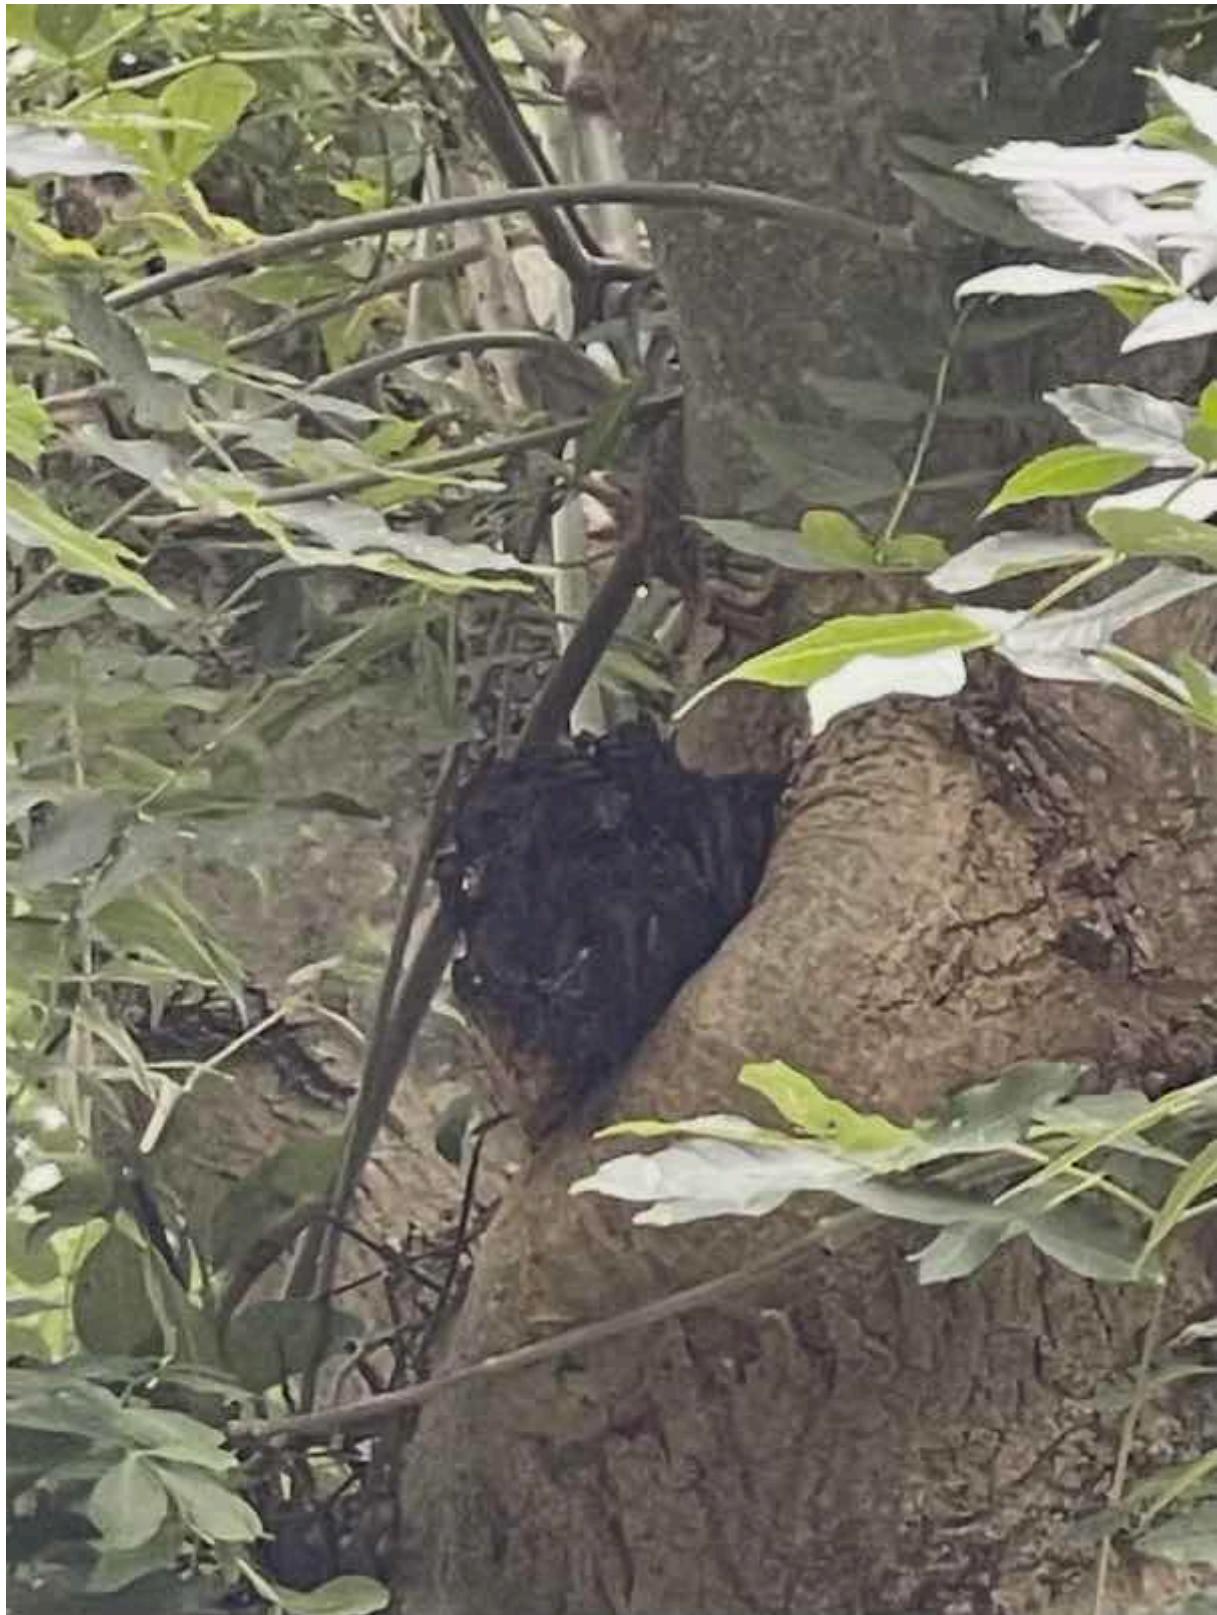
The Ash tree T3 has a total RPA of 248m<sup>2</sup> and the footprint of the new detached house has an incursion of 11m<sup>2</sup>, allowing for foundation works to slightly increase this figure it is still within acceptable limits. The roof of the detached house may interfere with the outer reaches of the canopy of the Ash tree and it is therefore noted that some lifting, or canopy reduction of the tree in that area maybe required. Whilst this is undertaken inspection of the black fungal growth located at 8m high on the end of a main branch to the south can be carried out. If this is *Inonotus hispidus* which causes a white rot in the trunk, then it is recommended that the local Tree Officer be informed and appropriate action be taken for the health of the tree.

T3 Ash tree - possible fruiting body of *Inonotus hispidus* to be inspected

Inspection of the trees T3 and T5 by the Tree Officer is recommended with regard to the fruiting fungal bodies found on the trees as indicated within this report.

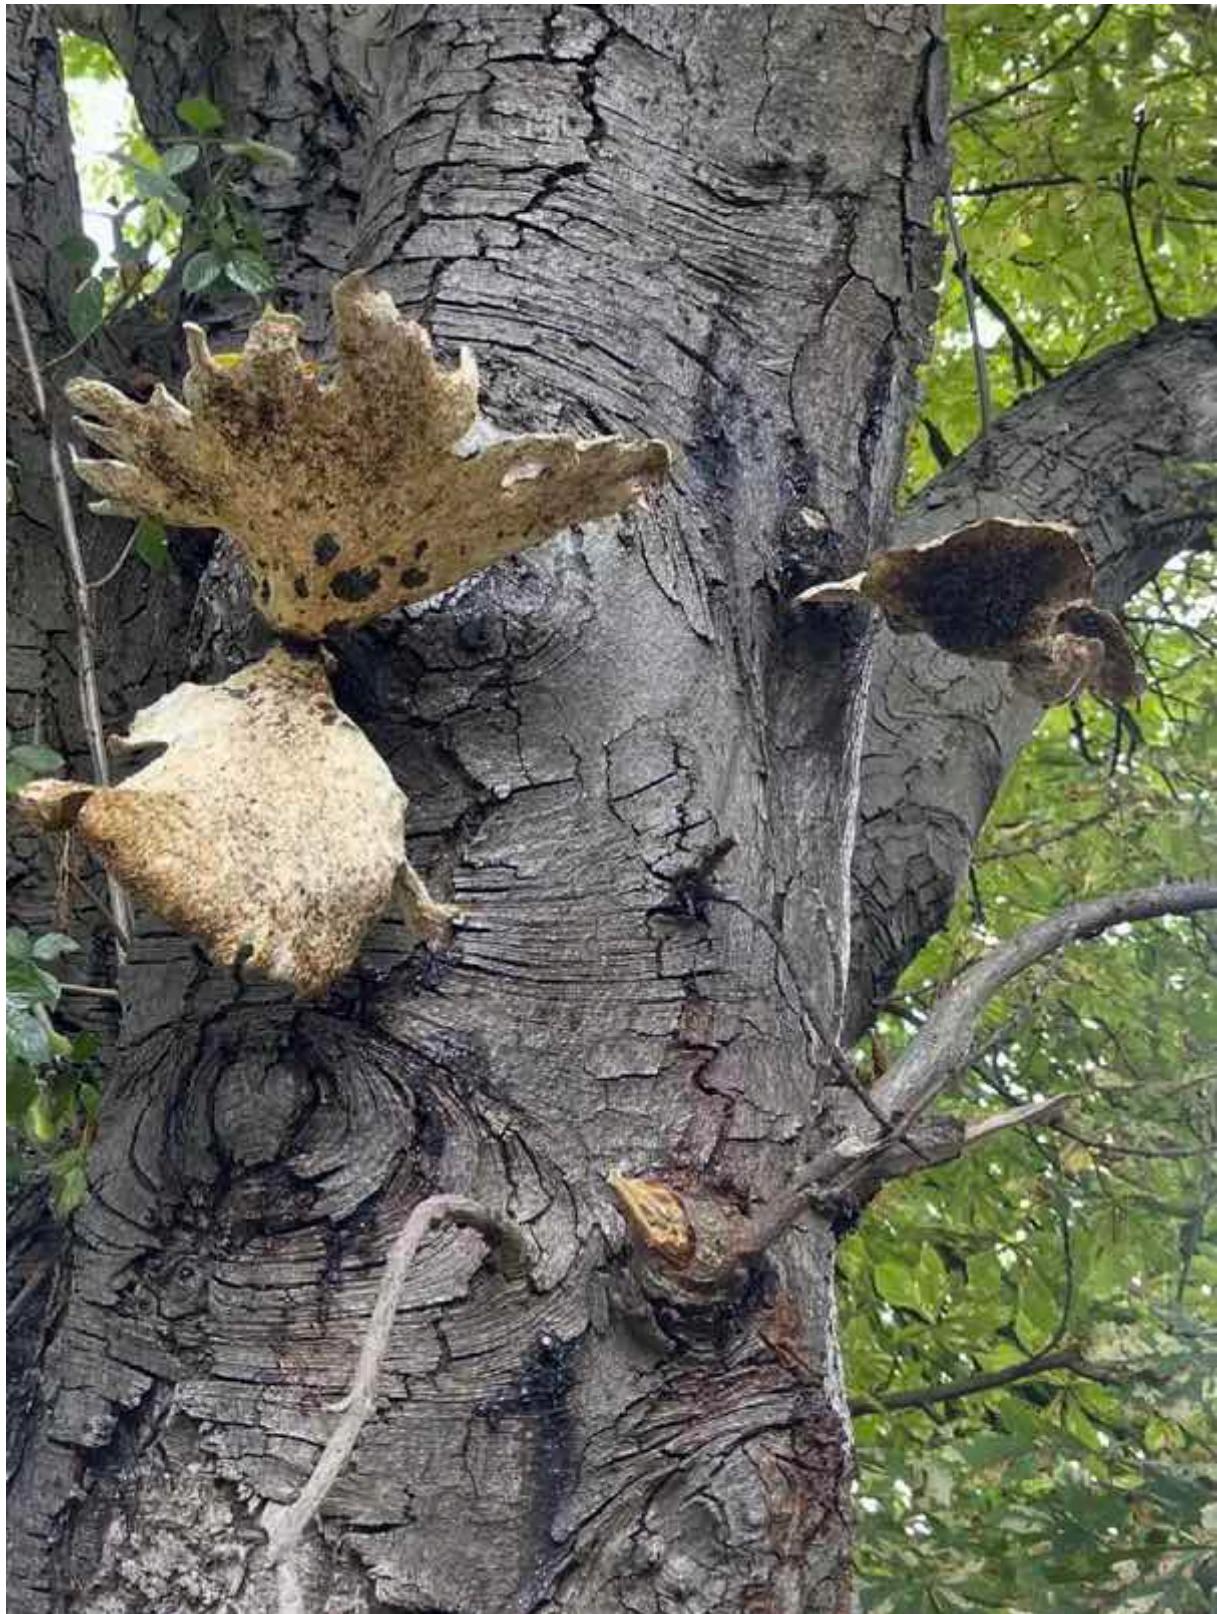
Outside the site is the Horse Chestnut tree T5, which has Oyster Mushroom fungal growth. The presence of Oyster Mushroom (*Pleurotus ostreatus*) on a Horse chestnut tree indicates the tree is in a state of decay as this is a saprobic fungus that causes white rot, decomposing the wood of the host tree. The tree also has a number of areas of canker staining. It is recommended that the local Tree Officer be informed and appropriate action be taken for the health of the tree.

Horse Chestnut T5 with fruiting bodies of Oyster Mushroom (*Pleurotus ostreatus*)

0.5-2m on northeast and south sides of main trunk Oyster mushrooms ( <i>Pleurotus ostreatus</i> ) found on dead limb sited on south side of tree @4m <b>Recommend:</b> Remove limb with <i>Pleurotus ostreatus</i> present and internal inspection be carried out				
<b>T6</b>	Oak <i>Quercus robur</i> T4 - TPO 1979	24	935	20.0Ø	6mN	M	Physiological Condition: Fair Structural Condition: Good Public Amenity Value: High Inspection Limitations: None Lost limb at g/l, wind healed well - heartwood revealed Bleeding canker ( <i>Phytophthora</i> ) @0.5 and 1.5m W side <b>Recommend:</b> Biannual inspection regarding canker infection	N Monitor	>40 <24	B2	11.22

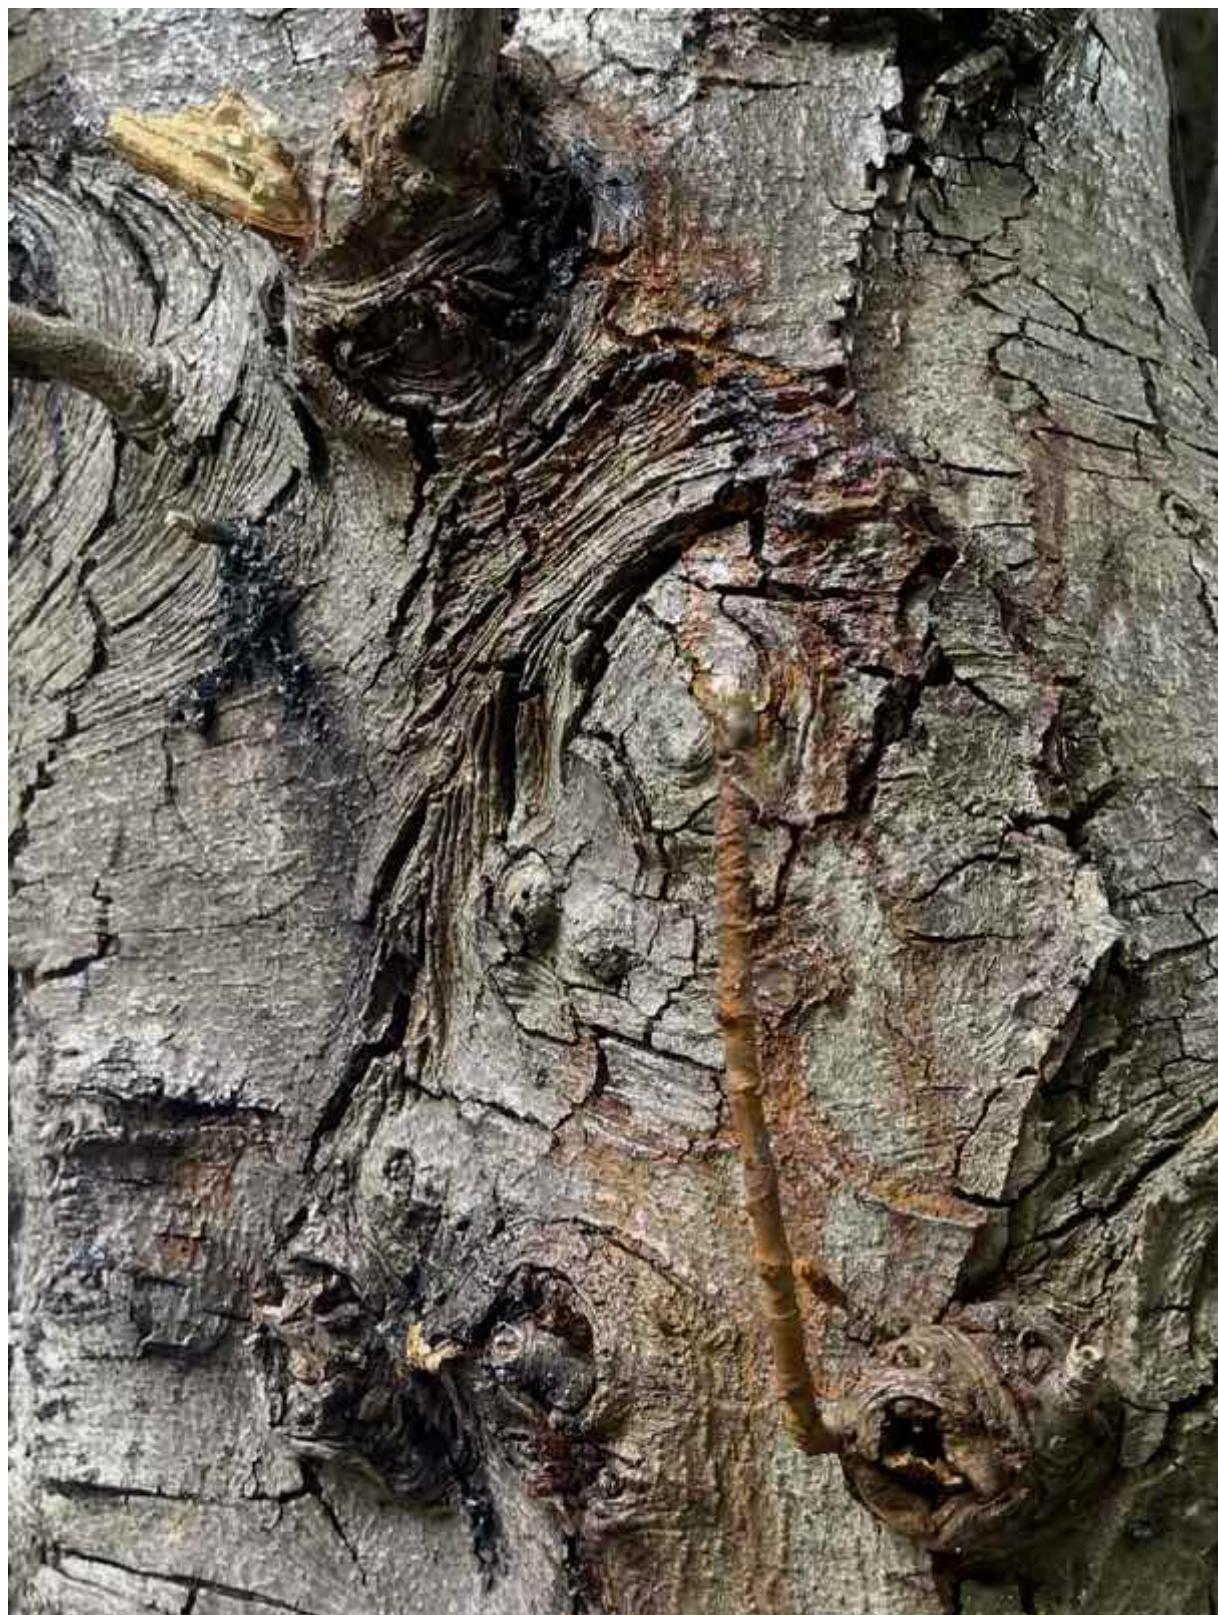
Horse Chestnut T5 with canker

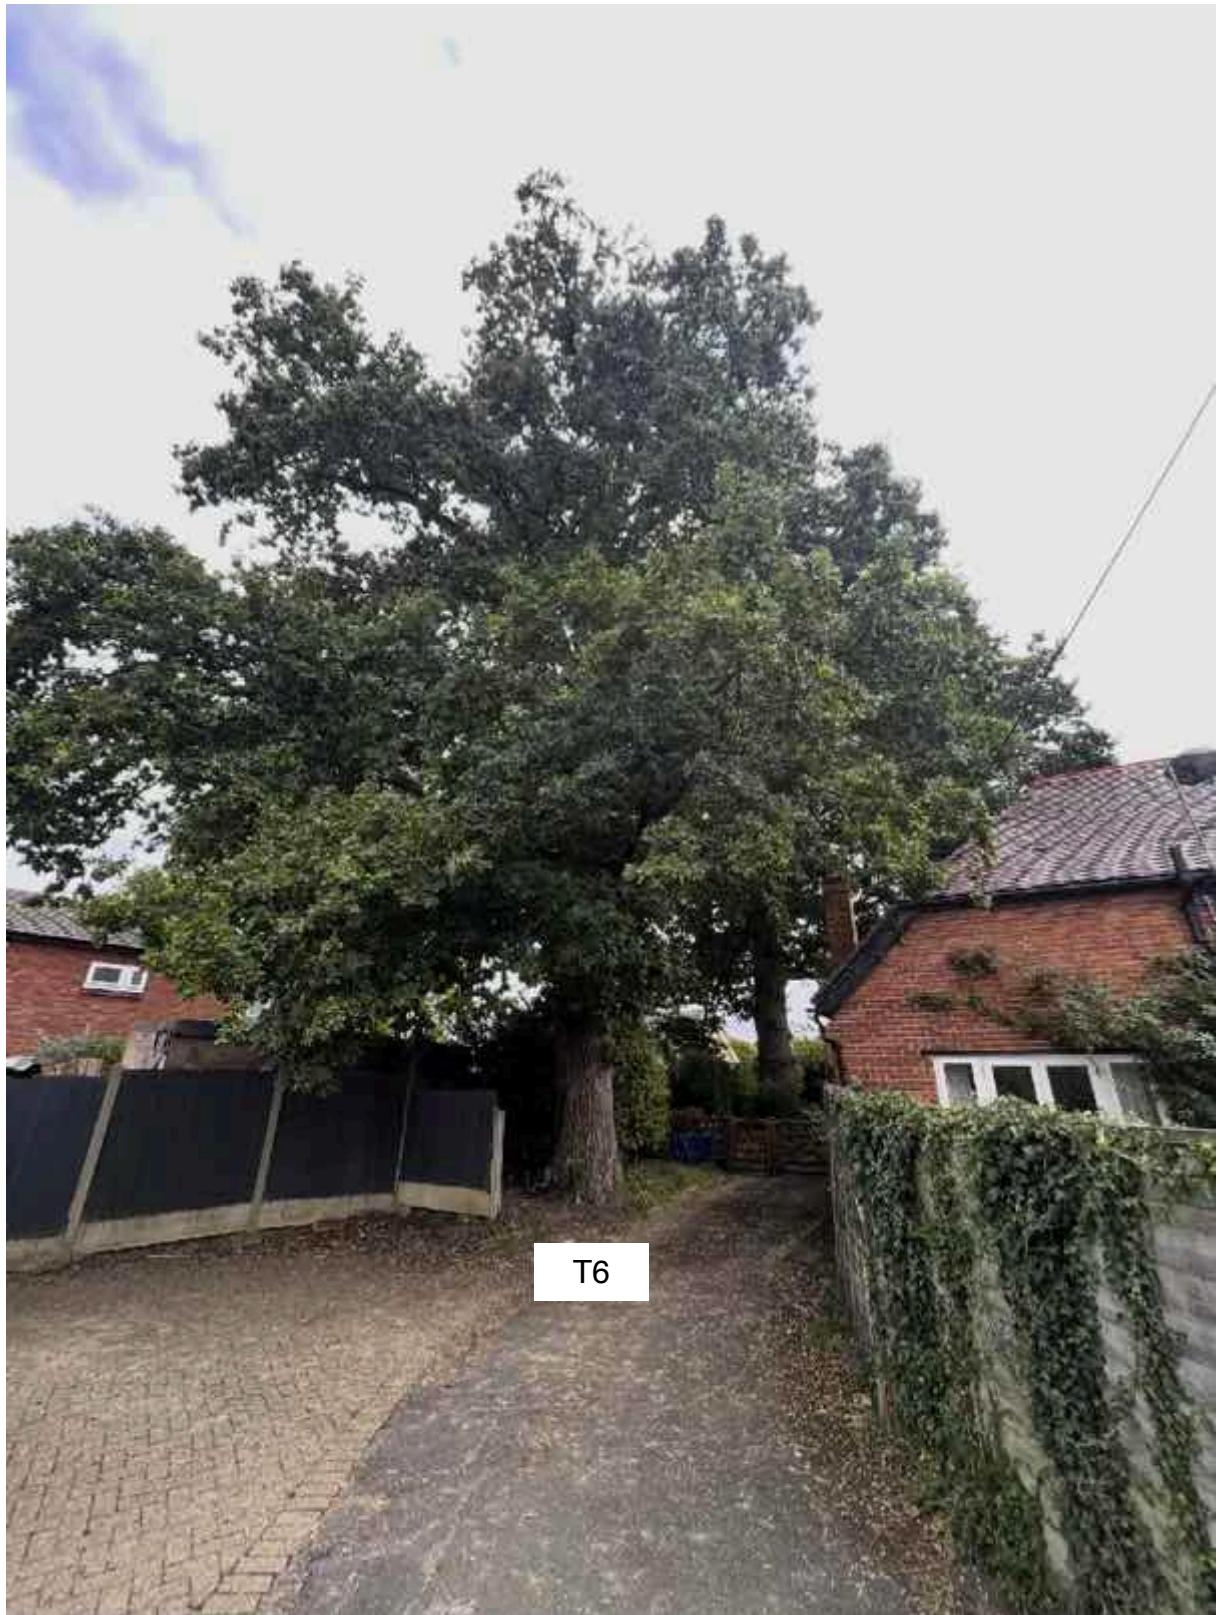
The Oak tree T6 sits outside the site boundary, however, the roots and canopy oversail the car parking area. This area is block paved and is already used for parking, but provision for a more permeable surface for the new parking area will be required. The removal of the existing surface and installation of the new materials will require monitoring to ensure that the root system of T6 is maintained in good condition and not damaged during this operation. Ground protection will be required for the duration of the build to ensure compaction of the ground this area is not compromised.

Oak tree T6 and existing parking area

3.10.1. The houses and their associated parking (which will be required to be permeable) will not interfere with the remaining trees, so there are no negative implications as regards landscaping. It is recommended that a permeable surface such as Ecogrid 40 be used and filled with crushed 14-20mm stone to both improve and maintain a surface suitable for parking and the roots of the Oak tree T6.
