**Arboricultural Report**  
**composed of**  
**Arboricultural Impact Assessment**  
**Arboricultural Method Statement**  
**& Tree Protection Plan**

Land adjacent 1 Woodcot New Road Billingshurst RH14 9DS

6th May 2026

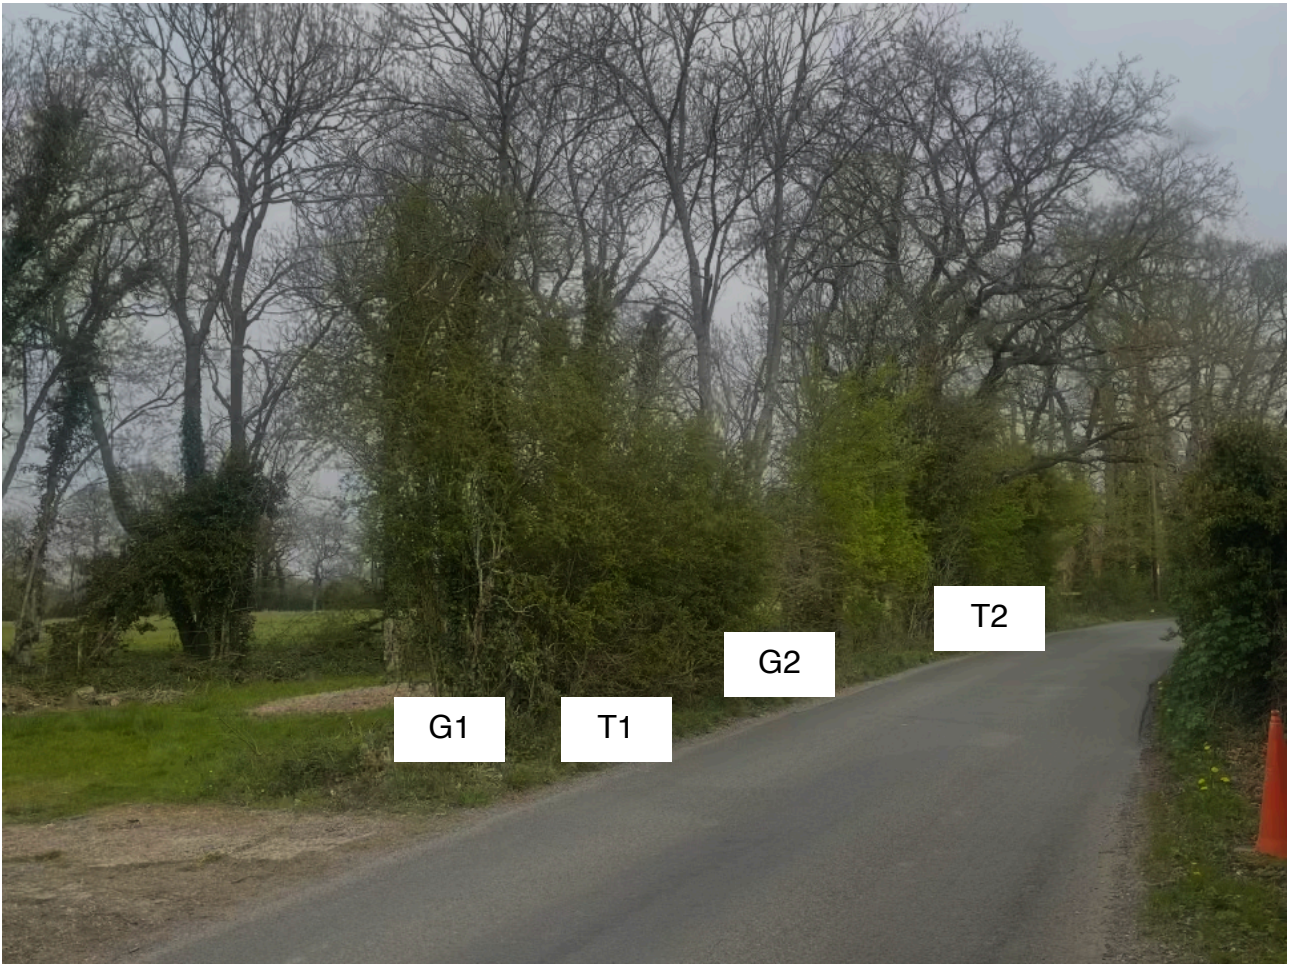
Roadside boundary planting looking eastwards

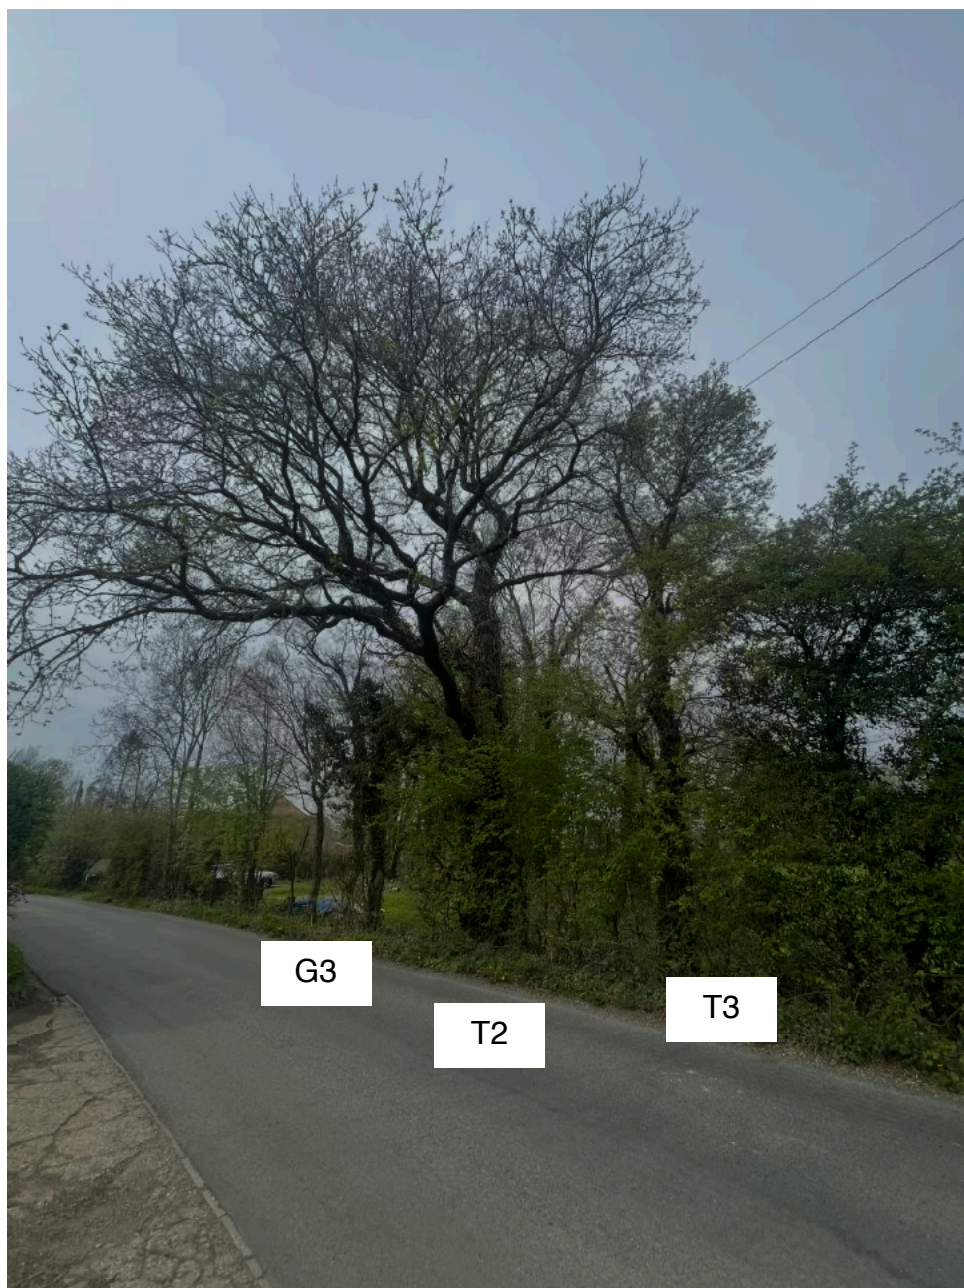
The boundary hedge forms an established screen along the roadside, but within this hedge are poor quality semi mature Ash trees suffering from Ash Dieback (*Hymenoscyphus fraxineus*) - T1, G2 and G3. By removing these trees it will be possible to augment the hedge with further species using bare rooted plants during the planting season (November to March). These plants include Hawthorn (*Crataegus monogyna*), Blackthorn (*Prunus spinosa*), Spindle (*Euonymus europaeus*) and the Wayfaring tree (*Viburnum lantana*). Reinforcing the screening will offer increased potential and benefits for wildlife and biodiversity.

Roadside boundary planting looking westwards

Removal of G3 group of Ash trees will allow for replanting using native hedging to reinforce screening along the roadside

The hedge reinforcement to the south will use Hawthorn (*Crataegus monogyna*), Blackthorn (*Prunus spinosa*), Spindle (*Euonymus europaeus*) and the Wayfaring tree (*Viburnum lantana*).

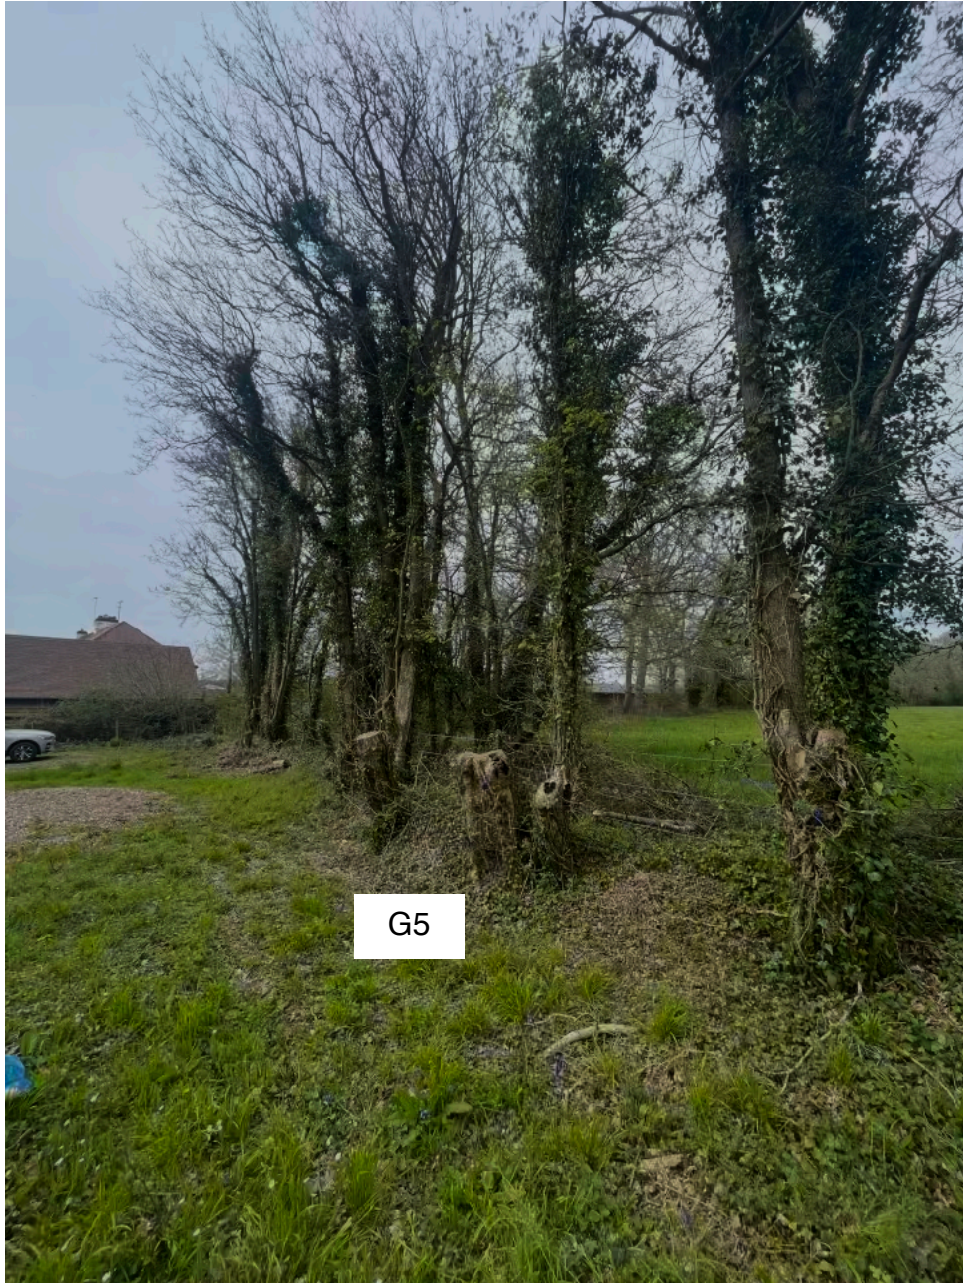
The northern boundary has a number of etiolated trees G5 set along the boundary fence with barbed wire attached to them. These are to be removed to enable the development. It is advocated that replanting is required using suitable species for a mixed native hedge grown to a height of 1.8m. See planting details below in 3.13 Conclusions.

Group of trees G5 along northern boundary

The hedge reinforcement to the north will use Hawthorn (*Crataegus monogyna*), Blackthorn (*Prunus spinosa*), Hazel (*Corylus avellana*) Field Maple (*Acer campestre*) and Wild Plum (*Prunus domestica*).
