# Arboricultural Impact Assessment

## Proposals at Furnace Lakes, Slinfold

Version 1 – 5<sup>th</sup> November 2025

**Document Reference: GS500.FurnaceLakes.AIA.v1**

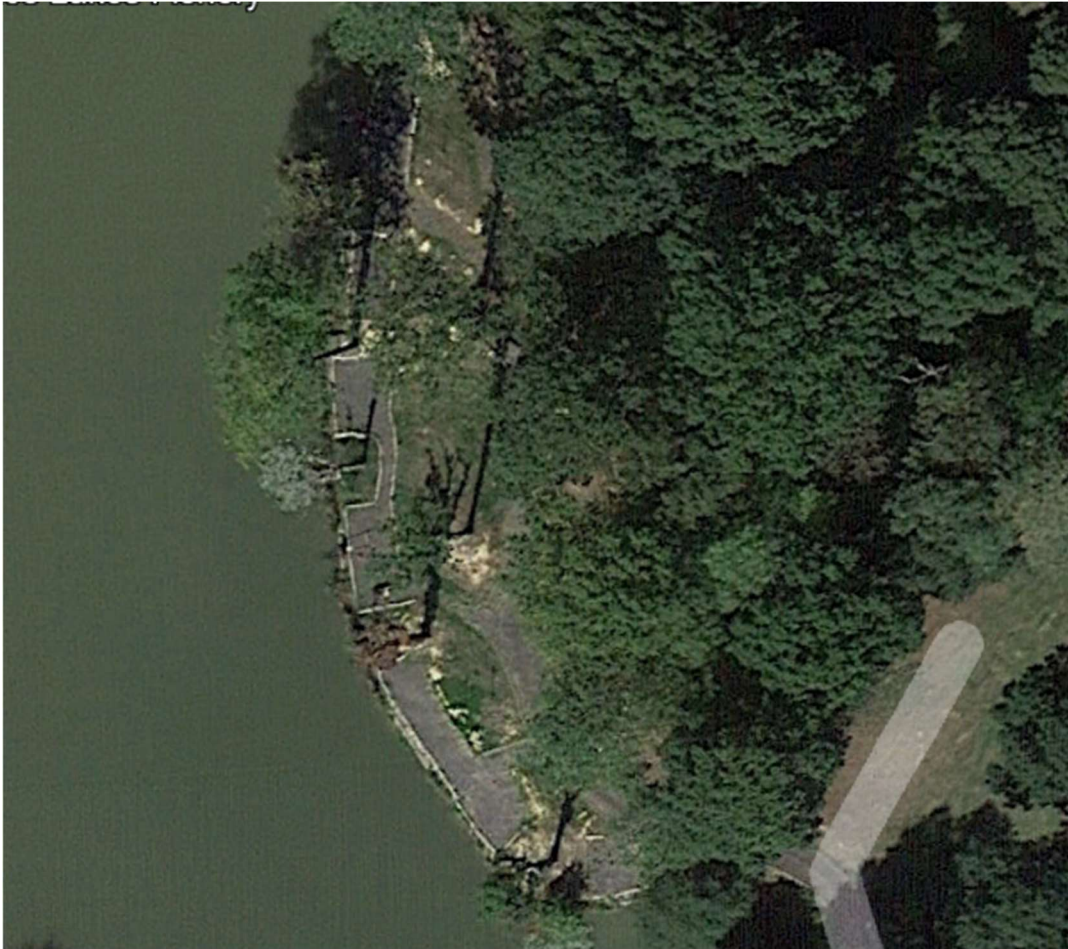
3.6 Image 1 – Google Earth Aerial Image from 2018.

- 3.2 It would appear that the site was originally part of the adjacent ancient woodland. The oaks remain as do a small number of understorey hornbeams to the east. The majority of any understorey and groundcover appear to have been removed in the past. The aerial imagery suggests this occurred between 2013-2018. By 2018, large areas of compacted hardcore had been laid and the area clearly stripped of much of the vegetation (see image 1 below). This was carried out by a previous owner of the site.

- 3.3 The historic works removed much of the understorey habitats and smaller trees. The oak trees were retained but the majority of canopy connectivity had been removed.

- 3.4 The historic surfacing works occurred within a number of tree RPAs and might have negatively impacted trees through root cutting and compaction. This is evident in the fact that many of the oak trees are retained in land higher than the surrounding paths, and display minor dieback and deadwood, suggesting some historic stress on the trees. Such impacts could not have arisen from the current works as there would be insufficient time for such impacts to become evident.

- 3.5 These historic works removed all groundcover and left the site with areas of grassland around the surfaces.
