**Arboricultural Report**  
**composed of**  
**Arboricultural Impact Assessment**  
**Arboricultural Method Statement**  
**& Tree Protection Plan**

Mrs R Shaw  
Pound Place  
Mill Lane  
Partridge Green  
RH13 8JU

Written by  
Barry Holdsworth MBA, RHS. Dip, MCI Hort, M.Arbor.A, MCMI  
Horticultural Consultant

22nd December 2025

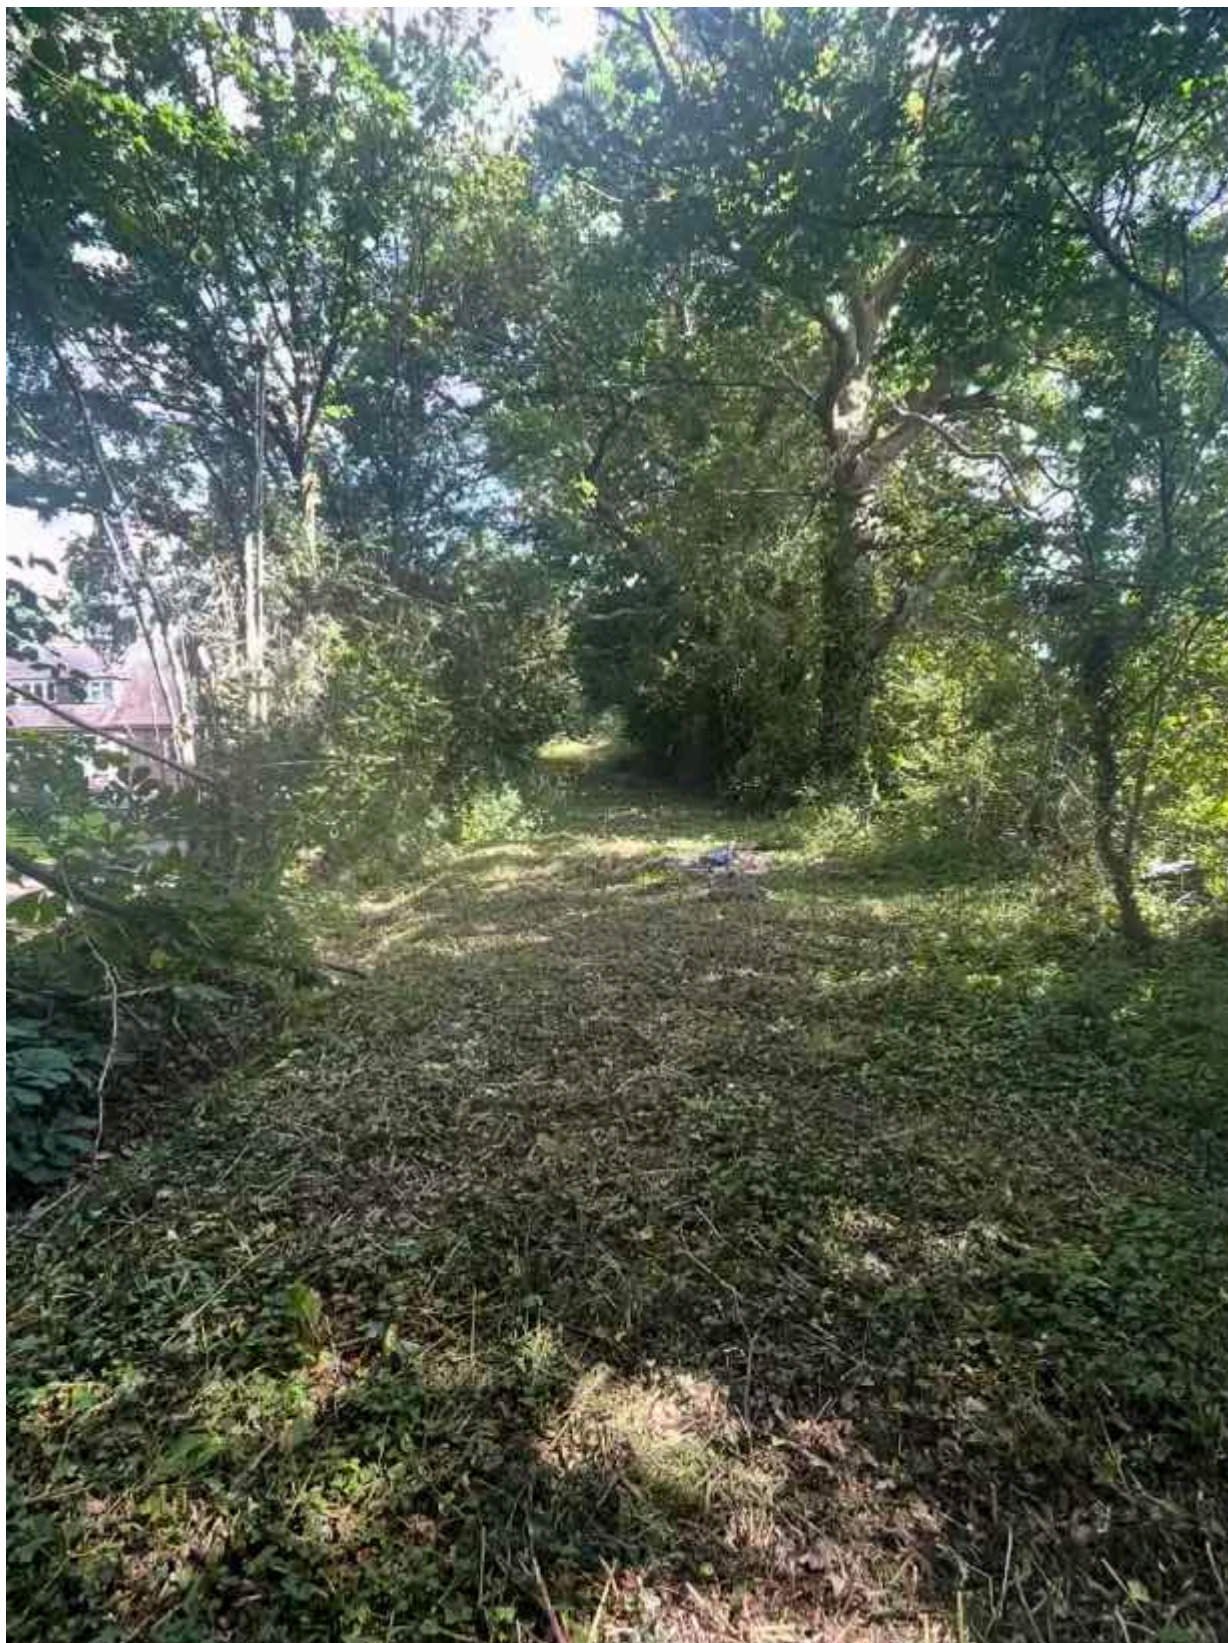
The Oak trees found along the site boundary up the unmade track are unmanaged and require crown cleaning to remove deadwood and to sever the ivy

| No | Species | Height | Ø at 1.5m | Spread | Crown | Age | Condition and | Removal | ERC | BS | RPA |
|---|---|---|---|---|---|---|---|---|---|---|---|
| T4 | Oak<br><i>Quercus robor</i> | 24 | 865 | 15.0Ø | 7mS | M | Physiological Condition: Fair<br>Structural Condition: Fair<br>Public Amenity Value: Low<br>Inspection Limitations: None<br>Mature ivy into canopy with 10% deadwood<br><b>Recommend:</b> Remove ivy and deadwood | N<br>S/I<br>CC | >20<br>B | C2 | 10.38 |
| T5 | Oak<br><i>Quercus robor</i> | 21 | 795 | 6/7/8#/8 | 10mS | OM | Physiological Condition: Poor<br>Structural Condition: Poor<br>Public Amenity Value: Low<br>Inspection Limitations: None<br>Much reduced canopy with 30% deadwood.<br>Mature ivy into canopy | N<br>CC<br>S/I | >10<br>B | C2 | 9.54 |
| T8 | Oak<br><i>Quercus robor</i> | 25 | 745 | 16.0Ø | 8mW | M | Physiological Condition: Fair<br>Structural Condition: Fair<br>Public Amenity Value: Low<br>Inspection Limitations: None<br>20% deadwood across canopy<br><b>Recommend:</b> Crown clean | N<br>CC | >10<br>B | C2 | 8.94 |
| T9 | Oak<br><i>Quercus robor</i> | 24 | 615 | 16.0Ø | 9mS | M | Physiological Condition: Fair<br>Structural Condition: Fair<br>Public Amenity Value: Low<br>Inspection Limitations: None<br>Mature ivy into canopy to 15m<br>Lost leader @15m with regrowth<br>Tree leans 10°E from g/l<br><b>Recommend:</b> Crown clean and sever ivy | N<br>CC<br>S/I | >20<br>B | C2 | 7.38 |

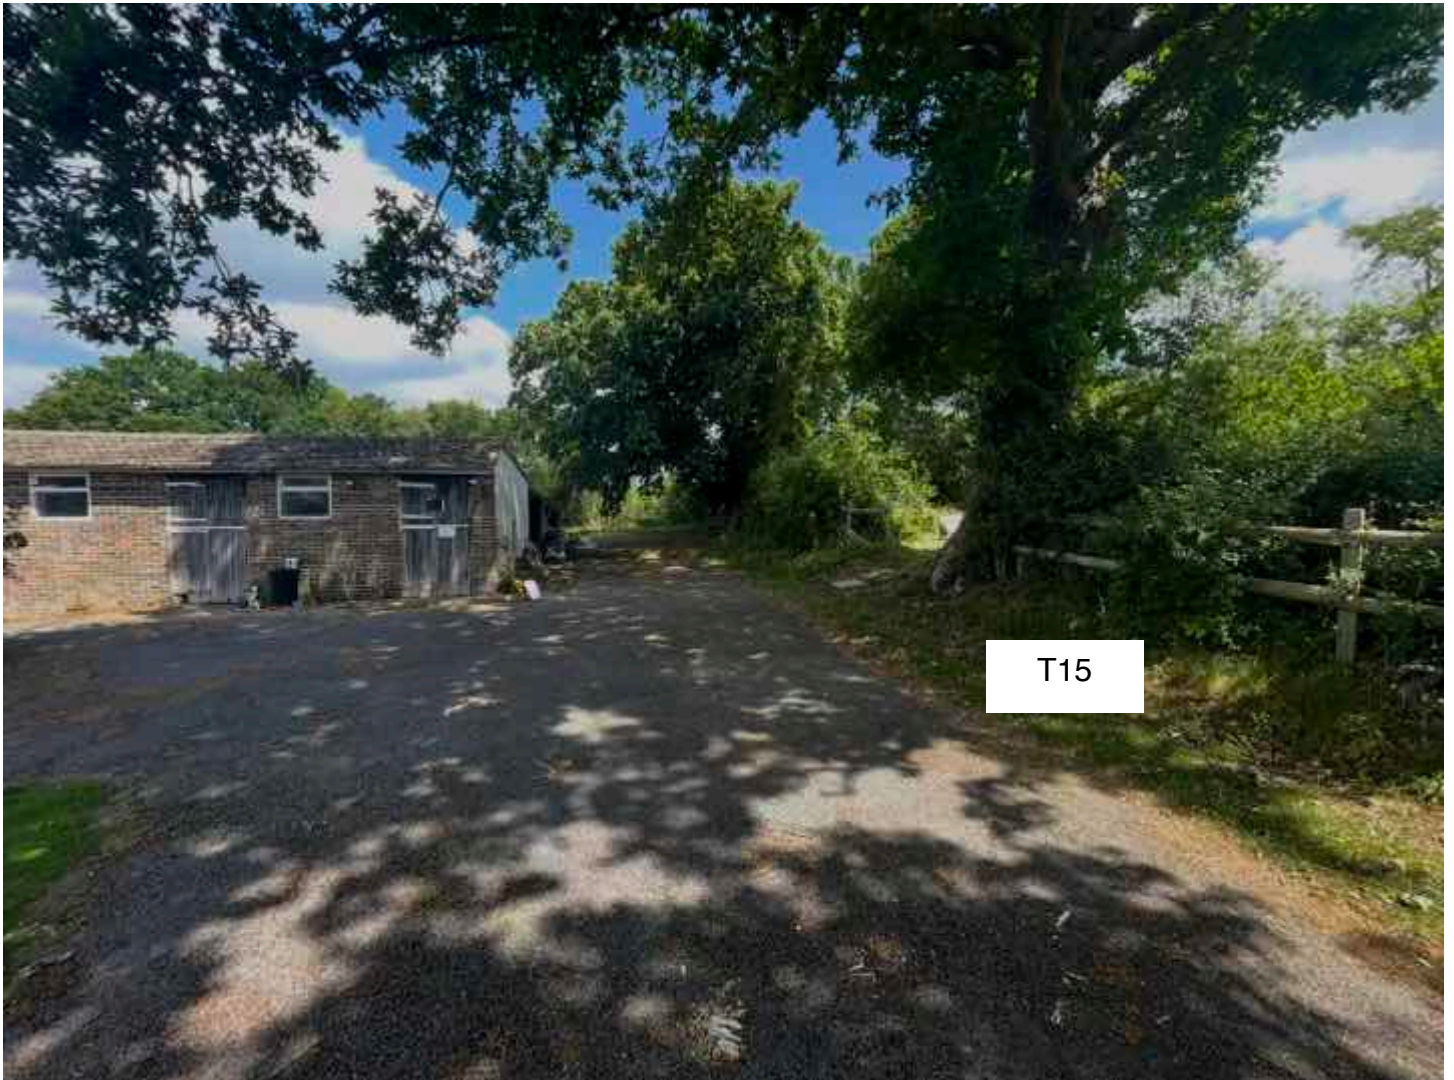
The existing tarmac drive will be used as access for the construction works and the new build thereafter. In order to protect the roots of T15 ground boarding will be laid over the RPA of T15 for the duration of the build. In addition T15 will be lifted to 5m above ground level to allow access for the construction traffic and tree protection fencing will run along the length of the track where the existing post and rail fence is found.

Although the existing tarmac and concrete access drive gives access to the plot it will be important that the roots of T15 are not subjected to overbearing stress and the ground becoming compacted under the weight of the construction traffic entering the site. Therefore, suitable ground protection is required to be laid for the duration of the build as shown on the Tree Protection Plan. This can be removed upon completion of the buildings works when the new parking area is to be formed.

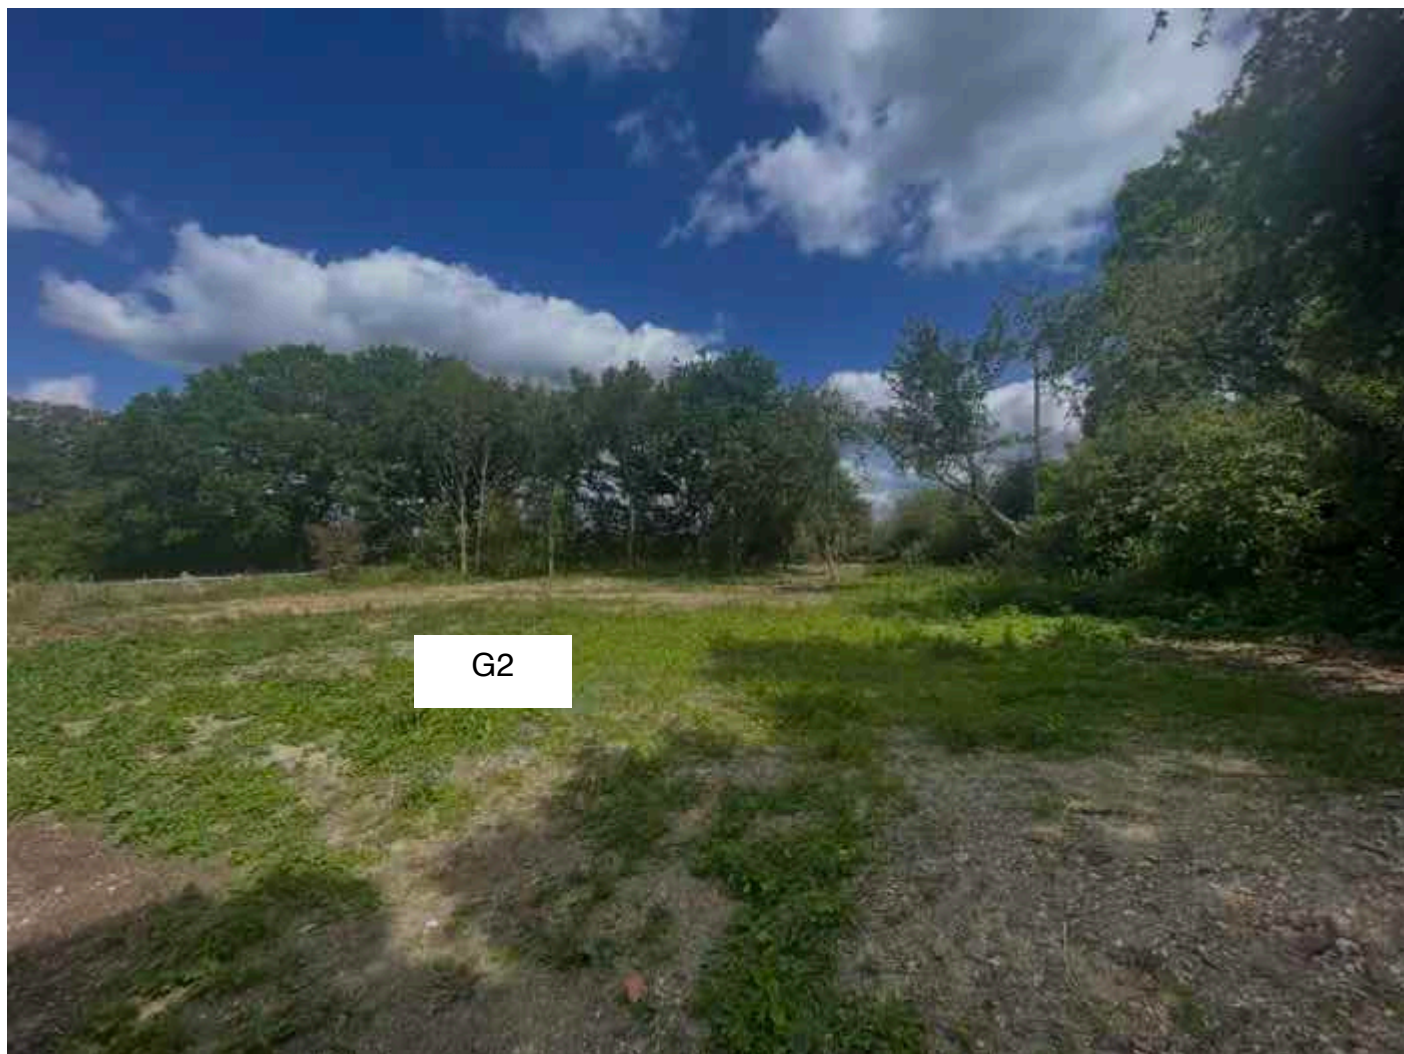
The group of trees G2 to the north of the site

| <b>G2</b> | Oak<br><i>Quercus robur</i> | 18 | 270 av. | 16.00 | 10.0mS | EM | Physiological Condition: Poor<br>Structural Condition: Poor<br>Public Amenity Value: Low<br>Inspection Limitations: None | N | >10 | C2 | 3.24 |

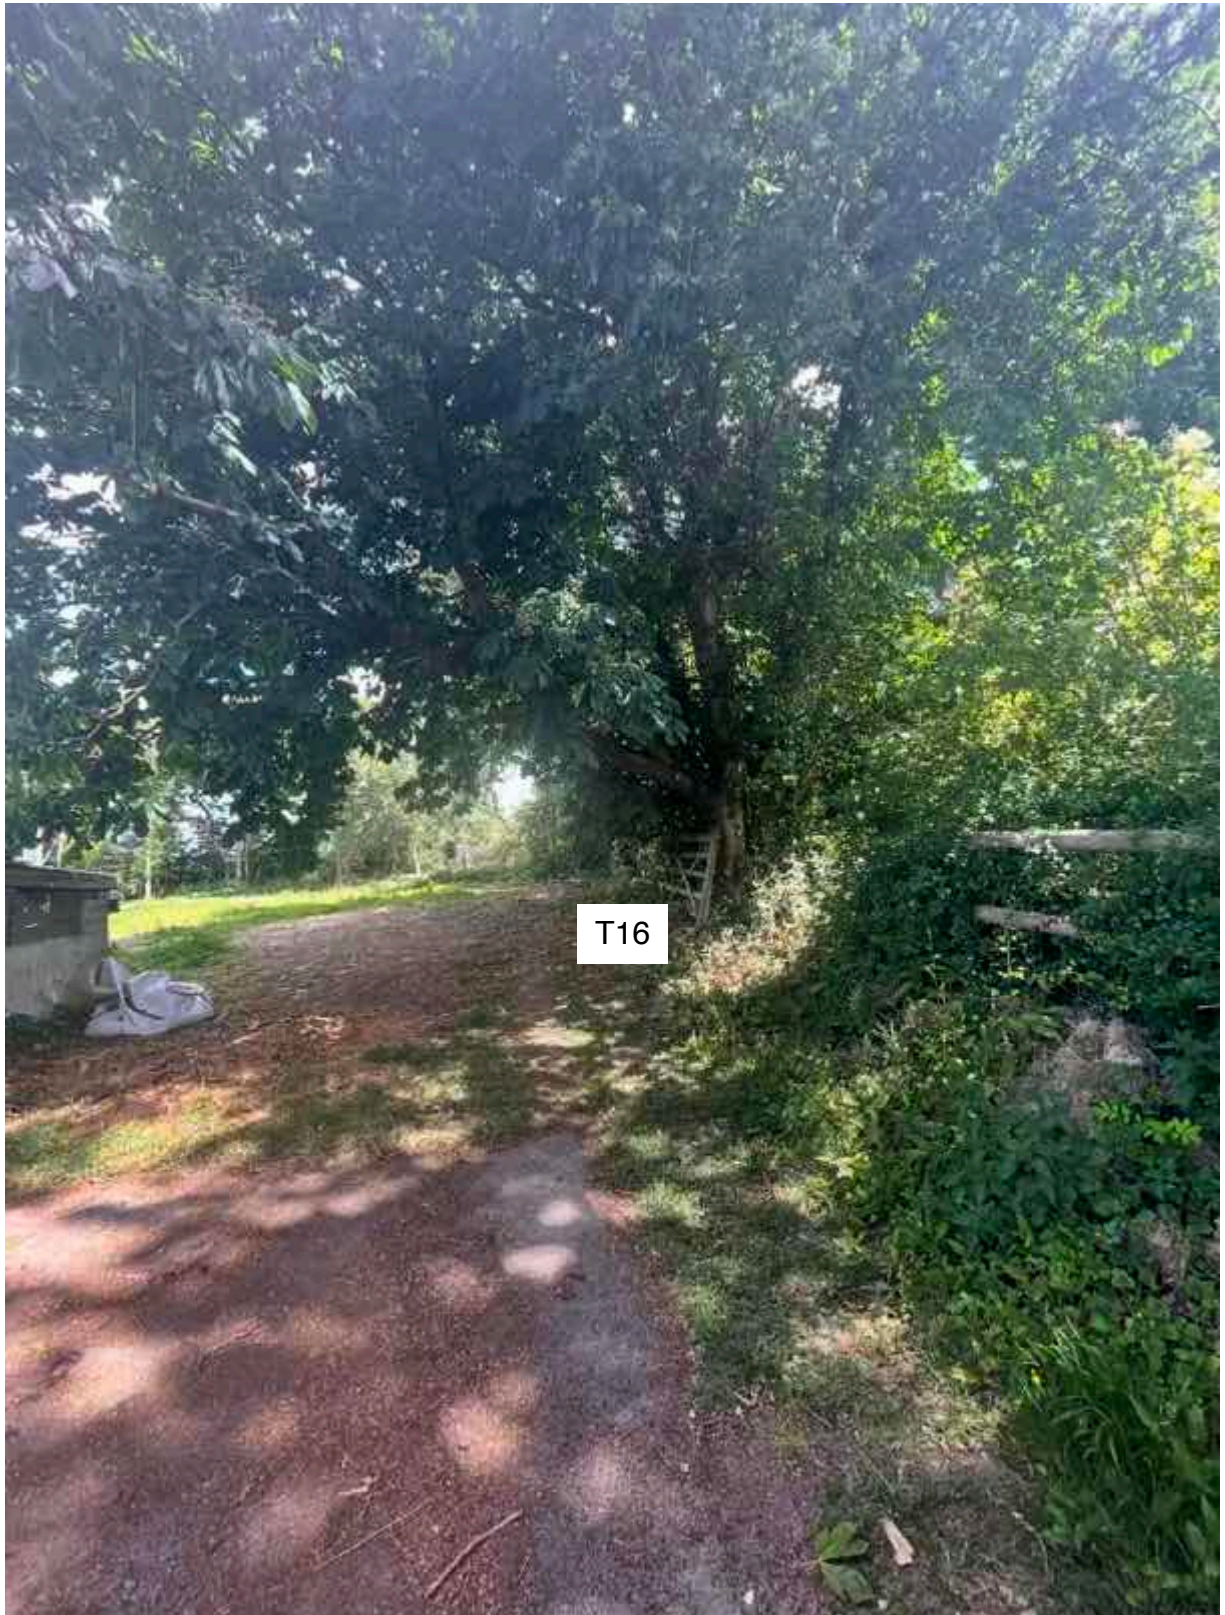
The Horse Chestnut T16 which overhangs the access to the paddock is to be removed

| <b>T16</b> | Horse Chestnut<br><i>Aesculus hippocastanum</i> | 16 | 555 | 4/8/6#/7 | 2mW | M | Physiological Condition: Fair<br>Structural Condition: Fair<br>Public Amenity Value: Low<br>Inspection Limitations: None<br>Bifurcates @ 1.5m with lower limb on W leaning heavily over paddock at 45°<br><b>Recommend:</b> Remove for development | N<br>Fell | >10<br>B | C2 | 6.66 |

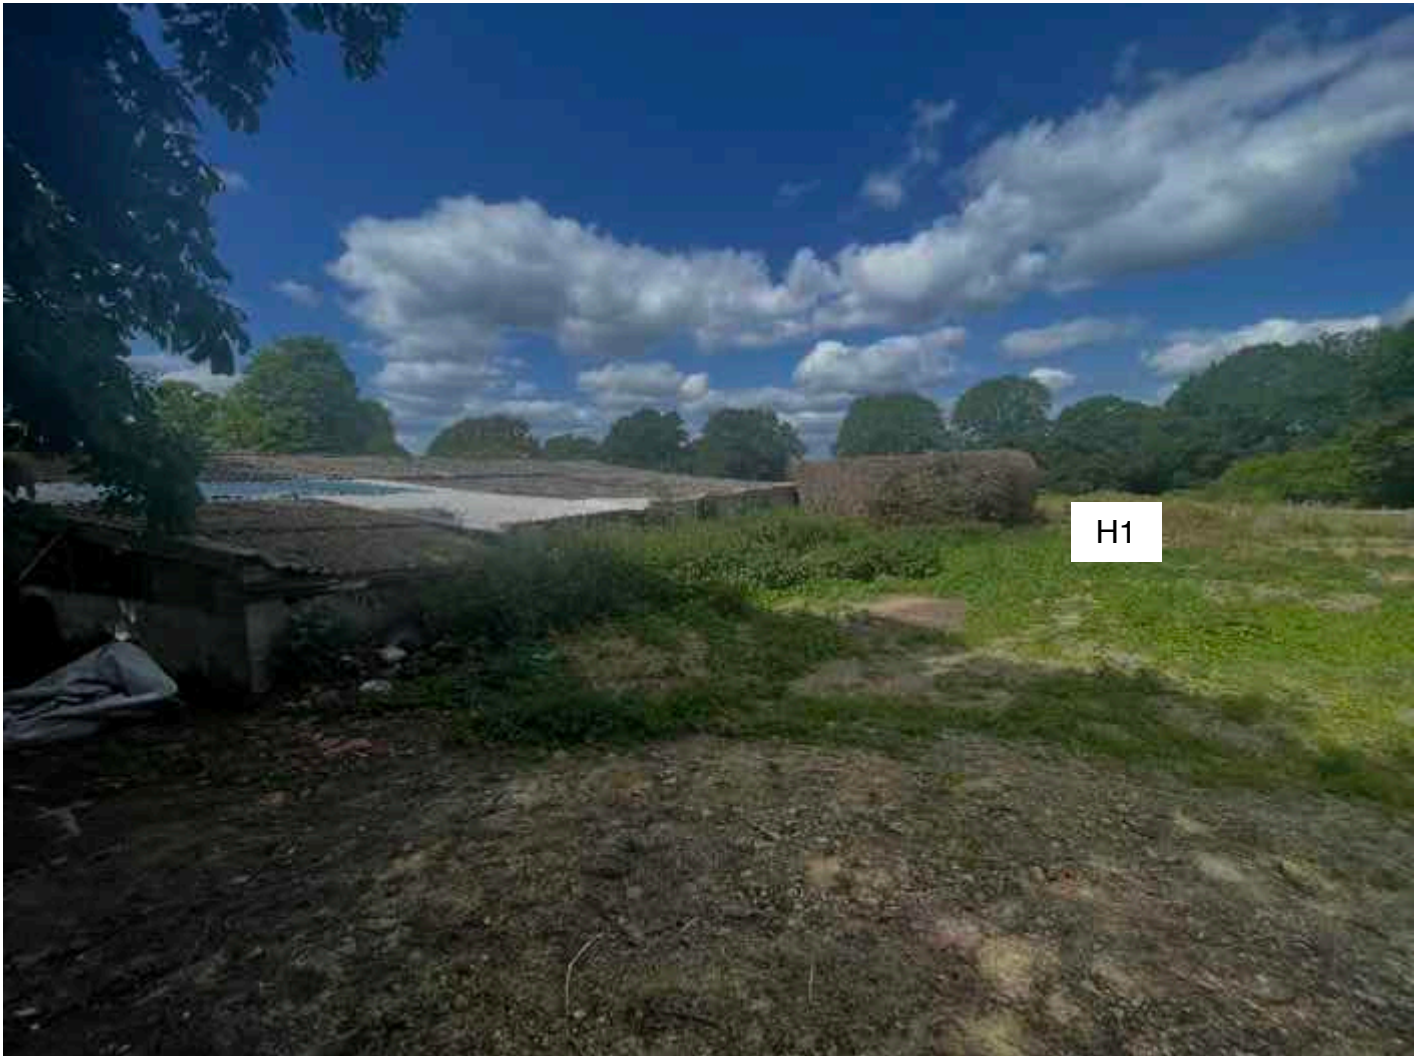
The rear of the stable block with the Conifer Hedge H1 that is to be removed

| H1 | Cupressus | 4 | 80 | 1.5Ø | g/l | SM | Physiological Condition: Poor | N | <10 | U | 0.96 |
