## **PLANNING AND HERITAGE STATEMENT**

**10 MARKET SQUARE, HORSHAM**

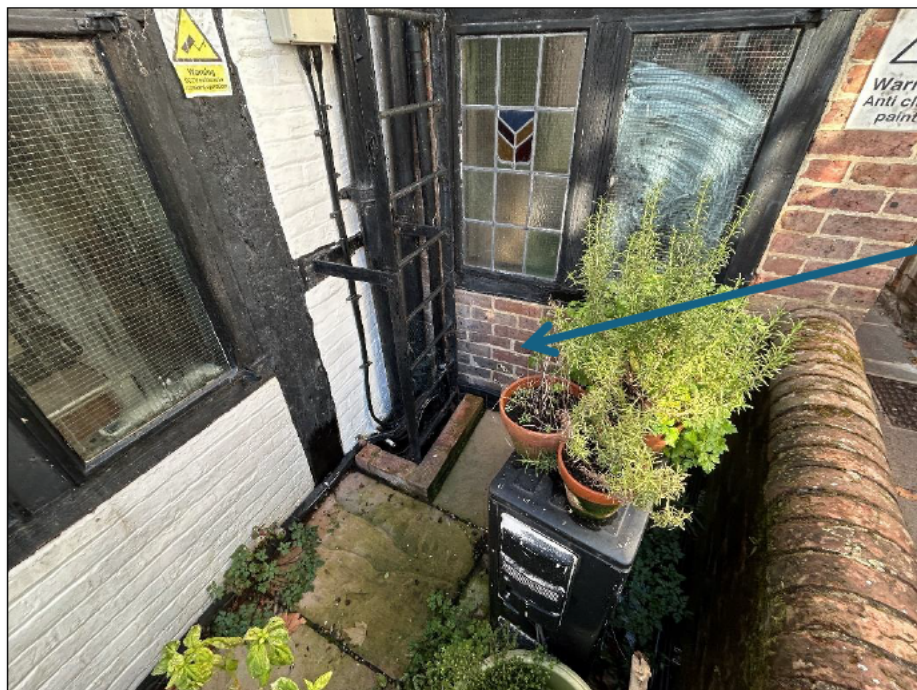
- 3.9 Dampness – Clay Drainage Pipe
- 3.10 The fit-out works had also exposed a section of the rear masonry wall to reveal a section of a clay drainage pipe that had been leaking into the cellar underneath the suspended floor structure. The clay pipe was leaking between a 90 degree connection joint.

- 3.11 A temporary repair had been undertaken to the leaking connection to prevent further leaks; however this repair has proved to be unsuccessful as there was still water ingress present. The clay drainage pipe is located within the masonry wall which raises concerns regarding the load bearing point of the brickwork directly above, as this may have caused the drainage pipe connection to be displaced.

- 3.12 When viewed externally, the drainage pipe appears to be connected to a clay gully located in the rear courtyard which serves multiple rainwater downpipes and a drainage pipe from the washing machine within the first floor flat.

Leak from  
drain pipe  
hidden in  
this wall.

**Photo 3: Source of drainage leak.**

- 4.2 The proposed remedial work will involve the following, in accordance with the drawings and specifications attached to the application:
- Replacement of the defective drainage pipework with matching materials.

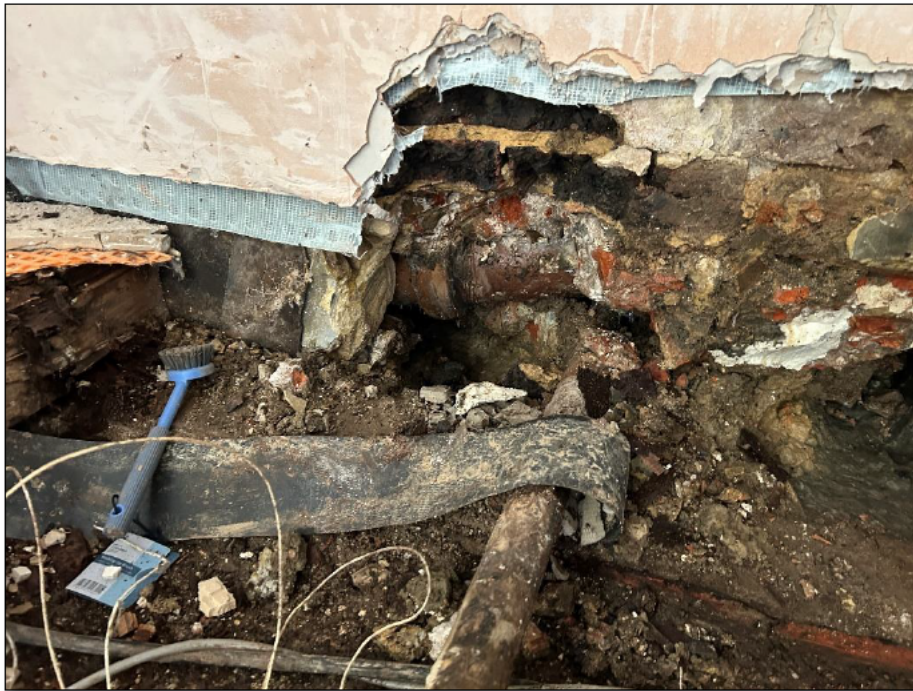
**Photo 4: Wall exposed internally to reveal defective pipe in wall.**

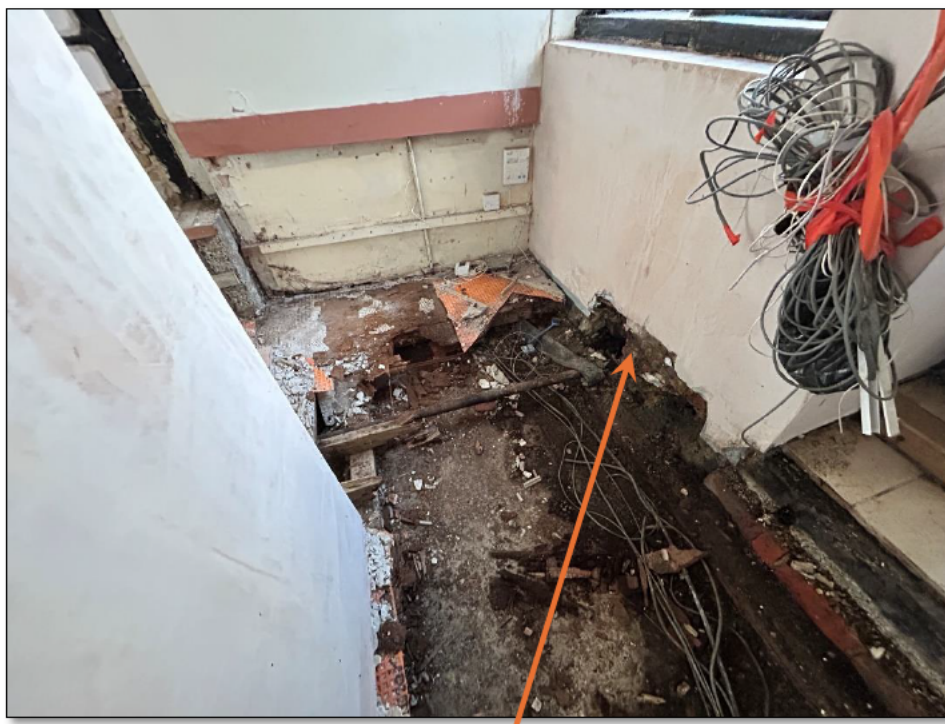
- 3.13 It was evident that the leak from the clay drainage pipe had introduced excessive moisture into the property and had likely caused the various issues of timber decay throughout the ground floor unit.

- 3.14 It was noted that the fungal decay to the timber directly adjacent to the leaking pipe had signs of advanced *conioophora puteana* (also known as wet rot). Wet rot is a more common form of fungal decay and requires a moisture content of around

**Photo 5: Damage timber flooring removed & source of leaking pipe exposed.**

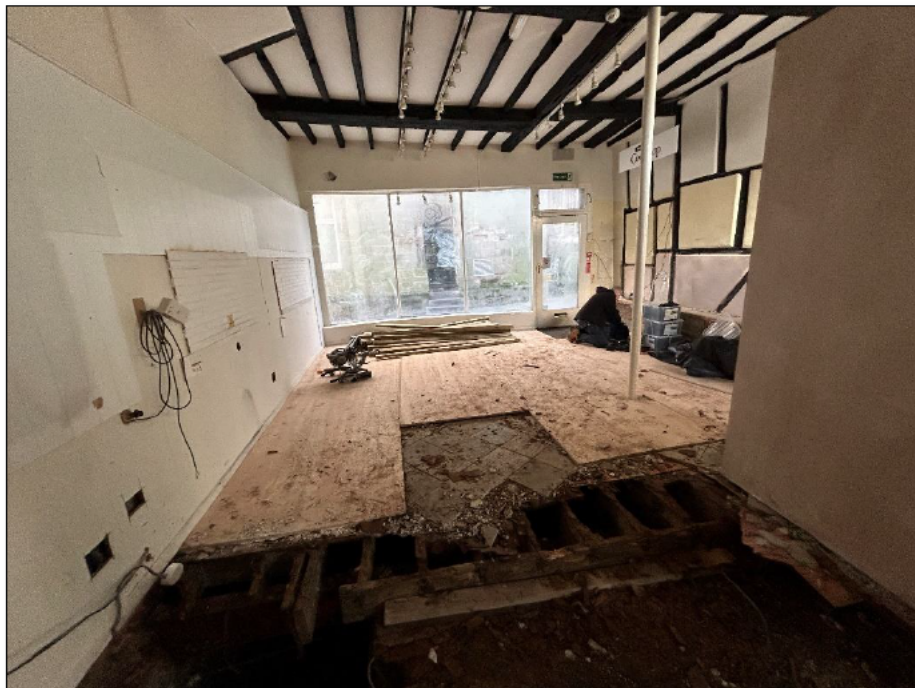
**Photo 6: View towards the entrance of the lower floor level where the timber floor structure is to be replaced.**

- Stripping out of the existing suspended timber floor structure above the basement area and over the concrete subfloor in the lower floor level.
  - Treatment of the dry rot in accordance with BWT South East Ltd's specification.

- Reinstatement of the suspended timber floor over the existing steel beams as specified by the structural engineer.
  - Localised brick repairs where required in accordance with the structural engineer's specification.

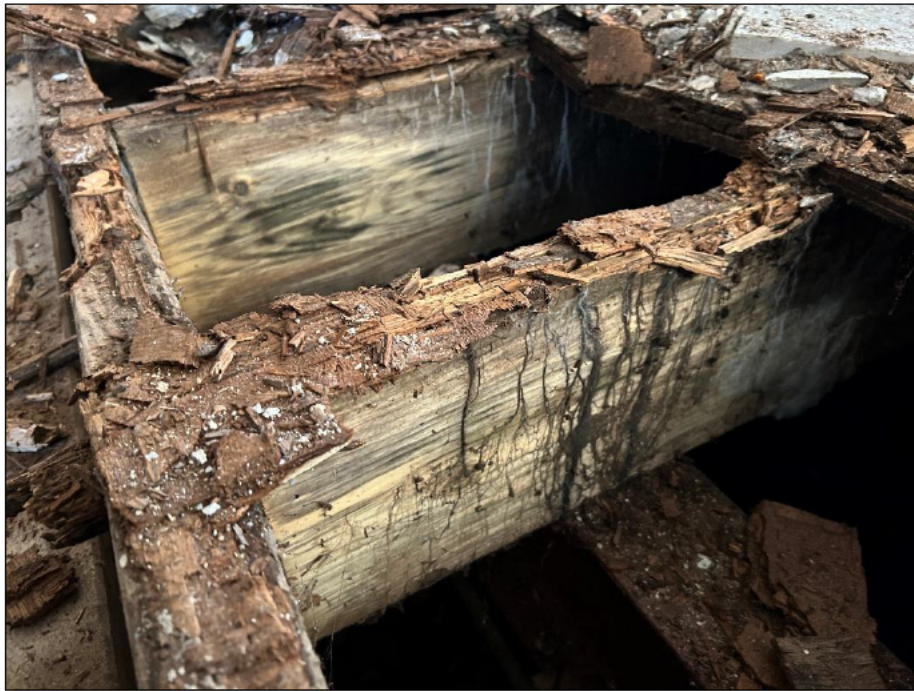
- 3.4 It was evident that the exposed timber joists had severely deteriorated due to extensive timber decay. The structural integrity of the timbers were significantly compromised and there were obvious signs of failure to the load bearing cross sections with the steel beams.

- 3.5 Further inspection of the timbers identified signs of cuboidal cracking, with the texture of becoming brittle and crumbling with moderate force. This indicated that the decay was due to fungal growth within the timbers.

**Photo 7: Decayed timber floor joists**

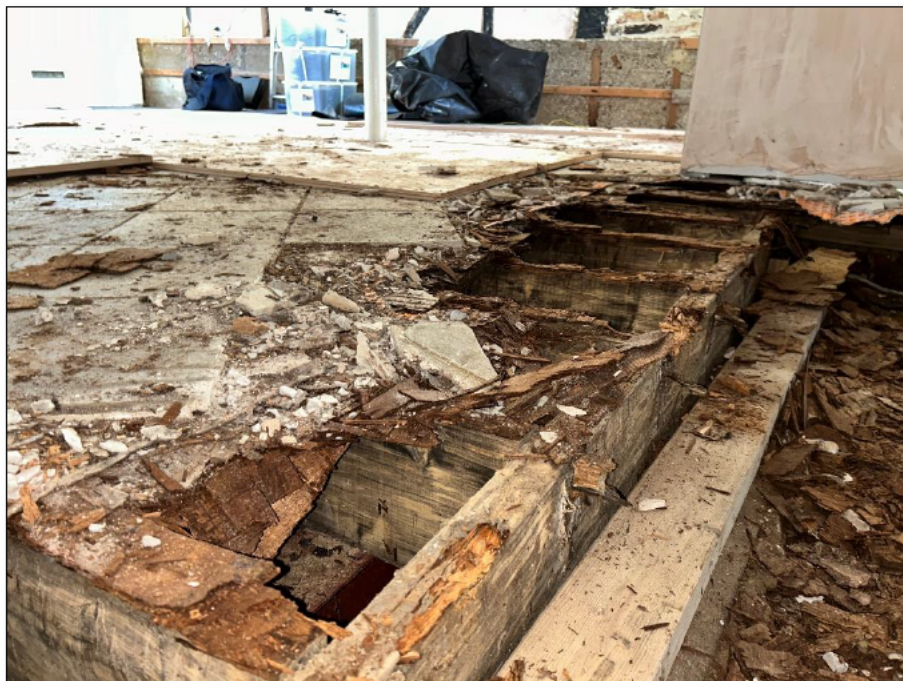
- 3.6 A section of the floor structure had been removed and access was gained into the void directly underneath the suspended floor structure. This identified that the void underneath is a cellar formed of solid masonry including stone and brickwork construction. There are two brickwork arches on the northern elevation which have been filled with loose rubble and building materials

**Photo 8: Exposed section of suspended timber floor**

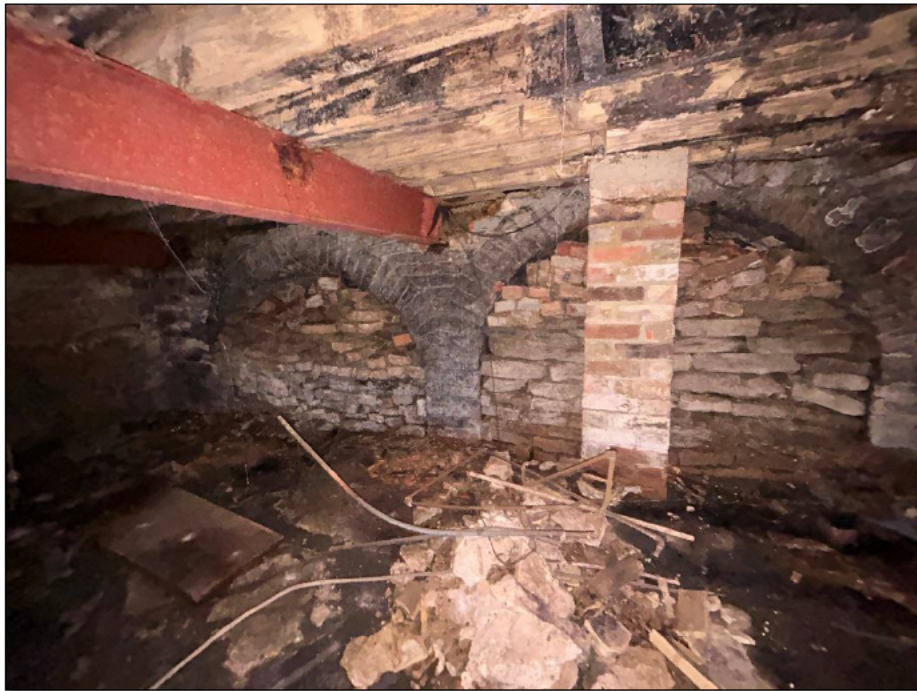
**Photo 11: Blocked up arches to vaults.**

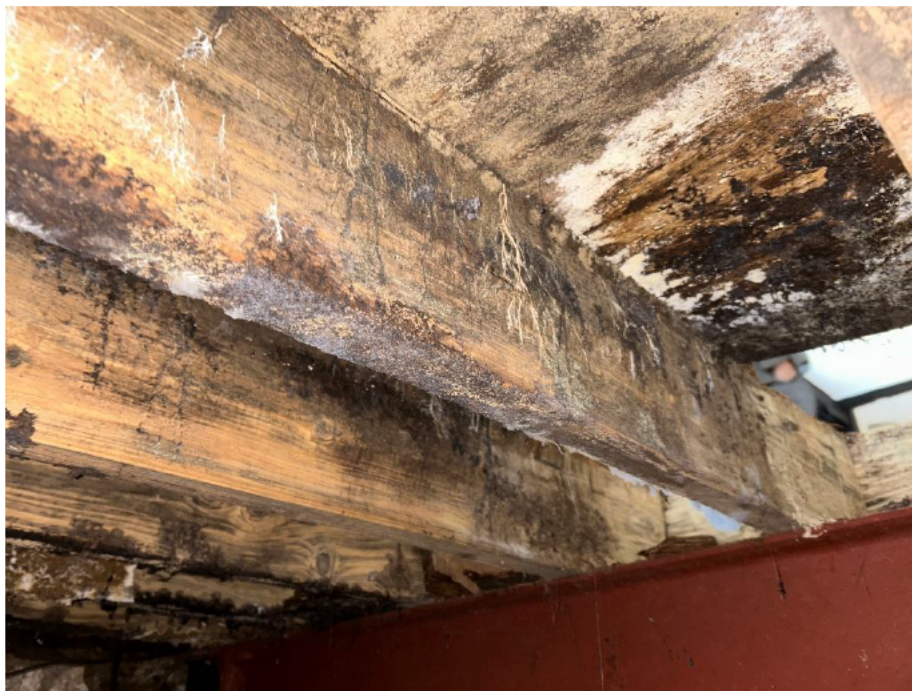
- 3.7 Further inspection of the timbers from within the cellar identified further evidence of extensive fungal decay throughout the entire suspended floor structure, including white mycelium growth and fruiting bodies indicating advanced stages of *serpula lacrymans* (also known as dry rot). Dry rot is highly destructive to timber elements and thrives in areas with poor ventilation with a moisture content of 20-30%. The cellar is currently unventilated and any introduction of excess moisture would create an ideal environment for growth.

**Photo 12: Existing floor joists affected by dry rot**
