## HORSHAM DISTRICT COUNCIL CONSULTATION

| <b>LOCATION:</b> | Phases 2 and 3 Land at Wellcross Farm Broadbridge Heath |
| <b>DESCRIPTION:</b> | Application for Approval of Details Reserved by Condition 2 (Construction Management Plan), <sup>3</sup> (borehole to meet Private Water Supplies), <sup>4</sup> (Private Water Supply Management Plan), <sup>5</sup> (finished floor levels and external ground levels) and 7 (underground services) to approved application DC/24/0205 Reserved matters application pursuant to condition 5 of outline planning permission DC/19/1897 for the provision of phases 2 and 3 of Land at Wellcross Farm to provide a continuing care retirement community with 94 units of accommodation (C2), with access, infrastructure, open space, landscaping and associated works including an onsite borehole water supply). |
| <b>REFERENCE:</b> | DISC/26/0012 & DISC/26/0013 |

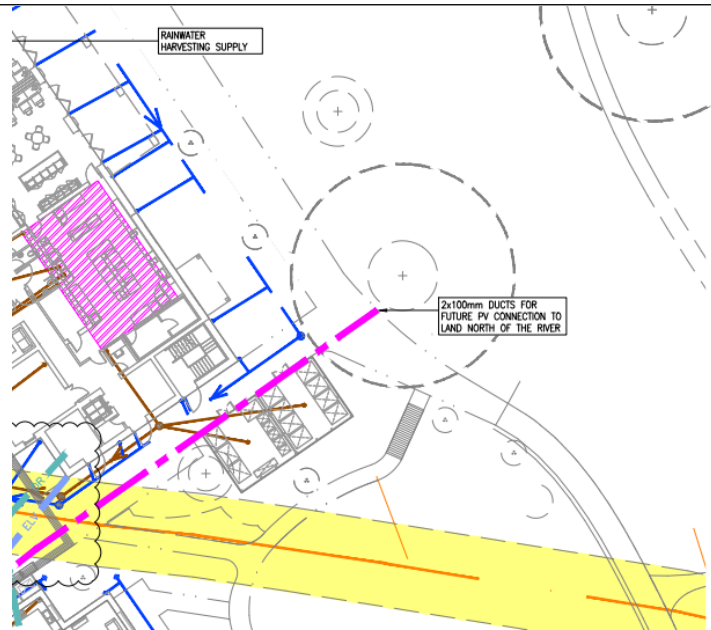
The RPA, of the unknown tree shown in the image above, taken from Electrical & Electrical Services Drawing No. 1163-ESD-XX-00-DR-XX-P2-1001, revision 2, still indicates that the ducts for the future PV connection to land north of the river fall within the tree's RPA. Please seek confirmation that the ducts will be removed and that the PV connection will not be sited within the RPA, or alternatively that trenchless installation methods will be used at a depth greater than 1.5 m below existing ground levels.

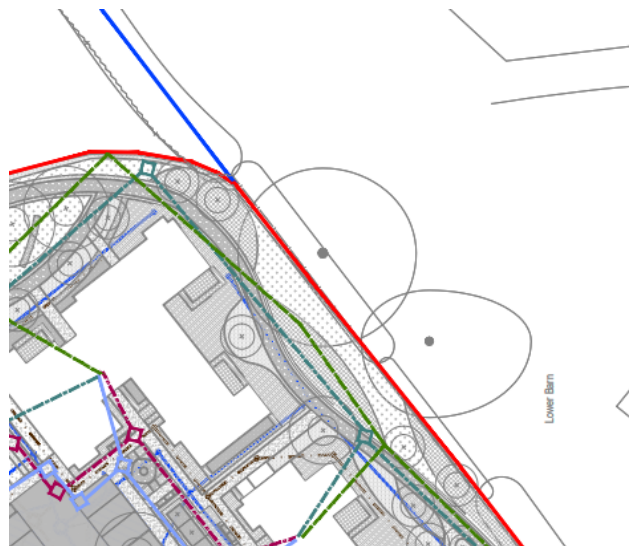
If the new services are installed using an open-trench method, the historically greenfield nature of the site and the absence of physical constraints that would have limited root development to the northwest of the tree indicate a high likelihood that trenching works would result in substantial root severance and long-term damage to T31.

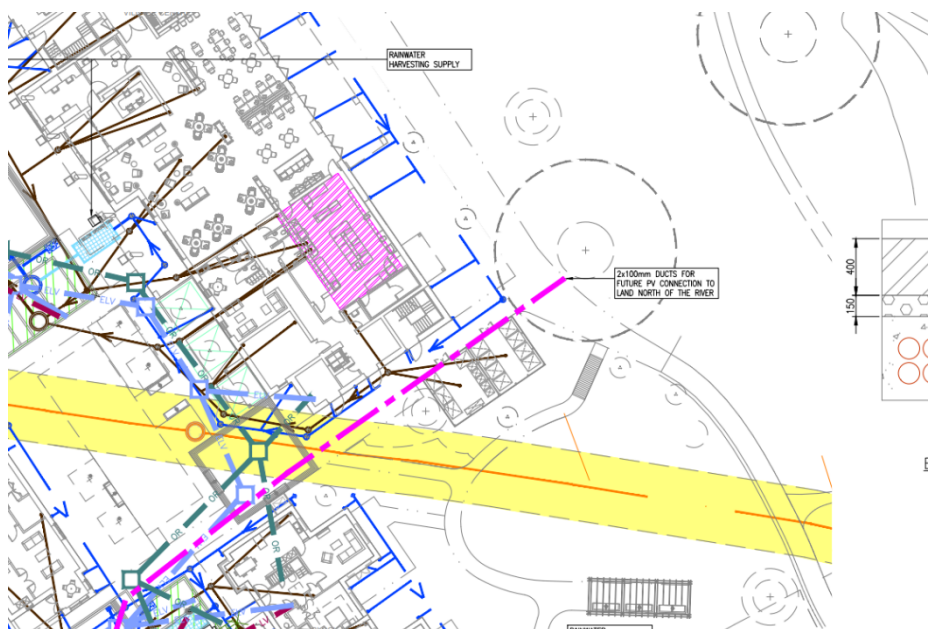
Given the greenfield nature of the site, it is essentially unconstrained. As such, it is not considered that there would be any *overriding justification* for significant development, such as open-trench excavations, to take place within the RPA of retained trees. Ideally, the site layout and design should take appropriate account of existing site constraints, including retained on-site and off-site trees.

Accordingly, amendments should be sought to the route of the service runs to ensure that they do not encroach within the RPA of tree T31, and outside of the RPA, of the unknown tree in the above image taken from Electrical & Electrical Services Drawing No. 1163-ESD-XX-00-DR-XX-P2-1001.

One potential solution would be to relocate the service runs further north, outside the RPA of T31, and outside of the RPA, of the unknown tree in the above image. If this is not

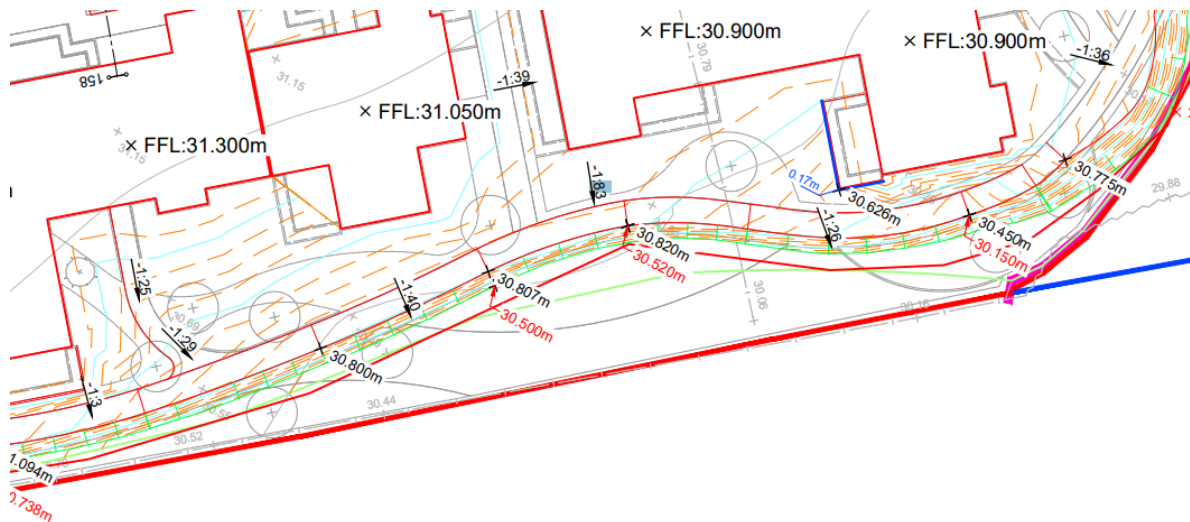
Further concerns are also raised in relation to the proposed landscaping works and associated land level changes in the area to the northwest of off-site trees T30 and T31, both oaks. Given the lack of detail on how the works would be completed without resulting in direct construction damage or indirect post-development harm, including root damage and soil compaction, these proposals are considered problematic. Please seek confirmation on the exact extent of the level changes and landscaping works within the RPA of T30, and T31.
