# Remediation Method Statement

at: Woodfords,  
Shipley Road,  
Southwater  
RH13 9BQ

for: Bellway Homes Ltd

Report Reference: 3750965/RMS/1

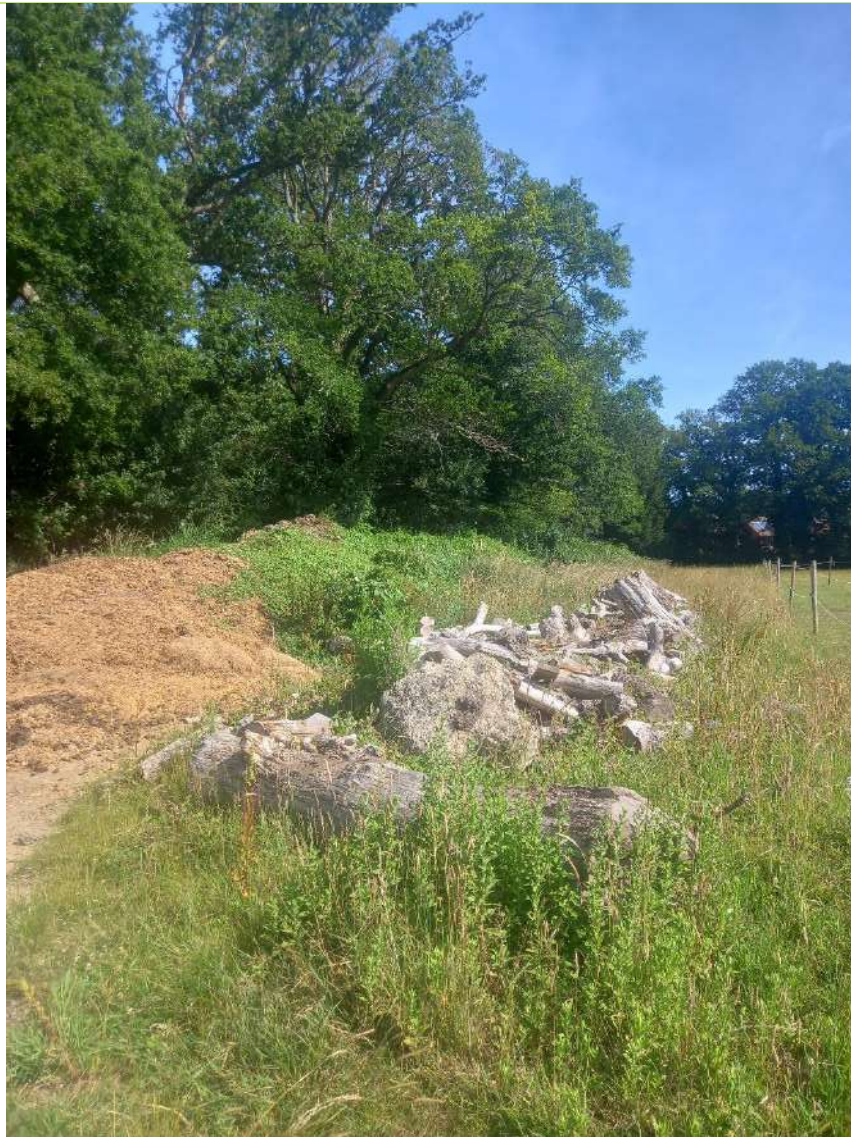
Photo 1: Looking northwards along the north western bund.

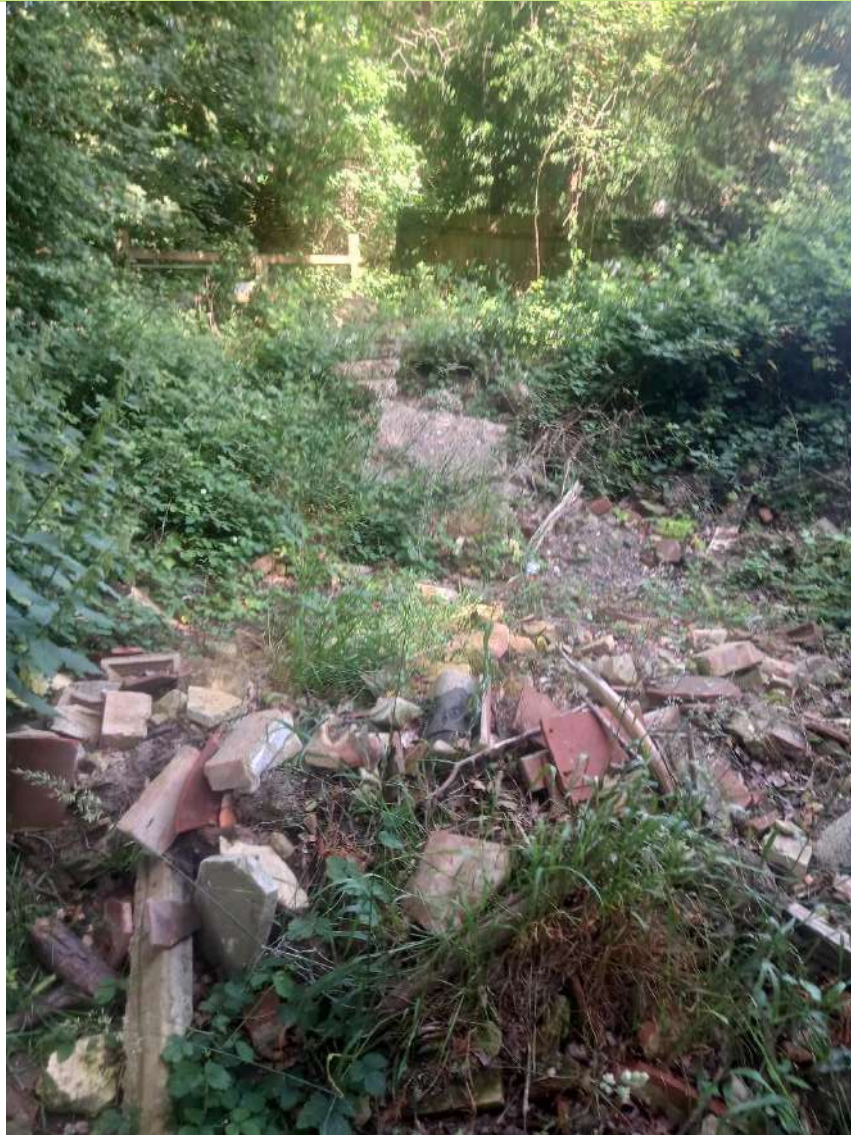
Photo 2: Stockpiled materials at northeastern gate

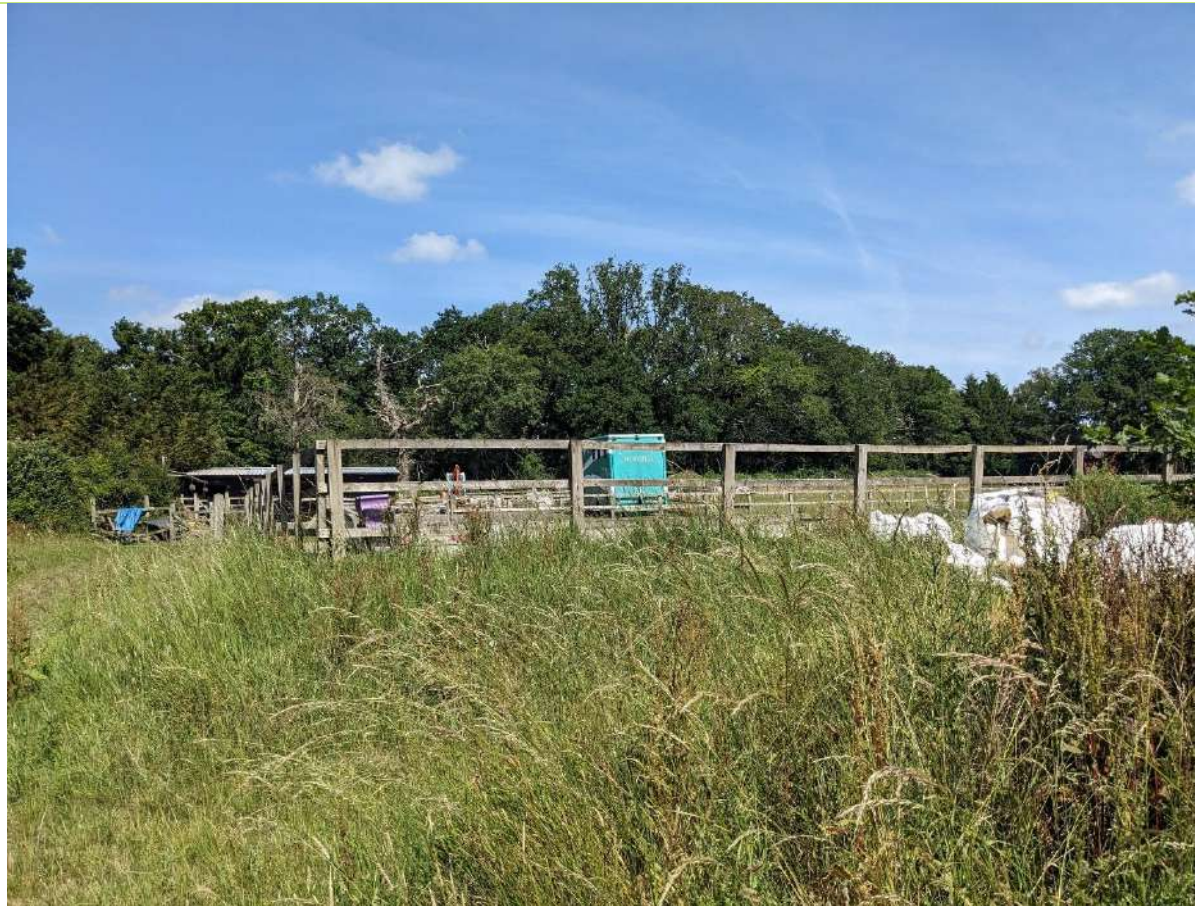
Photo 3: looking west across the sand school, the bund in foreground masked by tall vegetation. The site occupiers appear to have continued to use the southern end as an area for burn general waste (white plastic bags).

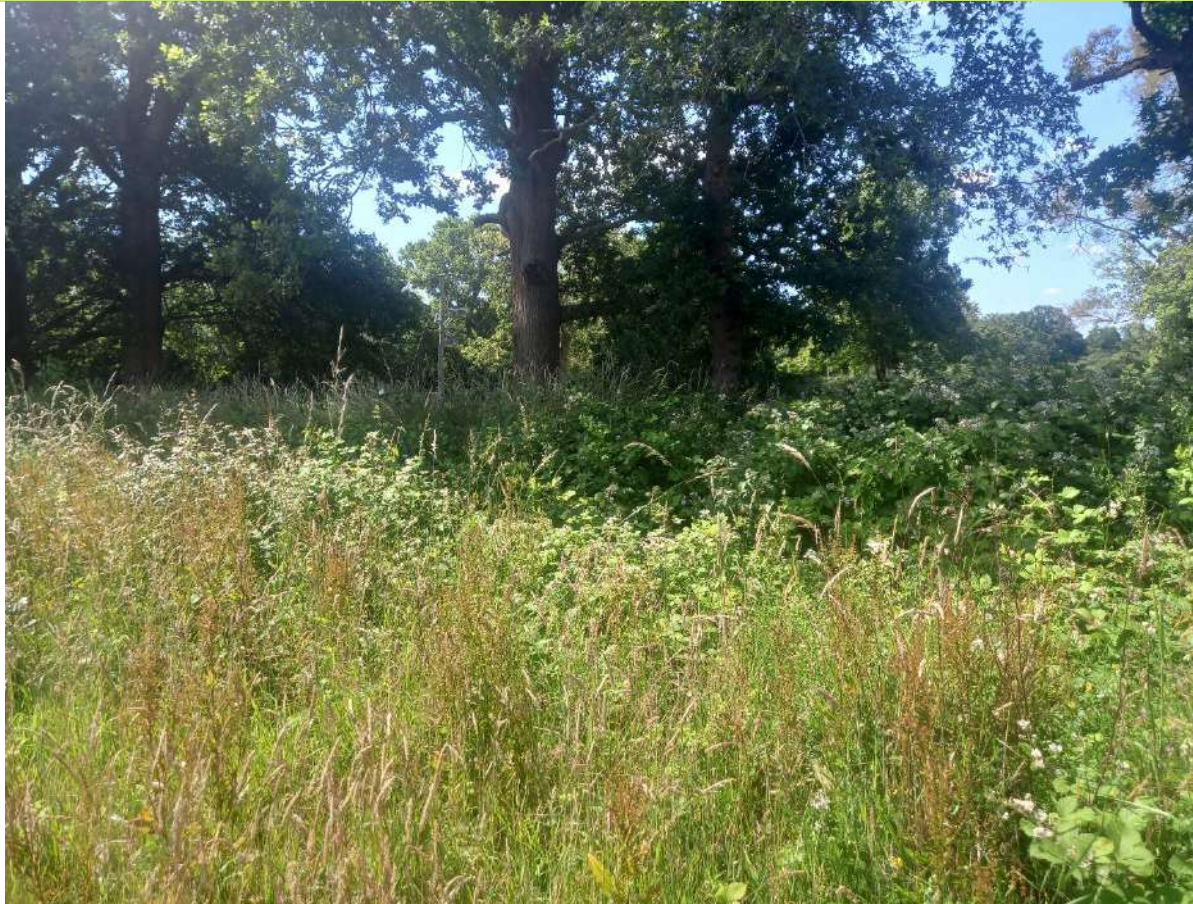
Within the area of the central drainage system, a sample of the mounded materials reported a concentration of arsenic marginally in exceedance of its Res<sub>IHGP</sub> GACs. This area is proposed as public open space within the new development and given the low concentration of 38.6 mg/kg arsenic, the area is not considered to pose an unacceptable risk to end users. It is still recommended that the mounded material is removed from site and disposed of following waste protocols to be protective of the local drainage system and controlled waters.

Photo 4: Looking south across the central drainage ditch and tree line, which is completely masked by vegetation.
