**Arboricultural Report**  
**composed of**  
**Arboricultural Impact Assessment**  
**Arboricultural Method Statement**  
**& Tree Protection Plan**

Christine Wells

Cherry Tree Cottage Pickhurst Lane Pulborough RH20 1DA

8th June 2026

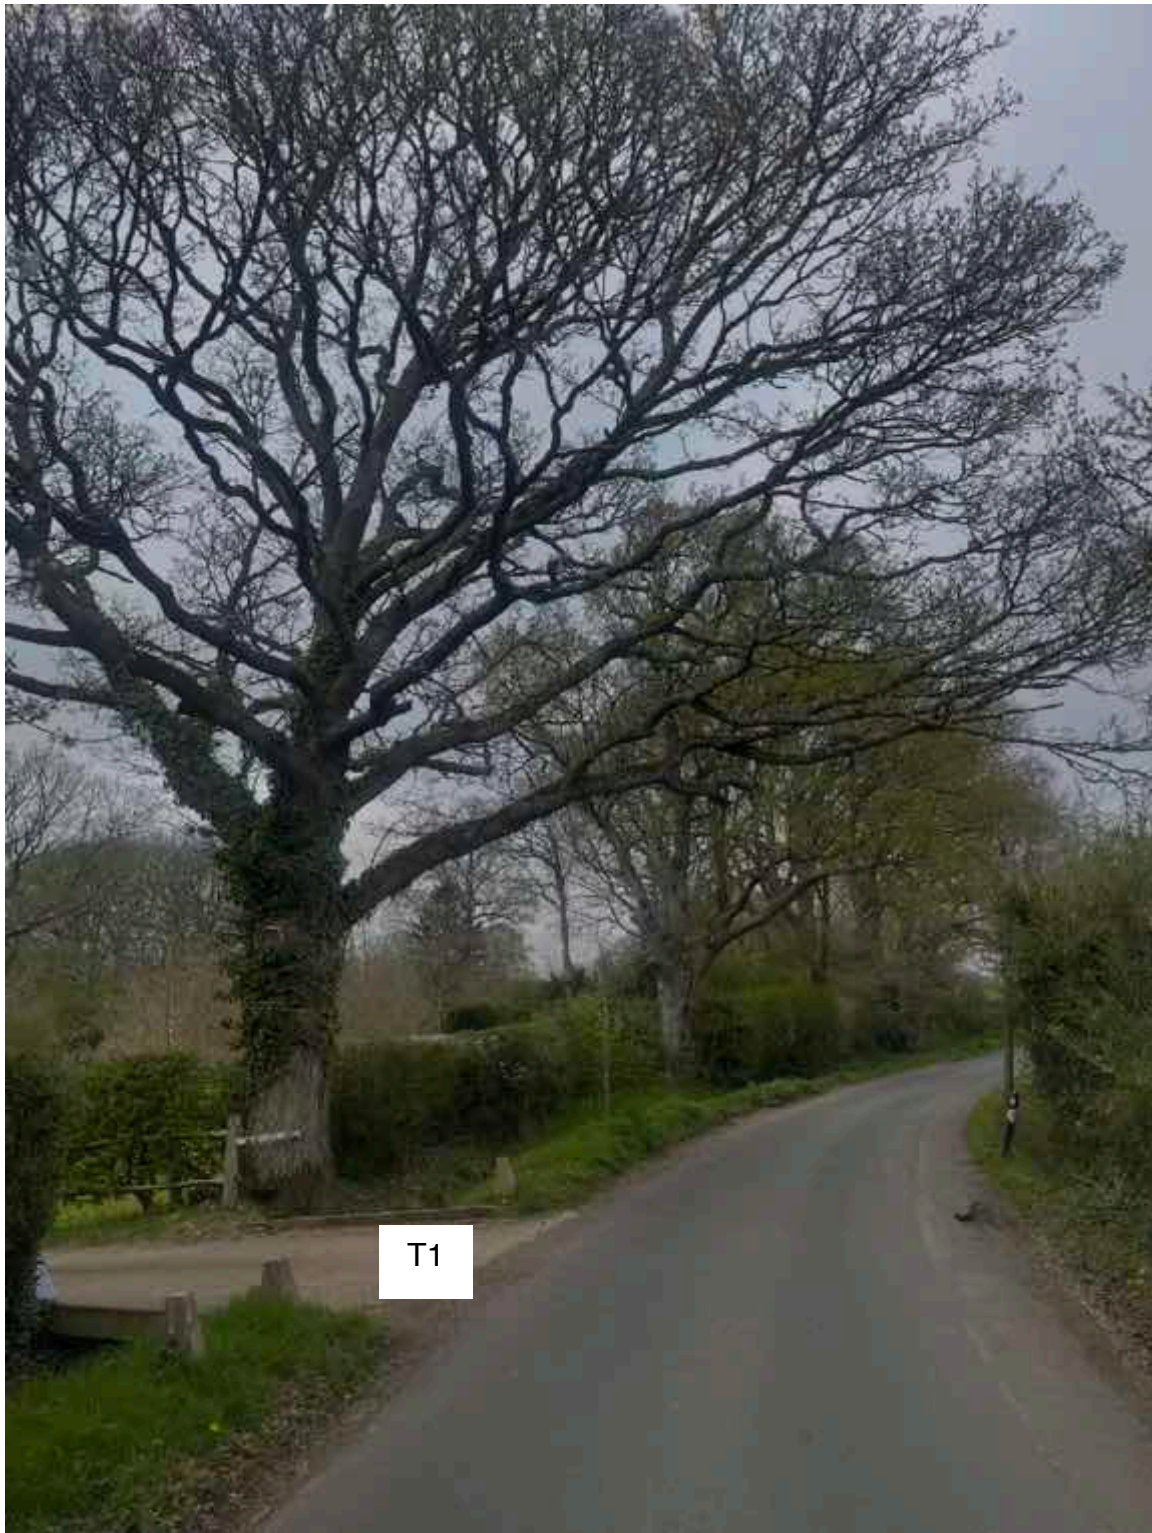
Existing entrance from Black Gate Lane by T1

| No | Species | Height | Ø at 1.5m | Spread | Crown | Age | Condition and Recommendations | Removal | ERC | BS | RPA |
|---|---|---|---|---|---|---|---|---|---|---|---|
| T1 | Oak<br><i>Quercus robor</i> | 20 | 950 | 10/9/11/12 | 8mE | M | Physiological Condition: Good<br>Structural Condition: Fair<br>Public Amenity Value: High<br>Inspection Limitations: None<br>Ivy up trunk and into canopy 10m. Minor deadwood across canopy. Tree lifted to 10m over drive. Two fruiting bodies of Ganoderma located at base of root flare south and west<br><b>Recommend:</b> Monitor health of tree < 18 months in regard to fungal infection | N<br>Monitor | >20<br>B | B2 | 11.4 |

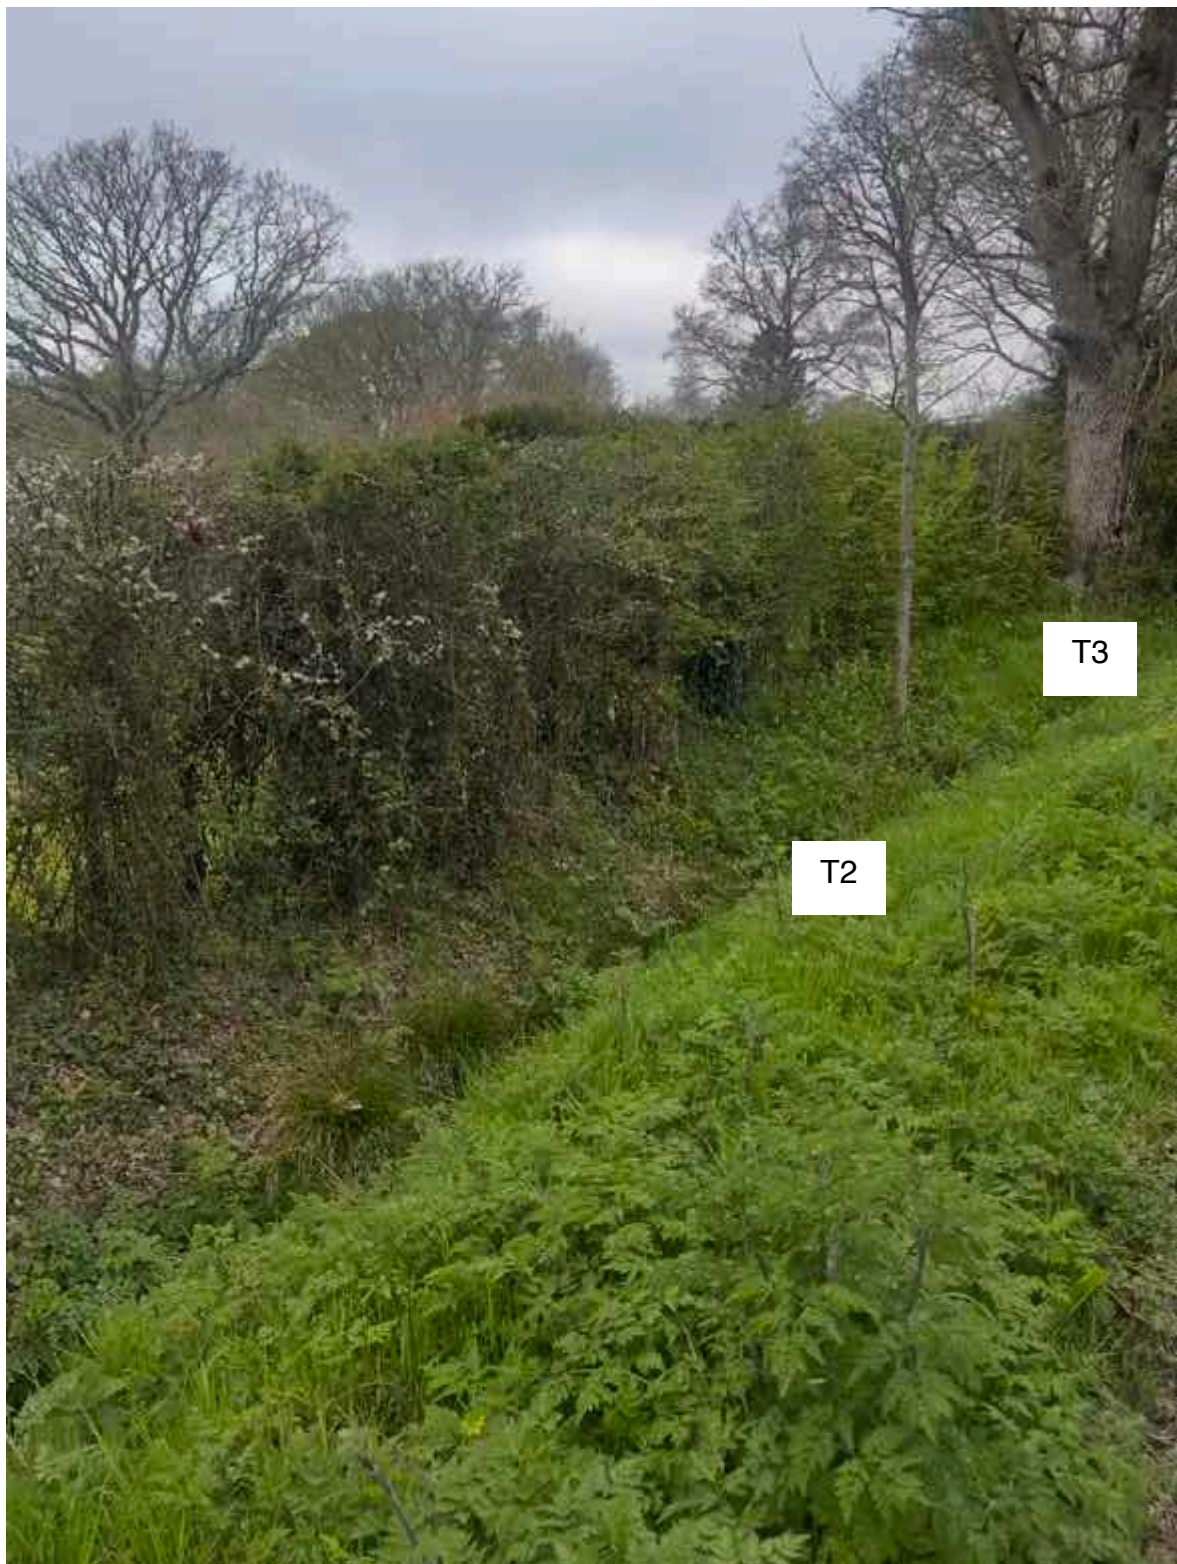
New entrance to be formed here by T2 which is to be removed.

| No | Species | Height | Ø at 1.5m | Spread | Crown | Age | Condition and Recommendations | Removal | ERC | BS | RPA |
|---|---|---|---|---|---|---|---|---|---|---|---|
| T2 | Oak<br><i>Quercus robor</i> | 5 | 95 | 1/2/2/1 | 2mE | Y | Physiological Condition: Poor<br>Structural Condition: Poor<br>Public Amenity Value: Low<br>Inspection Limitations: None<br>Tree barked on north side g/l-3.5m<br><b>Recommend:</b> Remove for development | Y<br>Fell | <10<br>B | U | 1.14 |

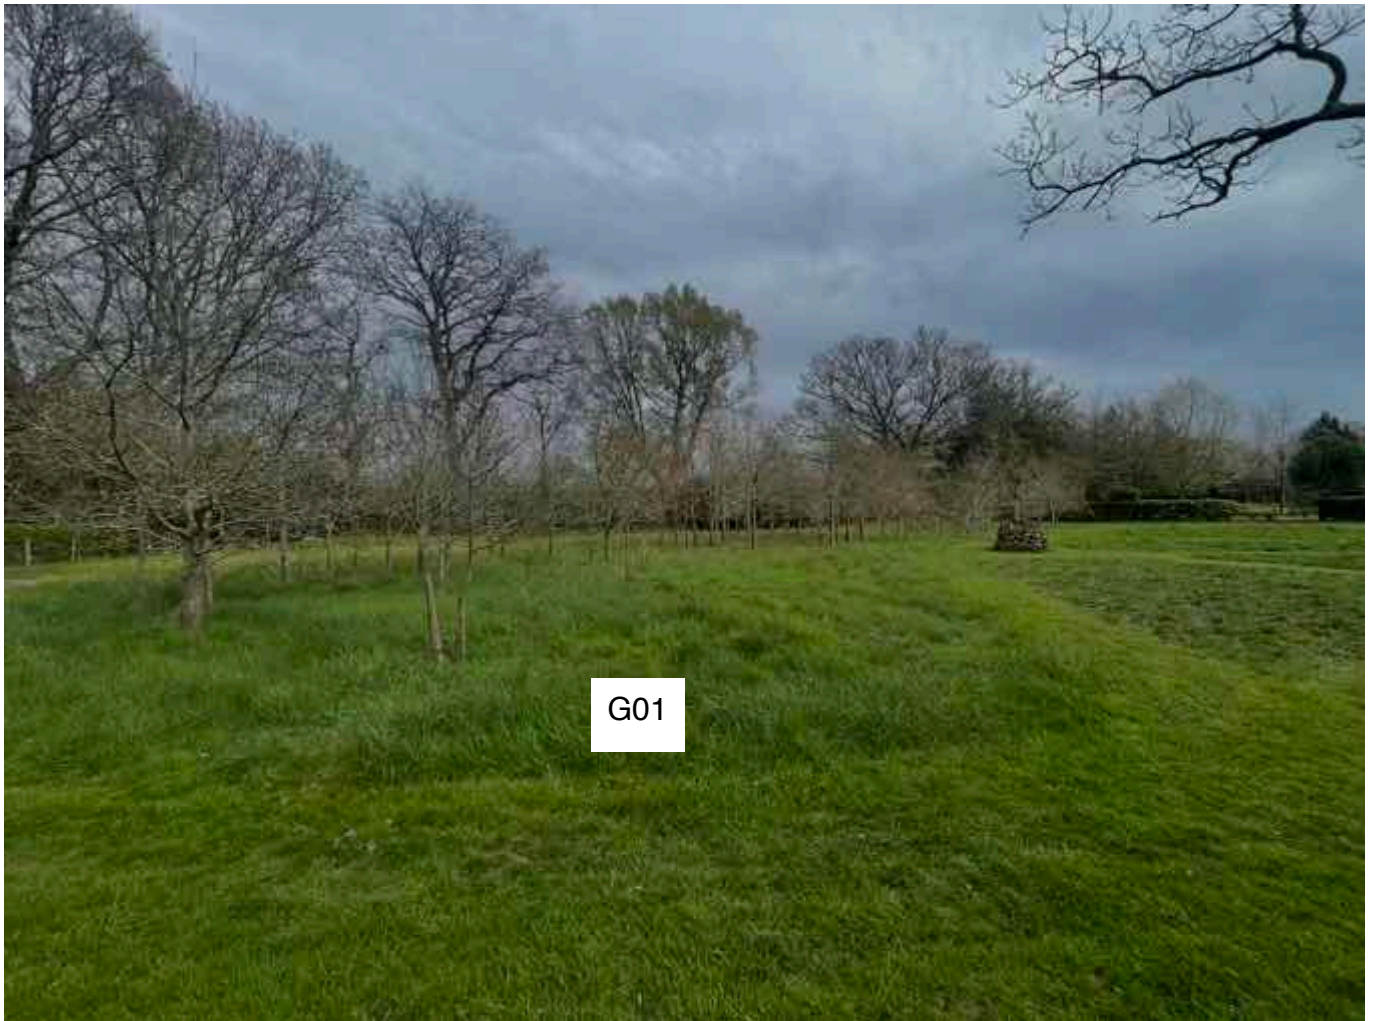
Site of new dwelling where the mass planting of young Oak trees G01 are to be removed.

3.5.2. No mature trees are required to be felled, but the mass planting of young Oak trees will be cleared to make way for the proposed new dwelling and associated garage along with the new drive.

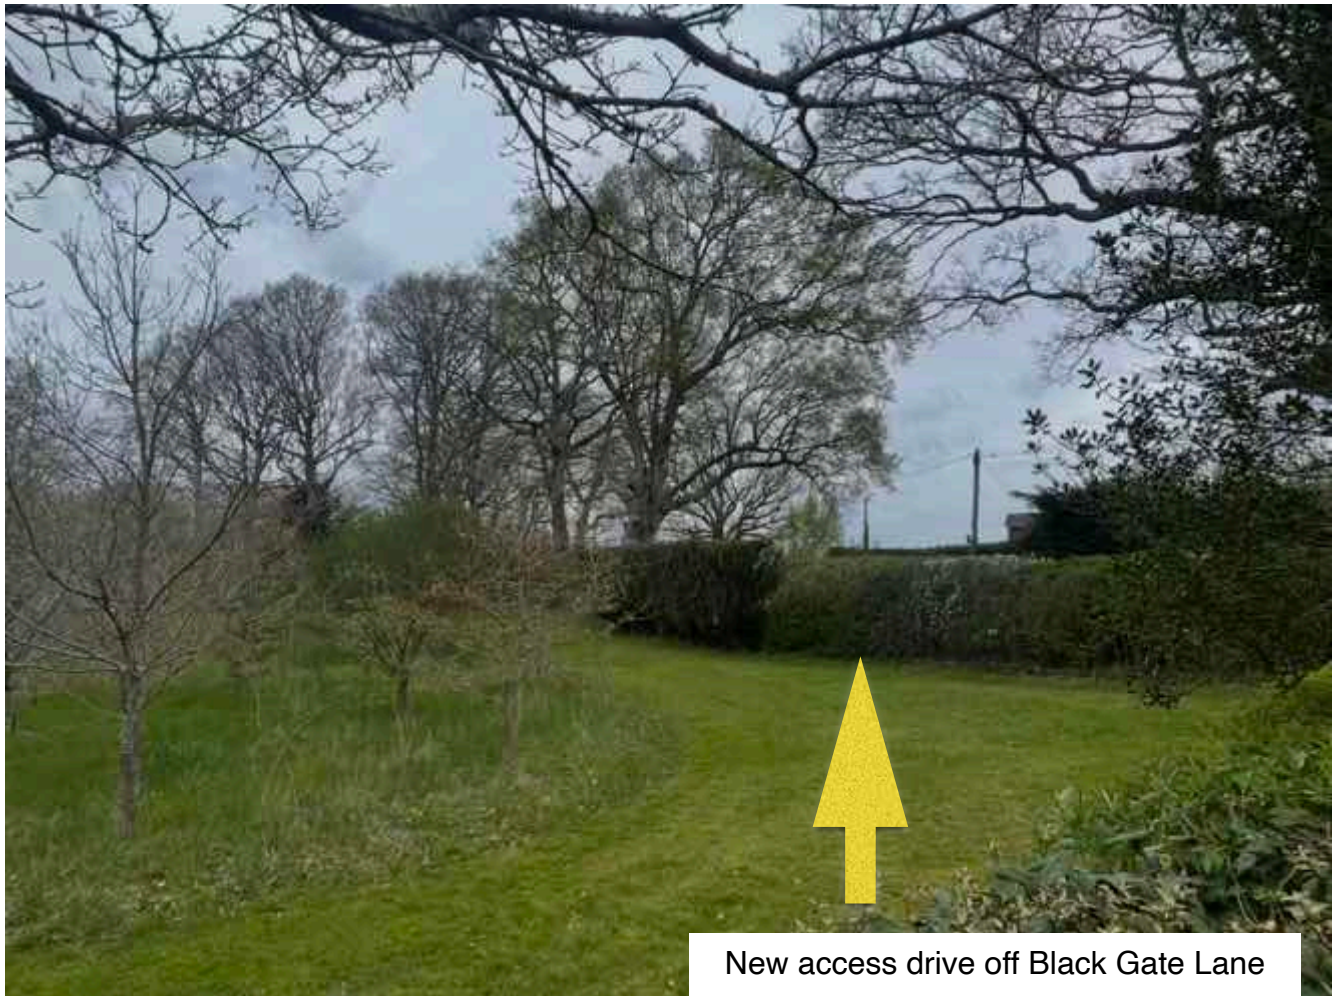
Photo from south of the site looking east to mass planting of young Oak trees G01 which are to be removed
