# Arboricultural Report

Tree Survey  
Arboricultural Impact Assessment  
& Tree Protection Plan

Mannings Heath Golf Club  
Hammerpond Road  
Mannings Heath  
Horsham  
RH13 6PG

AR/173226

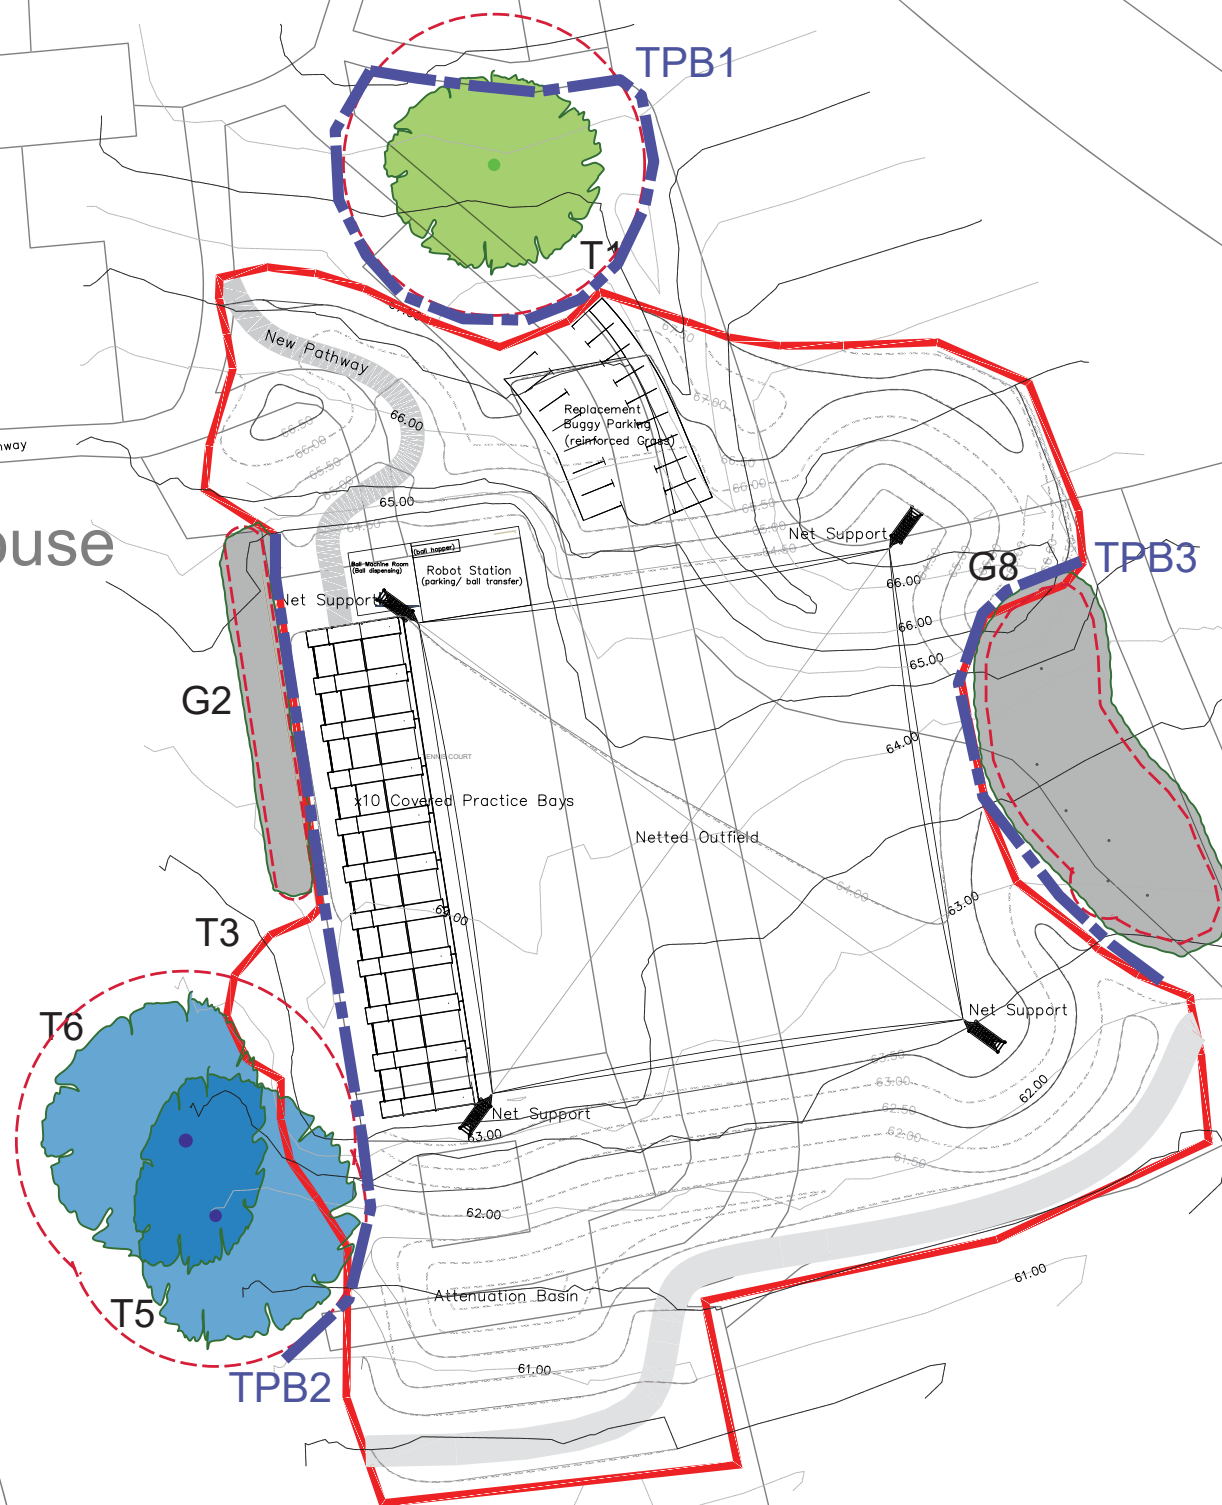
AR/173226 – Mannings Heath Golf Club  
 Hammerpond Road, Mannings Heath RH13 6PG  
**Tree Protection Plan**  
 September 2026  
 Do not scale from drawing

- 11.3.2 **The subject site:** The requirement for three Tree Protection Barriers has been identified and these have been illustrated at Appendix B.

- **TPB 1** - This barrier is located to the north of the proposal area. It is designed to protect the RPA and stem of T1 from damage during the construction period.
- **TPB 2** - This barrier is located to the west of the proposal area. It is designed to protect the RPAs and stems of trees beyond the barrier from damage during the construction period.

- **TPB 3** - This barrier is located to the east of the proposal area. It is designed to protect the RPAs and stems of trees beyond the barrier from damage during the construction period.
