## ARBORICULTURAL REPORT ADDENDUM

SECTION 73 VARIATION OF CONDITIONS APPLICATION RELATING TO THE TREE  
PROTECTION MEASURES APPROVED UNDER PLANNING CONSENT REF: DC/25/0944

MERRYHILL MUSHROOMS  
MERRYHILL  
STORRINGTON ROAD  
THAKEHAM  
RH20 3ED

Ref: 06986 / 2026

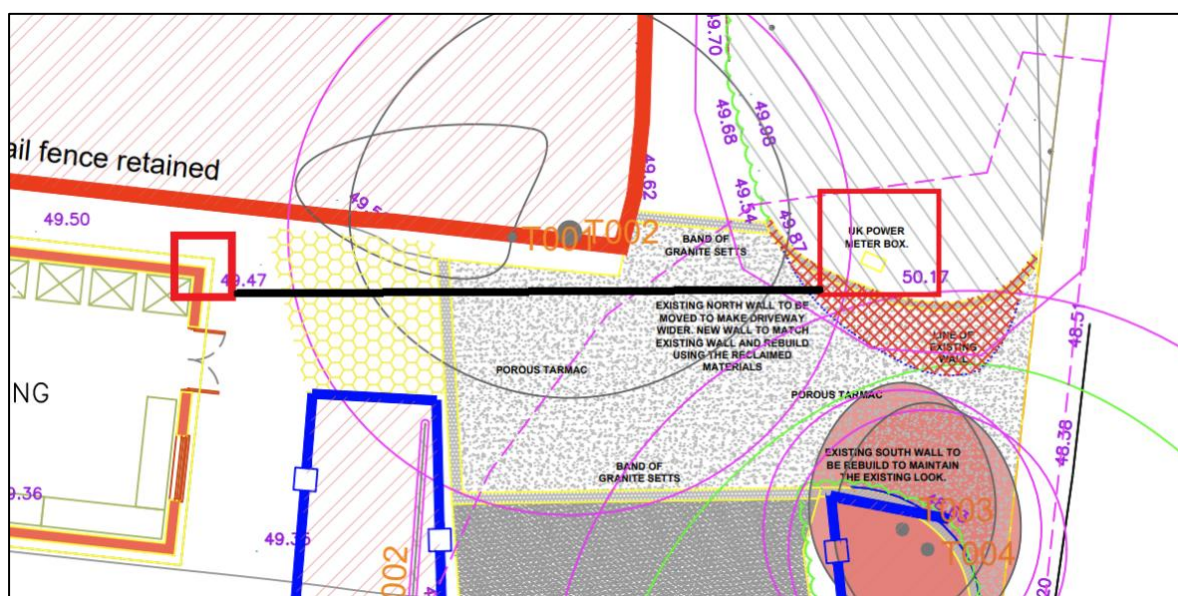
To create adequate clearance to T005 (Oak), the trench will be routed closer to low-grade trees (T001 (Oak) & T002 (Sycamore)). The proximity of the trench to T001 (Oak) & T002 (Sycamore) means that woody roots and smaller fibrous roots from these trees will be present in greater numbers, therefore a hand dug trench is not a practical option.

Figure 1 – Annotated planning showing route of proposed service trench

The decision has therefore been made to remove the lower quality trees to allow for practical open trenching whilst permitting greater protection for the higher quality Oak (T005) which is to be retained.

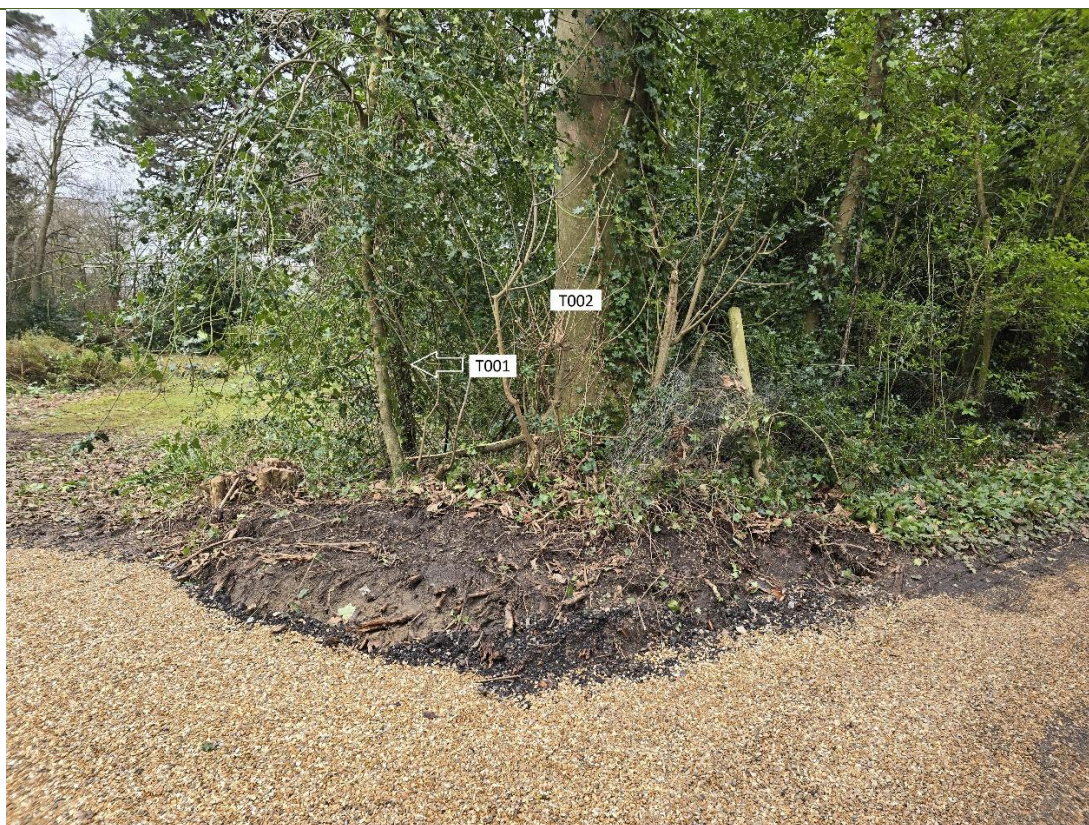
T001 is a young Oak with a slender trunk and suppressed, asymmetrical crown having grown in close proximity to T002 (Sycamore).

T002 (Sycamore) is a larger tree which also has an asymmetrical crown shared with T001. It is apparent that many roots on the southern and eastern side of T002 have historically been cut close to the trunk. Stub cut roots

are visible and exposed. This root pruning operation will have had a lasting effect on the health of the tree and will also undermine the long-term structure and stability of the tree as it grows.

Due to the low amenity and defects present, both trees have been classified as 'C1/2' trees being 'Unremarkable trees of very limited merit or such impaired condition that they do not qualify in higher categories' and 'Trees present in groups but without this conferring on them significantly greater collective landscape value; and/ or trees offering low or only temporary'.

**Photo 1 – Base and lower trunks of T001 (Oak) and T002 (Sycamore)**

The assessment demonstrates that the proposed removal of T001 (Oak) and T002 (Sycamore) is justified on arboricultural grounds, given their low quality, structural deficiencies, and limited amenity value. The removal of these two trees enables the service trench to be routed further away from T005 (Oak), thereby prioritising the retention and protection of this more prominent and valuable tree.

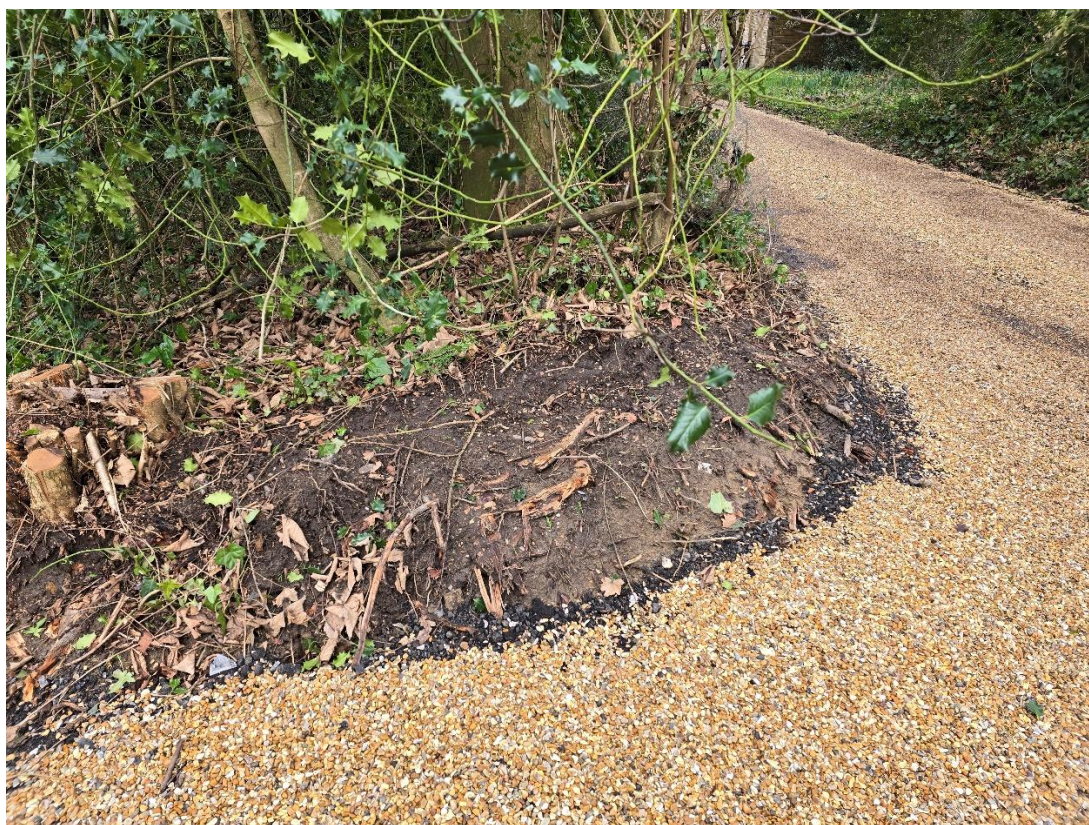
**Photo 2 – Historic root damage at the base of T002 (Sycamore)**

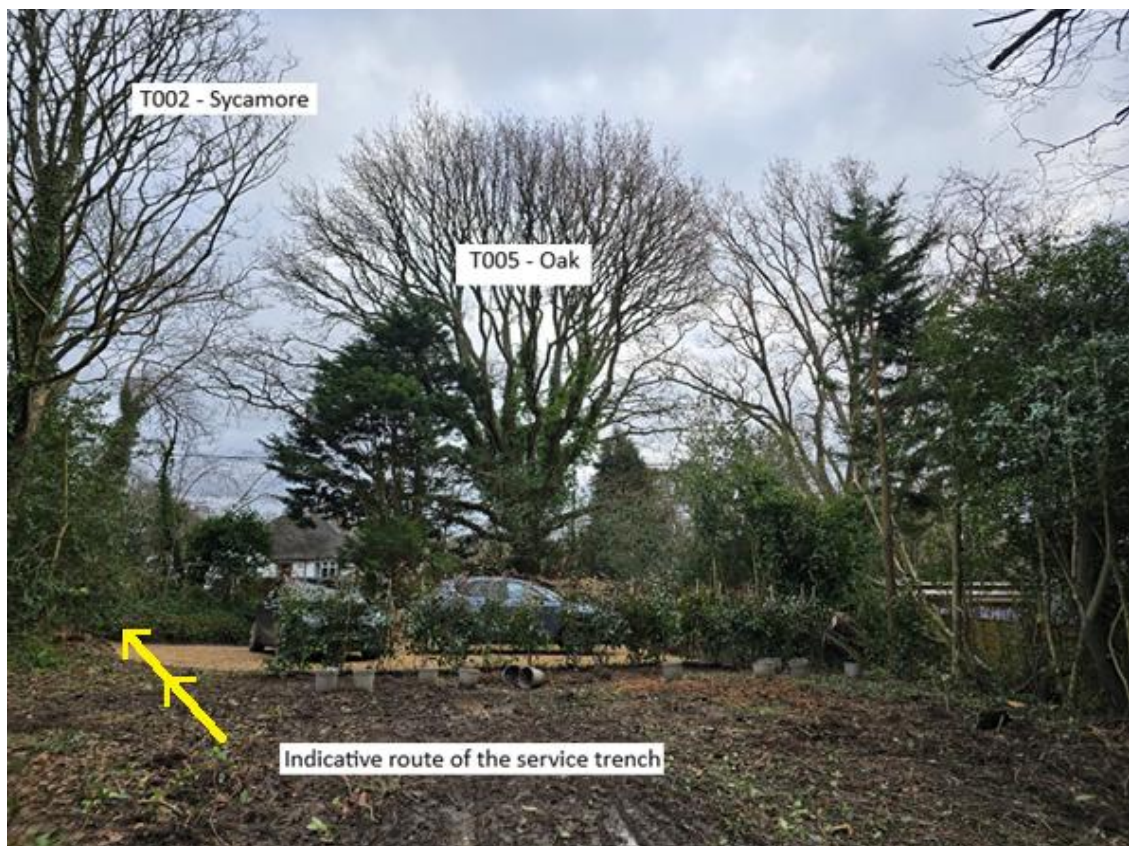
A short length of the service trench (5m) will be within the offset RPA of T005 (Oak). The trench will be on the far side of the access drive over 12m from the base of the tree in which location few significant woody roots from T005 are likely to be present.

A trench in this location is unlikely to result in any significant adverse impact on the T002 (Oak). However, as a precautionary measure it is recommended that the last 5m at the eastern end of the service trench be excavated by hand to allow any woody roots to be retained and the services fed beneath.

**Photo 3 – Indicative route of services in relation to T005 (Cat 'A' Oak)**

The following methodology will be adhered to when excavating the easternmost 5m of the service trench where it falls within the offset RPA of T005 (Oak)

1. Pre-commencement
  - The extent of the RPA and the route of the service run will be clearly marked on site.
2. Excavation Method
  - Within the offset RPA, the service trench will be excavated by hand only (no mechanical plant).

- Surface layers will be removed using hand tools (e.g. trowels, brush, air spade if needed).
  - The ground will be excavated in shallow incremental layers to expose roots without causing damage to bark.

3. Root Protection
  - Roots <25mm can be cut using sharp secateurs or saws.
  - In the unlikely event that Oak roots >25mm diameter are discovered, these will be retained and the earth excavated around them.

- If this is not possible, work should stop immediately and arboricultural advice sought before proceeding.
  - The trench will be kept to the minimum width required.

- Any roots exposed during the excavation will be covered with damp hessian to prevent desiccation.
4. Services Installation
  - Services will be installed with minimal ground disturbance feeding pipework under the larger retained tree roots.

5. Backfilling
  - Once installed the service trench will be backfilled immediately with excavated soil or suitable topsoil.
  - The ground will be lightly compacted by hand. Care will be taken not to over-compact the area.

- The backfilled trench will be watered to improve settlement and reduce air pockets.

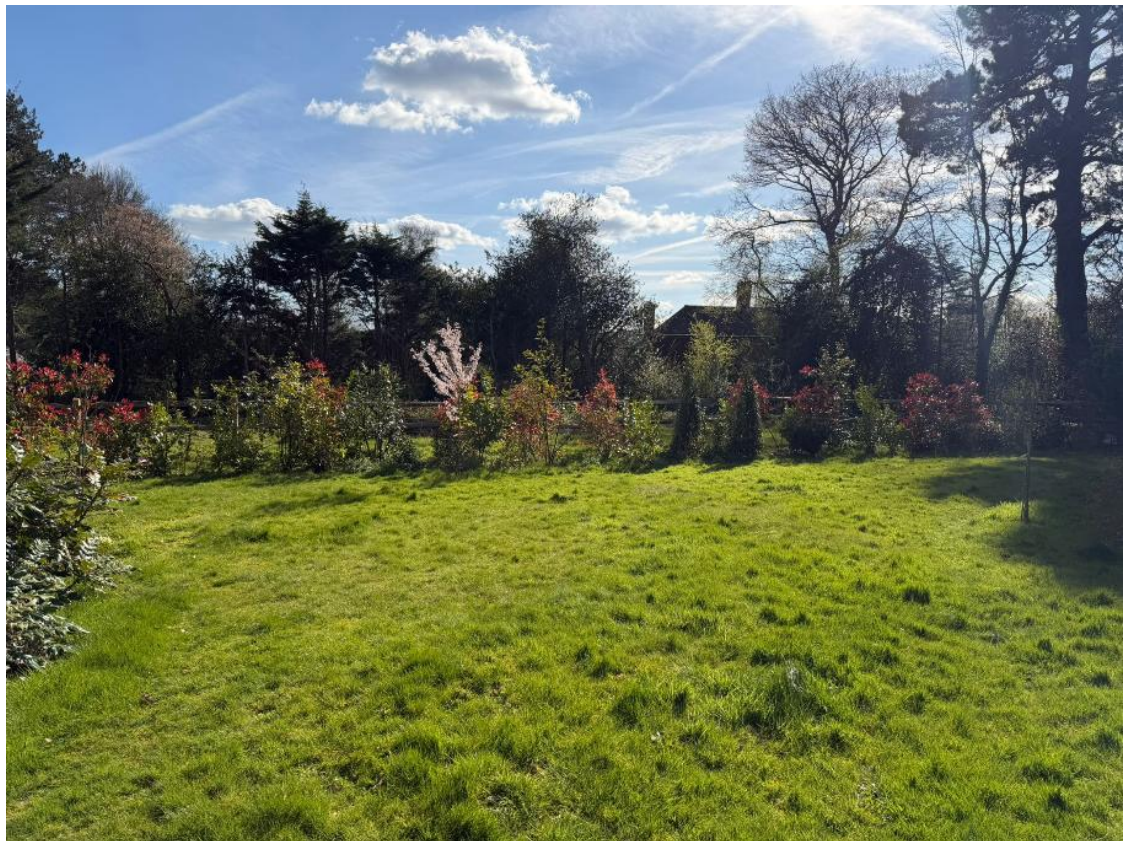
- 4x small yews on the bank by the oak.
- 1x Yew on the southern border
- 2x Field Maples
- 2x Flowering Cherries

The young trees are healthy and establishing well and will be maintained / irrigated by the client until they are fully established on site.

The new trees will increase net tree numbers on site and when mature these young trees will adequately mitigate the removal of T001 (Oak) and T002 (Sycamore) as proposed.

**Photo 4 – Examples of new tree and shrub planting already undertaken within the site**
