**Arboricultural Report**  
**composed of**  
**Arboricultural Impact Assessment**  
**Arboricultural Method Statement**  
**& Tree Protection Plan**

Haynes, Littleworth Lane  
Partridge Green Horsham  
West Sussex RH13 8JF

Written by  
Barry Holdsworth MBA, RHS. Dip, MCI Hort, M.Arbor.A, MCMI  
Horticultural Consultant

12th August 2025

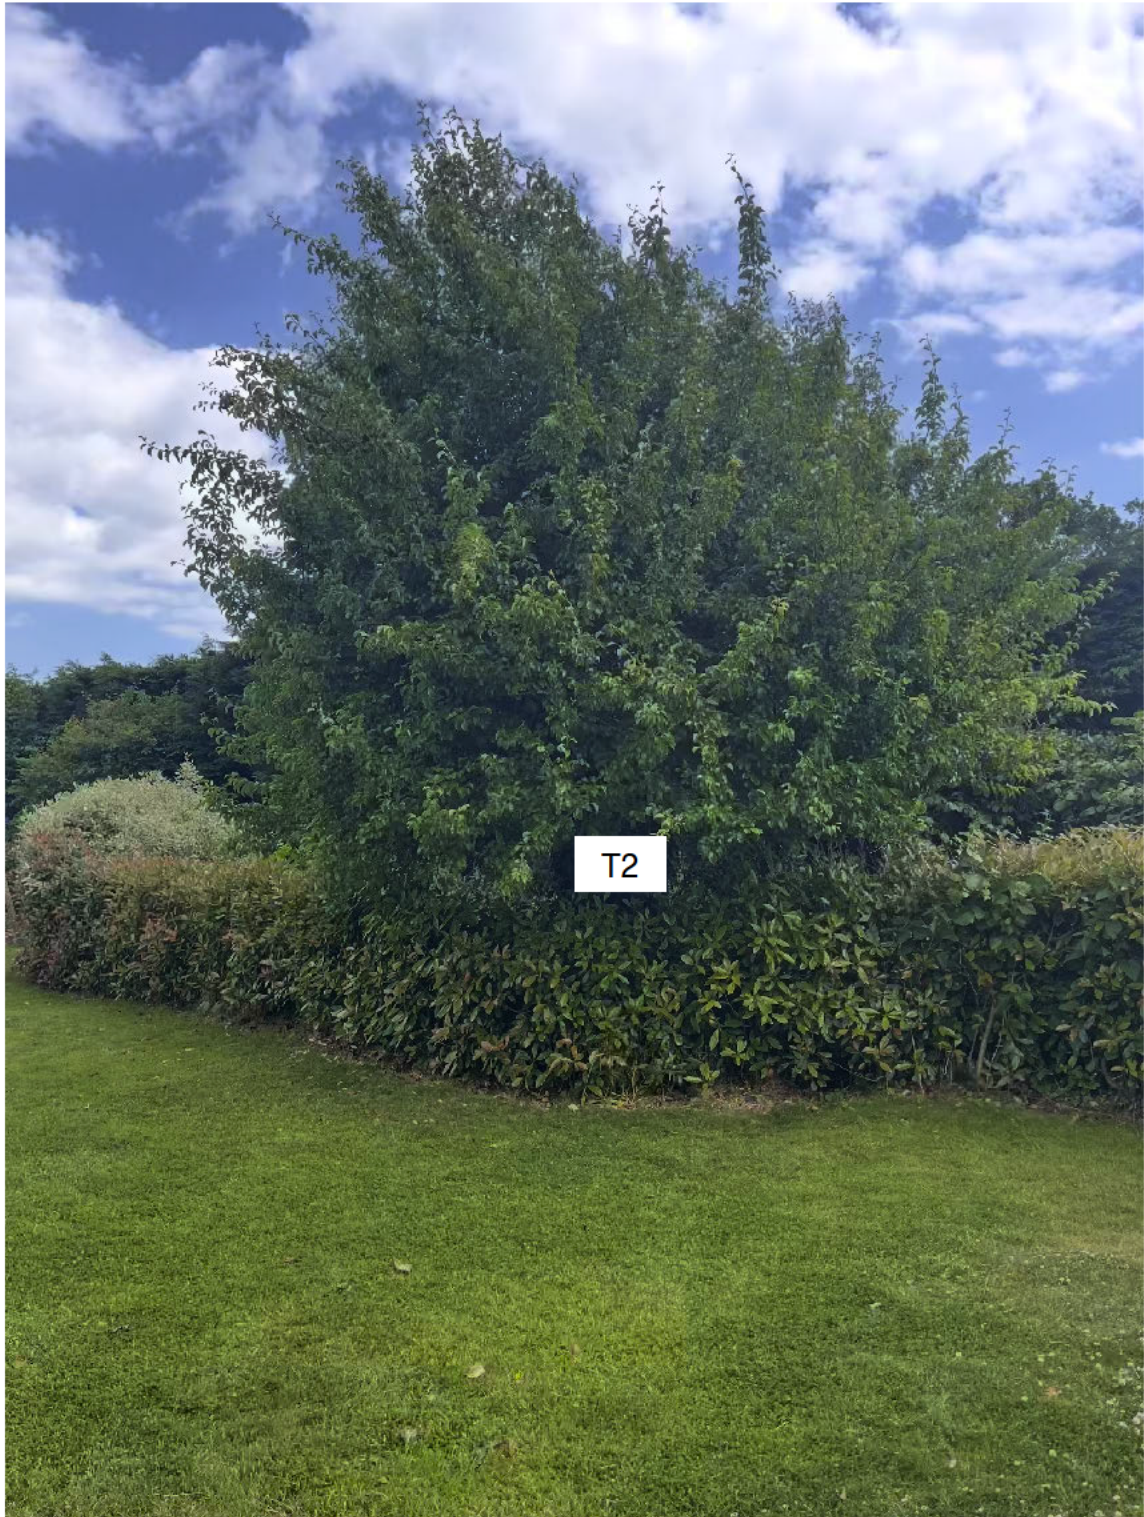
Site of access drive requiring the removal of the Photinia hedge and T2

| No | Species | Height | Ø at 1.5m | Spread | Crown | Age | Condition and<br>Recommendations | Removal | ERC | BS | RPA |
|---|---|---|---|---|---|---|---|---|---|---|---|
| T2 | Pear<br><i>Pyrus communis</i> | 10 | 695 | 6.0Ø | 2mN | OM | Physiological Condition: Fair<br>Structural Condition: Fair<br>Public Amenity Value: Low<br>Inspection Limitations: Yes - vegetation cover<br>Hollow trunk with decay. Lost leader but good regrowth<br>Ivy into canopy<br><b>Recommend:</b> Remove for development | Y<br>Fell | >10<br>B | C2 | 8.34 |

The small group of trees G1 (Category C) being a mixture of Elm and Wild Plum is to be removed for the drive along with the Pear tree T2 (Category C), the Photinia hedge H3 (Category C) and shrubs within the footprint of the drive.

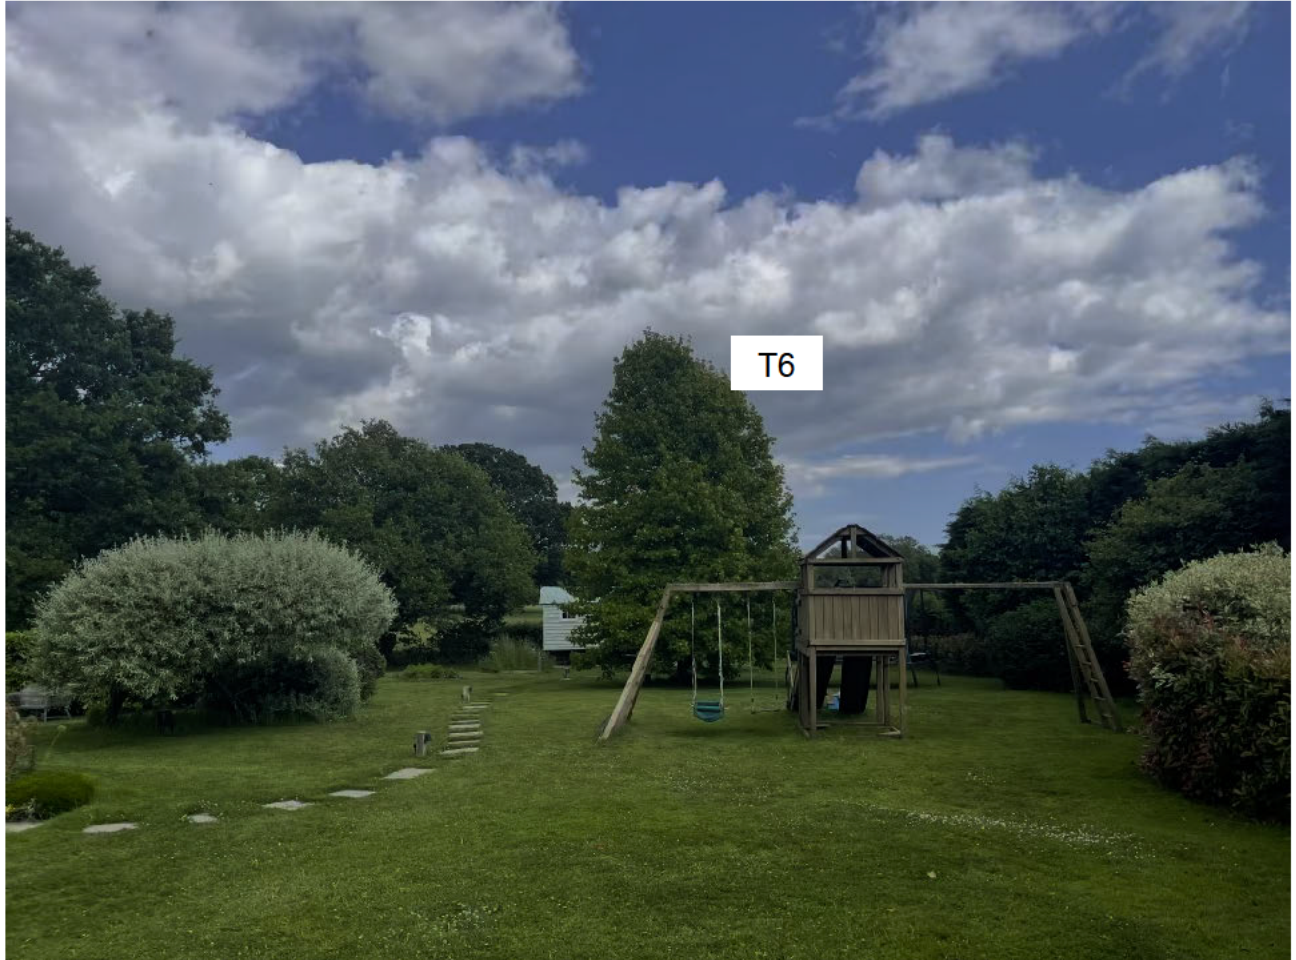
Access drive on right of picture with parking and turning where playground is sited. T6 to be removed to site new house

| T6 | Sweet Gum<br><i>Liquidamber styraciflua</i> | 17 | 220+250 | 6.0Ø | 1mN | M | Physiological Condition: Good<br>Structural Condition: Good<br>Public Amenity Value: Moderate<br>Inspection Limitations: None<br><b>Recommend:</b> Remove for development | Y<br>Fell | >40<br>B | B2 | 3.99 |

The house footprint will require the loss of the Sweet Gum T6 (Category B).

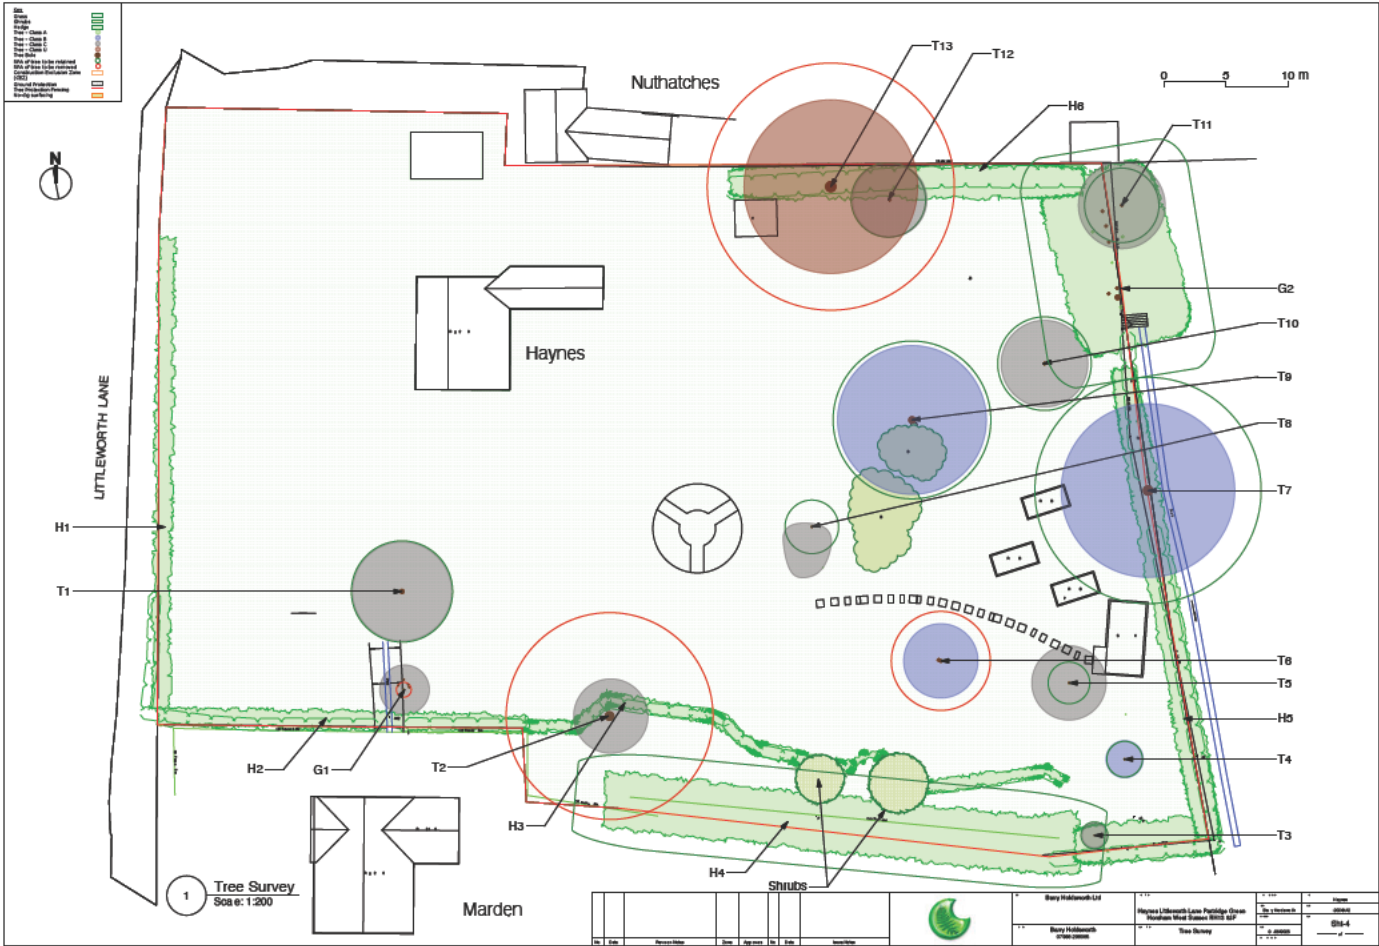
Appendix 1. Tree Survey Plan

3.5.1. The Tree Survey Plan by Barry Holdsworth Ltd indicates the trees on site and their Root Protection Area (RPA) and if they are to retained (green outlined tree canopy) or removed (red outlined tree canopy). The Tree Protection Plan by Barry Holdsworth Ltd (Appendix 2. Tree Protection Plan) shows the proposed footprint of the buildings.

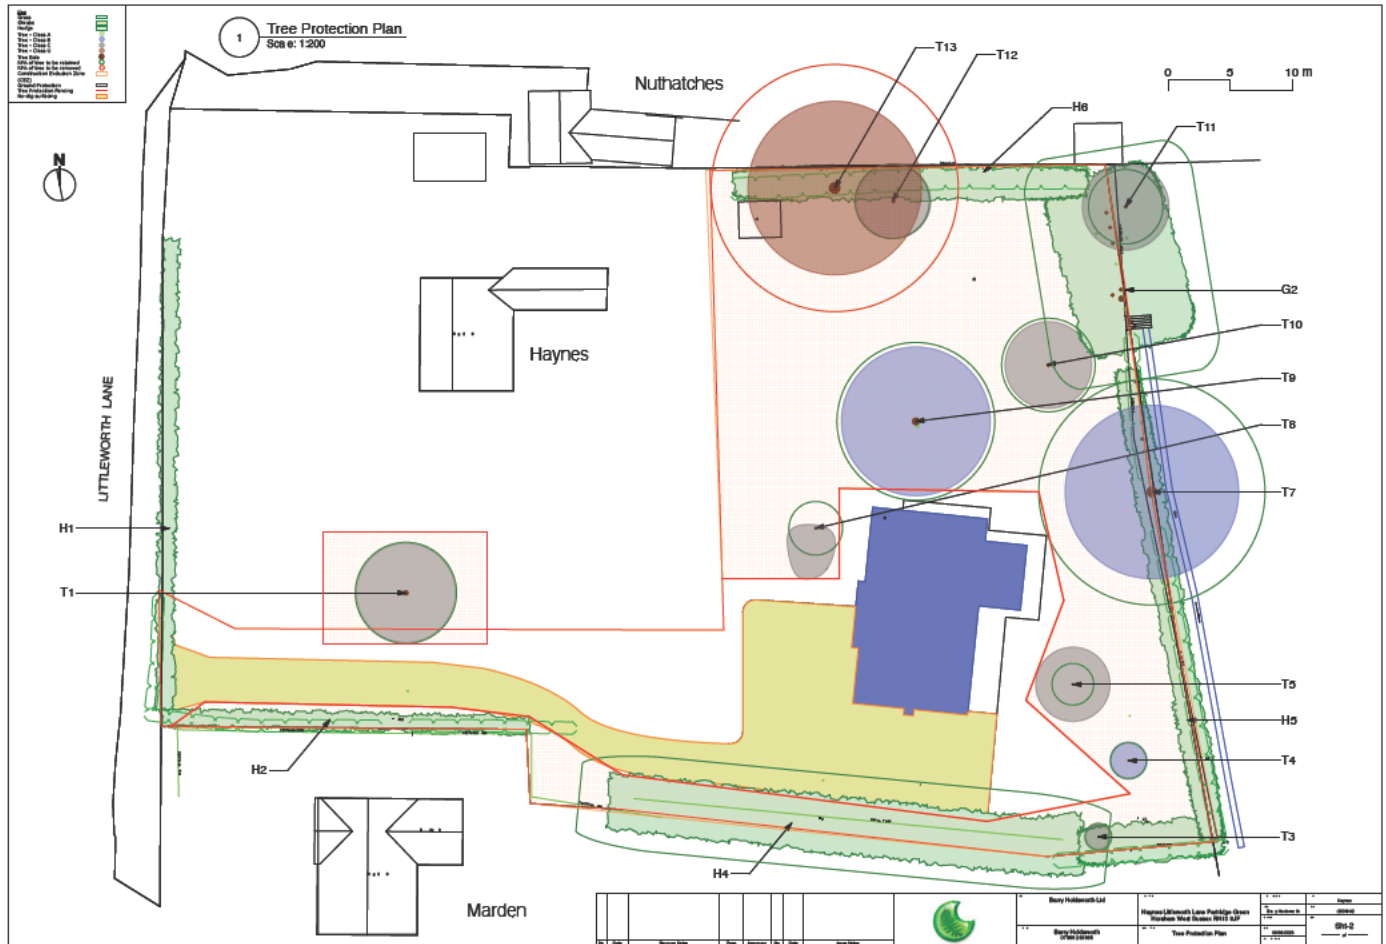
## Appendix 2. Tree Protection Plan

3.7.2. The Tree Protection Fence will create a Construction Exclusion Zone (CEZ) and this is shown as orange hatching on the Tree Protection Plan (Appendix 2. Tree Protection Plan).

All the remaining trees found on the site are situated outside the building zone. However, in order to protect the root zones and canopies of the remaining trees a Construction Exclusion Zone is to be arranged with tree protection fencing erected across the site, as shown on the Tree Protection plan, see Appendix 2.
