# **PHASE 1 DESK STUDY**

**ST CRISPINS CHURCH,  
CHURCH PLACE, PULBOROUGH,  
WEST SUSSEX RH20 1AF**

**EARLSWOOD HOMES SOUTH EAST LIMITED**

**21/12217/KJC**

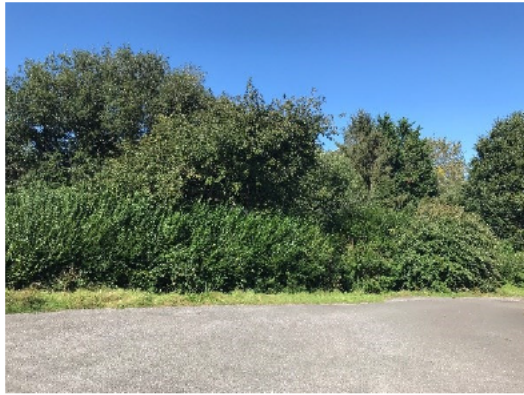
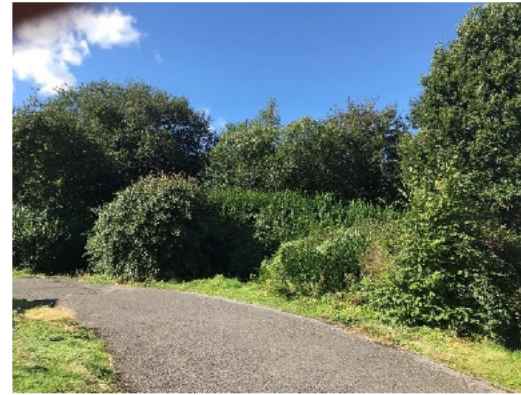
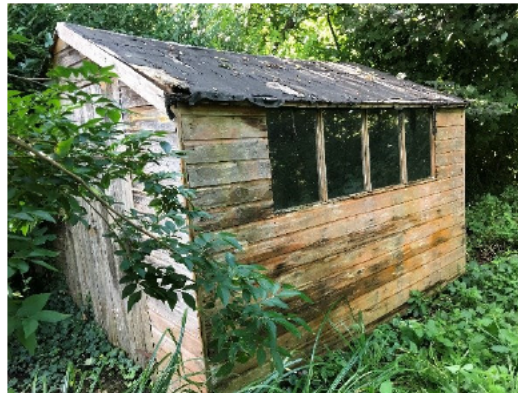
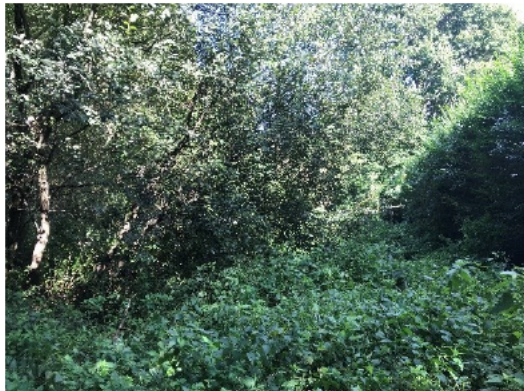
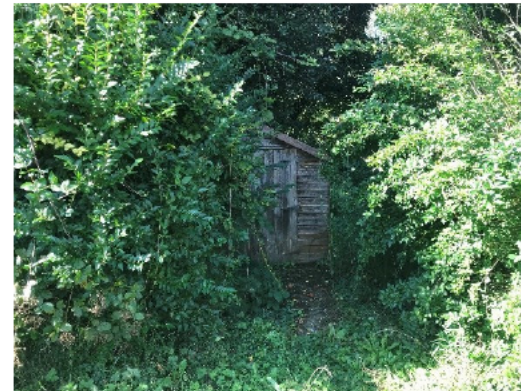
## NORTHERN AREA OF SITE

The former church building was still present at the time of the walkover survey and was no longer in use. The building is situated on the southern part of the site and is surrounded by soft landscaped areas comprising long grass. A macadam access road lies to the north of the church and leads to areas of car parking. There is an exit back out on to Church Place. The northern part of the site is covered with trees and is fairly overgrown. A timber shed is also present in the area on a concrete base.
