**SURFACE WATER MANAGEMENT PLAN  
GLEBE FARM  
STEYNING  
VISTRY GROUP  
SWMP-21949AH-25-183  
MAY 2025**

SURFACE WATER MANAGEMENT PLAN  
GLEBE FARM  
STEYNING  
VISTRY GROUP  
SWMP-21949AH-25-183  
APRIL 2026

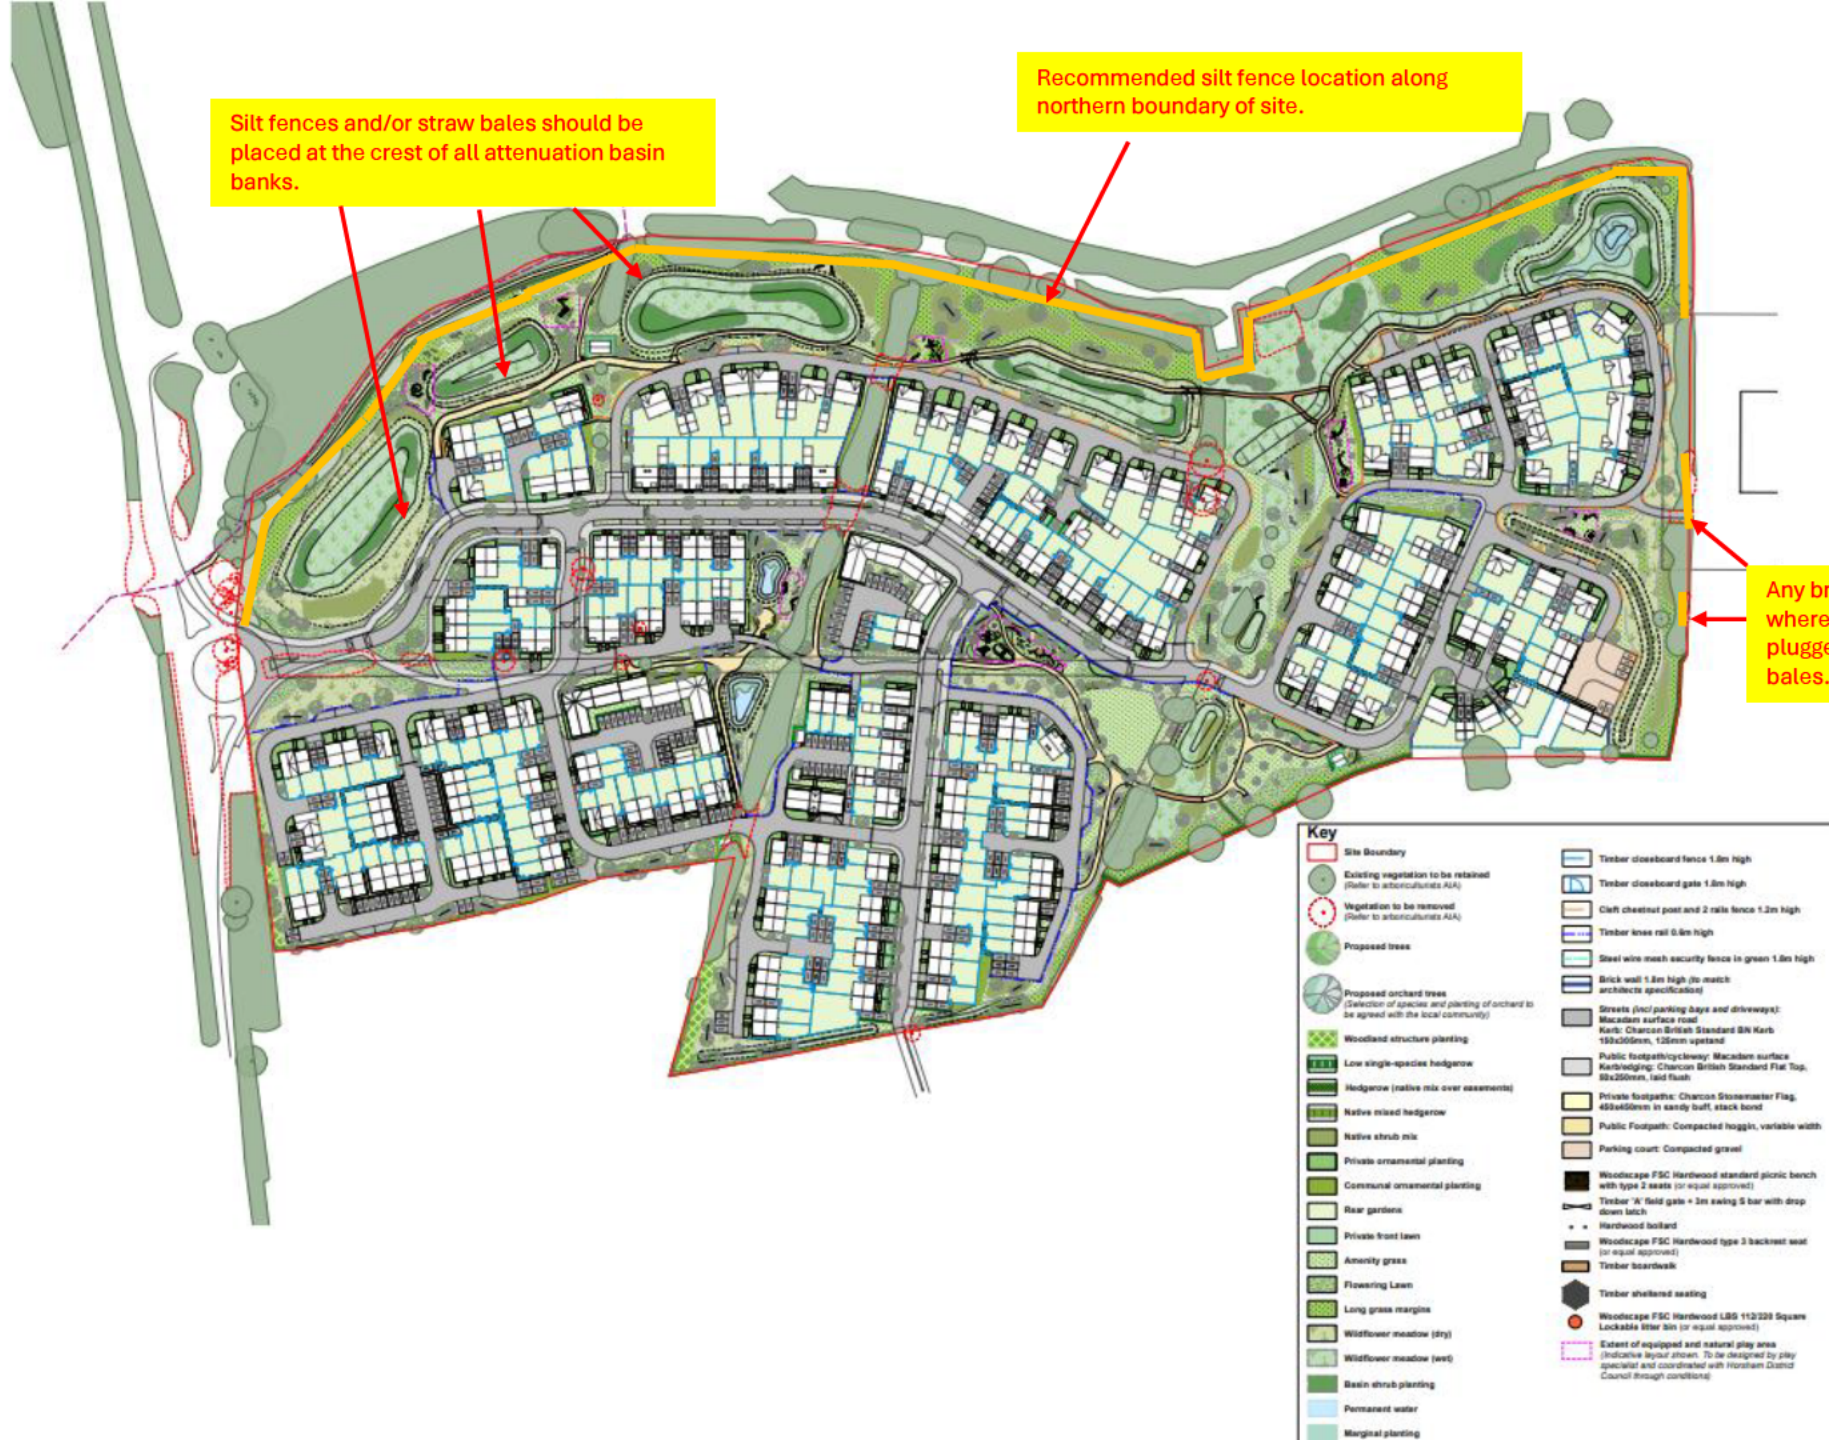
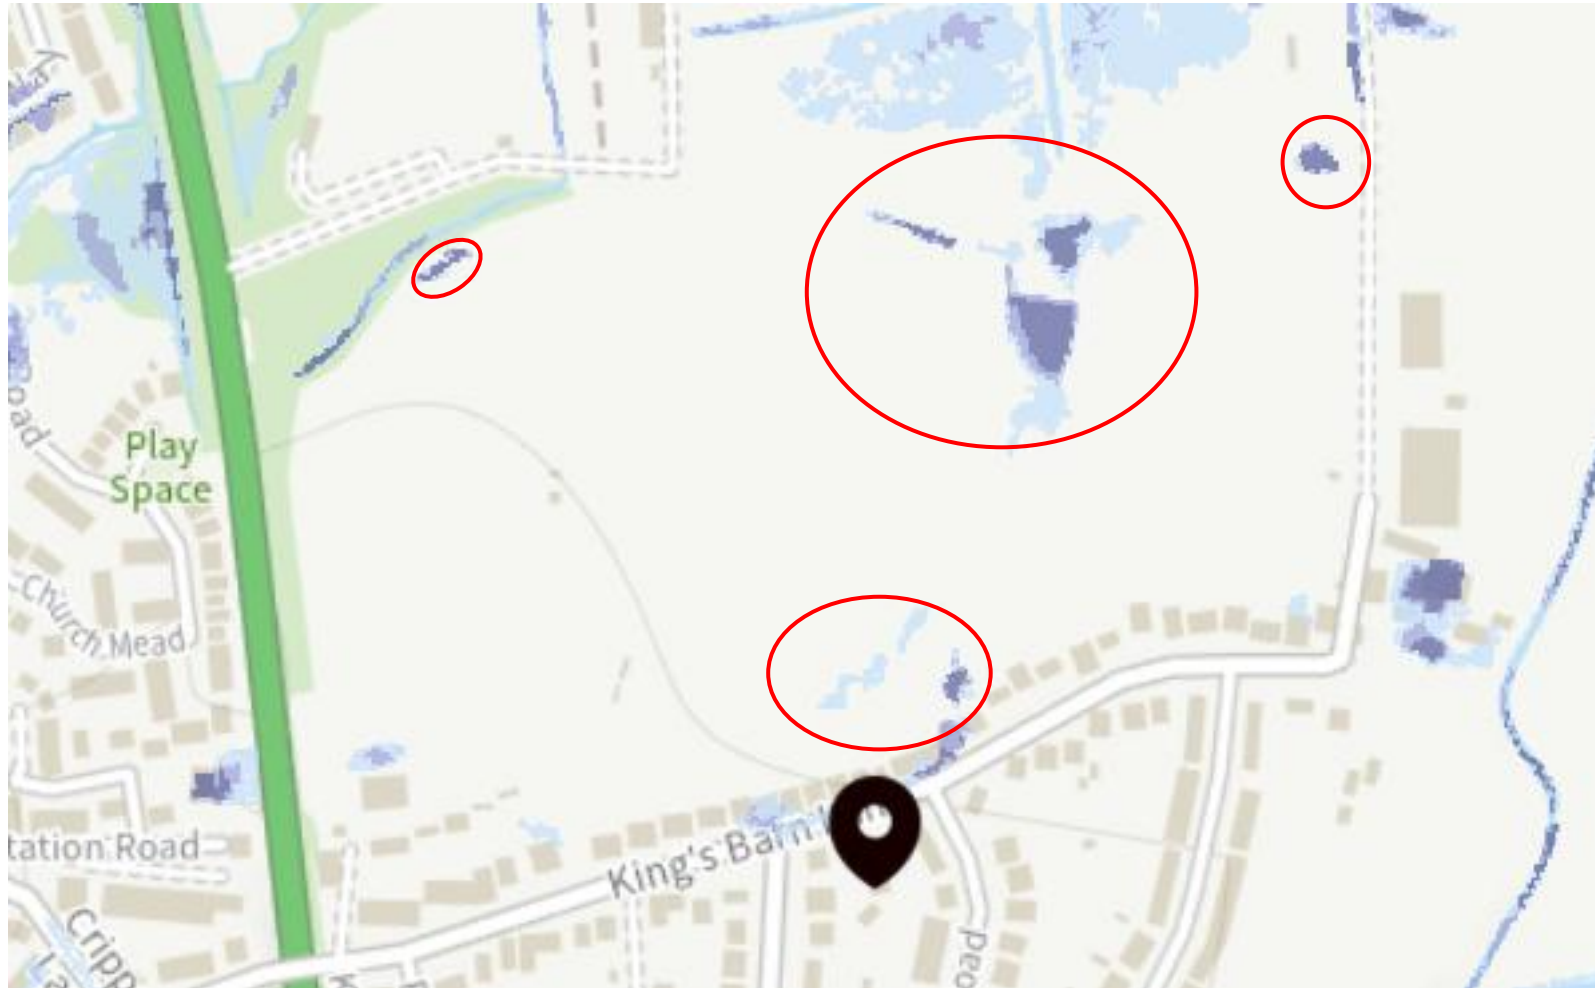
Recommended silt fence location along northern boundary of site.

Any breaks in the eastern boundary where runoff could occur should be plugged by silt fencing and straw bales.

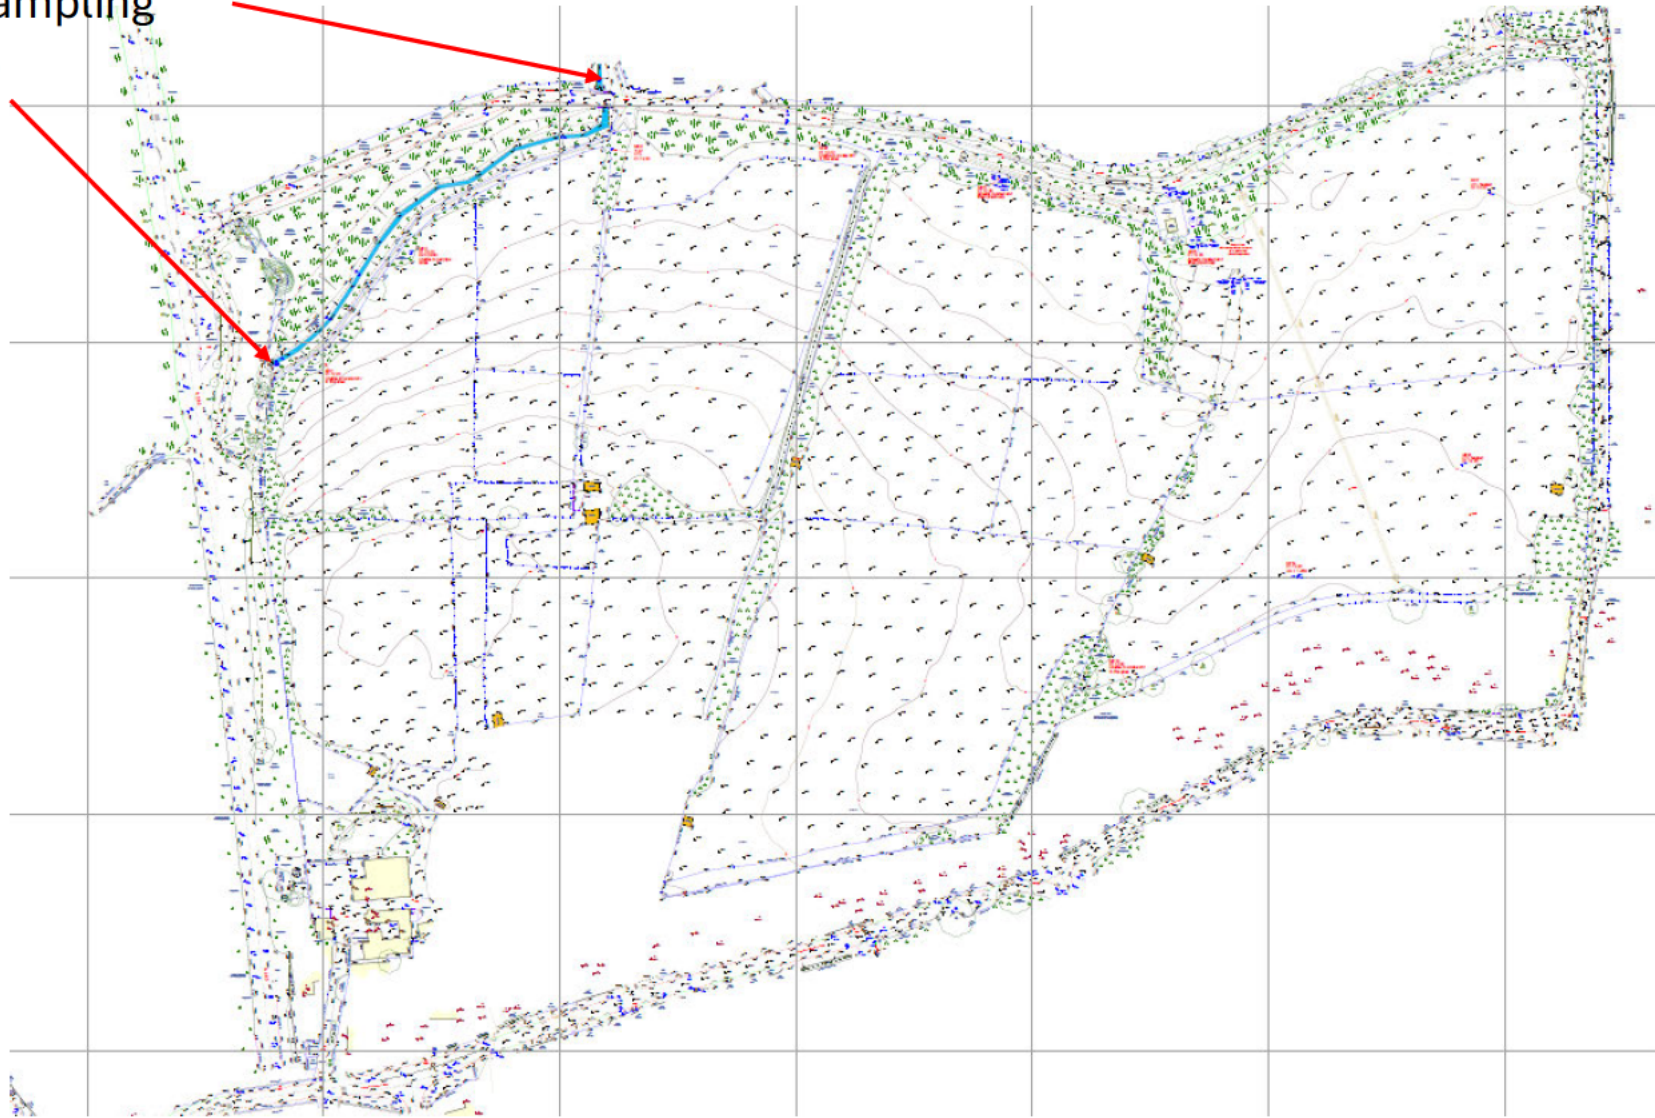
Areas of the site susceptible to surface water flooding should be regularly checked and managed to ensure runoff areas off site are not created. Silt fencing and straw bales can be utilised in these areas to prevent runoff. Re-profiling of the site surface to manage the water through the use of gulleys and grips or pumping of excess water can be used to redirect flood water away from sensitive areas.

Recommended  
stream sampling  
locations

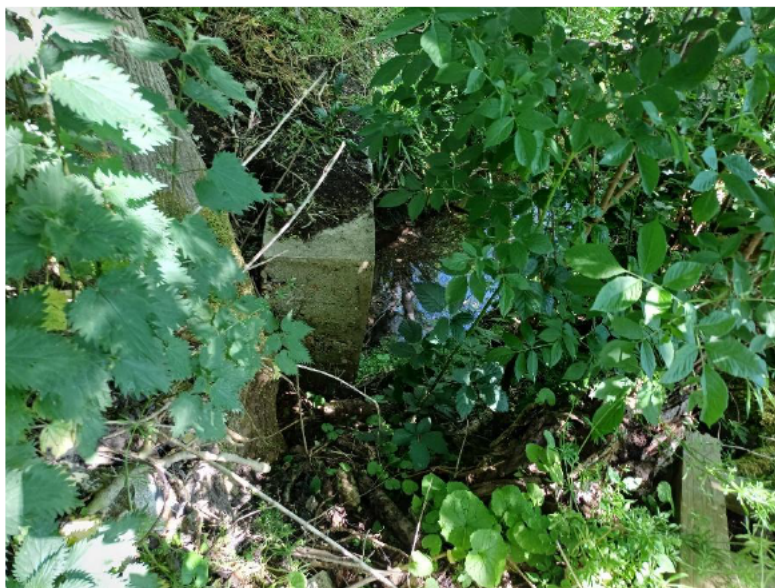
Plate 1: Exit point of northwestern stream from Steyning Bypass (A283) culvert. A potential sampling location.

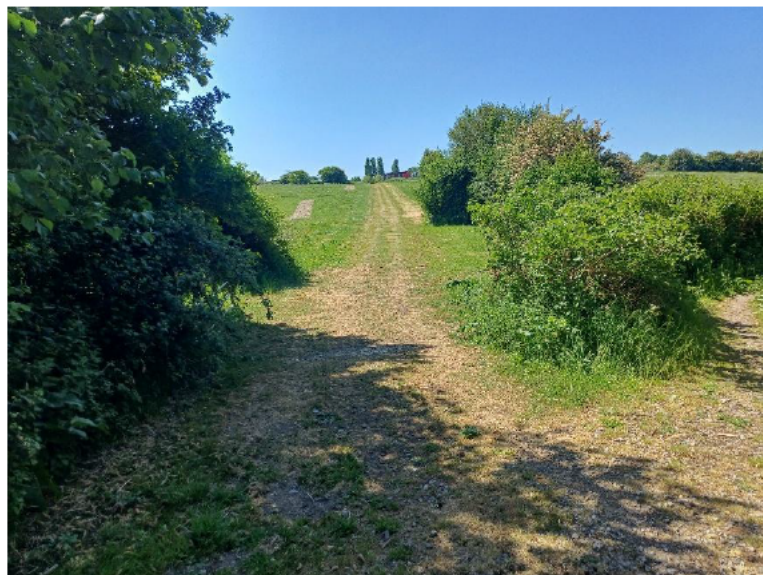
Plate 7: View looking south from the northern boundary of the site – potential silt runoff area, silt fence required.

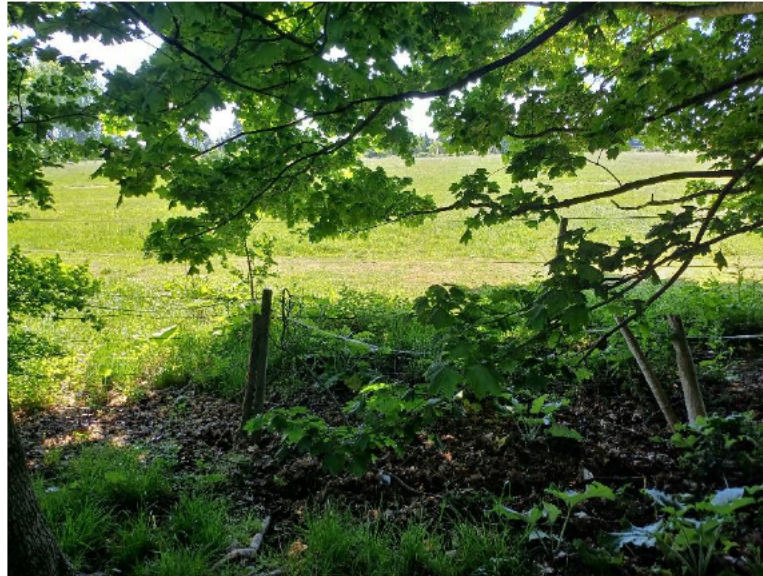
Plate 7: View looking south towards site from the northern boundary – lack of natural barriers to prevent silt runoff, silt fence required.

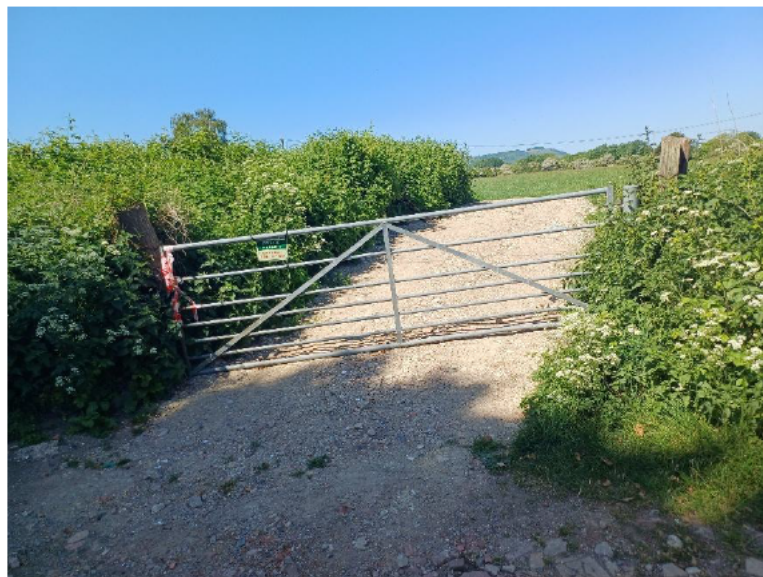
Plate 7: Looking west towards the eastern boundary of site – potential run off area. Silt mitigation measures recommended.

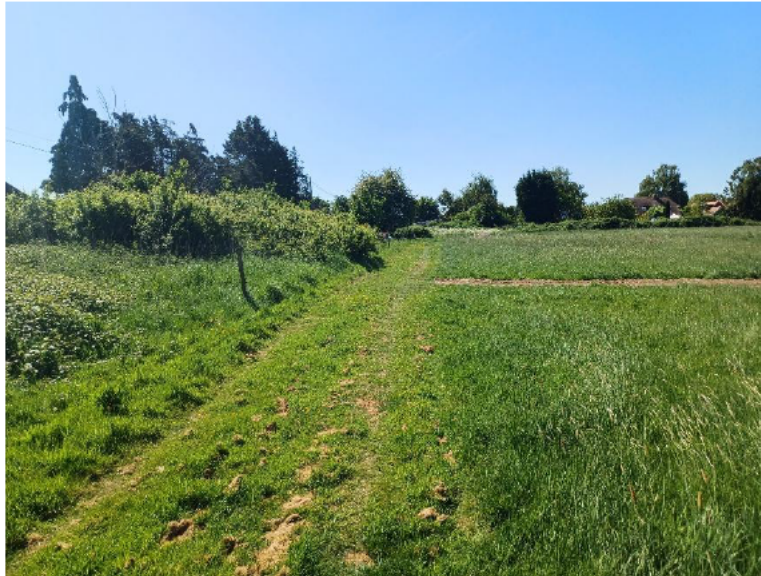
- 3.2.5 The eastern boundary is thickly vegetated and is slightly raised creating a natural barrier to silt runoff, however there are gaps within the hedgerow where gravel access tracks have been created. These provide pathways for silt runoff from site to Kings Barn Lane.

Plate 7: Eastern boundary of site is slightly raised creating a natural barrier to silt runoff.

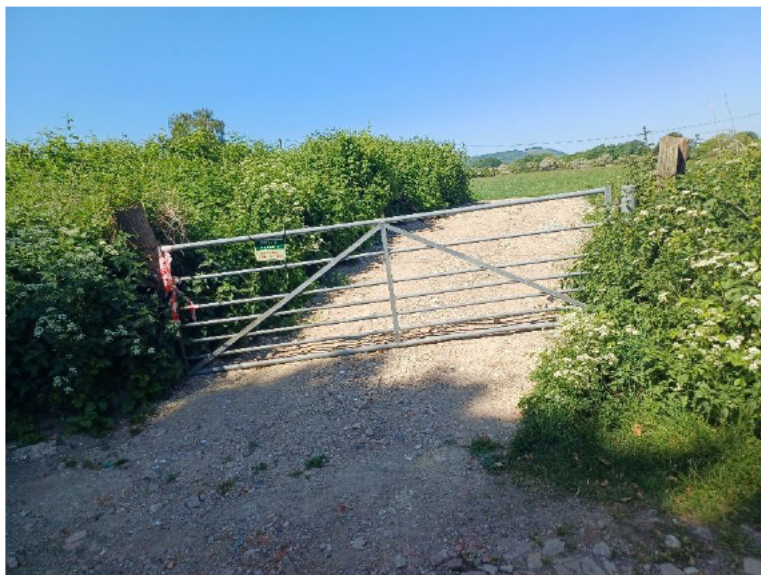
Plate 7: Looking west towards the eastern boundary of site – potential run off area. Silt mitigation measures recommended.
