Client: SDP Developers

Project Title: P10959 Church Farm, Upper Beeding

Date : 09/07/2026

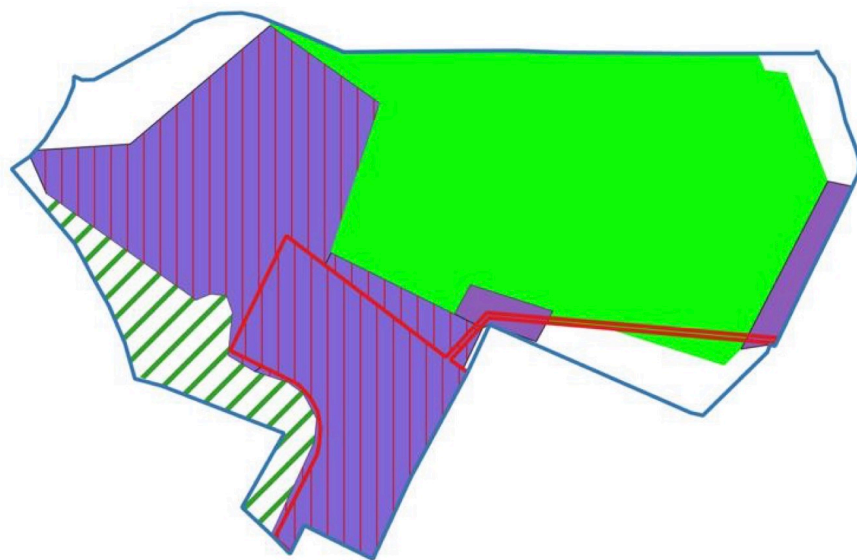
Assessment below submitted by The Eco Co -op  
The western off-site area hd3 and used as a baseline for BNG

| On-site habitats | | Condition Assessments |
|---|---|---|
| Bramble scrub (h3d) | Recently cleared/ flailed bramble <i>Rubus fruticosus</i> scrub throughout the site. | N/A |
| Bramble scrub (h3d) | Recently cleared/ flailed bramble <i>Rubus fruticosus</i> scrub west of the site. | N/A |

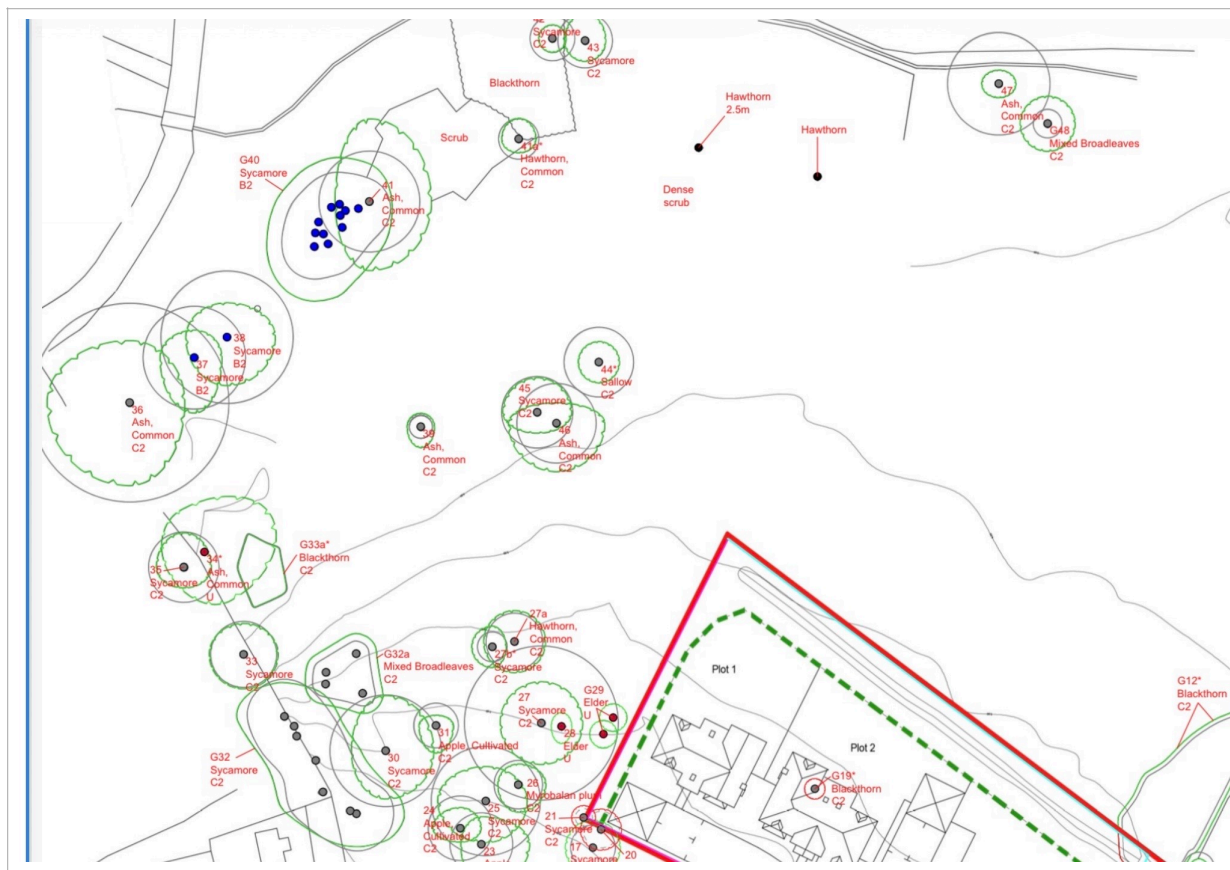
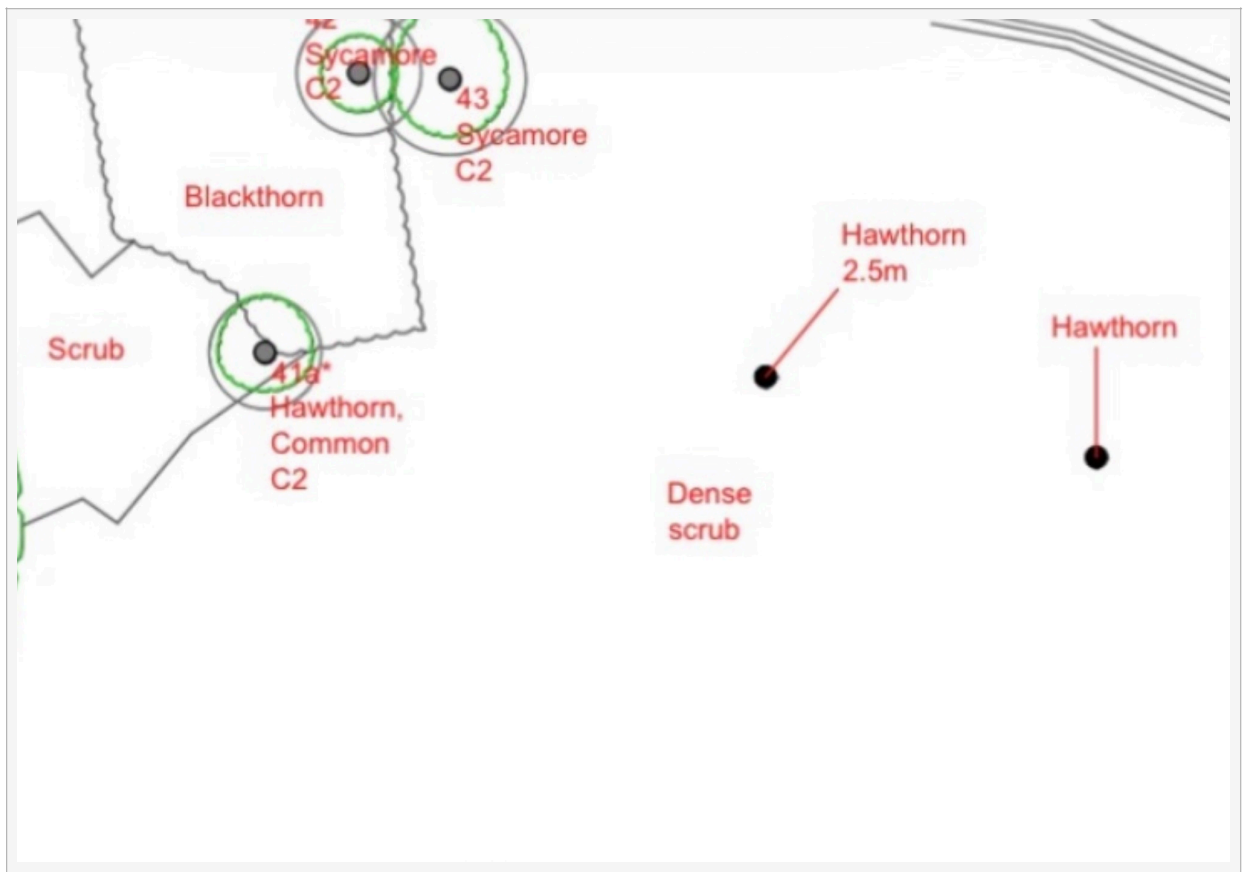
Assessment below by Arbortrack Systems Ltd 12th December 2025  
of that same area...showing Mixed Scrub....no reference to flailed Bramble (*Rubus fruticosus*)  
scrub
