**The Guest House  
St Hugh's Monastery  
Parkminster  
West Sussex  
RH13 8EB**

**Heritage Statement**

**To accompany a Listed Building Consent Application for; repairs to the south elevation  
of the Guest House of St Hugh's Monastery a Grade II\* Listed Building**

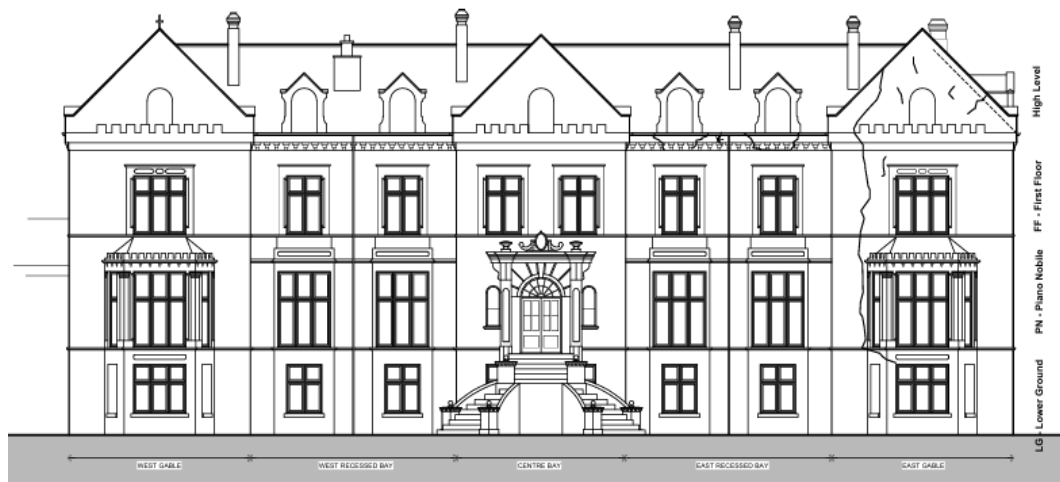
Fig 4: south elevation

The condition is very poor, requiring extensive repairs to prevent further decay and loss of Historic fabric. Repairs are proposed only, no alteration or additions to the existing form, finish or layout are proposed.
