**Arboricultural Report**  
**composed of**  
**Arboricultural Impact Assessment**  
**Arboricultural Method Statement**  
**& Tree Protection Plan**

Land on Blackhouse Road Colgate RH13 6HSD

Written by  
Barry Holdsworth MBA, RHS. Dip, MCI Hort, M.Arbor.A, MCMI  
Horticultural Consultant

5th June 2026

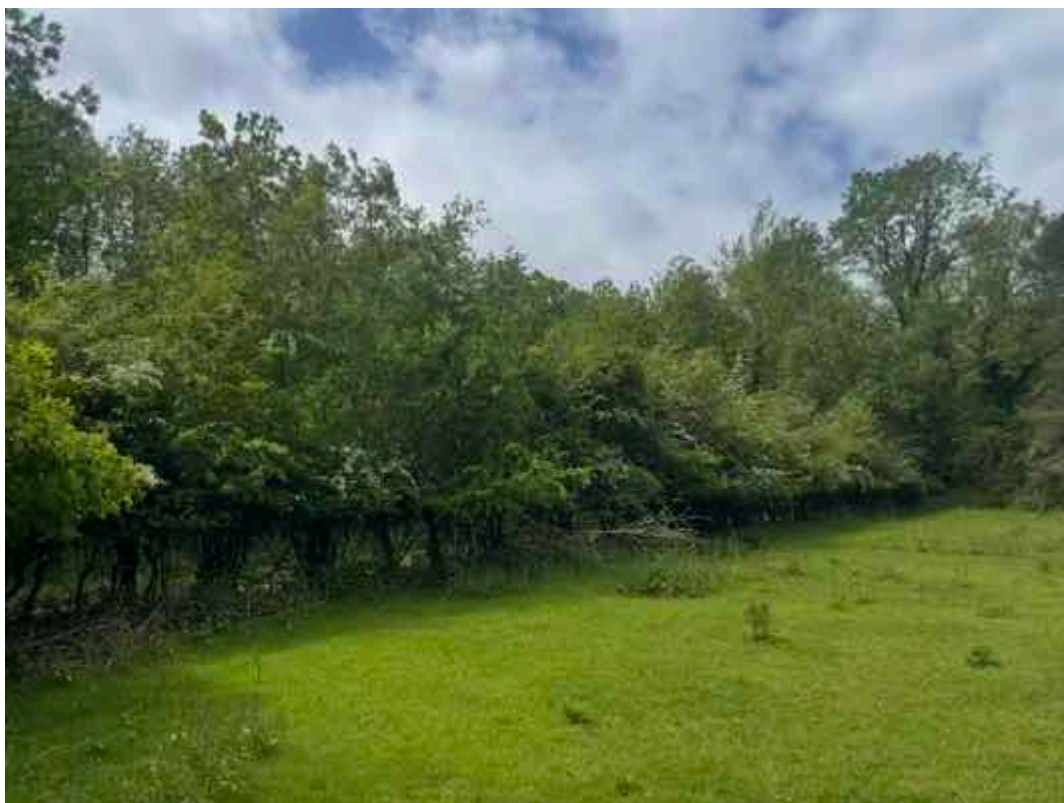
Southern boundary hedge H01

| No | Species | Height | Ø at 1.5m | Spread | Crown | Age | Condition and Recommendations | Removal | ERC | BS | RPA |
|---|---|---|---|---|---|---|---|---|---|---|---|
| H01 | Boundary Hedge<br>Hawthorn<br><i>Crataegus monogyna</i> | 6-8av. | 100 av. | see plan | 1mE | M | Physiological Condition: Fair<br>Structural Condition: Fair<br>Public Amenity Value: Low<br>Inspection Limitations: None<br>Exposed base to 1m. Hedge not maintained for some years | N | >10 | C2 | 1.2 |

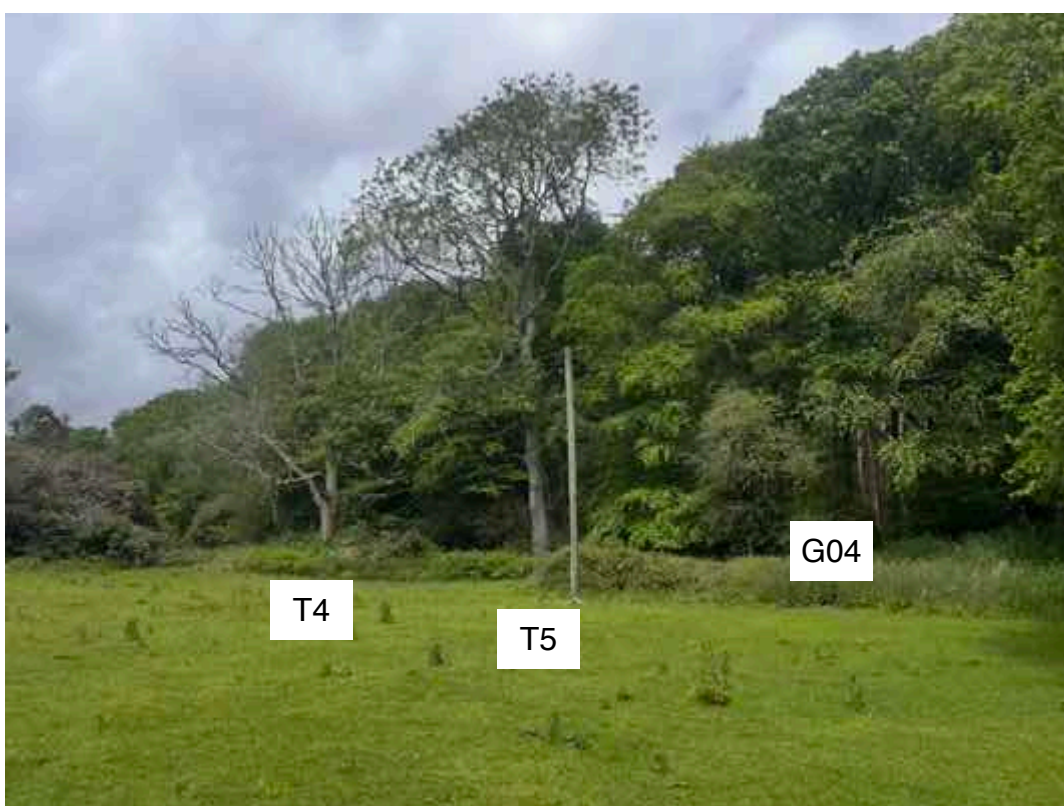
Woodland set behind Ash trees T4 and T5

| T4 | Ash<br><i>Fraxinus excelsior</i> | 20 | 750# | 10/10/8/8 | 6mS | DEAD | Physiological Condition: Poor<br>Structural Condition: Poor<br>Public Amenity Value: Low<br>Inspection Limitations: Dense vegetation<br><b>Recommend:</b> Consider either removal or making a monolith once the house is occupied | N | <10 | U | 9.0 |
| T5 | Ash<br><i>Fraxinus excelsior</i> | 22 | 790 | 13/8/12/12 | 10mS | M | Physiological Condition: Poor<br>Structural Condition: Fair<br>Public Amenity Value: Low<br>Inspection Limitations: Dense vegetation<br>Reduced crown with 20% dieback across canopy<br><b>Recommend:</b> Consider either removal or making a monolith once the house is occupied | N | <10 | U | 9.48 |

No trees are required to be removed for this project to be undertaken. The dead Ash tree T4 and the dying Ash tree T5 could be either removed or made monoliths after the property is occupied in order to manage them safely, as they are a potential hazard to the occupants, but their removal is not required for this build to be undertaken.
