### CONTEXTUAL SITE PHOTOGRAPHS

Renovation and Conversion of Redundant Agricultural Barns

**Tanners Farm Barns**  
Lordings Road · Adversane · Billingshurst  
West Sussex · RH14 9JE

**Doc No: 704-603**  
**Rev: (-) – 18.01.2026**  
**Status: Planning Application Issue**

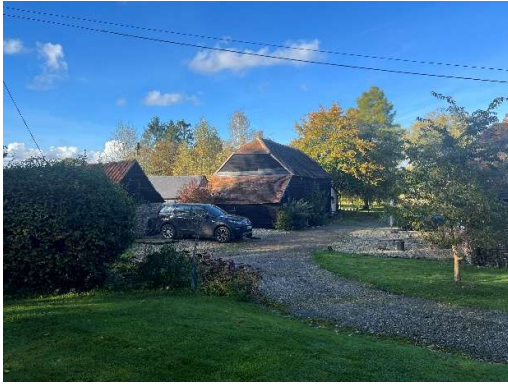
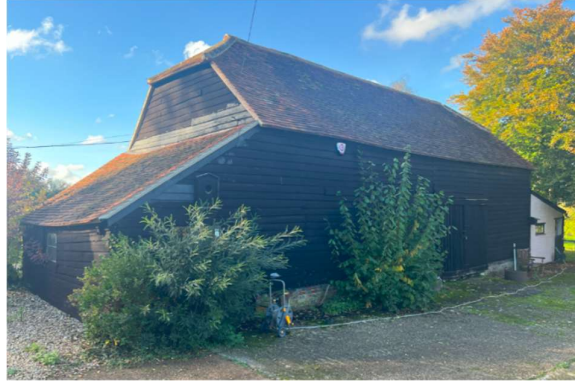
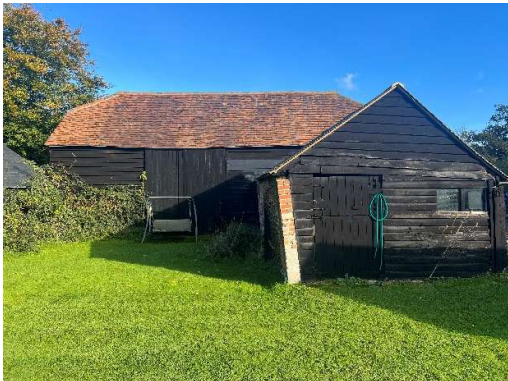
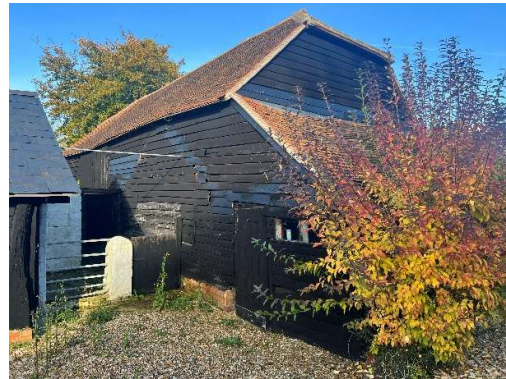
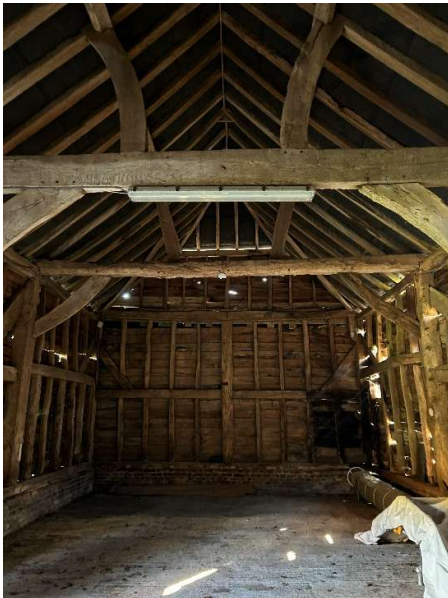
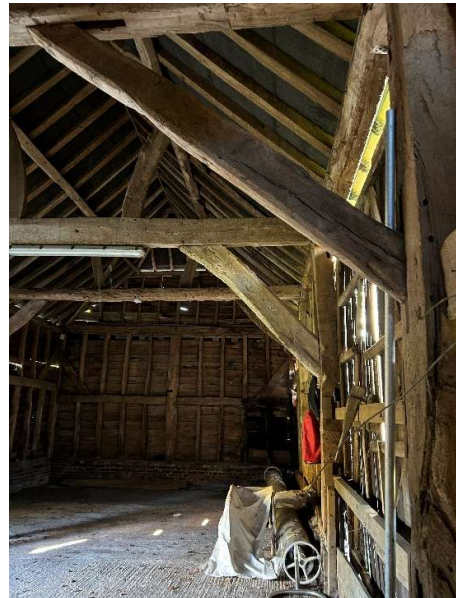
## Barn-1

Mid-17th Century threshing barn altered in the C19, including cat-slide bay to its southern end, and later abutting stable wing to the north. There is further evidence to suggest the timber structure has recently been restored along with re-roofing, and a concrete floor.

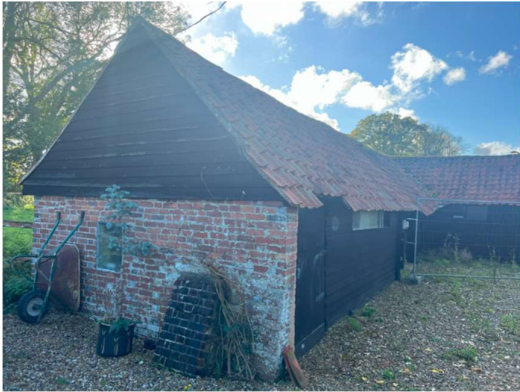
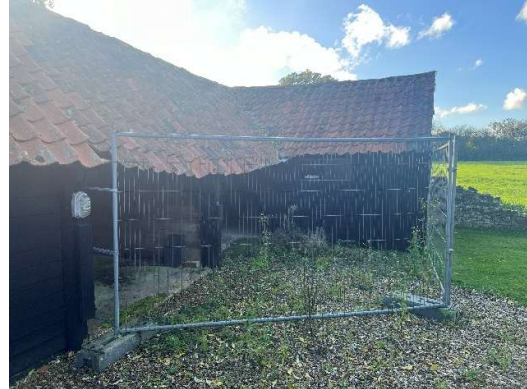
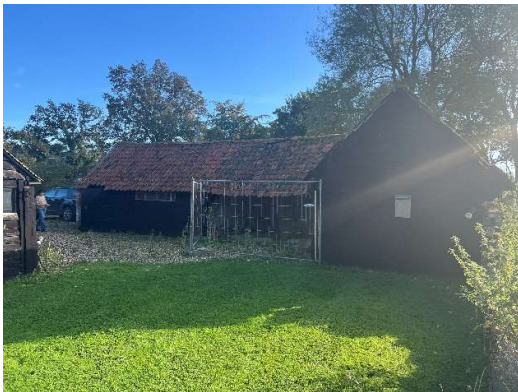
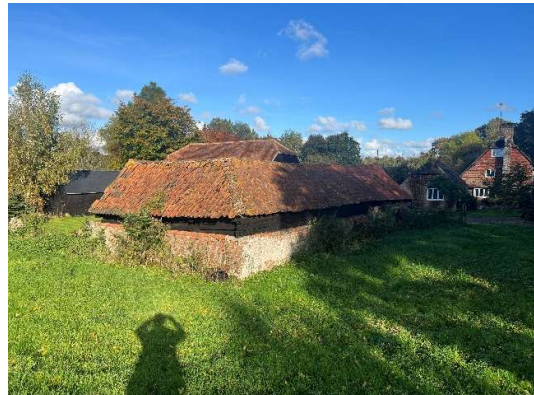
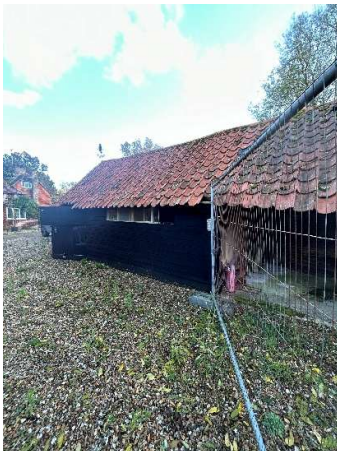
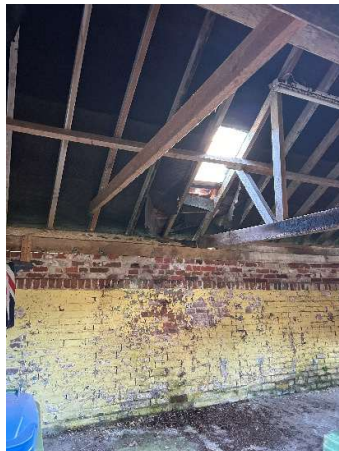
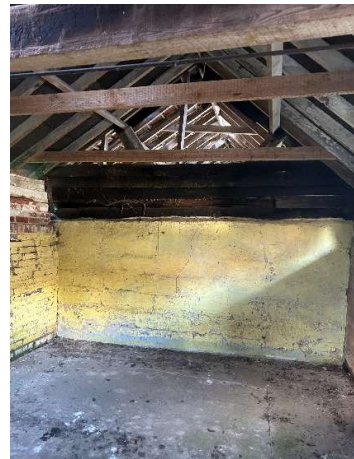
## Barn-2

19<sup>th</sup> Century former animal shed. A single storey timber frame structure built against the south, east and west masonry walls enclosing the former farmyard. The Front (north) façade is mainly timber with two open central bays. We believe the building evolved with the farmstead when livestock was introduced. This building is in particularly poor condition, structurally unsafe and requires urgent structural attention to prevent collapse, while the clay pantiles have started slipping from the roof.

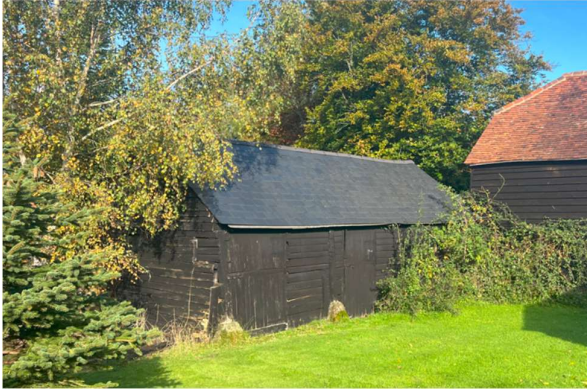
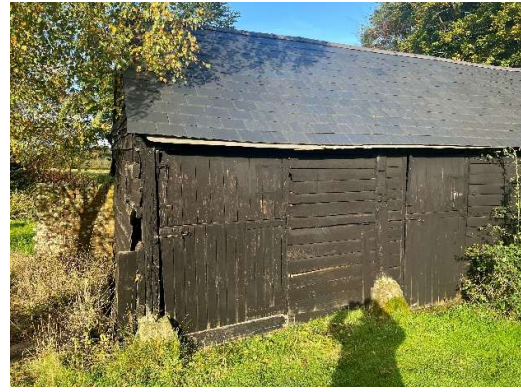
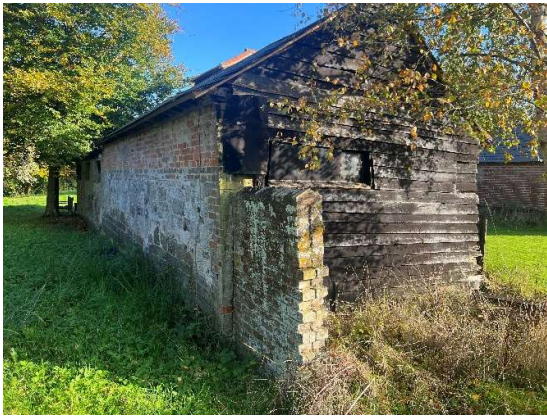
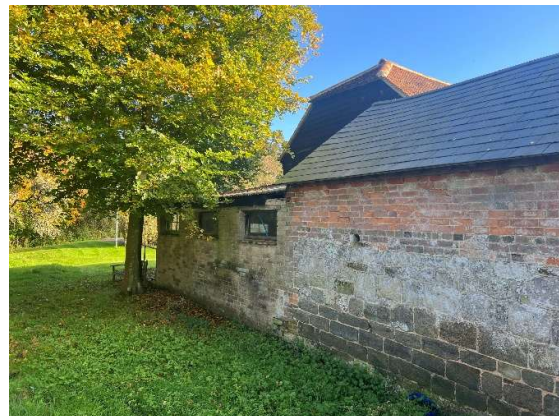
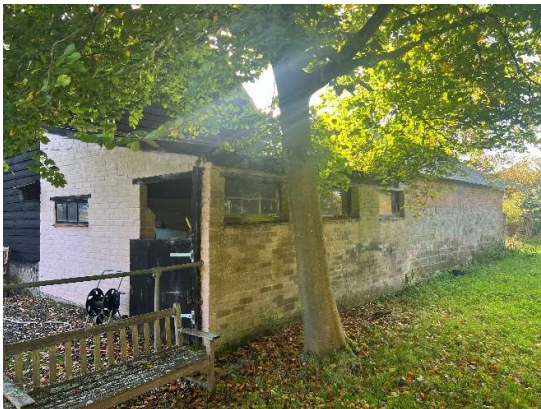
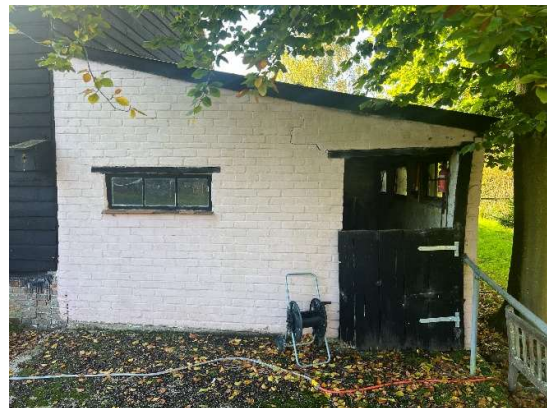
### Barn-3

Mid-19th Century single storey stable range comprises part timber frame and built against the northern brick/stone wall enclosing the former farmyard, while also abutting the northeastern corner of the former threshing barn. This barn has been subject to various additions and alterations over time.

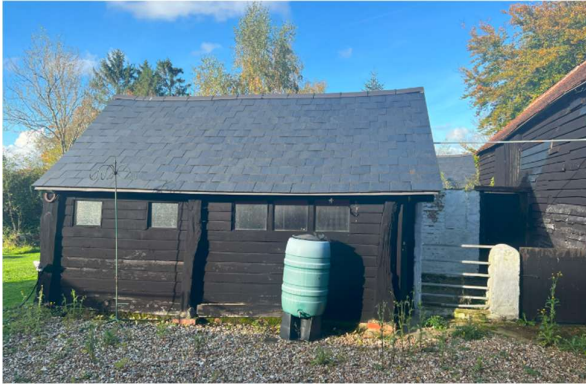
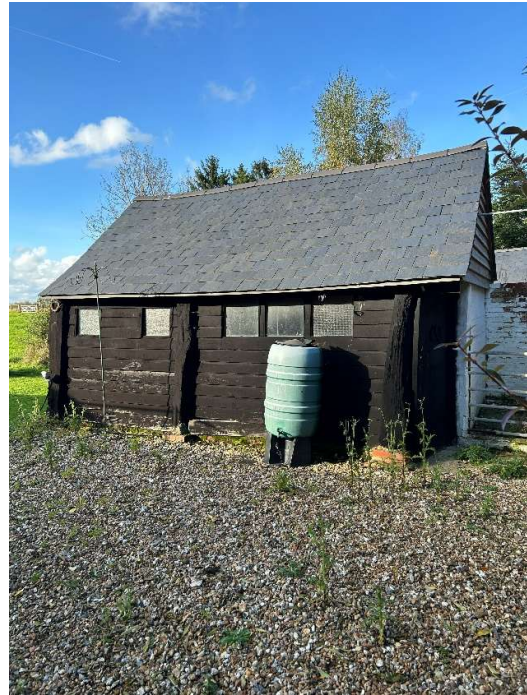
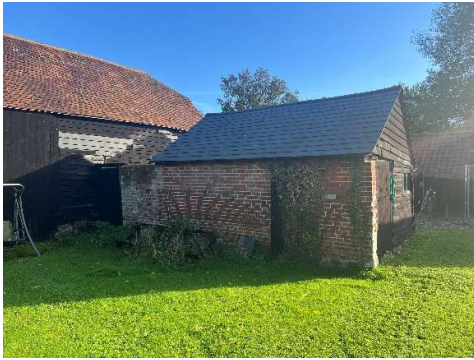
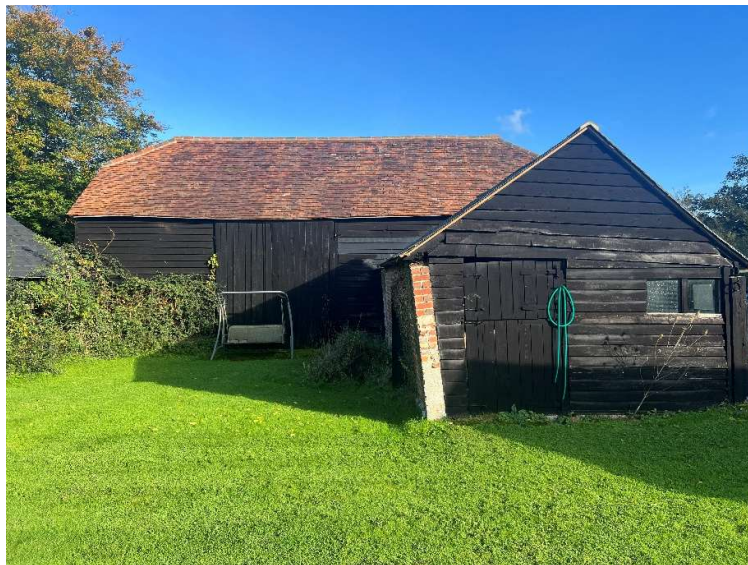
## Barn-4

Single storey part timber frame/brick structure, believed to be a former open cart barn, with evidence of two open bays facing southwards, albeit currently boarded up. This barn has been subject to recent remedial repairs along with a new roof, albeit using incongruous slates to the pitched roof.
