Bat Roost Potential Report

Barn at Hillybarn Farm

The Mount

Sylvatica Ecology Ltd

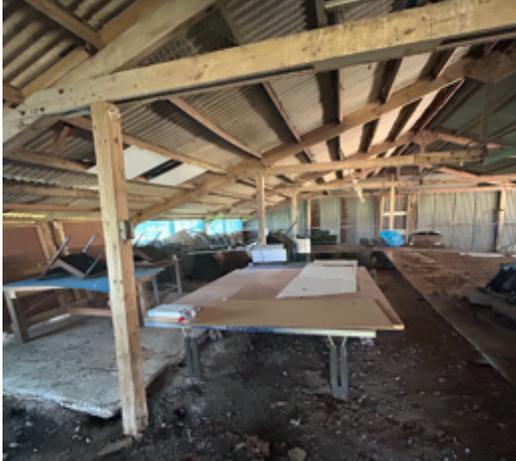
<p>Plate 1: Internal Work Space</p>

4.8 There was a single large and long building within the application area, which comprised of a corrugated sheeted wall, which was single layered on the western and eastern aspects. The roof was pitched but comprised of a single layered corrugated metal sheeting. The internal space was divided into workshop rooms (**Plate 1**), which were all relatively interconnected. No evidence of bats was observed within this internal space and there was also layers of dust and cobweb throughout this building, indicating no recent sweeping or clearing.

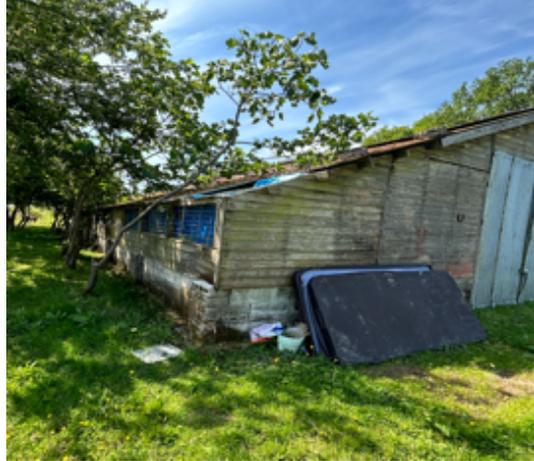
<p>Plate 2: Northern Wooden Cladding</p>

4.9 The northern gable end of the external wall had an area of wooden cladding (**Plate 2**). This cladding had a small cavity behind, with some gaps leading to this area. This area was small and accessible to inspection with an endoscope. The cavity was relatively dirty within and had large areas of old cobwebbing (**Plates 3 & 4**). There were not any areas that had been cleared by what could have been ingress and exit of a bat. A small section had evidence of use by a nesting bird, but this was not inspected completely to prevent disturbance of a nesting bird. No evidence of bats were observed during the endoscope inspection.

4.11 Overall, the building did not offer any potential to support roosting bats. The cavity at the wooden cladding at the northern end of the building was full of cobweb and other detritus. There was also a nesting blue tit (*Cyanistes caeruleus*) present within this location.

5.1 No evidence of bats was observed within the building. The cavity behind the wooden cladding was inspected and there was not any evidence of bats present behind this feature. Therefore, no further surveys in relation to roosting bats are recommended. This endoscope inspection, should, be repeated if a period of 12months passes between this inspection and any demolition works and consideration for the presence of nesting birds would be required.
