1.0 Introduction

1.1 This technical note has been prepared to discuss and provide the additional information that has been requested by West Sussex County Council (WSCC) as the Lead Local Flood Authority (LLFA) in their holding objection to DC/25/1327.

LAND EAST OF MOUSDELL CLOSE ASHINGTON

Phase II Geoenvironmental Assessment

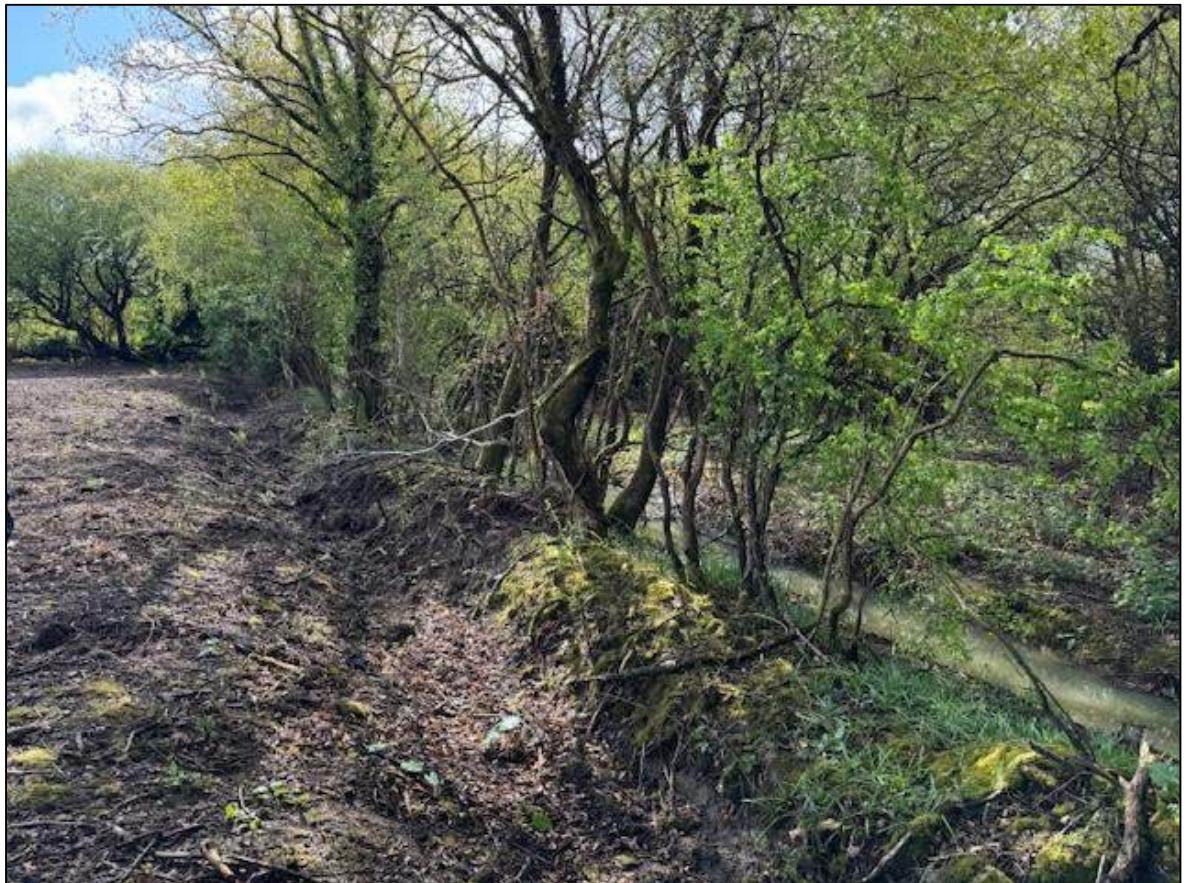
- 2.3 The drainage ditch shown in the topographic survey is not that which is intended for the surface water discharge (hence why we are not addressing the comment that there appears to be a blockage in this ditch). The drainage ditch that is on the topographic survey is a drainage grip dug by the farmer to assist with field drainage. The actual discharge point will be the watercourse that is immediately to the south of the drainage grip on the boundary of the site (and which the landowner has riparian rights to).
- 2.4 The juxtaposition of the farmland grip and the watercourse can clearly be seen in the below photo taken in January 2025, where the watercourse has water within it.

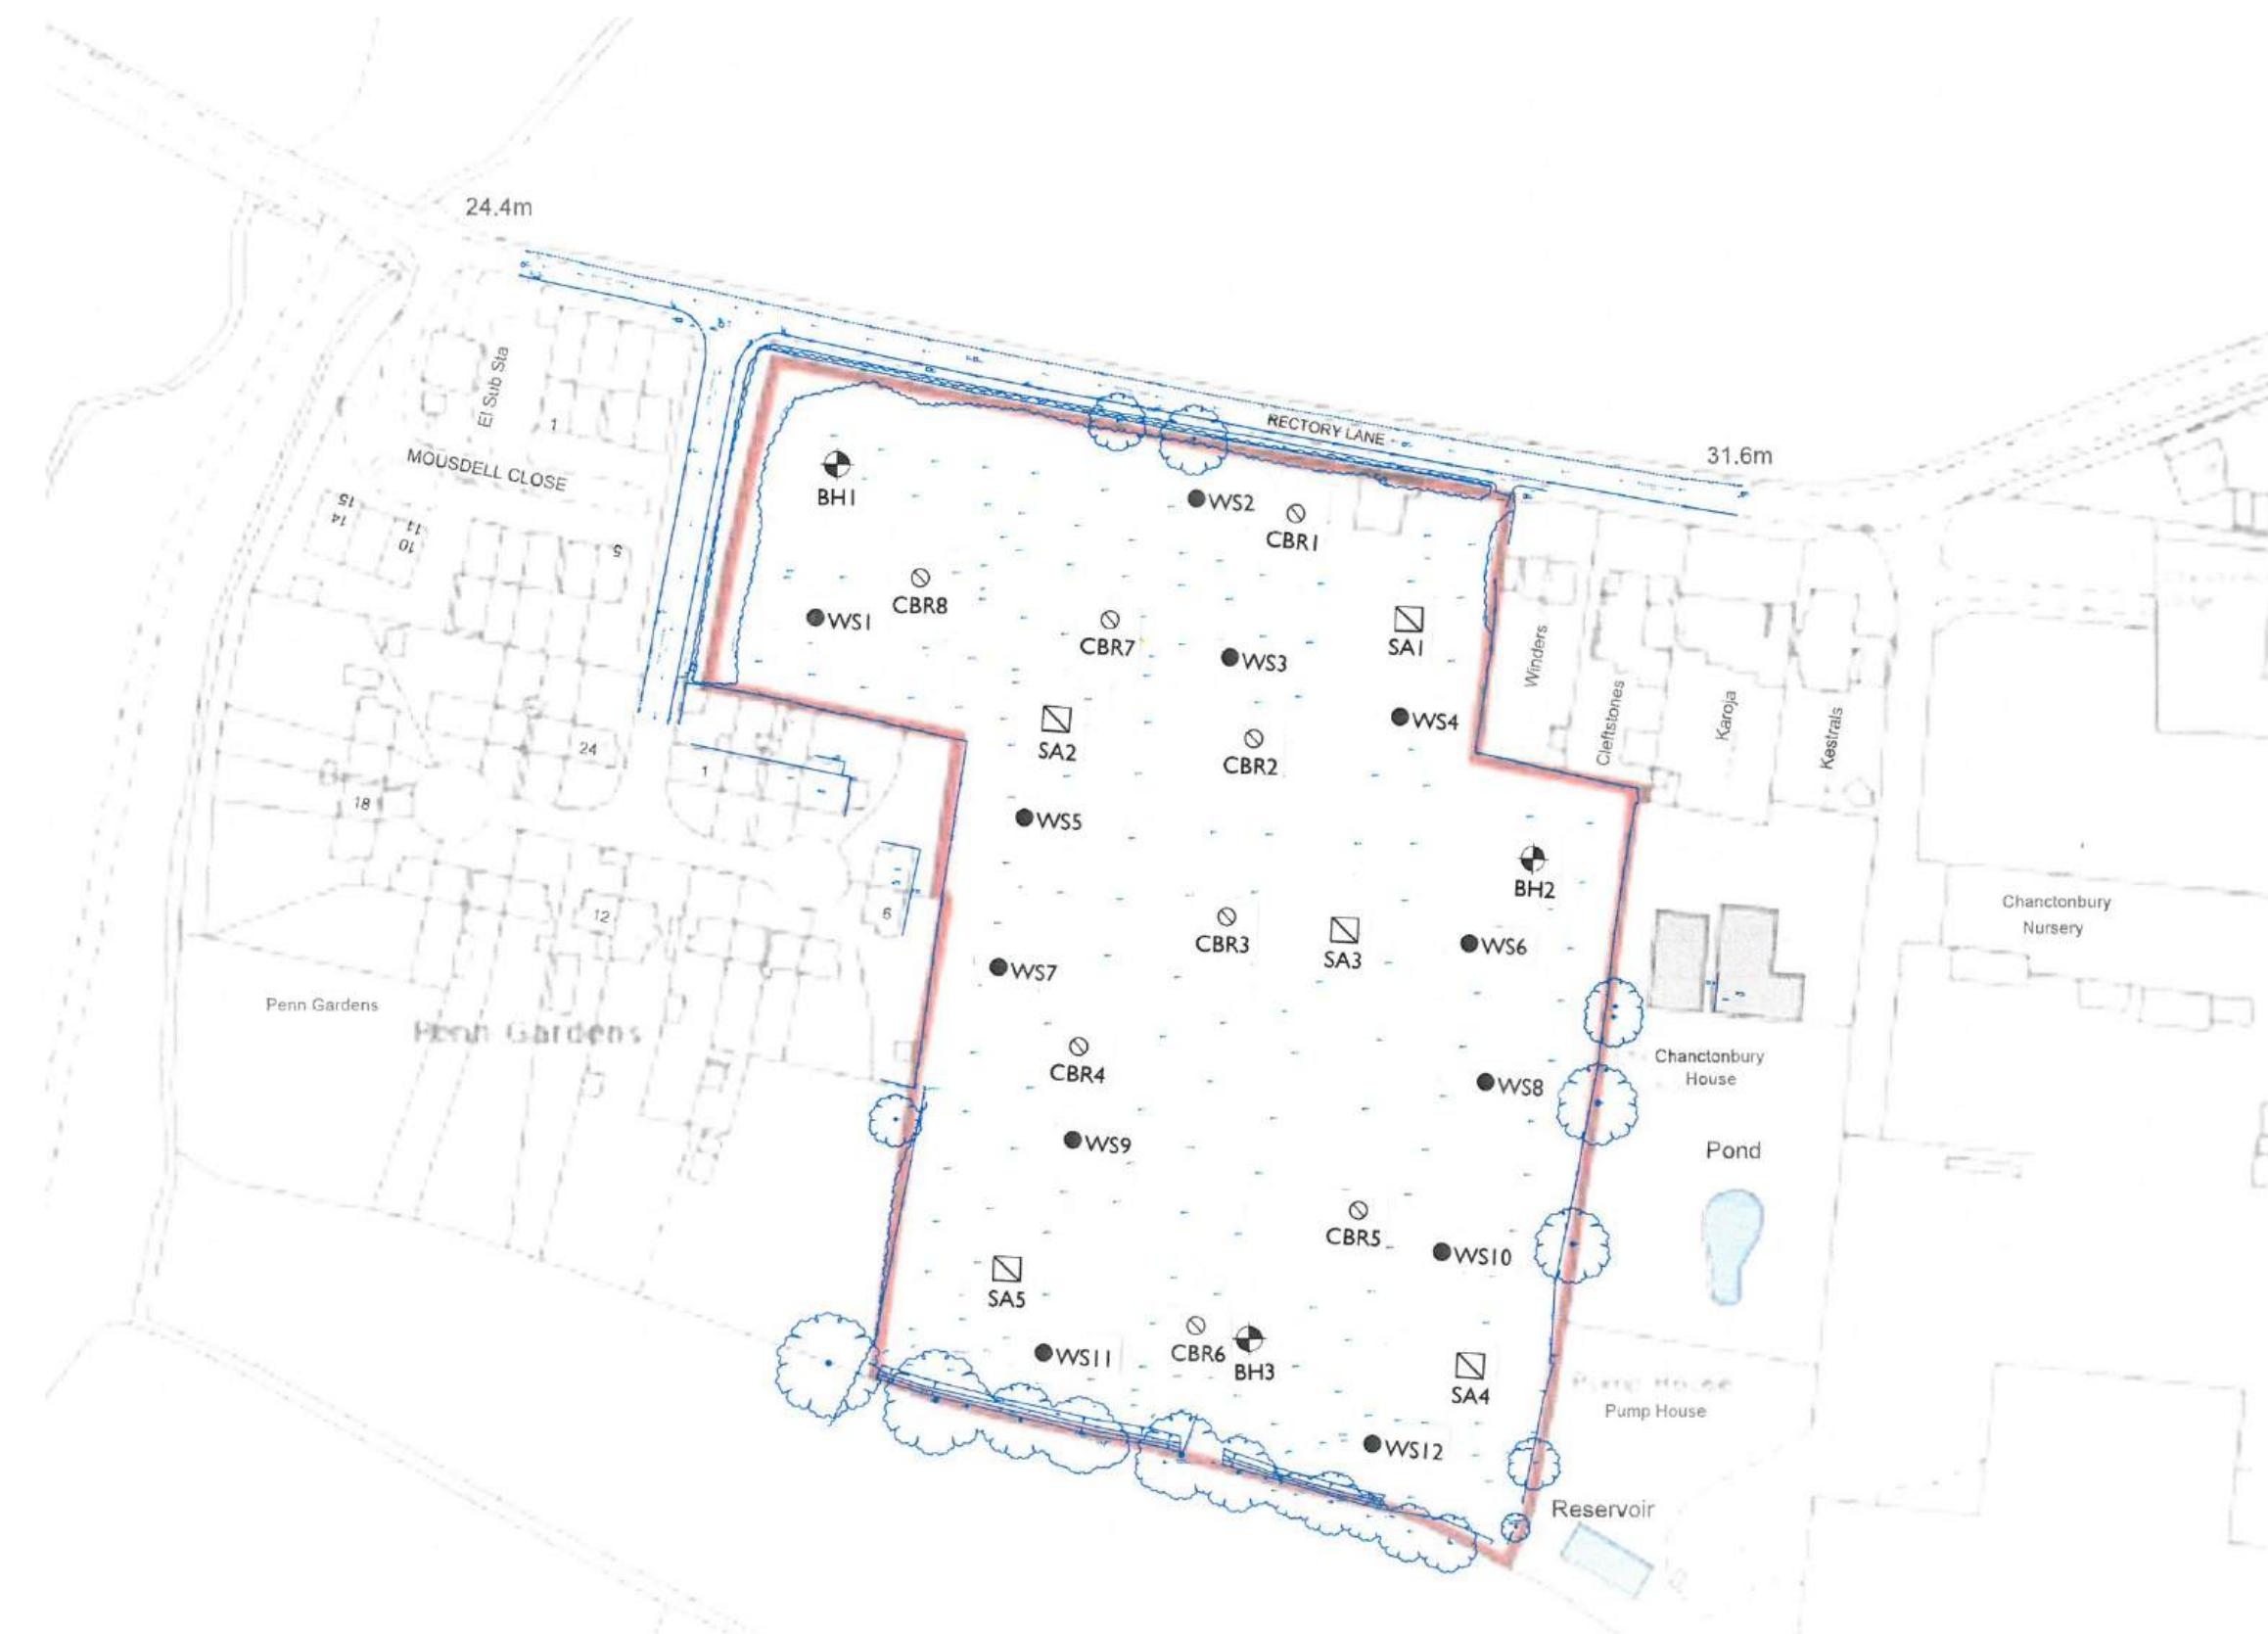
Figure 1

Approximate Exploratory Hole Locations

The extent of the field work was agreed with the Client and comprised three boreholes advanced by light percussive techniques to a maximum depth of 16.5 m. In addition, 12 continuous open drive (windowless) samplers were bored to a maximum depth of 4.0 m. The original intention had been to drill the cable percussive boreholes to a depth of 25 m but this proved unachievable in the ground conditions encountered. Five machine excavated trial pits were carried out to give a more detailed description of the near surface soils and to carry out soakaway tests.

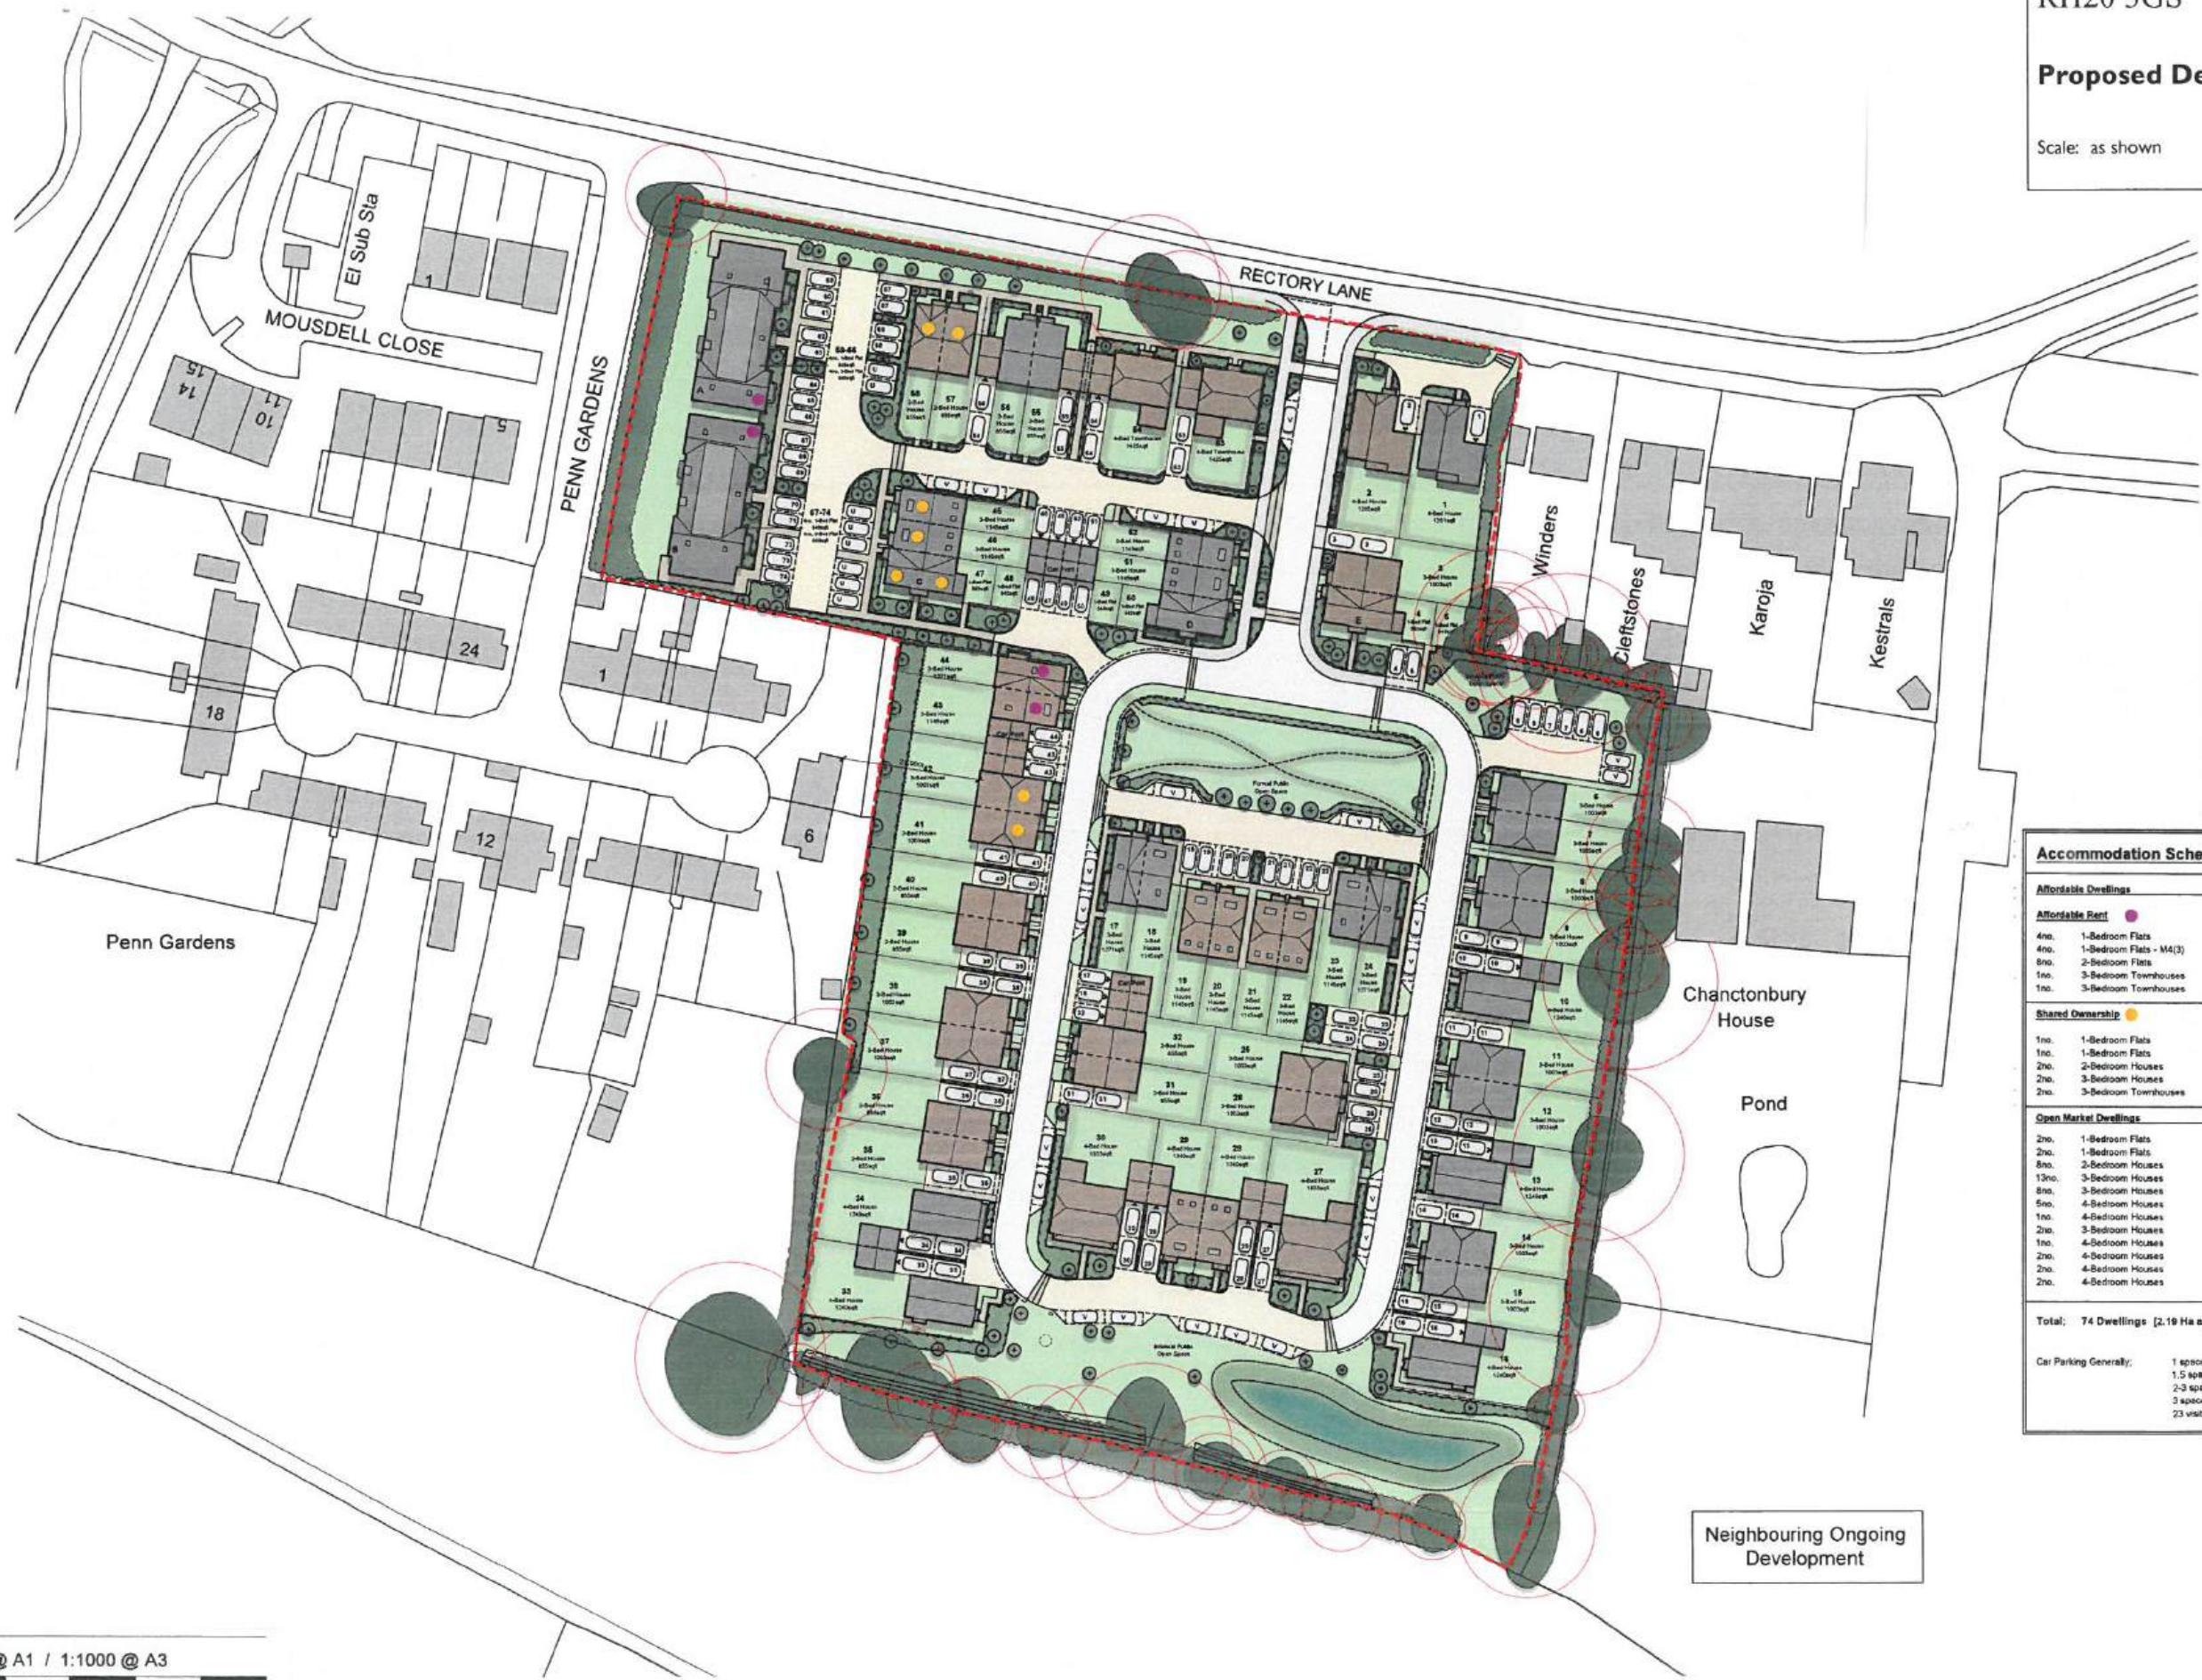
Proposed Development

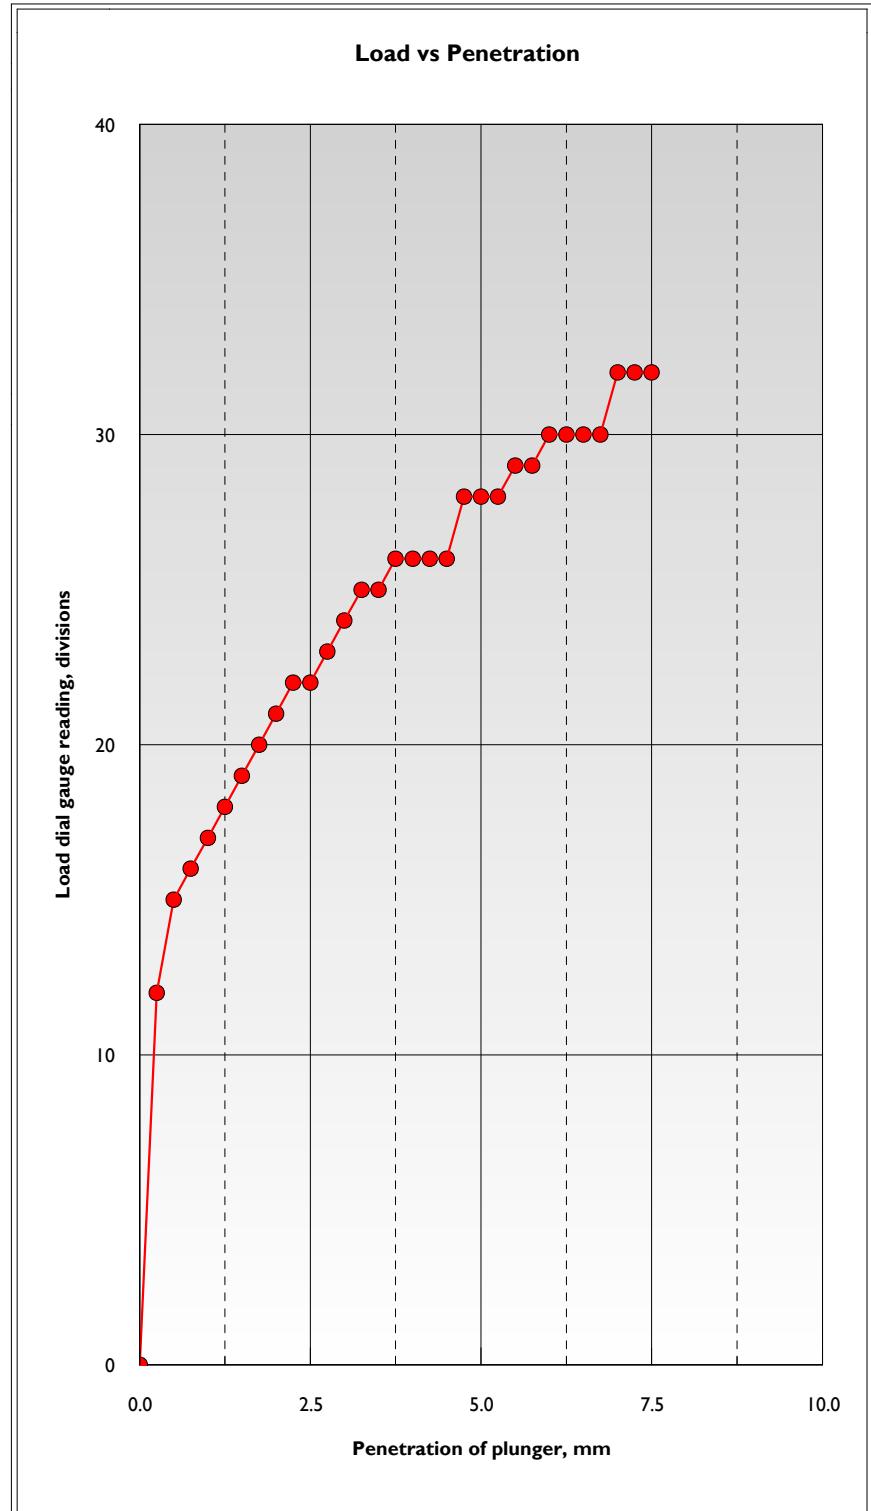
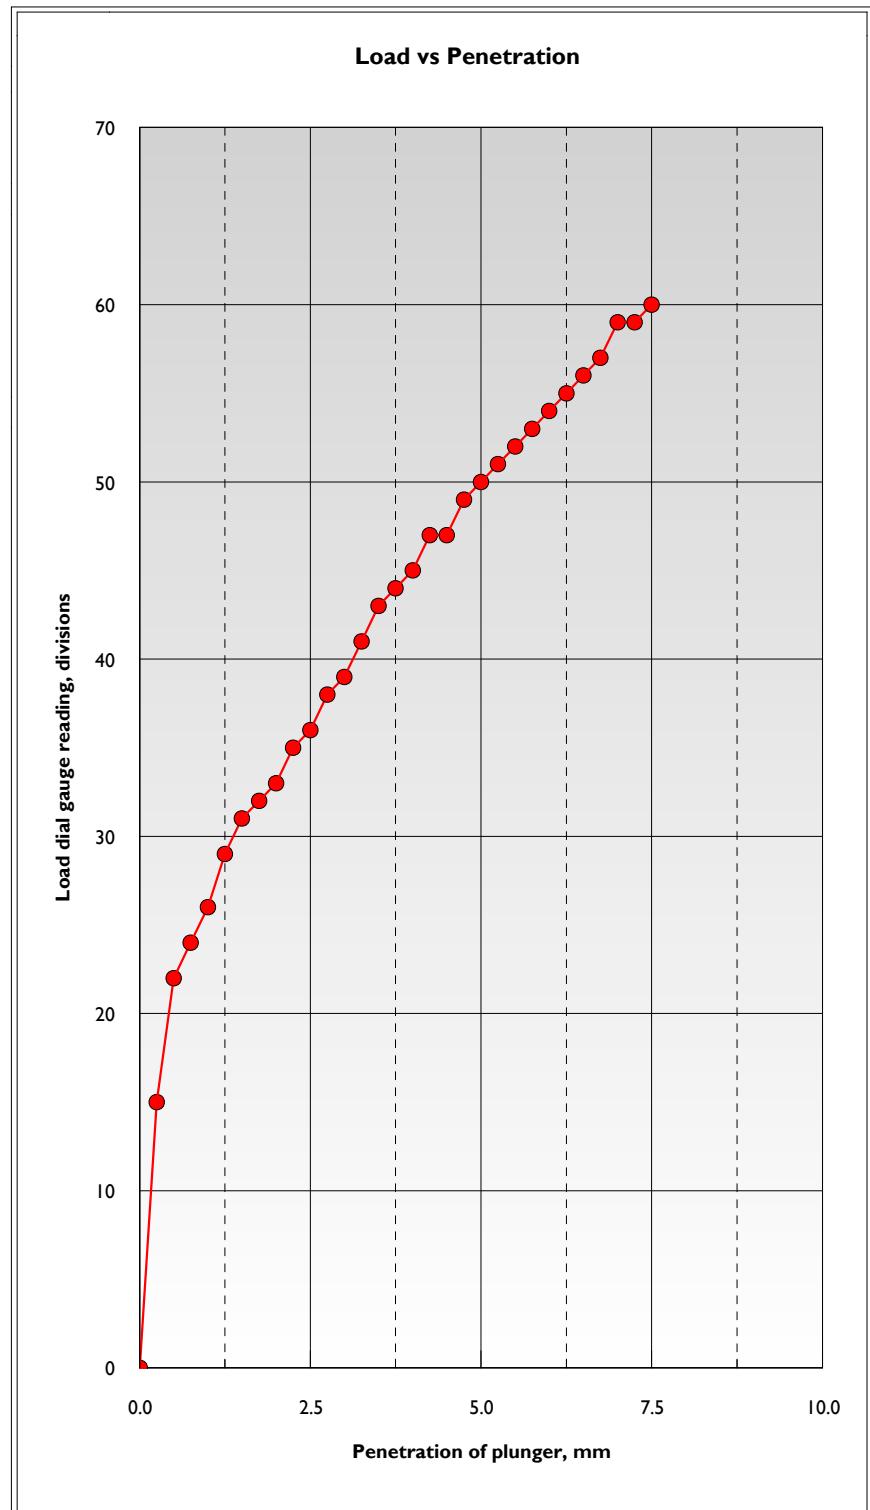
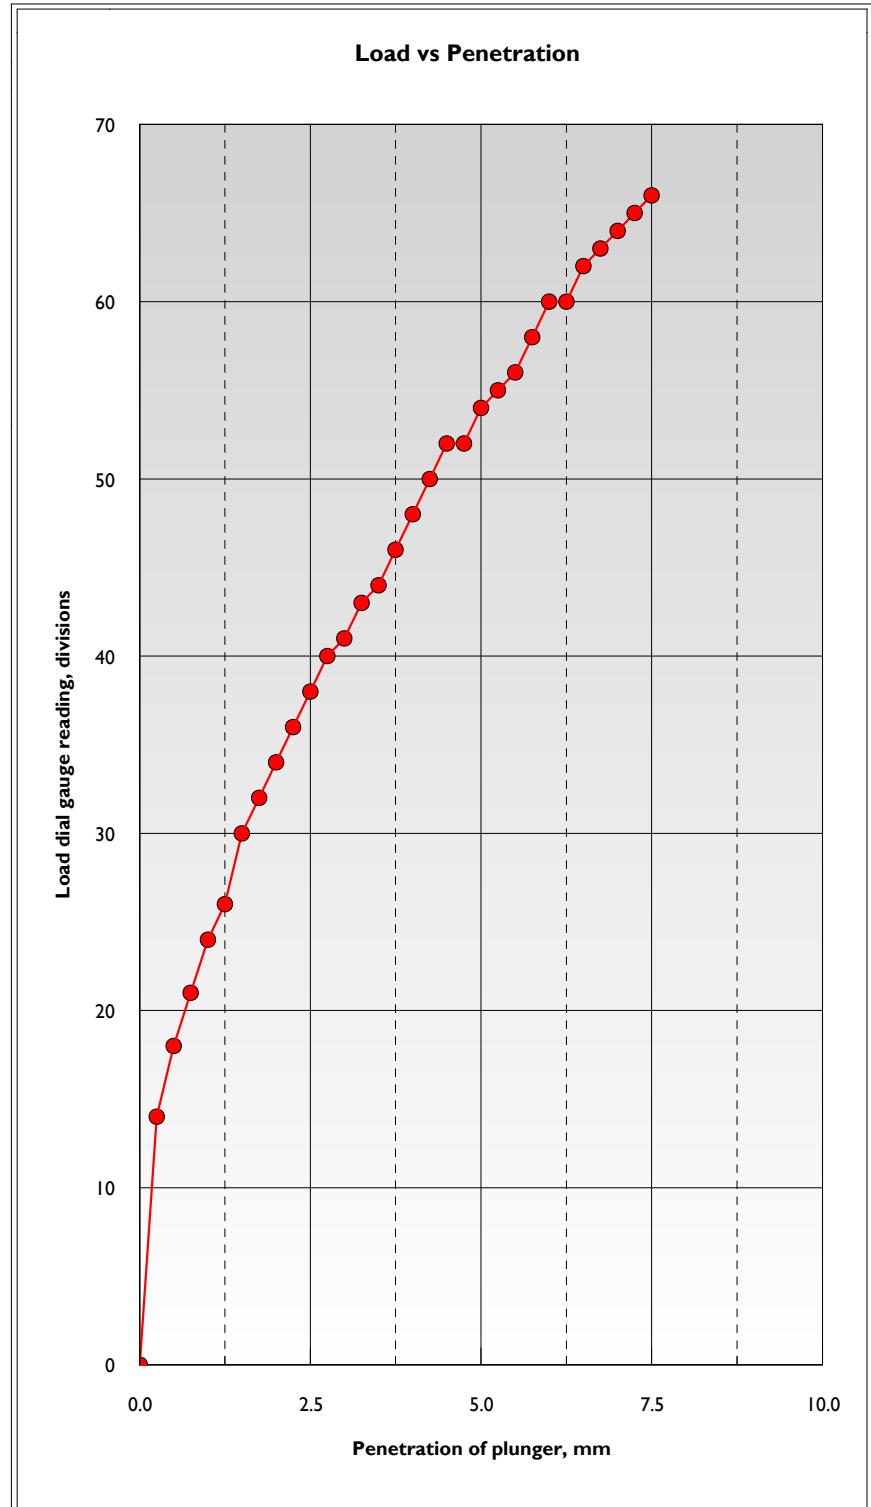
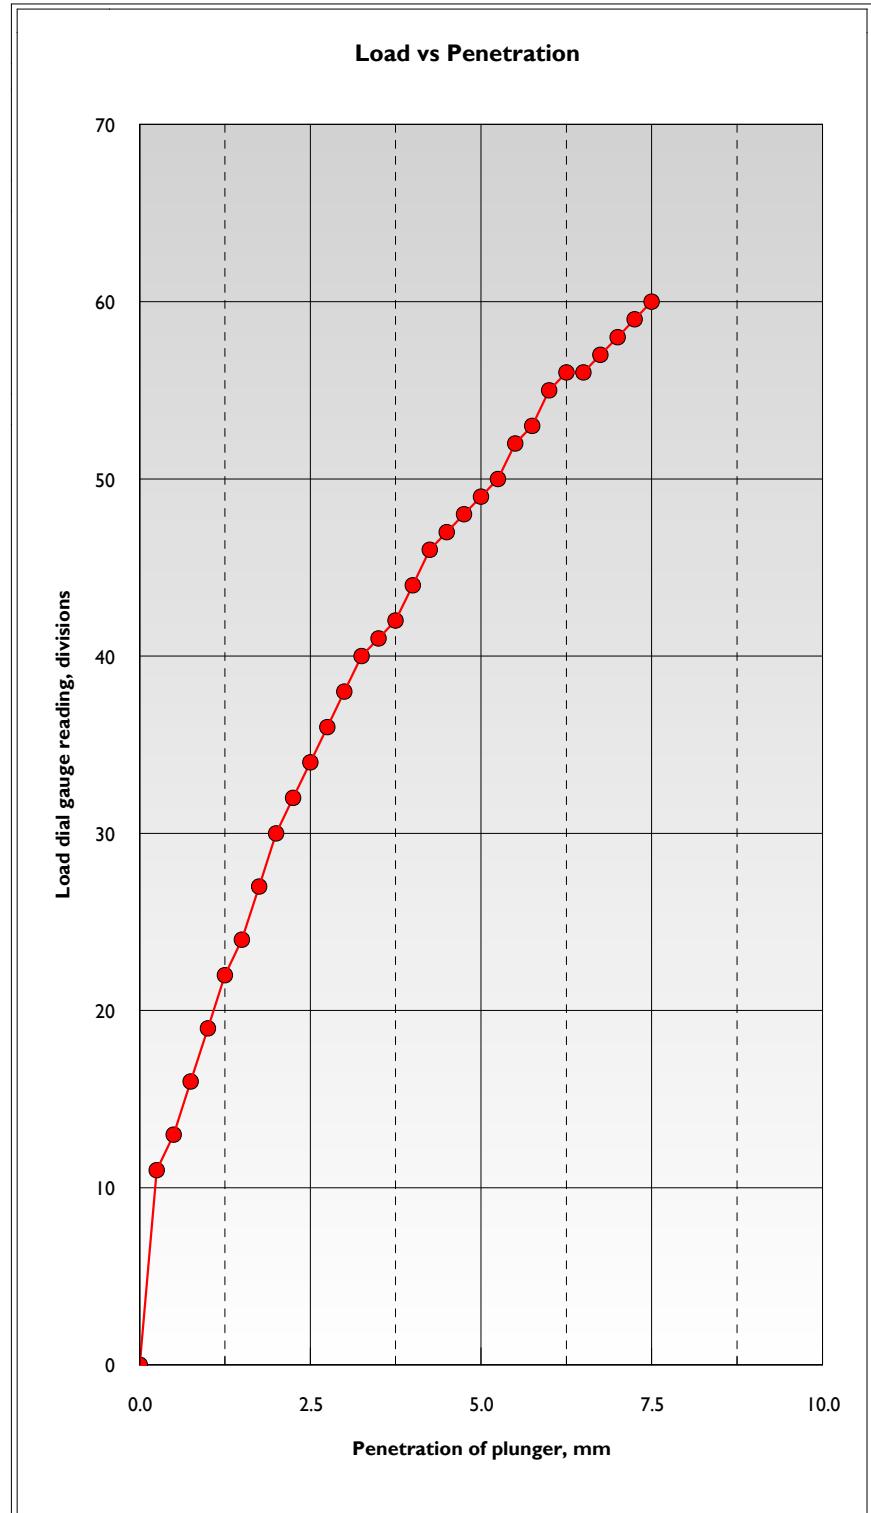
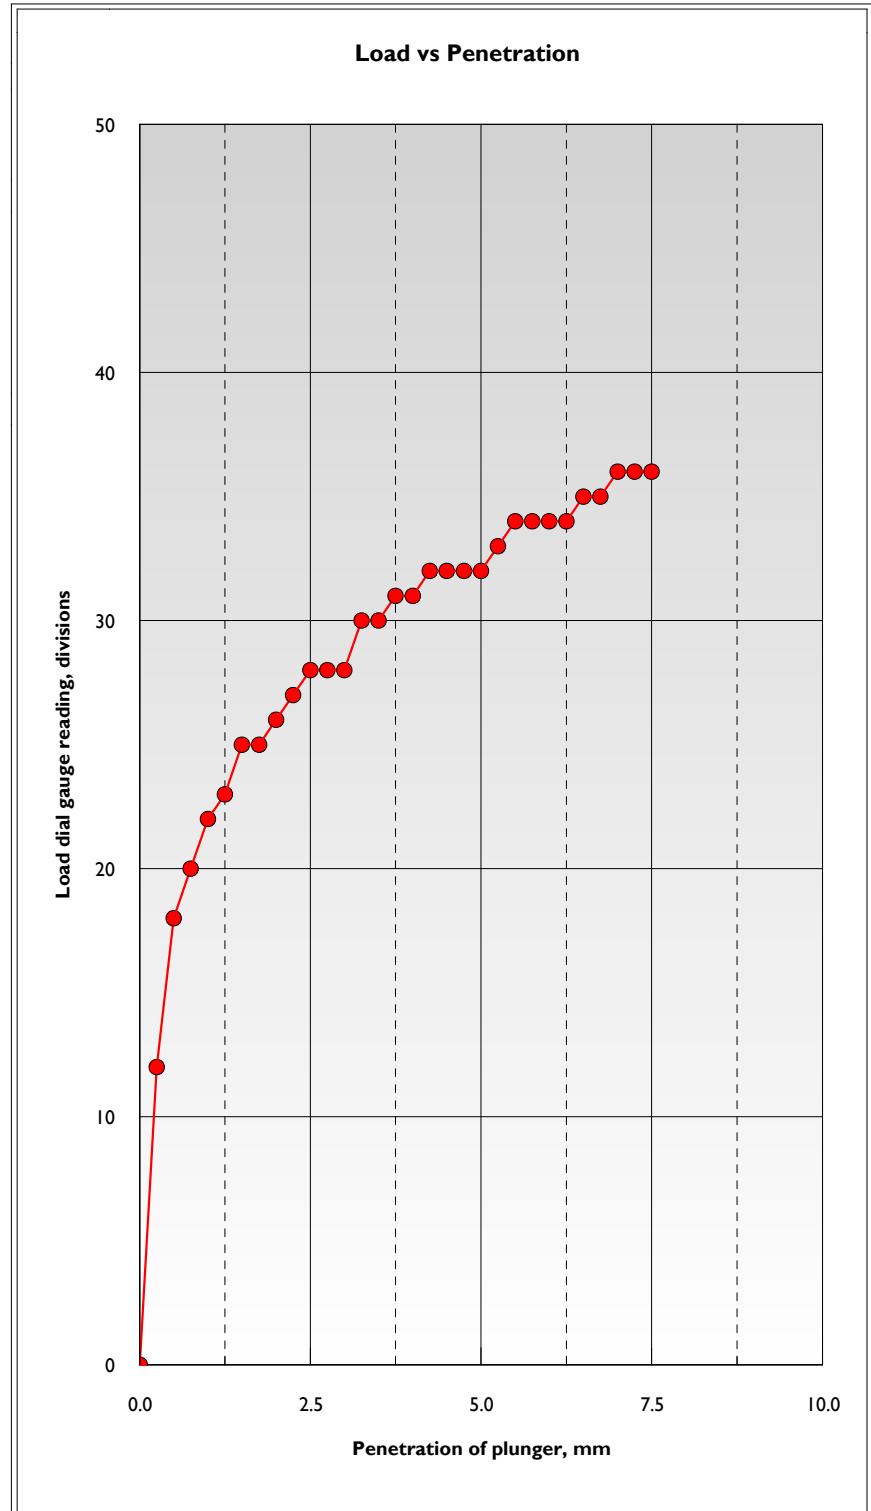
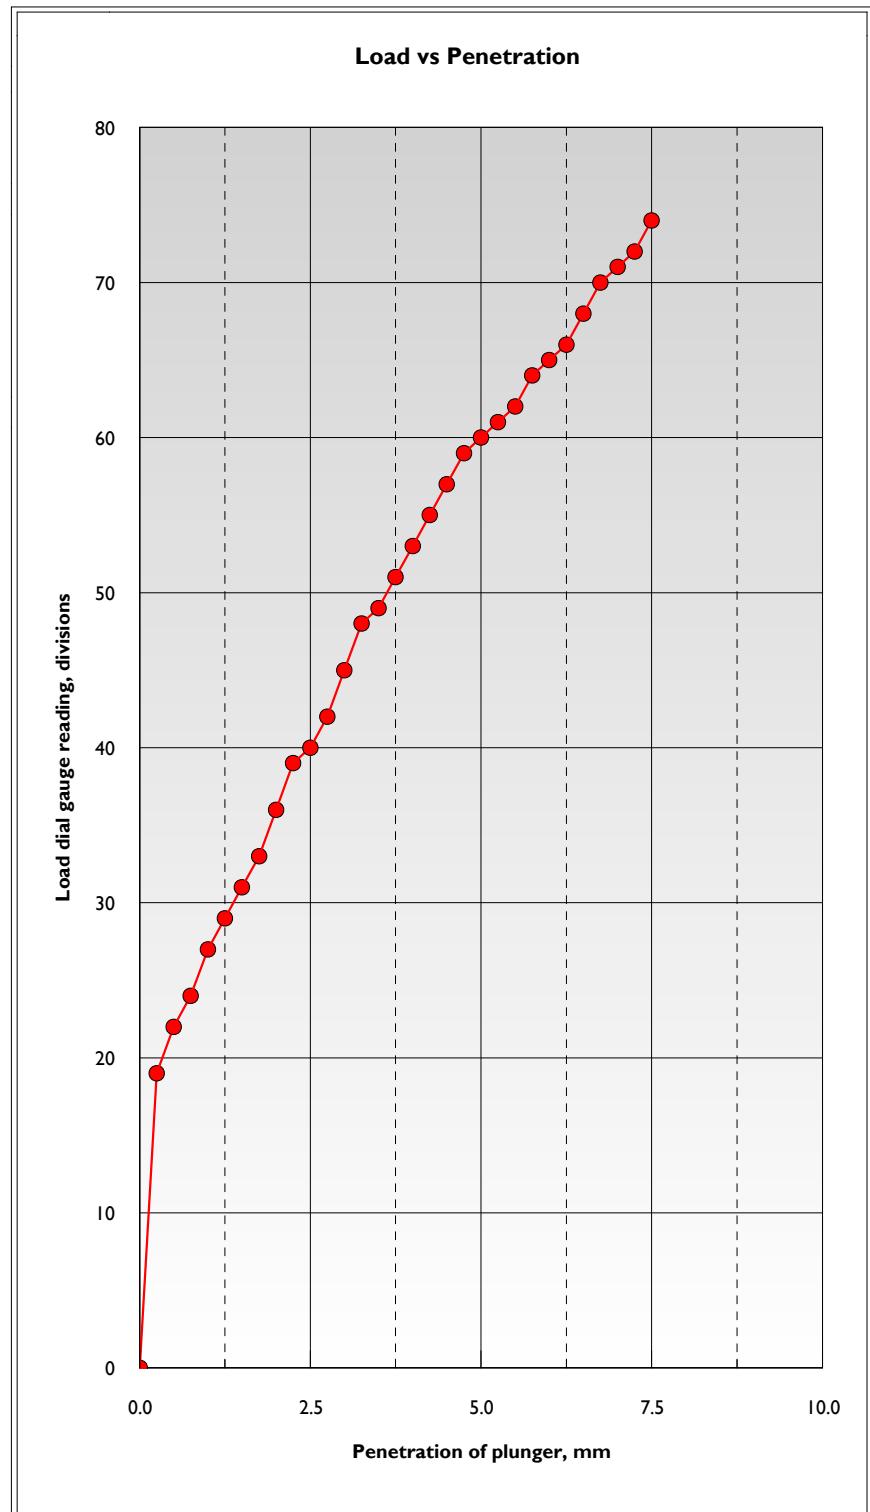
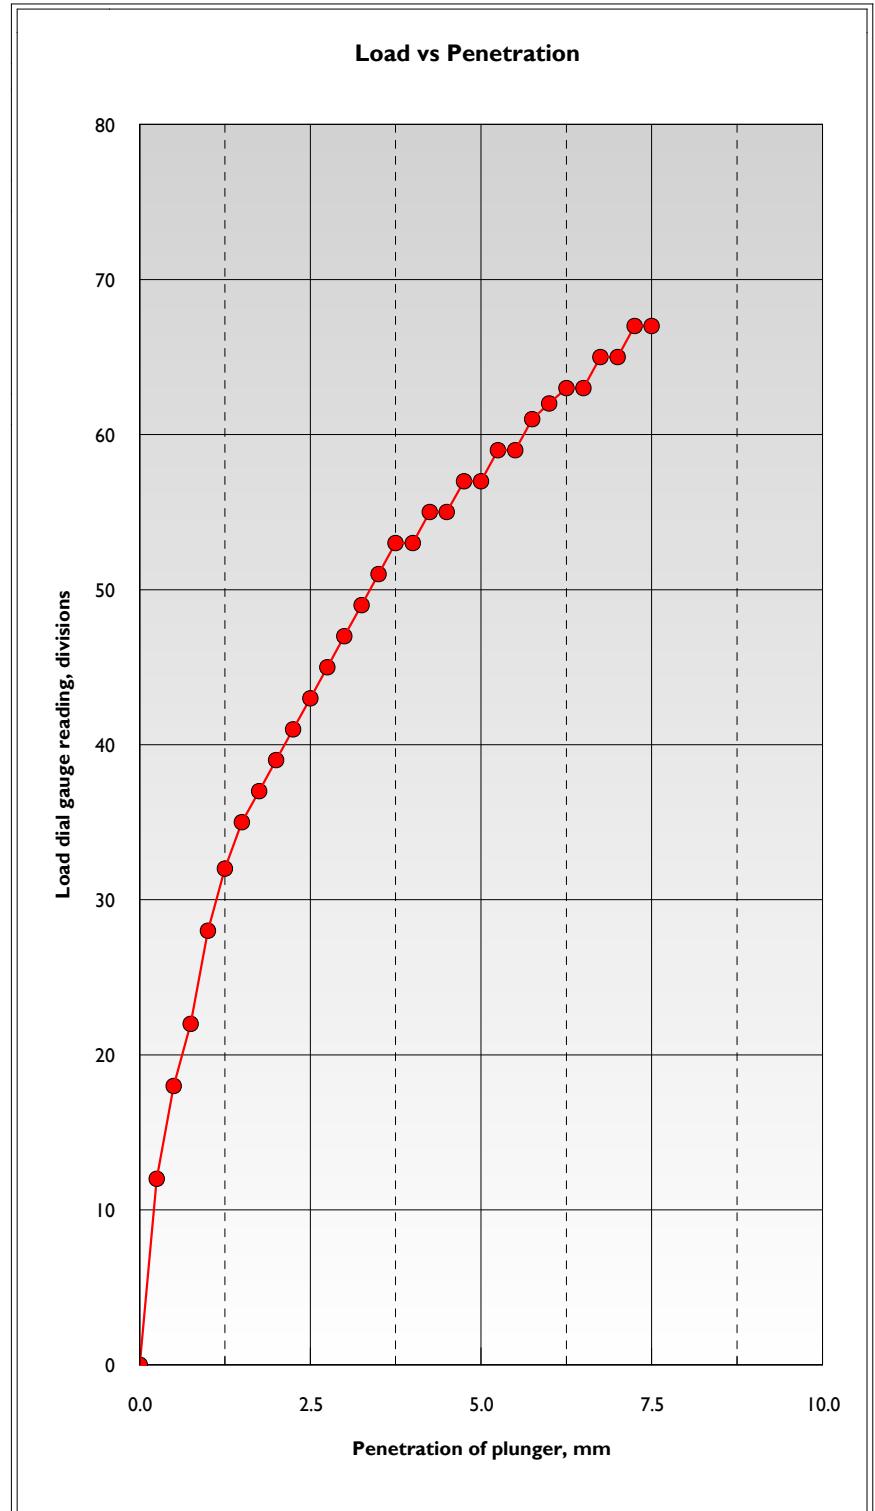
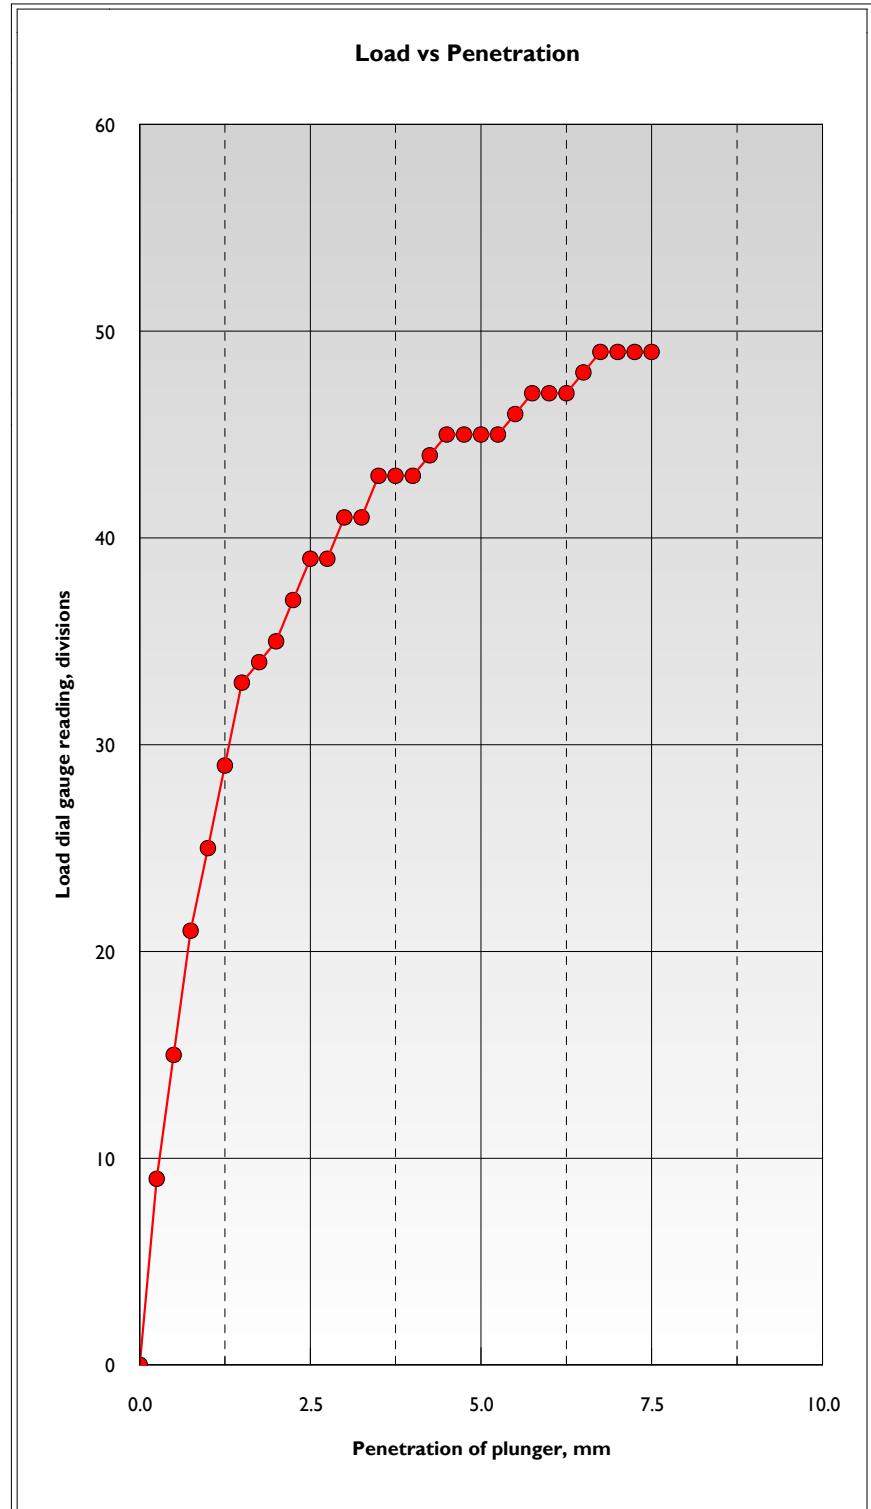
The results of the eight in situ California Bearing Ratio (CBR) tests are presented at Appendix C and show values ranging from 1.8 % to 4.3 %, depending on the particular composition and moisture content of the material under test.

It is well documented that CBR values decrease as soil moisture content increases. Unless efficient sub - grade drainage is installed and can be guaranteed to perform throughout the life of the proposed pavement, it is likely that the sub - grade moisture content will increase in service, leading to a reduction in the CBR value. Therefore, although the test results may be used as a guide for pavement design, it would be prudent to allow a reduction to reflect the in - service condition beneath the pavement to a value of some 1.5 % for design purposes.
