1.0 Introduction

1.1 This technical note has been prepared to discuss and provide the additional information that has been requested by West Sussex County Council (WSCC) as the Lead Local Flood Authority (LLFA) in their holding objection to DC/25/1327.

LAND EAST OF MOUSDELL CLOSE ASHINGTON

Phase II Geoenvironmental Assessment

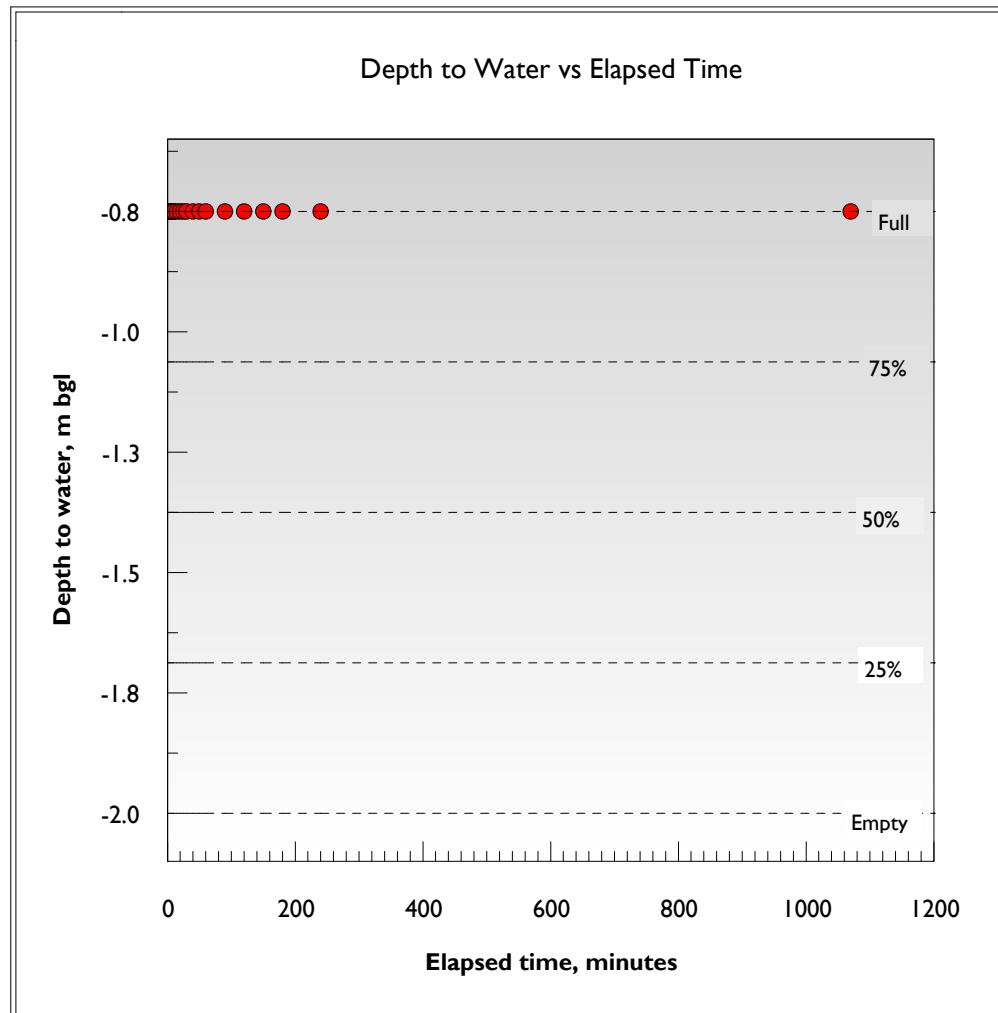
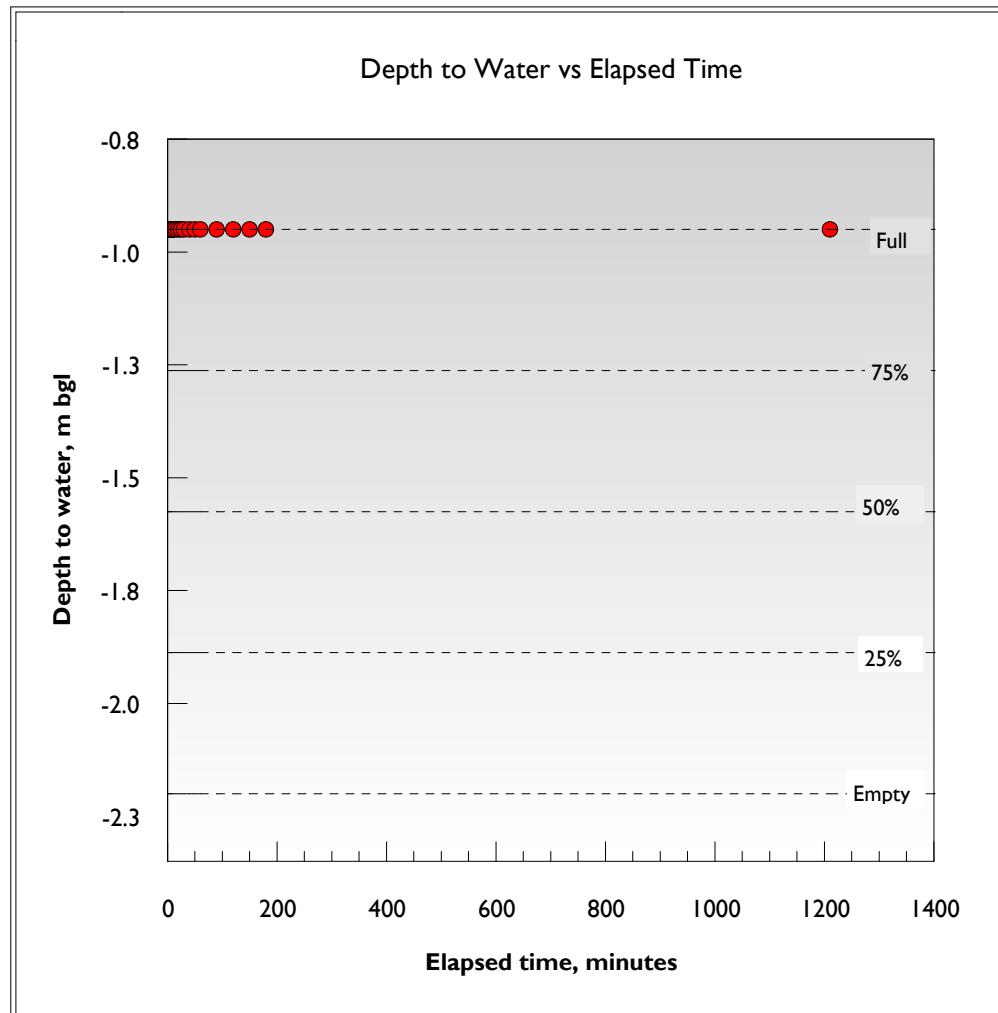
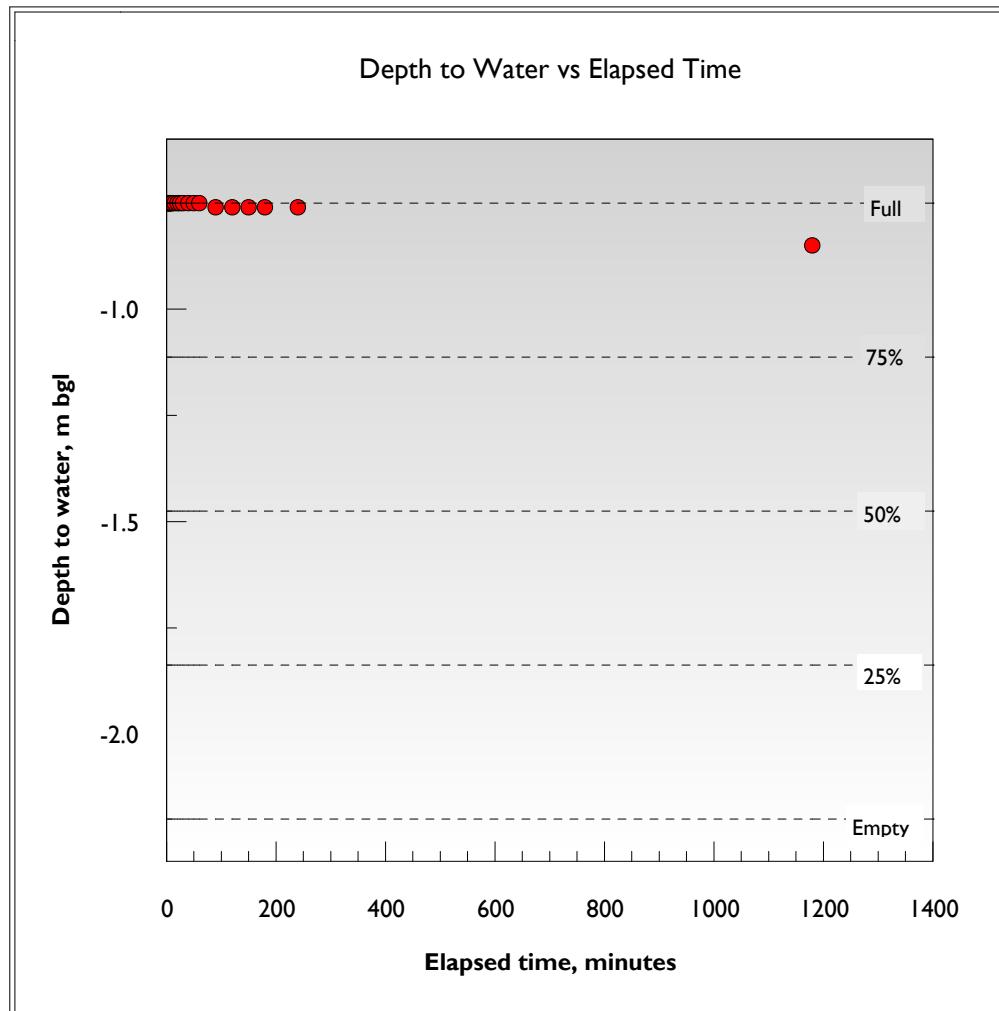
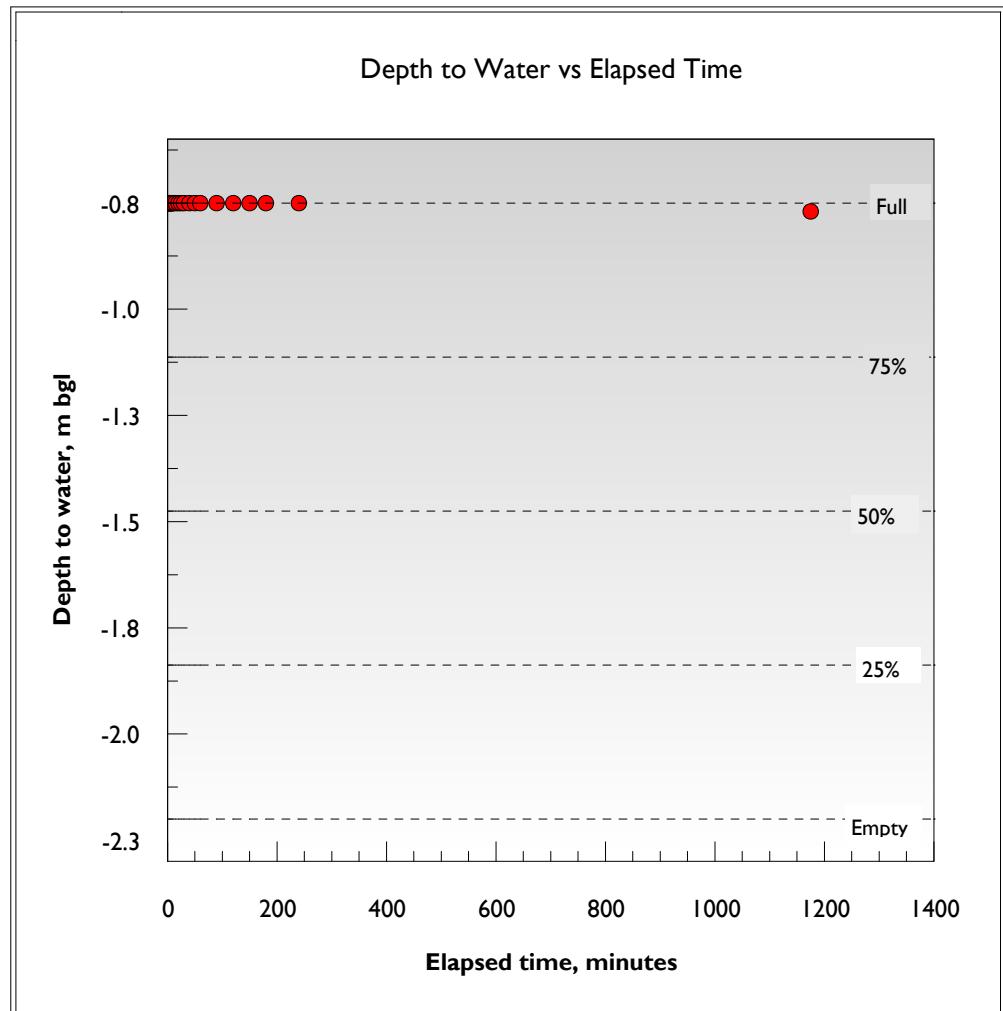
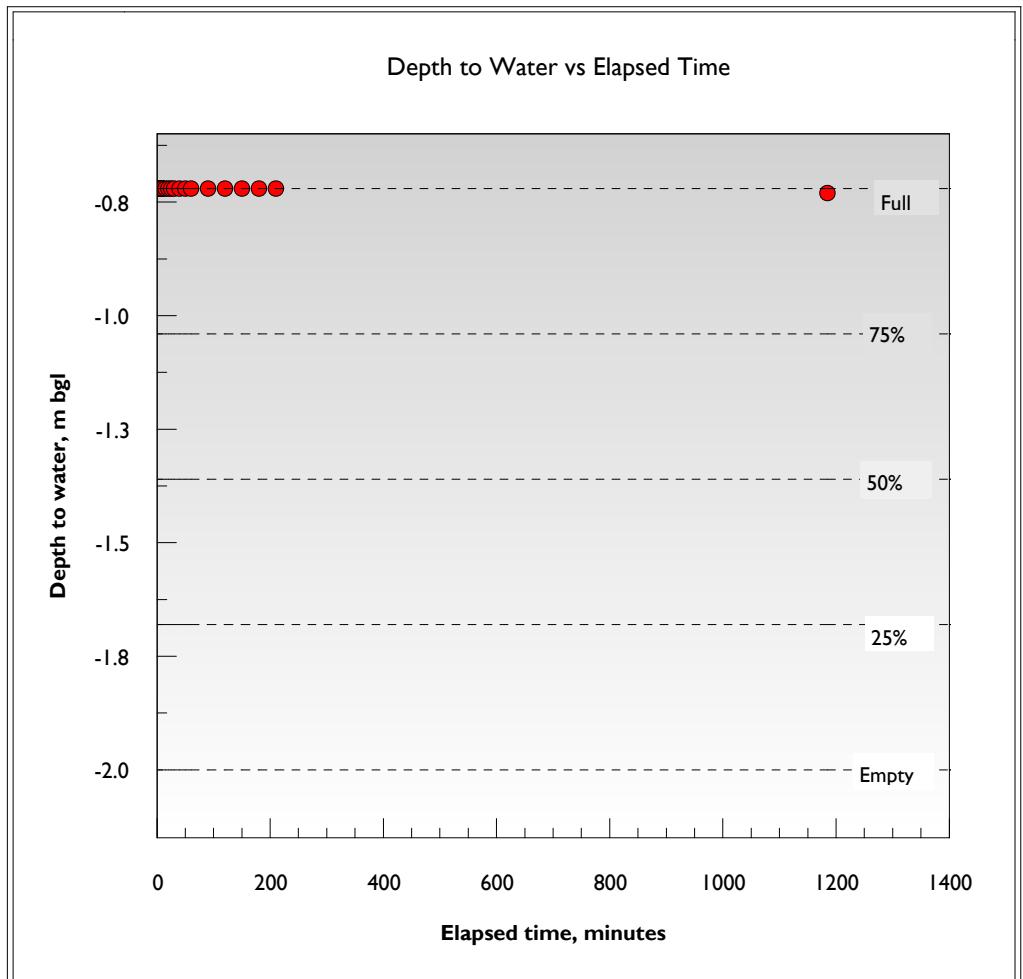
Soakaway testing, generally in accordance with BRE Digest 365, was carried out at five locations with the results available at Appendix D. The infiltration rates were negligible, despite the length of time allowed for the test (overnight). Shallow, surface water soakaways are not therefore recommended at this site.

BRE DIGEST 365 - SOIL INFILTRATION RATE

2.2 We would refer the LLFA to the geoenvironmental report in [Appendix A](#) of this technical note, particularly Section 7.6 and the information within Appendix D. It confirms the assessment made in the Drainage Strategy that infiltration is not viable on the site, and this has been established through on-site BRE365 soakage testing.

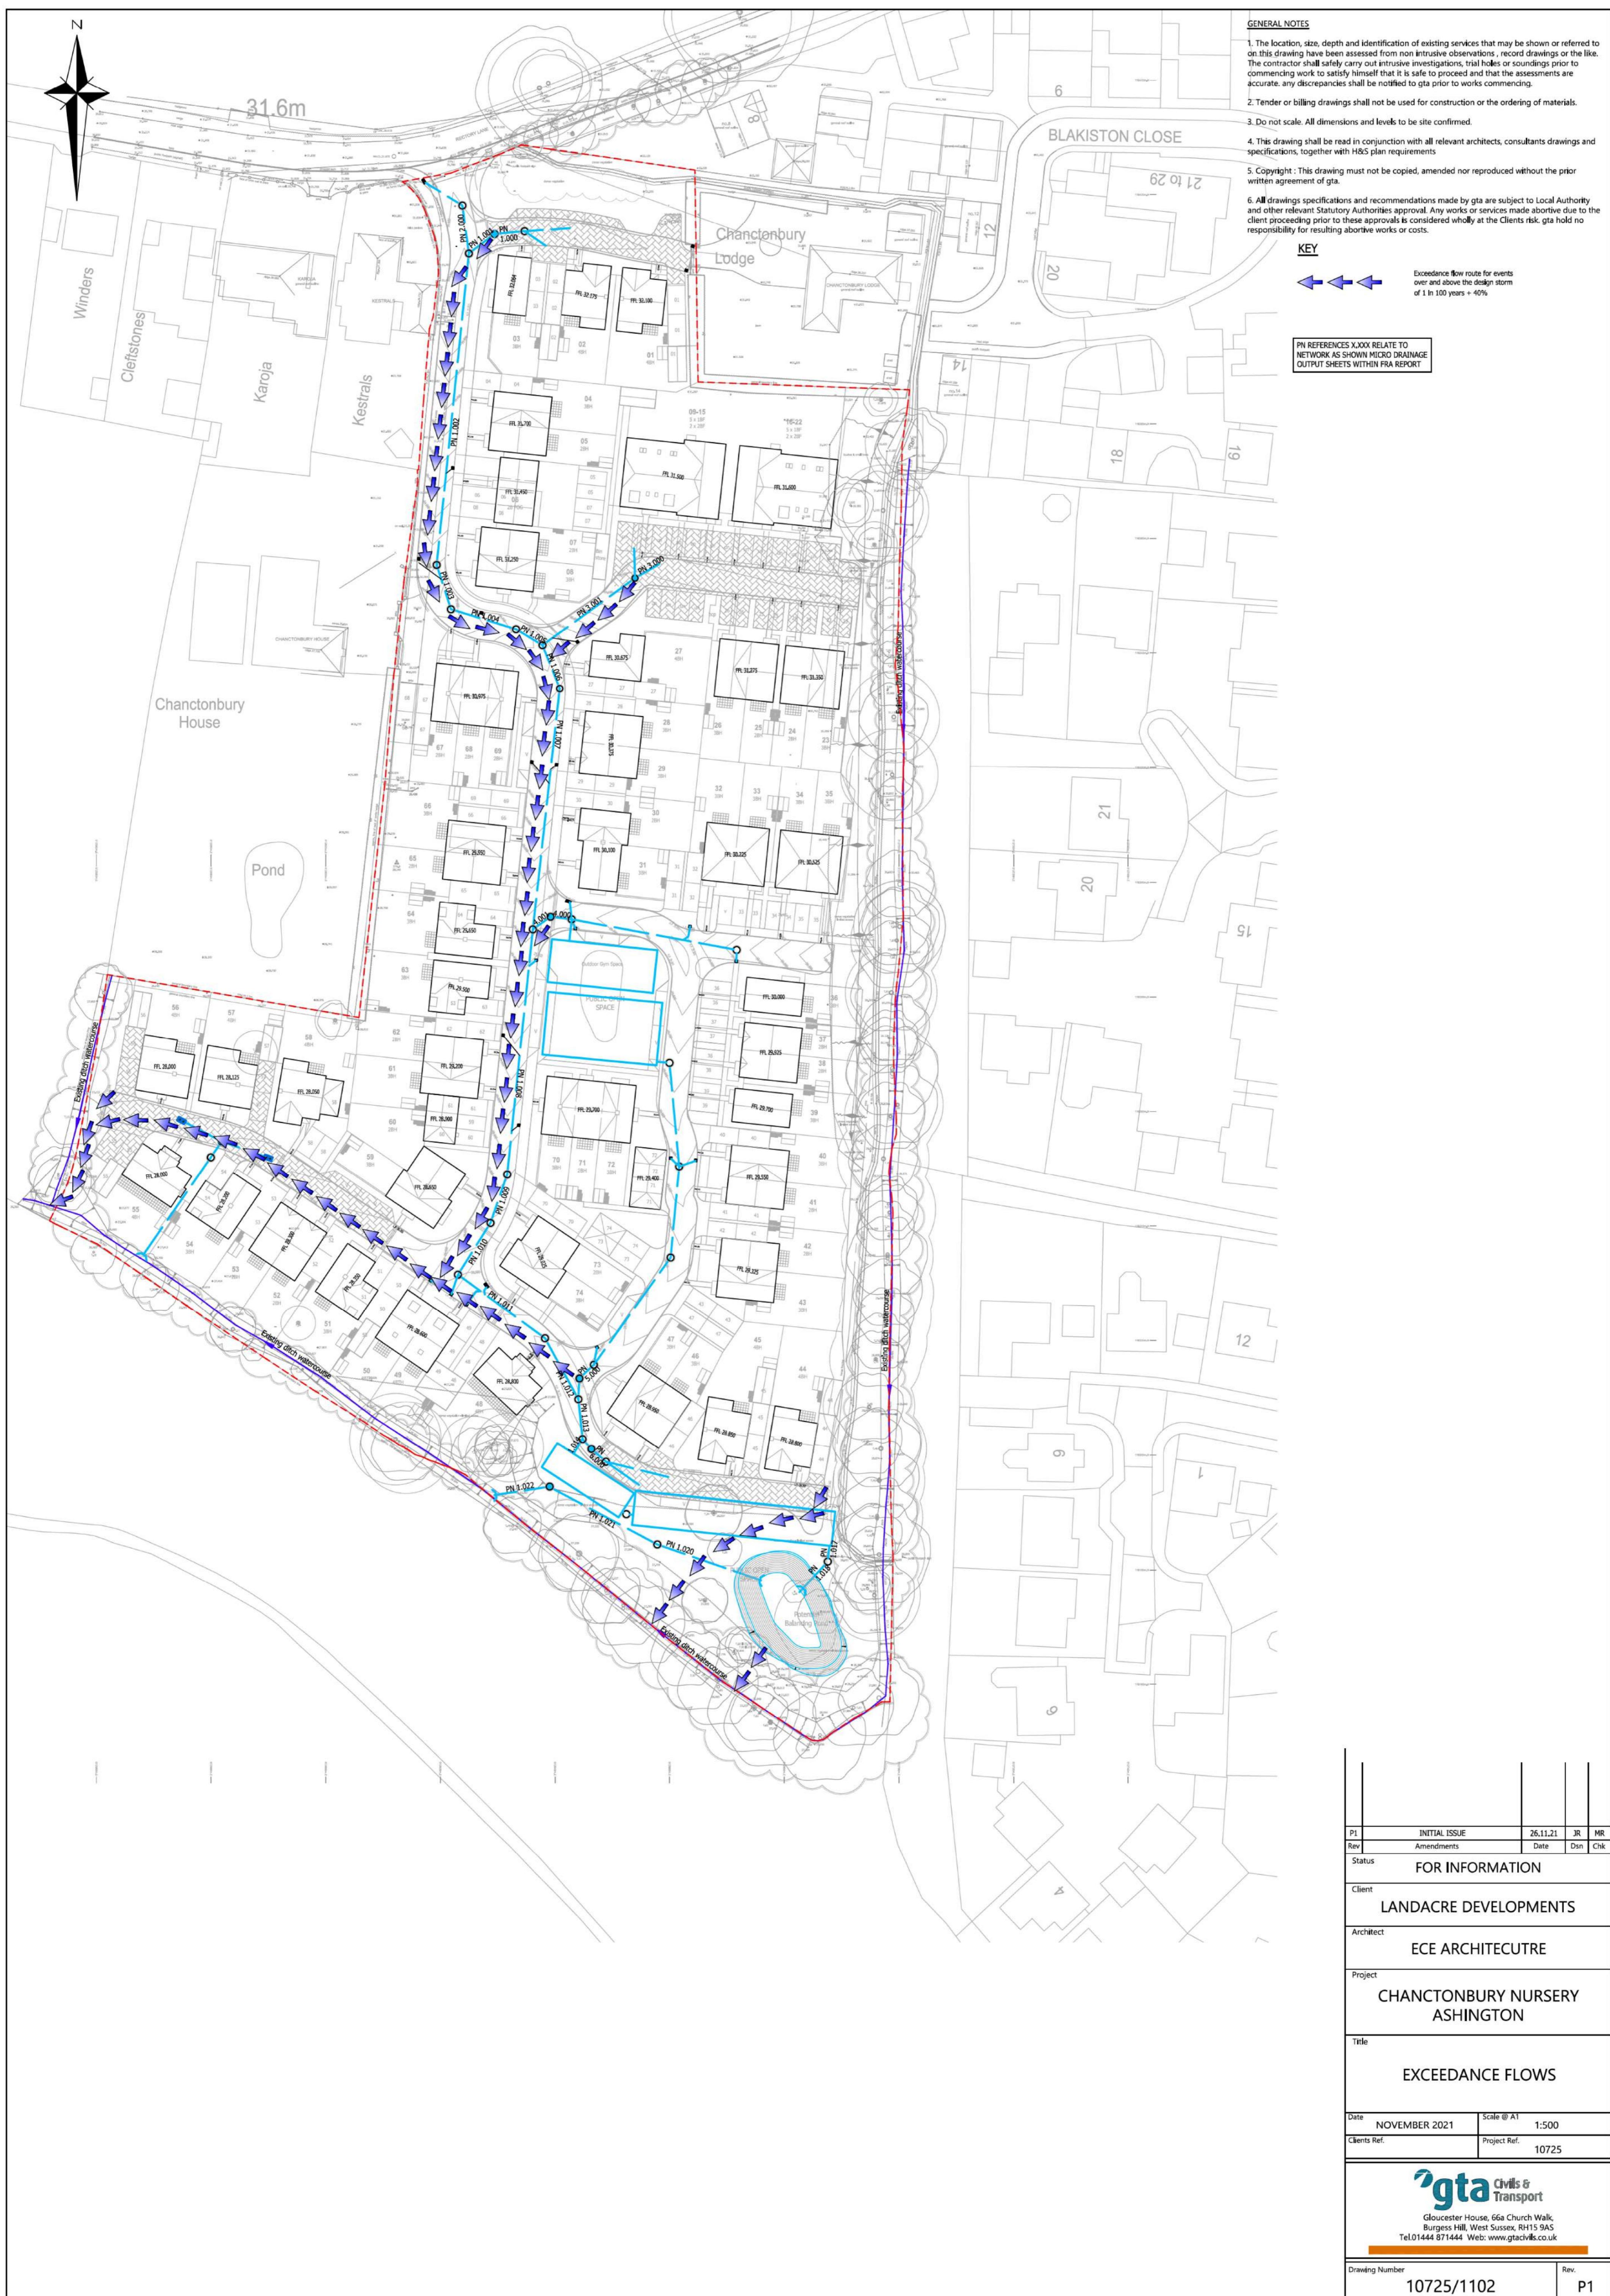
Appendix B
DC/22/0372 Drainage Strategy

- 2.5 With reference to planning application DC/22/0372 for the neighbouring site, the consented drainage strategy utilises a discharge to the same watercourse to which the current site intends to discharge to. The site associated with DC/22/0372 is immediately upstream of the current development, and the discharge to the watercourse was fully accepted by the LLFA. The drainage strategy proposed and accepted for DC/22/0372 is appended to this Technical Note in [Appendix B](#). Therefore, a precedent from the LLFA exists for accepting this watercourse as a suitable outfall for surface water, and from a point upstream of the current development proposals. This watercourse has ongoing connectivity and connection to the wider hydraulic network. To give the LLFA further comfort on this, we have included a LiDAR contour plan that shows the full length of the watercourse and its confluence with another watercourse to the west. This can be seen in [Appendix C](#).

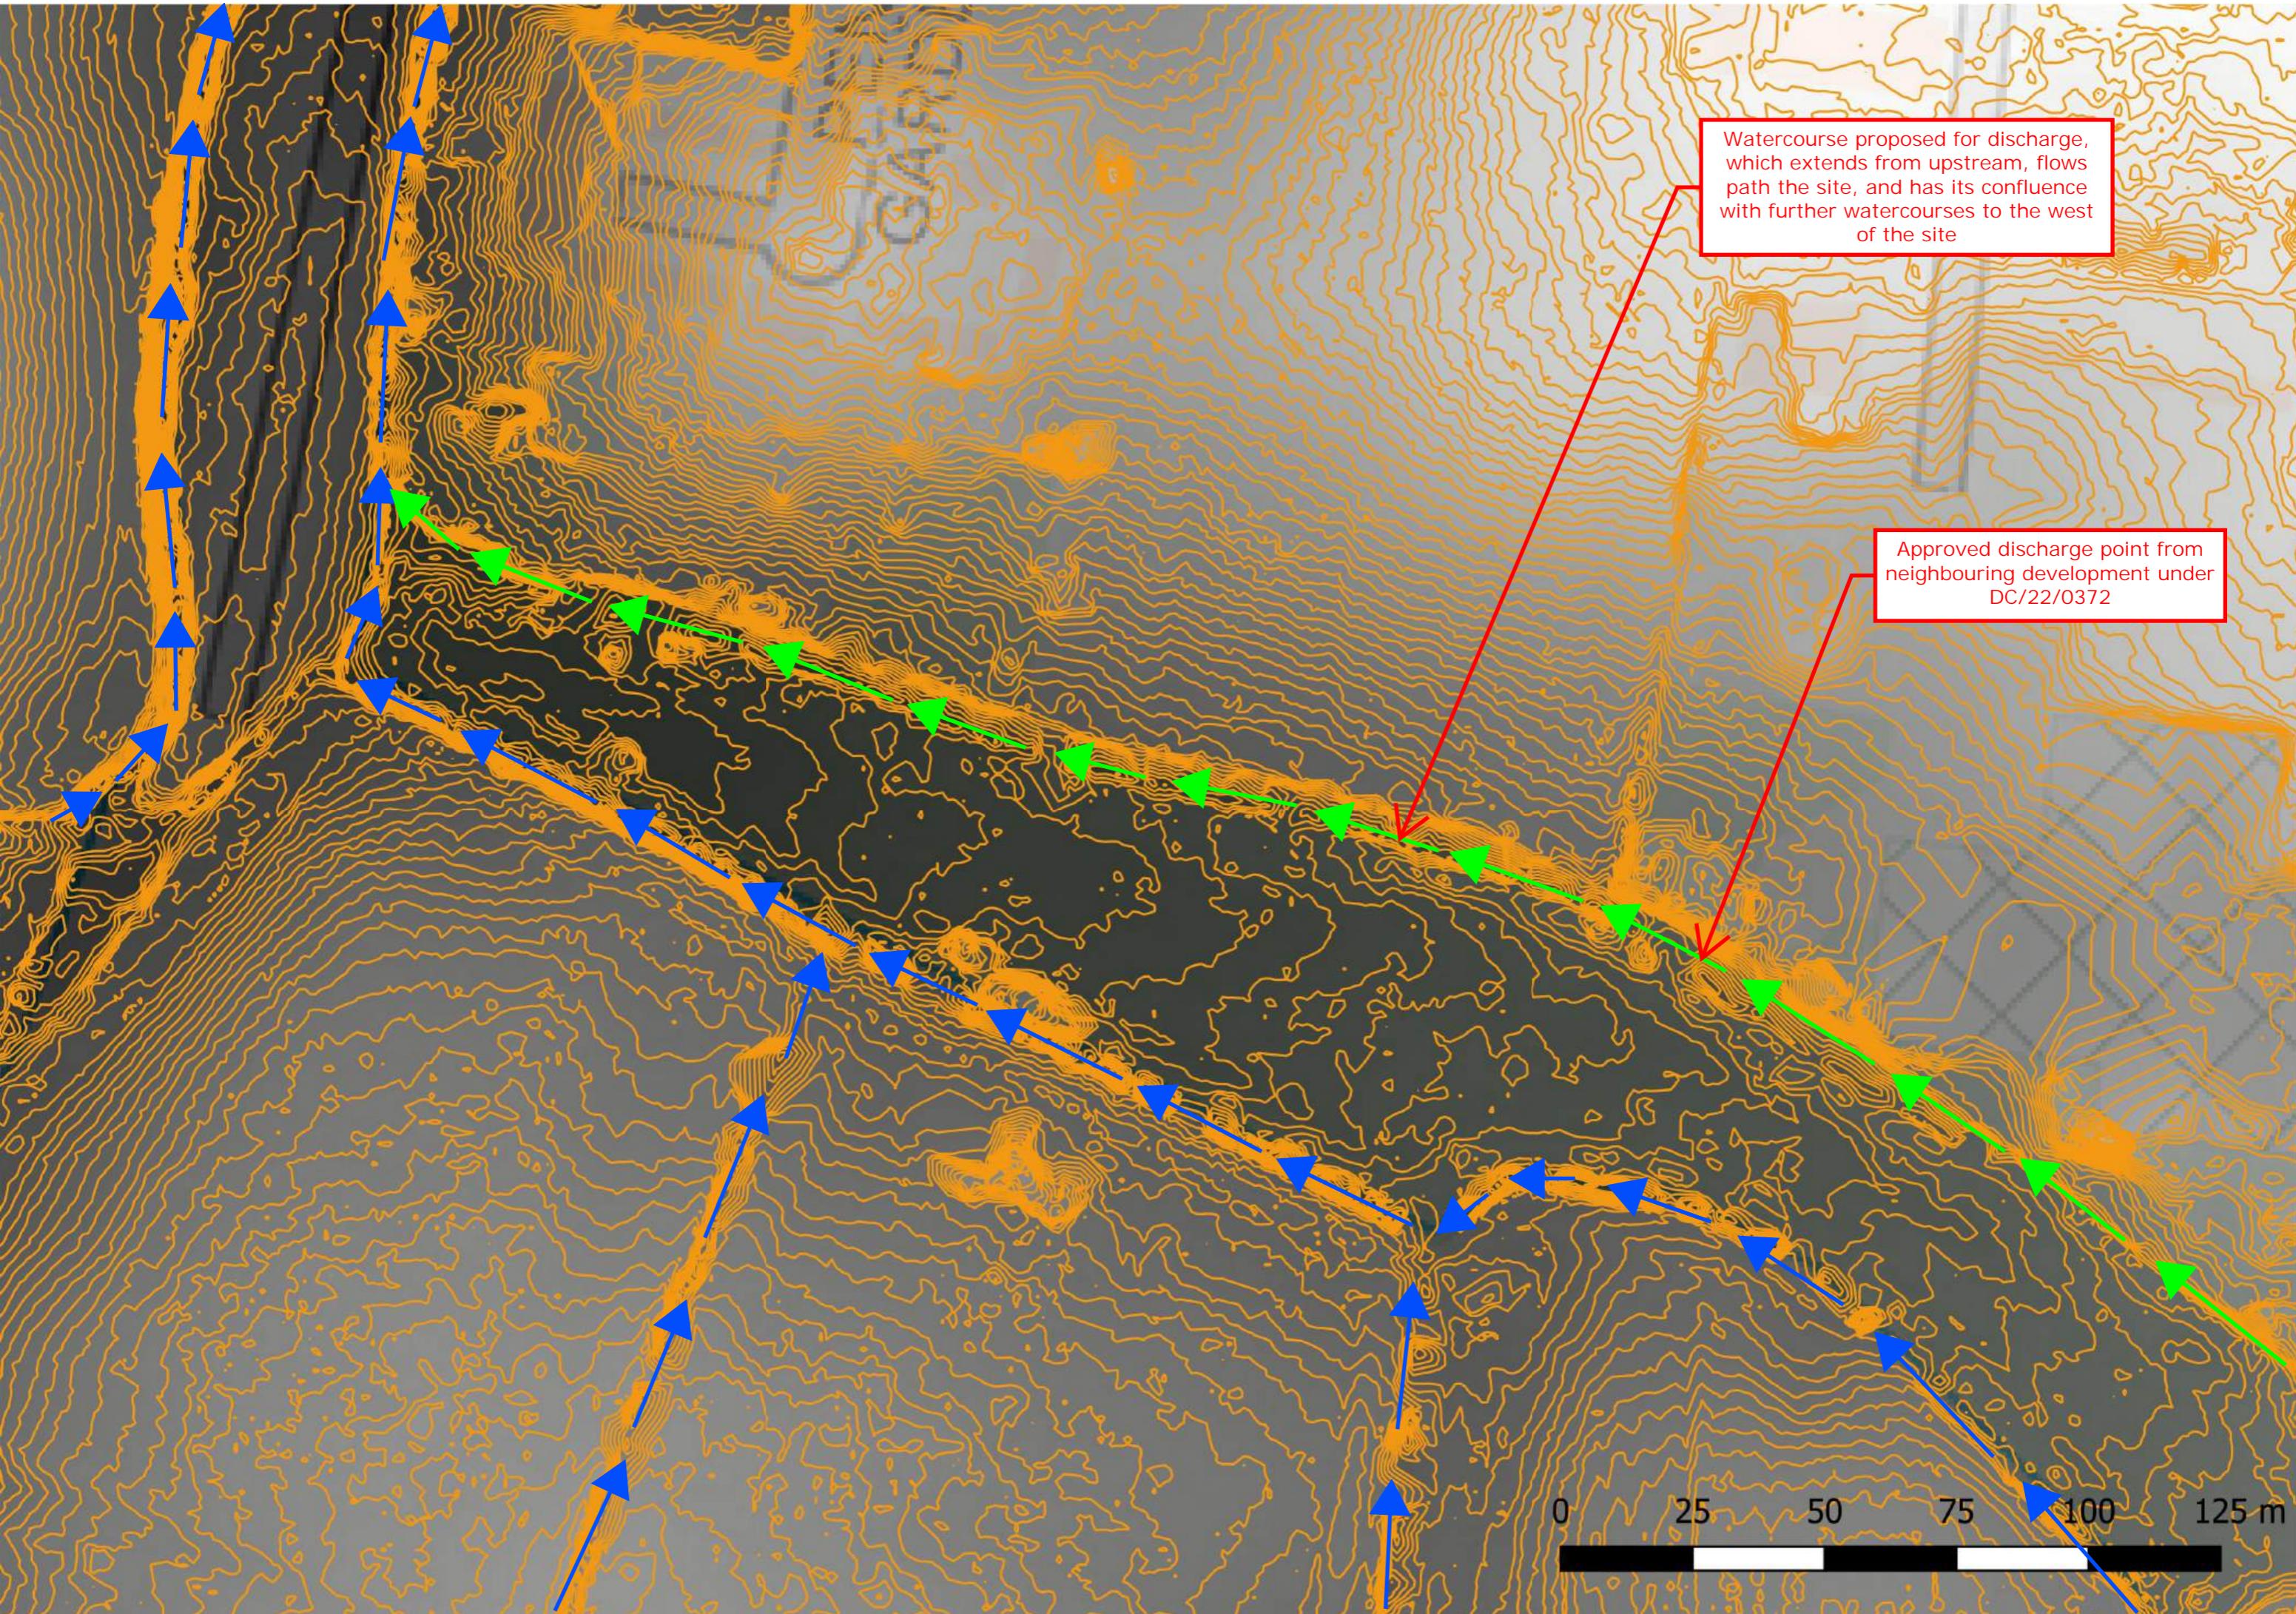
Appendix C

- 2.6 As can be seen, due to the impervious clay-based geology, there is a well-established and connected hydraulic network.

LiDAR Contour Plan Showing Watercourse Connectivity

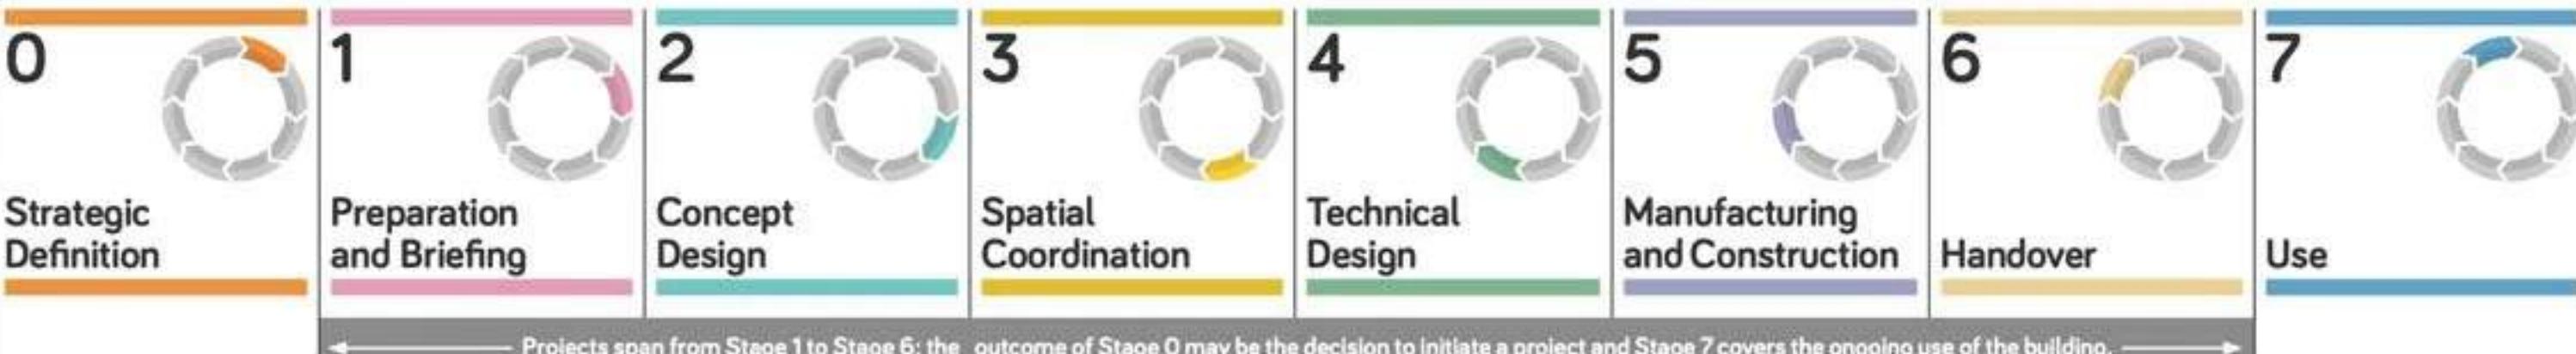
Appendix D

The RIBA Plan of Work organises the process of briefing, designing, delivering, maintaining, operating and using a building into eight stages. It is a framework for all disciplines on construction projects and should be used solely as guidance for the preparation of detailed professional services and building contracts.

- 2.8 The RIBA Plan of Work 2020 has been included in [Appendix D](#) of this Technical Note for the LLFA's reference. We have highlighted relevant text in the RIBA Plan of Work to direct the LLFA towards the key processes regarding drainage design in the concept, design and build timeline of development and construction projects.

- 2.9 Planning submission occurs at RIBA Stages 2 and 3 and detailed design takes place from Stages 4 to 5, and design is refined thereafter alongside site-based work and feedback. As such, it is unusual to provide construction issue designs on any aspect of the development until RIBA stages 4 and 5 are underway. The current project has not yet completed RIBA Stage 3.

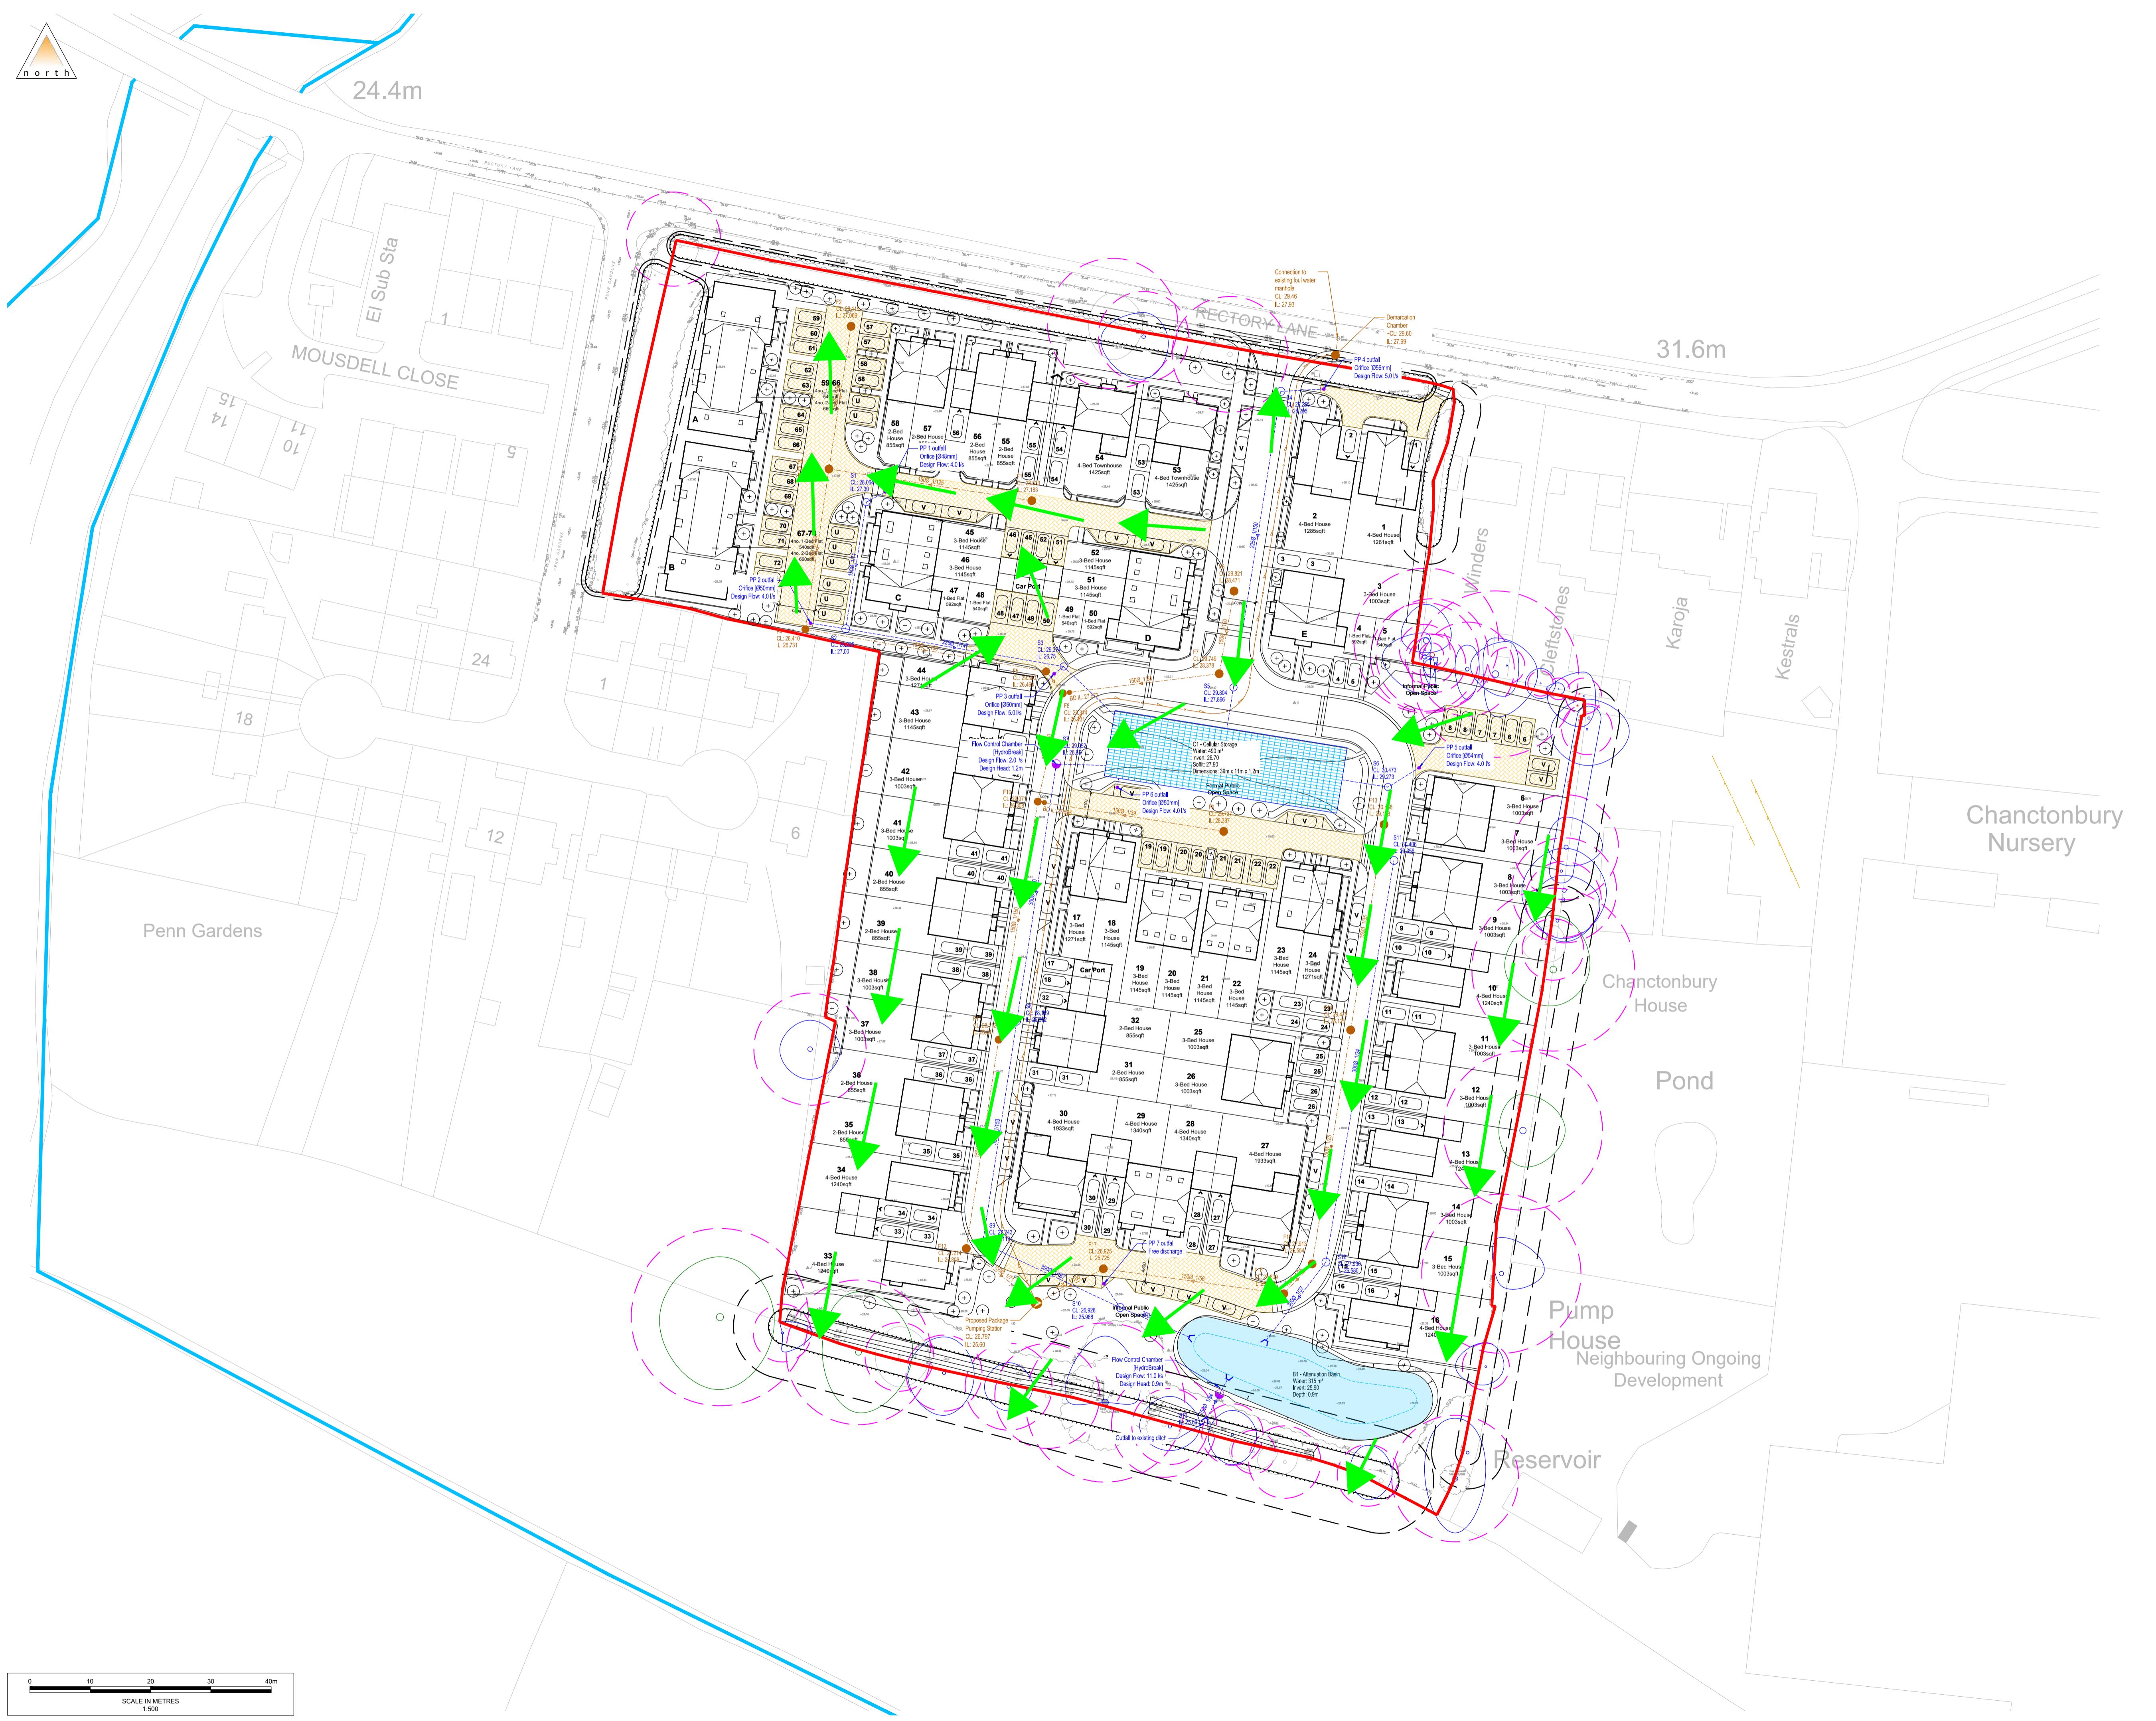
Appendix E
Exceedance Plan

- Site Boundary** (Red line)
- Existing Watercourse** (Blue line)
- Pervious Pavement** (450mm-600mm no infiltration Type 3 open graded sub-base with 30% void ratio)
- Surface Water Attenuation Basin** (Yellow hatched)
- Surface Water Gravity Pipe** (Dashed blue line)
- Surface Water Manhole** (Blue circle)
- Surface Water Flow Control Chamber** (Purple circle)
- Porous Pavement Outfall with Orifice Plate** (Green arrow)
- Proposed Headwall** (Blue dashed line)
- Foul Water Gravity Pipe** (Orange dashed line)
- Foul Water Rising Main** (Orange line with dots)
- Surface Water Manhole** (Blue circle)
- Foul Water Pumping Station** (Orange circle with arrow)

- 2.12 This has been produced and is [Appendix E](#). As can be seen, there are no receptors to exceedance flows as the area is rural.
