Technical Note

Project No: ITS19302
Project Title: Land North of Handcross Road, Plummers Plan
Title: Stage 1 Road Safety Audit – GG119 Response Format
Ref: DS/OT/ITS19302-009
Date: 1 July 2025

**B2110 HANDCROSS ROAD,
PLUMMERS PLAIN,
HORSHAM, WEST SUSSEX**

**Stage 1 Road Safety Audit
J190512**

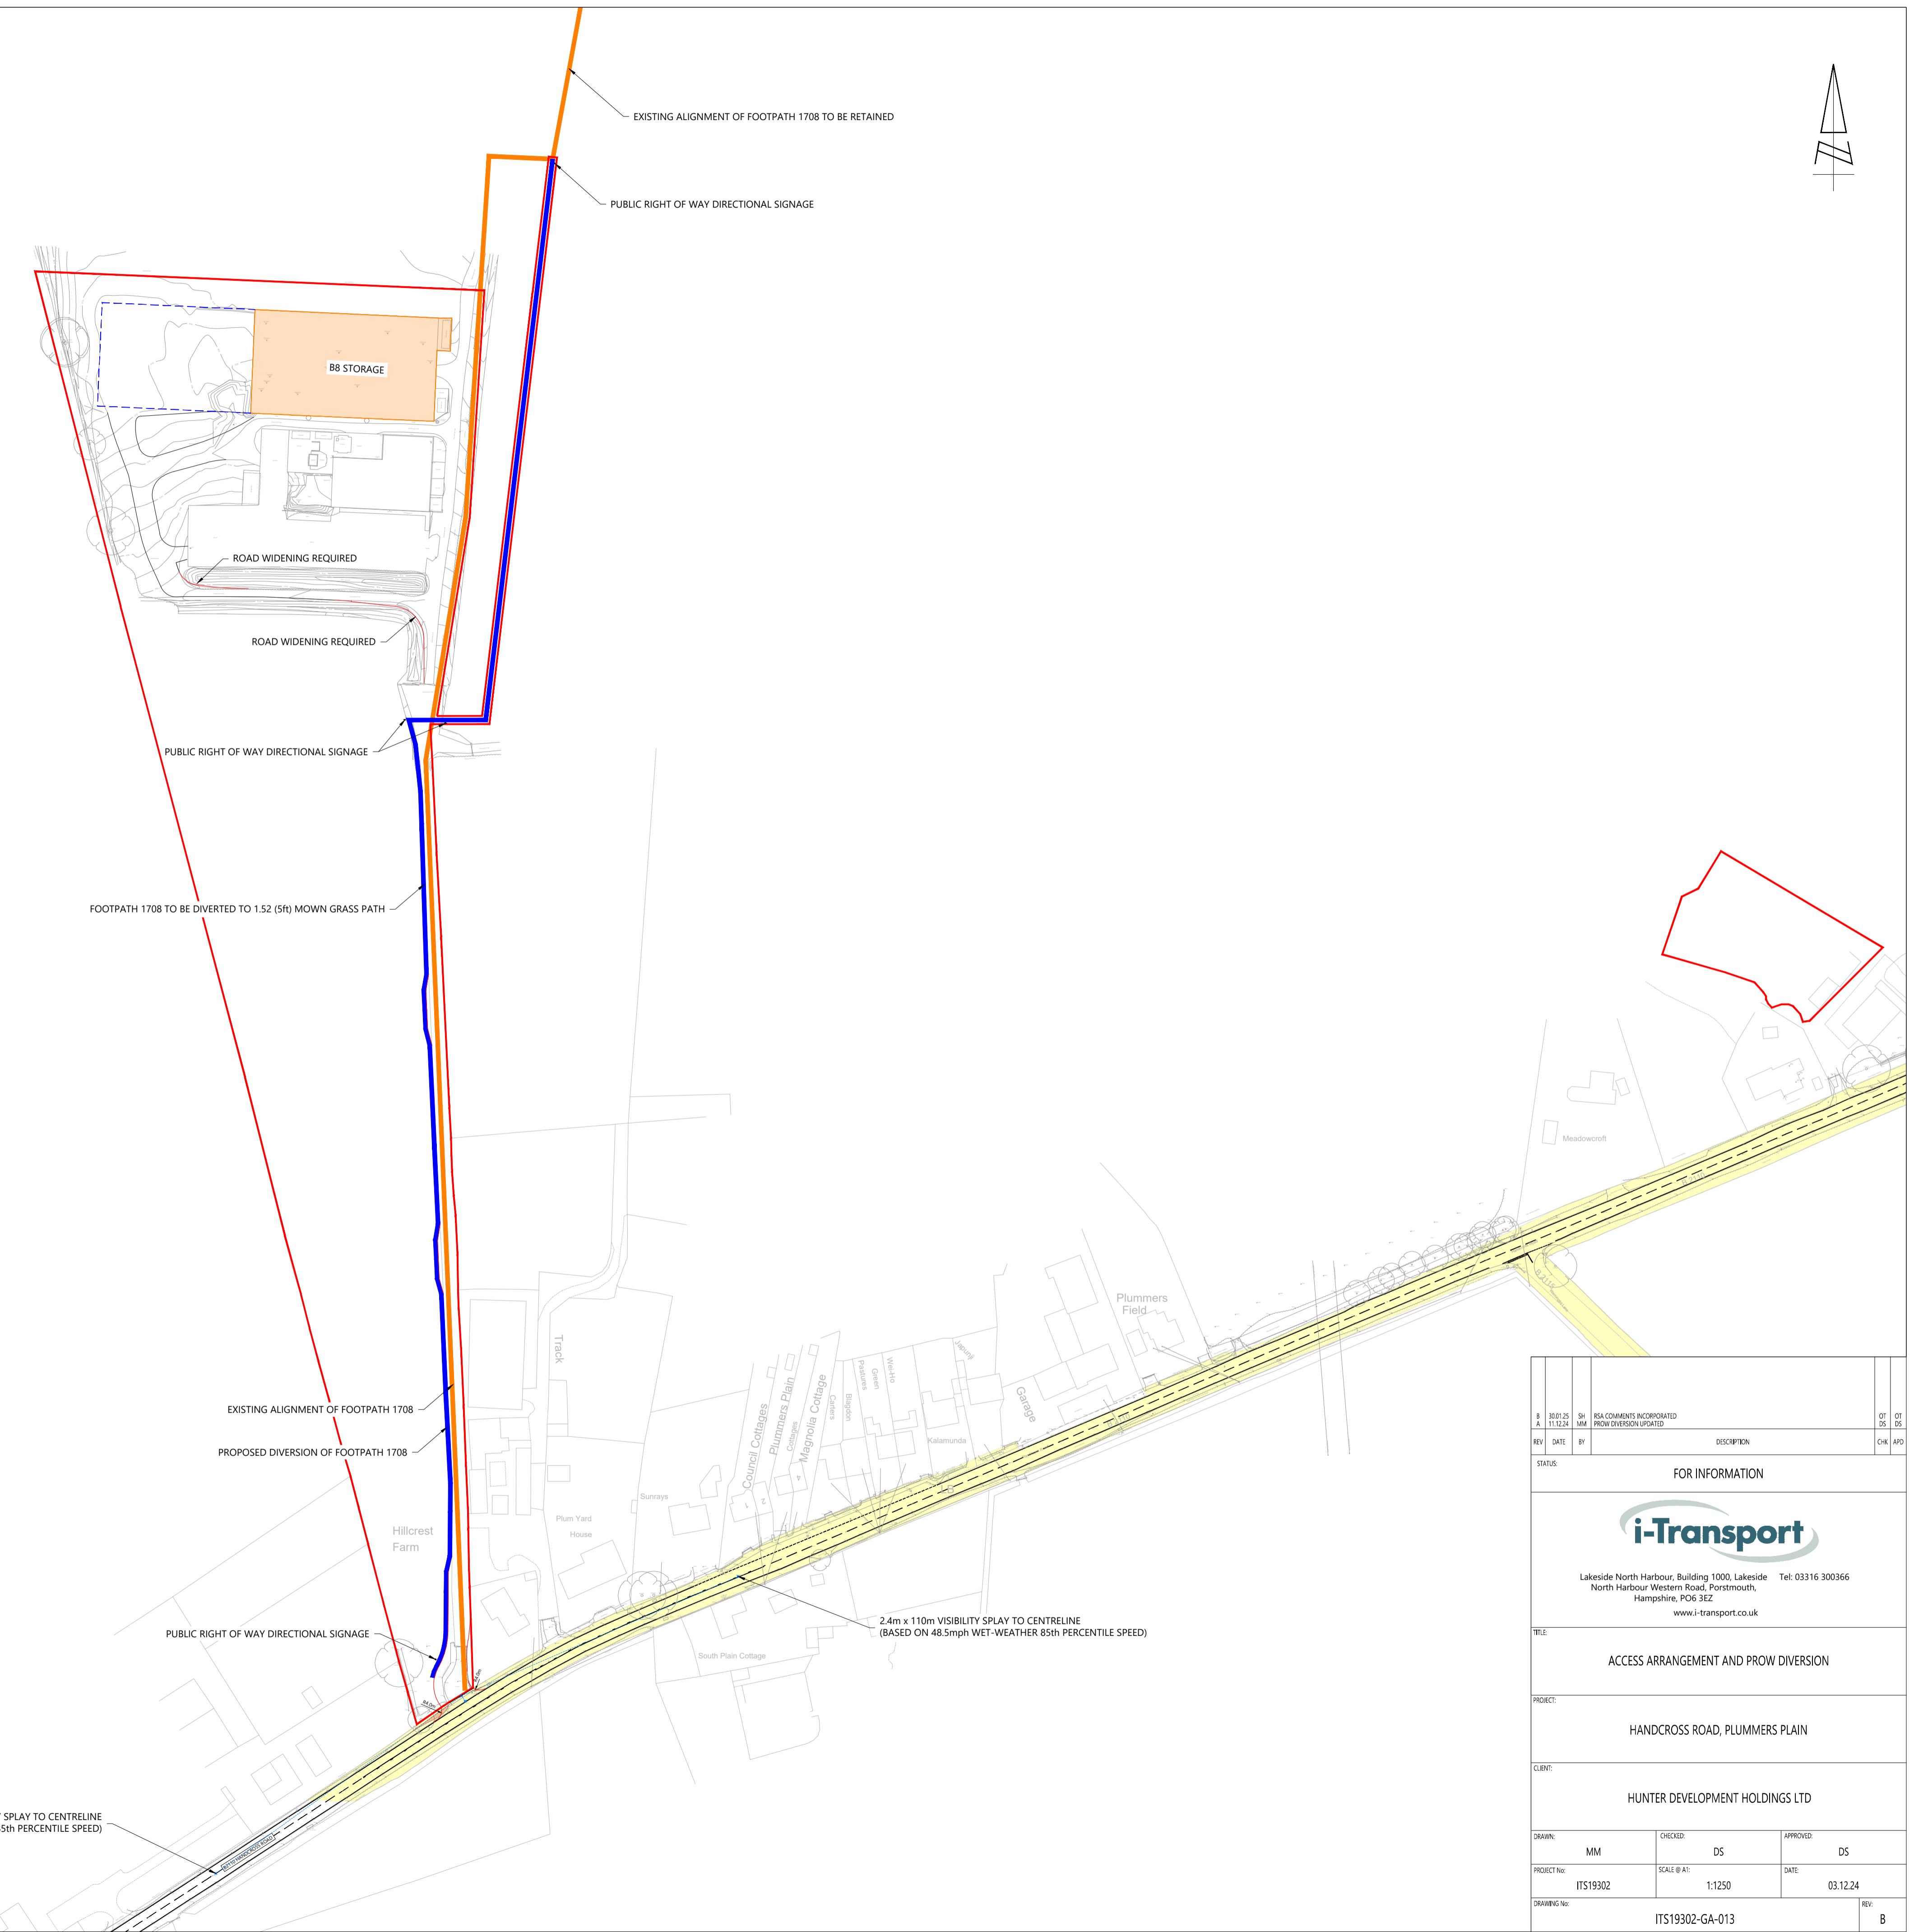
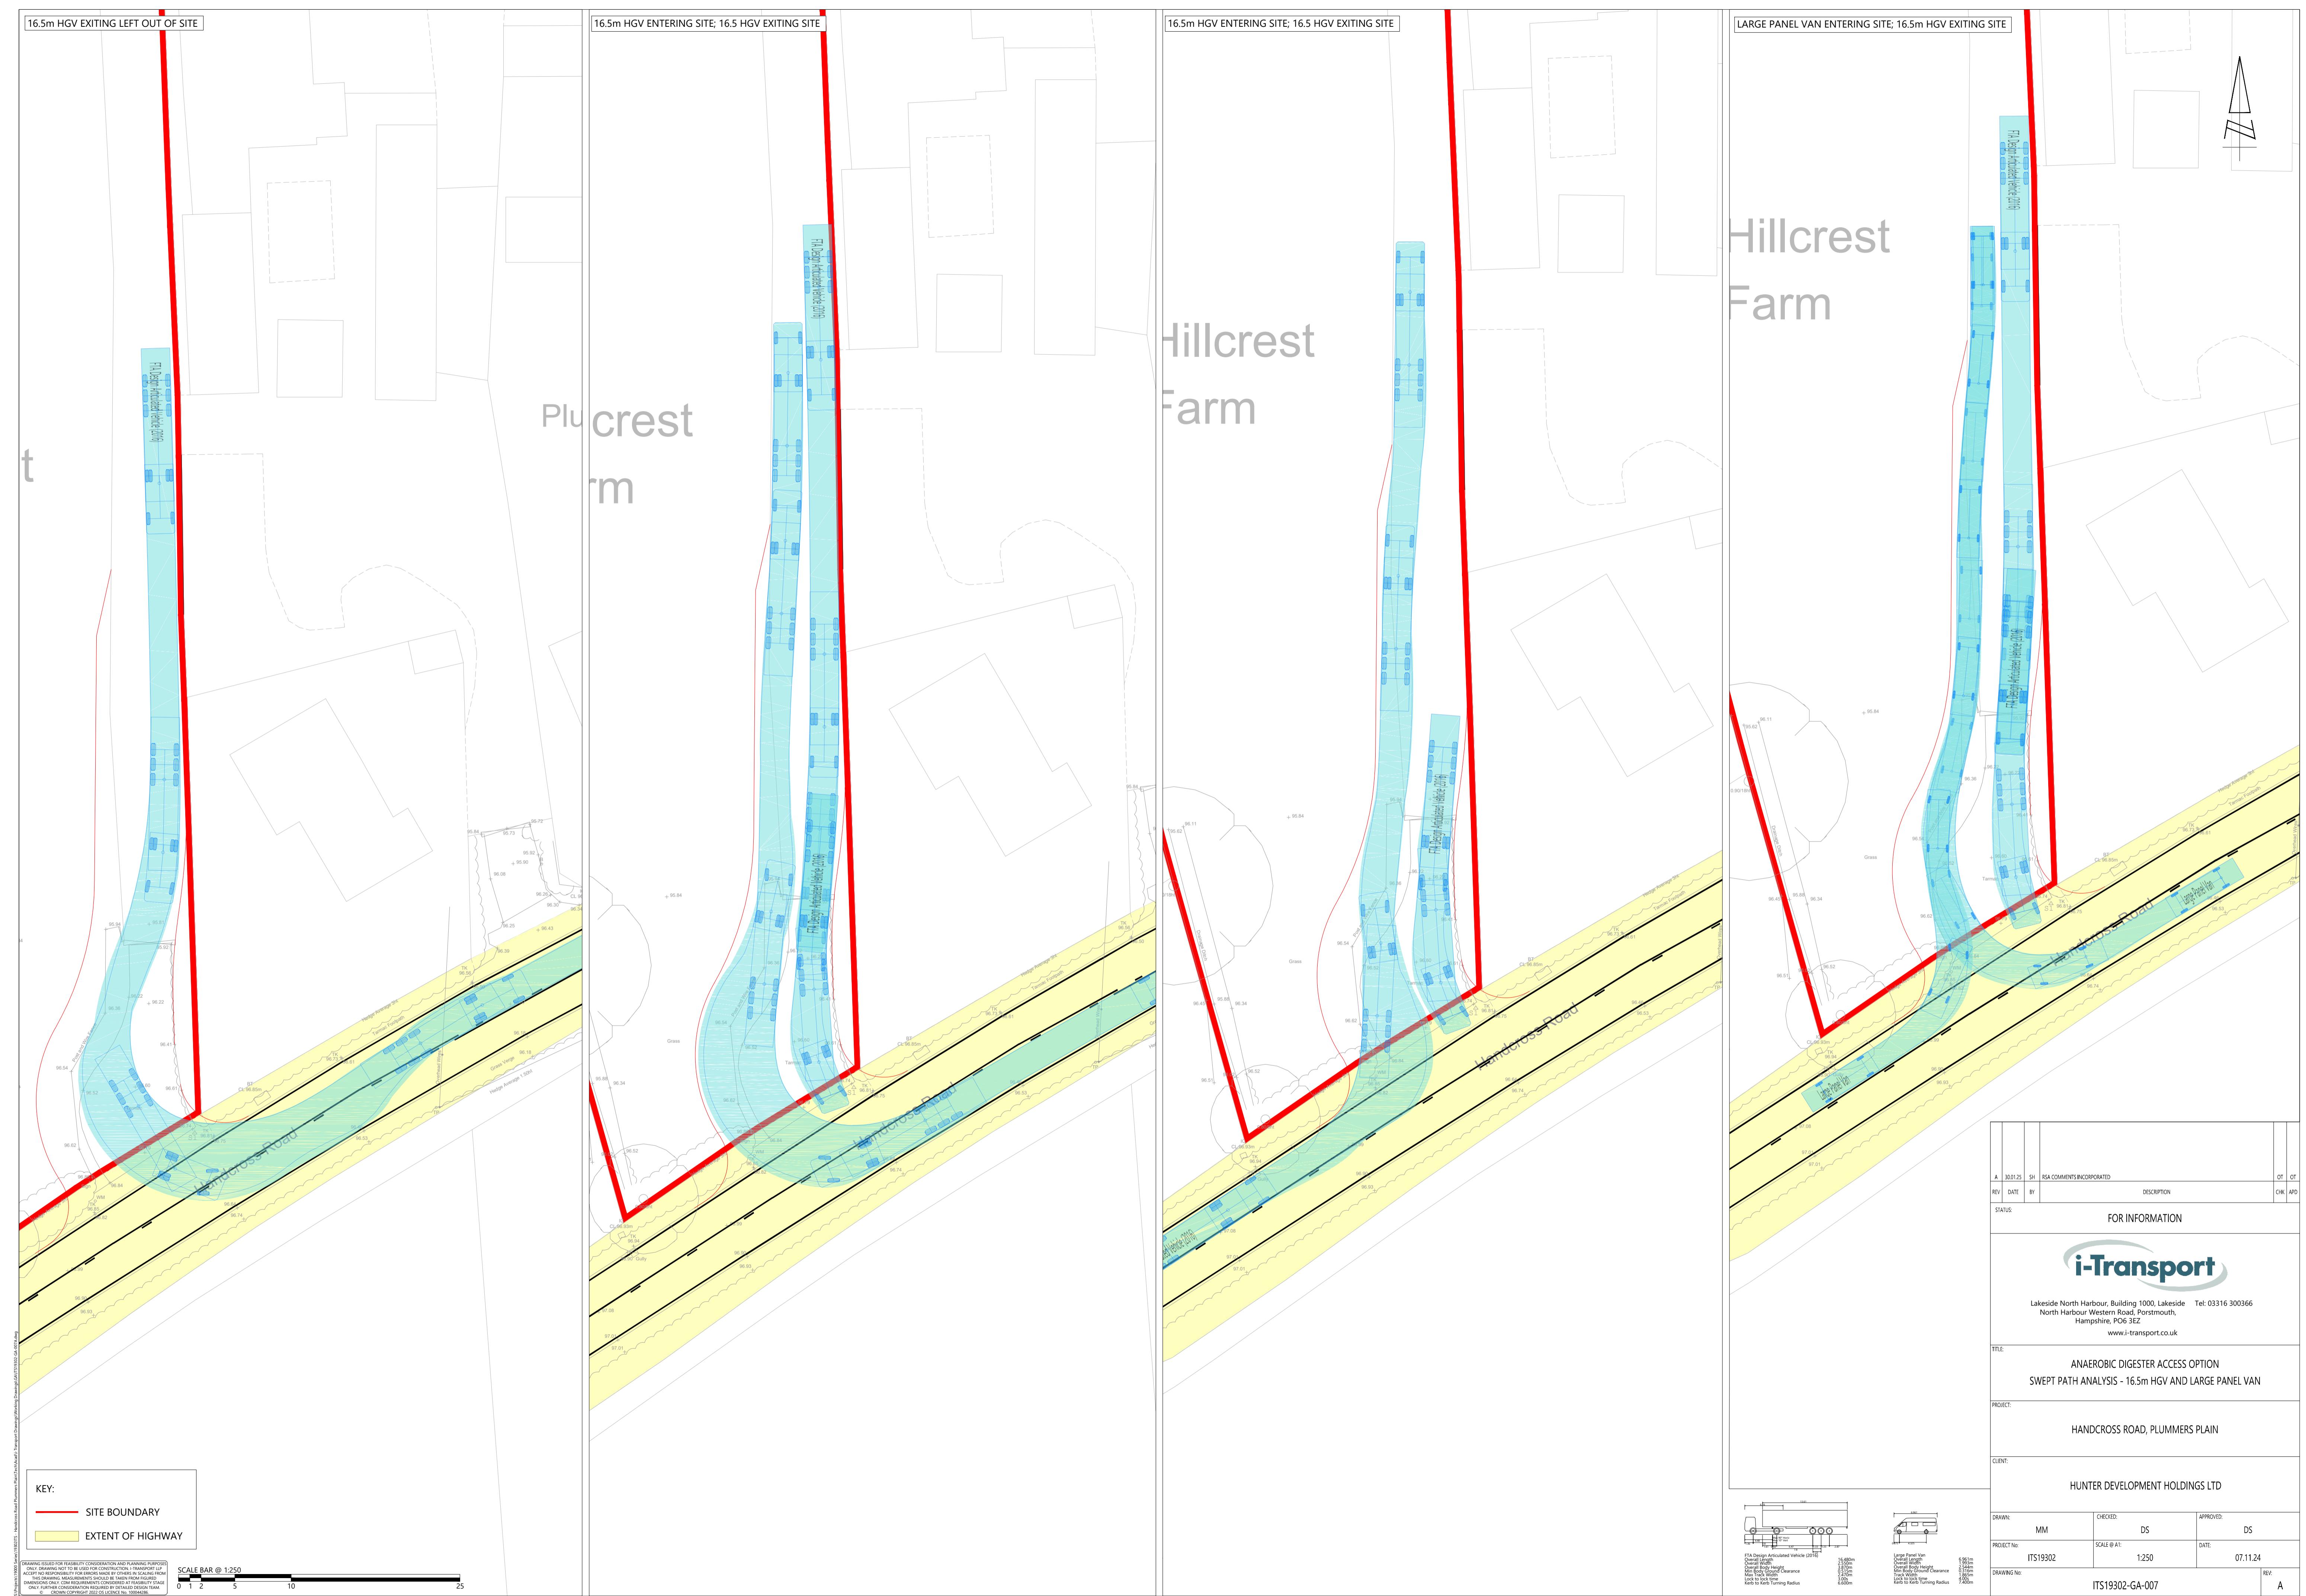
- 1.3 Following receipt of the RSA, additional drawings have been prepared that accompany this note, as follows:
 - ITS19302-GA-007 Rev A – Vehicle Swept Path Analysis

- ITS19302-GA-013 Rev B – Site Access Arrangement

RSA Problem	RSA Recommendation	Design Organisation Response	Overseeing Organisation Response	Agreed RSA Action
<p>1. Risk of collisions with pedestrians: There are existing hedges directly adjacent to the site access. There are no proposals to provide pedestrian splays onto the footway from both sides of the amended access. This will cause an obstruction to pedestrian intervisibility, which may result in collisions with passing pedestrians</p>	<p>Provide appropriate pedestrian intervisibility from the site access.</p>	<p>Accepted – The hedgerow within the adopted highway boundary / the applicant's ownership will be trimmed back and maintained to ensure that a pedestrian to driver splay can be achieved.</p> <p>The access arrangement is existing with a minor increase in vehicle movements as a result of the proposal. The development will improve the current interaction between pedestrians and vehicles by maintaining the hedgerow. This is shown as an inset on drawing ITS19302-GA-013B.</p>

RSA Problem	RSA Recommendation	Design Organisation Response	Overseeing Organisation Response	Agreed RSA Action
<p>2. Risk of head on collisions: Swept path analysis has not been shown for all movements expected at the site access. Left-turning artics have not been demonstrated to be able to safely exit onto Handcross Road. This may cause site vehicles to encroach into the westbound lane, which may result in head-on or side-swipe collisions with passing traffic</p>	<p>Undertake swept path analysis for all expected vehicle movements</p>	<p>Accepted – Drawing ITS19302-GA-007A illustrates swept path analysis for all expected vehicle movements generated by the site.</p> <p>All movements can be undertaken without encroachment into the opposing lane (e.g. movements into the site), with the exception of the left turn out of the site access. It should be noted that this is an existing situation – the proposal can, and already does, generate large HGV manoeuvres. A detailed assessment of vehicular movements has been undertaken which demonstrates that pre and post-development movements are broadly comparable. The proposal includes improvement at the site access (e.g. widening and an increase in kerb radii) to enhance access for larger vehicles and provide a betterment to existing conditions.</p>

<p>3. Increased risk of rear-end shunts: The proposed internal give-way line is set back over 50 metres from the site access/ Handcross Road. This may cause slow moving exiting vehicles to encounter arriving vehicles after leaving the give-way position, resulting in confusion and the requirement for large vehicles to reverse back onto Handcross Road. This may result in collisions with passing vehicles.</p>	<p>Amend give-way position and associated widening.</p>	<p>Accepted - Drawing ITS19302-GA-13B has shown the removal of the give-way markings, although passing bays have been retained for use along the access road. In addition, further localised widening of the site access has been incorporated into the design to enable vehicles to pass at the access and prevent obstruction of Handcross Road and reversing manoeuvres back onto the road.</p>

RSA Problem	RSA Recommendation	Design Organisation Response	Overseeing Organisation Response	Agreed RSA Action
<p>4. Risk of vehicles overhanging onto the main road: The proposed layout includes widening a short section of the access road to accommodate large vehicle entering the site. Swept path analysis has not been provided to demonstrate that a right-turning artic (entering) can do so when another artic is waiting to exit the site. This may cause inappropriate carriageway area to be provided, which result in collisions between entering and exiting vehicles.</p>	<p>Amend access layout/arrangement to accommodate expected movements.</p>	<p>With reference to Problem 3, the site access arrangement has been amended to incorporate additional widening at the access. Drawing ITS19302-GA-007A illustrates swept path analysis for all expected vehicle movements generated by the site which demonstrates that a right-turning artic can enter the site whilst another vehicle waits to exit.</p> <p>With reference to the TS accompanying the planning application, the TRICS analysis demonstrates that a negligible number of two-way articulated vehicle movement is expected. Similarly, the identified operator of the site has confirmed that articulated vehicle access is only required infrequently – i.e. once per week.</p>

RSA Problem	RSA Recommendation	Design Organisation Response	Overseeing Organisation Response	Agreed RSA Action
<p>5. Risk of side swipe collisions: No swept path analysis provided to demonstrate that the largest expected vehicles can safely negotiate the passing areas and that the give-way lines are suitable. This may cause vehicles to wait at inappropriate positions, which may result in collisions.</p>	<p>Undertake swept path analysis for all passing areas.</p>	<p>Accepted - The design of the passing bays has been informed by swept path analysis for with reference to the expected movements as forecast using the TRICS database.</p> <p>The passing bays can accommodate the expected use without conflict, as shown in the extracts of an HGV & Large Panel van passing one another in both directions. With reference to Problem 3, the give way markings are to be removed from the scheme.</p>

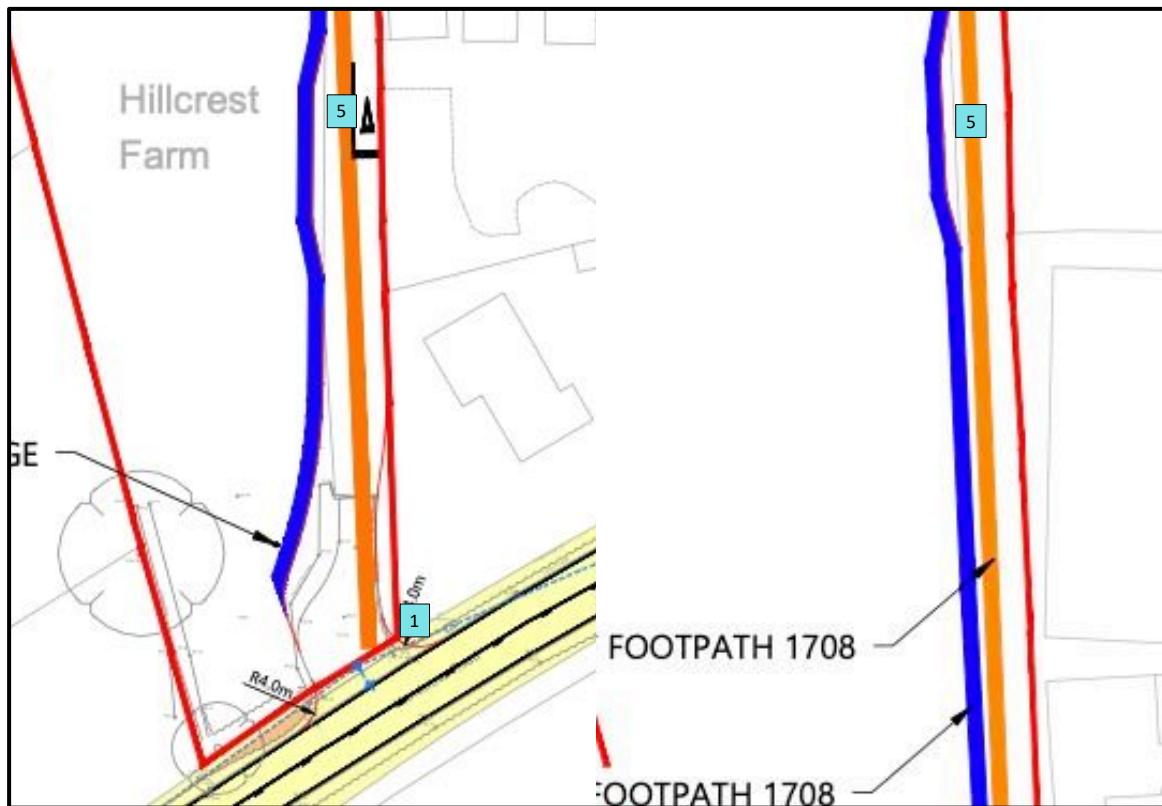
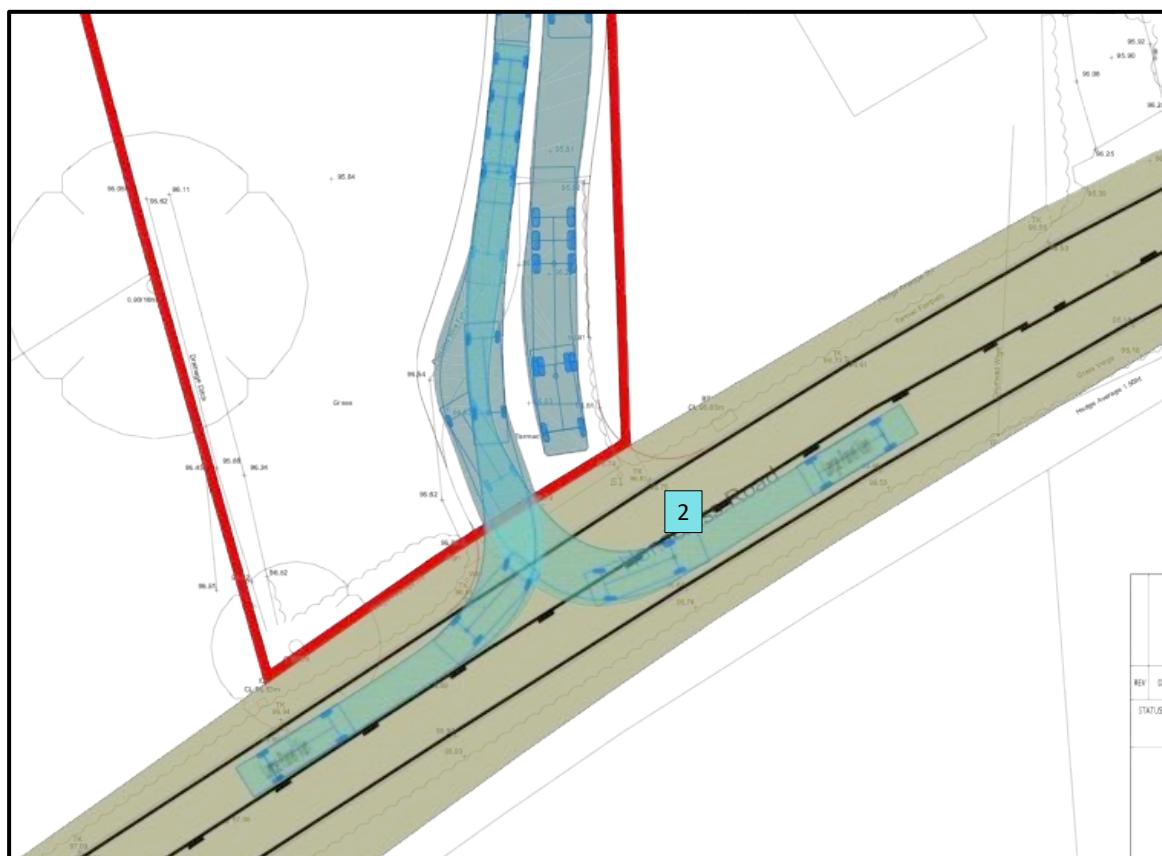
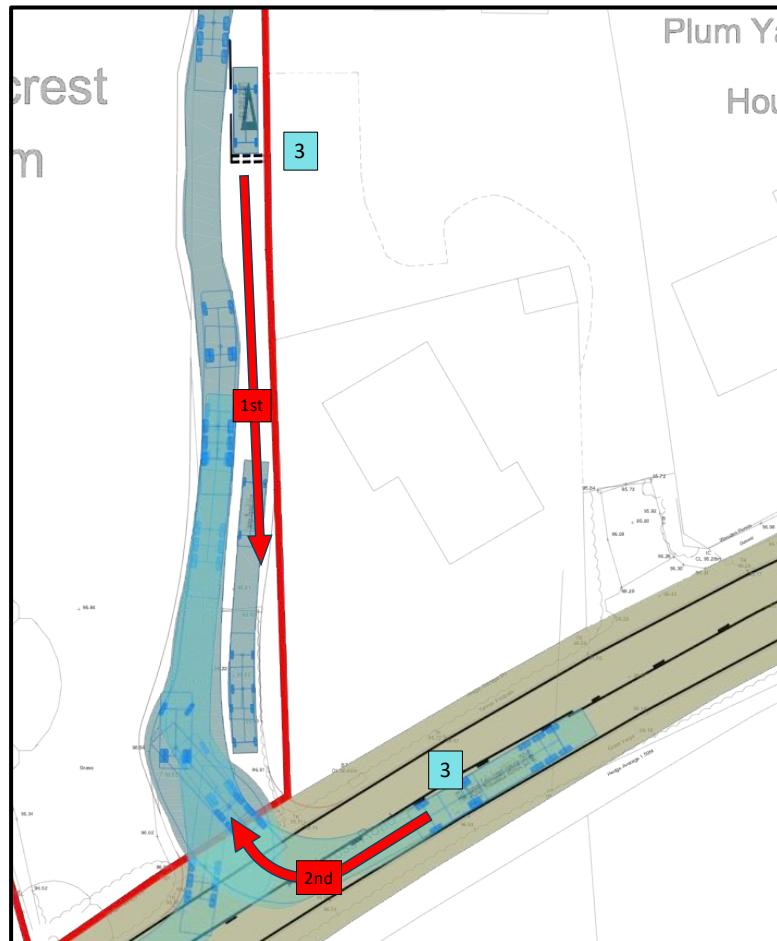
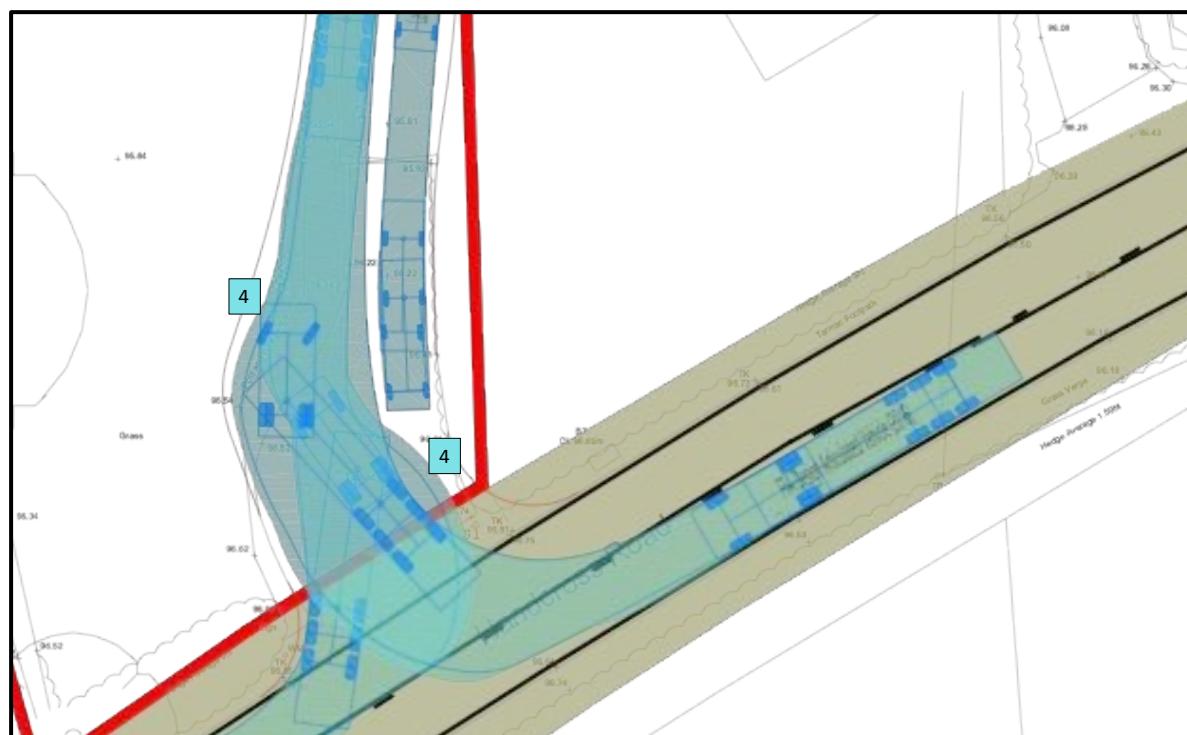
Appendix C Problem Location Plan

Problem 1	
Location	Site access
Summary	Risk of collisions with pedestrians

Location	Handcross Road / site access junction
Summary	Risk of head-on collisions
<p>Swept path analysis has not been shown for all movements expected at the site access. Left-turning artics have not been demonstrated to be able to safely exit onto Handcross Road. This may cause site vehicles to encroach into the westbound lane, which may result in head-on or side-swipe collisions with passing traffic.</p>	
Recommendation	Undertake swept path analysis for all expected vehicle movements.

Location	Internal give-way line
Summary	Increased risk of rear-end shunts
<p>The proposed internal give-way line is set back over 50 metres from the site access/ Handcross Road. This may cause slow moving exiting vehicles to encounter arriving vehicles after leaving the give-way position, resulting in confusion and the requirement for large vehicles to reverse back onto Handcross Road. This may result in collisions with passing vehicles.</p>	
Recommendation	Amend give-way position and associated widening

Location	Site access widening
Summary	Risk of vehicles overhanging onto the main road
<p>The proposed layout includes widening a short section of the access road to accommodate large vehicle entering the site. Swept path analysis has not been provided to demonstrate that a right-turning artic (entering) can do so when another artic is waiting to exit the site. This may cause inappropriate carriageway area to be provided, which result in collisions between entering and exiting vehicles.</p>	
Recommendation	Amend access layout/arrangement to accommodate expected movements. Also see Problem 3

Location	All passing areas
Summary	Risk of side swipe collisions
<p>No swept path analysis provided to demonstrate that the largest expected vehicles can safely negotiate the passing areas and that the give-way lines are suitable. This may cause vehicles to wait at inappropriate positions, which may result in collisions.</p>	
Recommendation	Undertake swept path analysis for all passing areas.
