Leonardslee House and Gardens

Conservation Management Plan 2023

Revision 2 - 13th March 2023

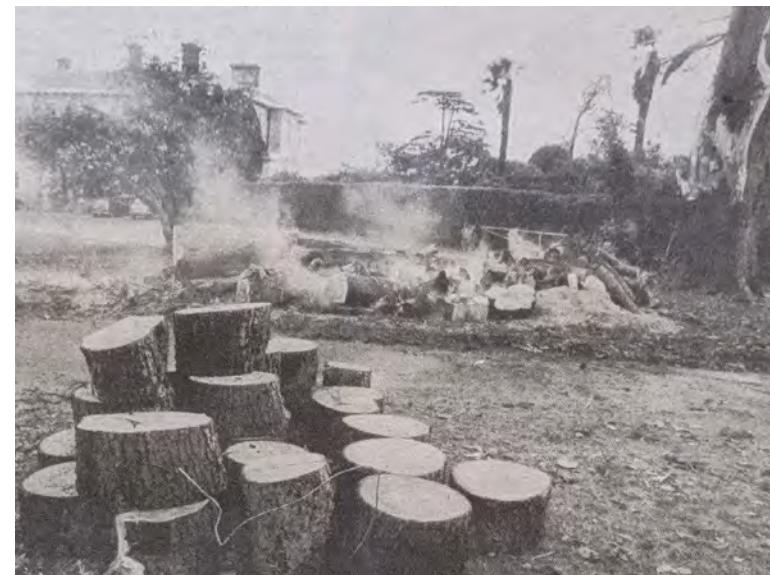
Plate 14 - The aftermath of the Great Storm of 1987, image sourced from the WSCC Archives.

The Great Storm of 1987 did some damage to the gardens, toppling a large number of elderly trees in the estate [Plate 14]. This included the toppling of what was once the garden's tallest Fletcher cypress, *Chamaecyparis lawsoniana 'Fletcheri'*. This now forms a natural arch over the estate's Falling Walk path.¹³ However, this had the added benefit of opening up new vistas, with reports of improvements to sites across the valley, and increased flowering of the shrubs now afforded more sunlight. This also resulted in the wallabies being allowed to roam over a greater area in the park – to combat increased weed growth stemming from removal of trees.

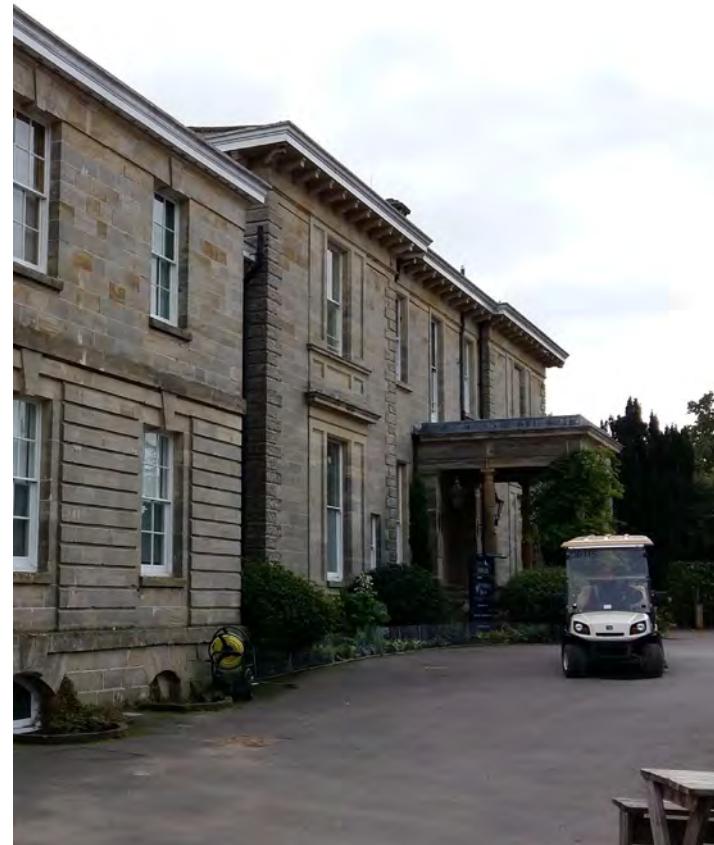
Plate 6.3 - The porch.

The large porch on the central ground floor bay is supported on four rusticated and banded Tuscan columns, now significantly eroded. The open sides shown in early twentieth century pictures have been infilled, and narrow columns have been added to each side to support the over-long lintel stones forming the entablature. **[Plate 6.3]**

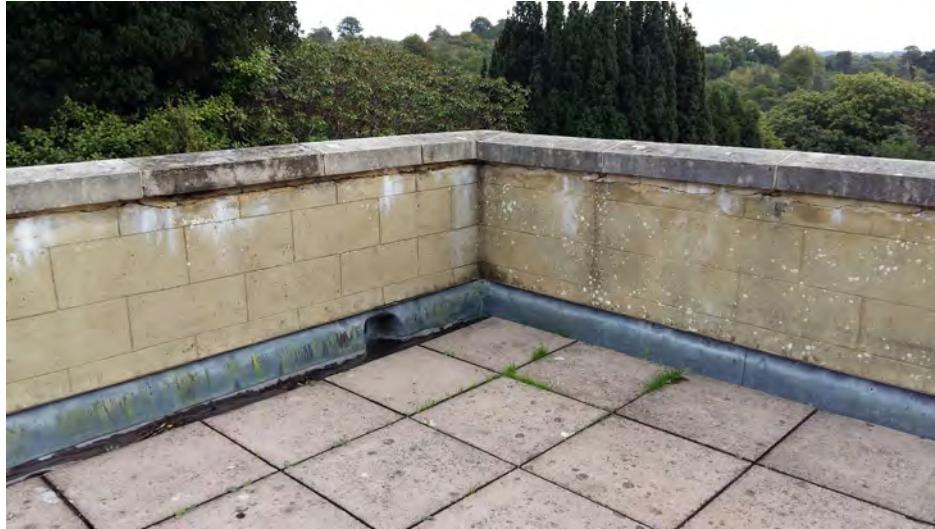
Plate 6.4 - The terrace walls.

On the north side of the house is a large, currently unused, terrace. Walls are faced with render inner face and scored to give appearance of stonework matching the house. **[Plate 6.4]**

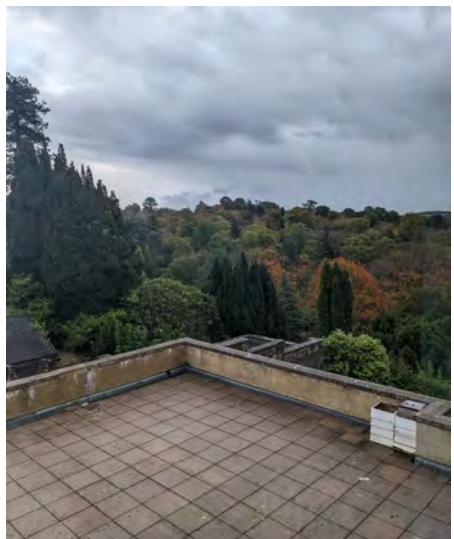
Plate 6.5 - A view of the terrace from the Meadowsweet bathroom.

The area could do with attention, including weeding, as although it remains hidden from view from the grounds, it can be seen from a number of the rooms. **[Plate 6.5]**

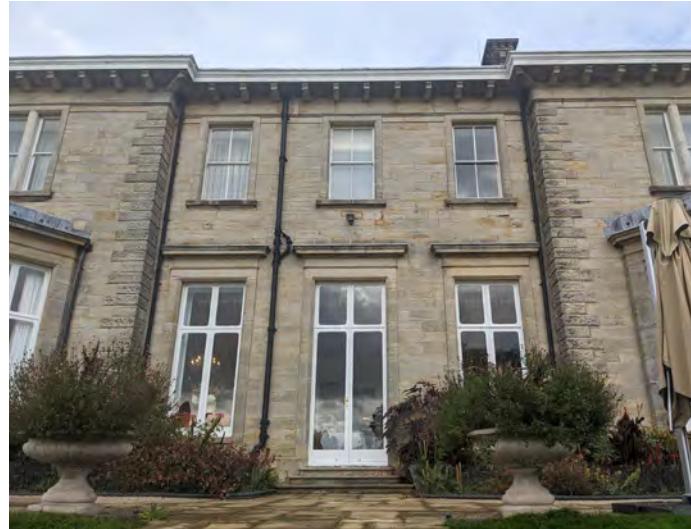
Plate 6.6 - The east elevation windows.

The main rooms to the garden elevations are fitted with mullioned windows, with large panes, whereas the service wing rooms have more standard 6 on 6 pane sliding sashes, all painted white. **[Plates 6.6 & 6.7]**

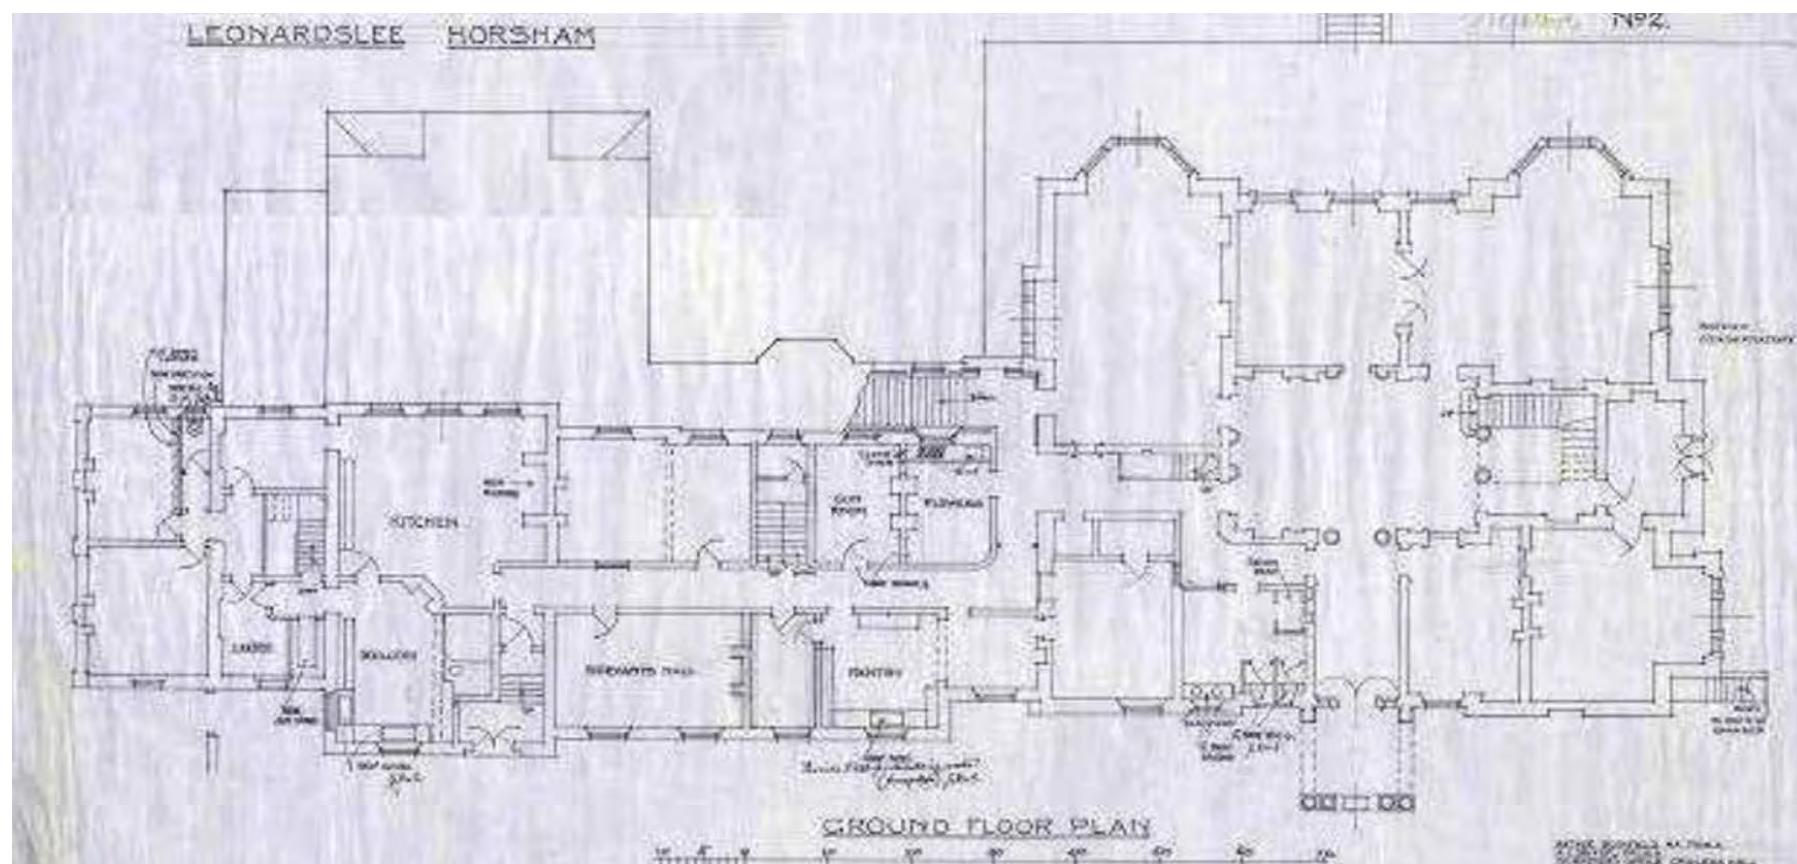
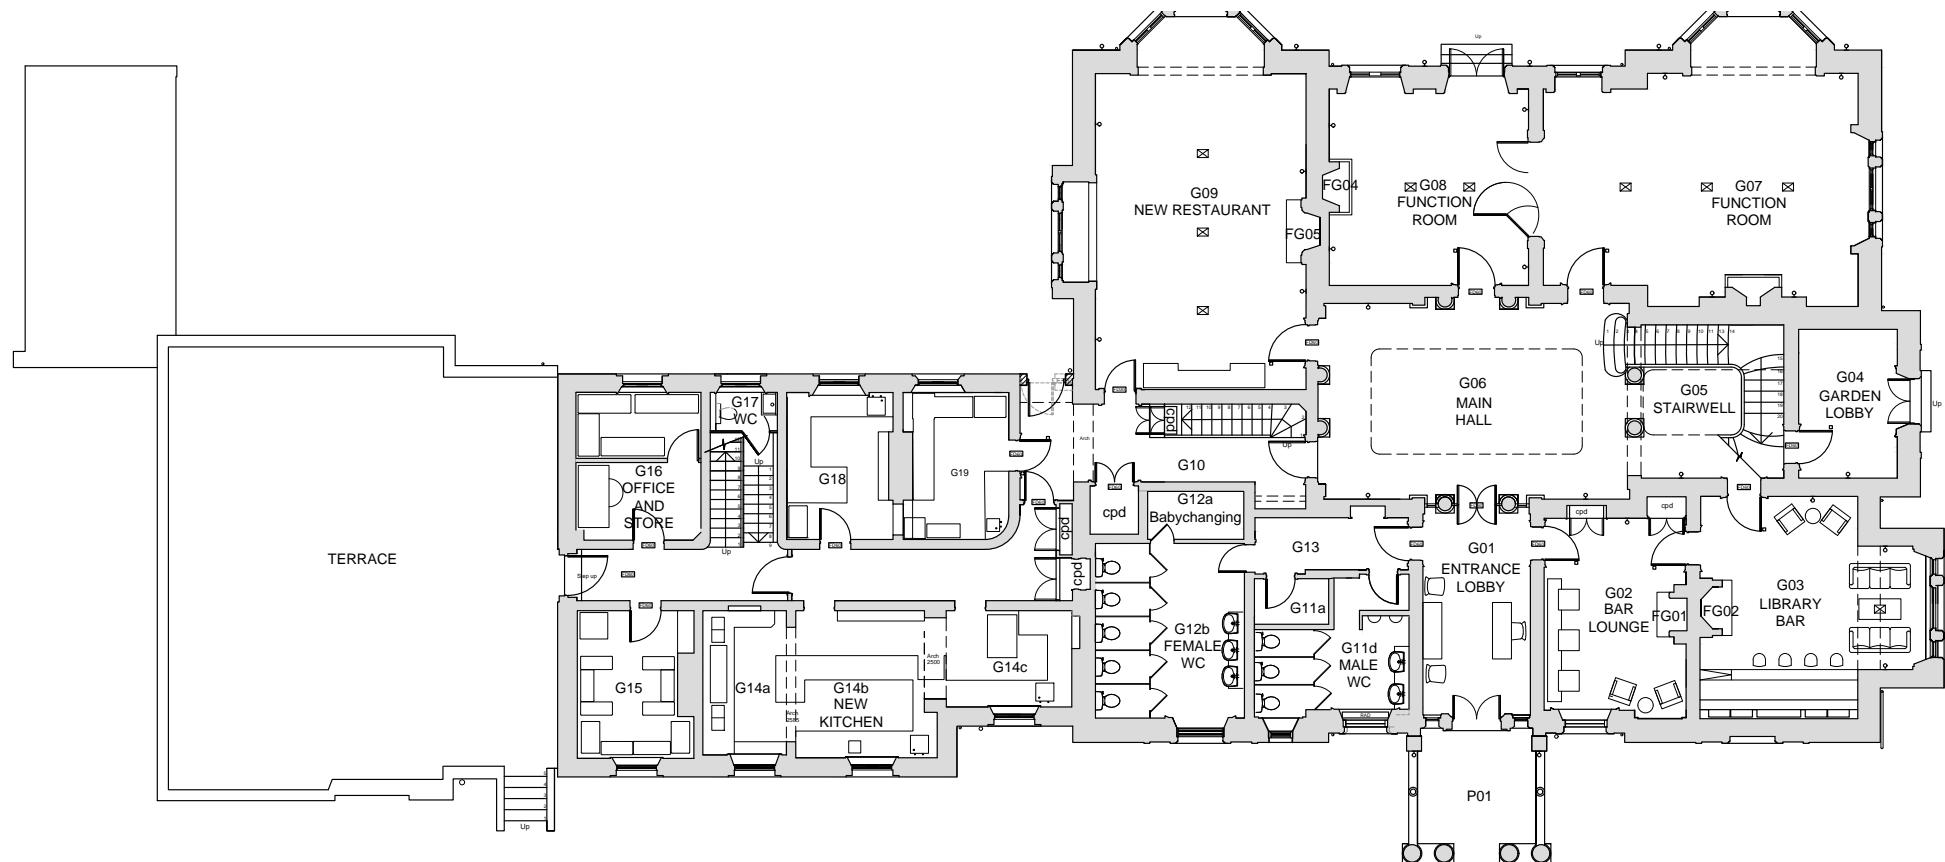
Ground Floor: refer to 1920s plan **[Plate 6.8]** and Plan as Existing **[Plate 6.9]**. P01, porch, is largely described above. Additionally, to note are the raised floor within the porch, which never-the-less leaves a step up to the front door.

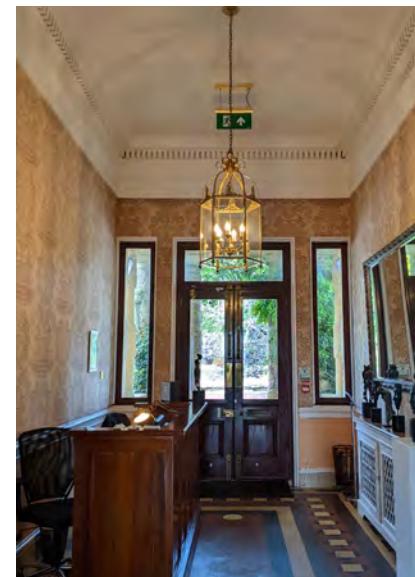
Plate 6.10 - The Entrance Lobby as viewed from the Main Hall.

- Floor:
The flooring is encaustic tiles, laid in a geometric pattern and matching those seen in the Main Hall. These are original to the house.
- Condition:
The entrance lobby is in a good condition with no notable defects, it appears to have been recently redecorated.

- Significance:
This room is of high significance, retaining its original plan form and joinery.
- Opportunity for change:
The fitting and fixtures within the space are high quality modern pieces. These although within keeping with the space hold no significance.

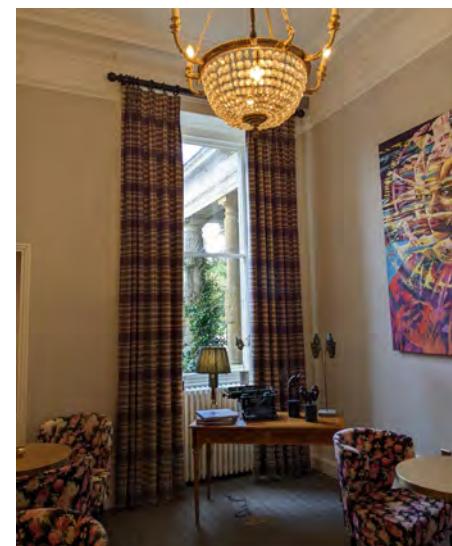
Plate 6.11 - The Bar Lounge viewed from the east

- Floor:
Modern blue carpet
- Condition:
The lounge area has recently been redecorated and is in a good condition.
- Significance:
This room is of high significance due to its retained plan form and original fireplace and joinery remain.

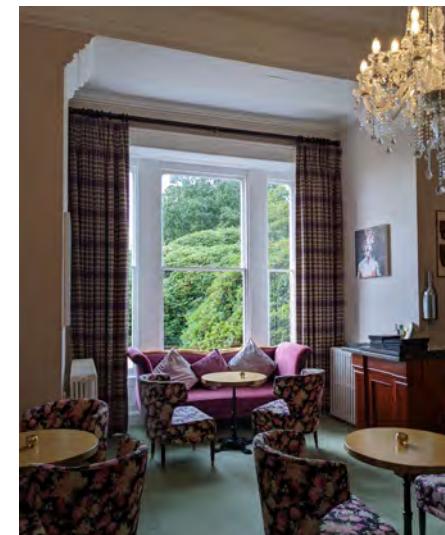
Plate 6.13 - The Library Bar viewed from the east

- Significance:
This room is highly significant with the original library shelves and chimney piece retained.
- Opportunity for change:
The door on the east wall was originally located further to the south providing access into G04. If room G04 was to be brought back into use, the reinstatement of the door in its original position could be considered.

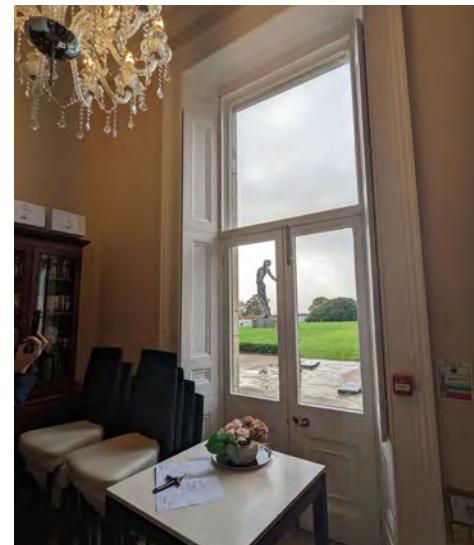
Plate 6.15 - The Garden Lobby and its views of the lawn.

- Condition:
The garden lobby is in a fair condition. The door to the terrace has cracked and peeling paint. The linoleum flooring does not run all the way to the door and below the door the floor boards are in need of refinishing. The skirtings and plinth blocks to the architraves are scuffed. The wall paper appears to be lifting at the edges at high level.
- Significance:
This room is significant, however there have been alterations to the door locations.
- Opportunity for change:
There is opportunity here for this room to take on a more front of house use. With the potential for an extension where the conservatory once stood to the south, and the opening up of the now blocked door from G03.

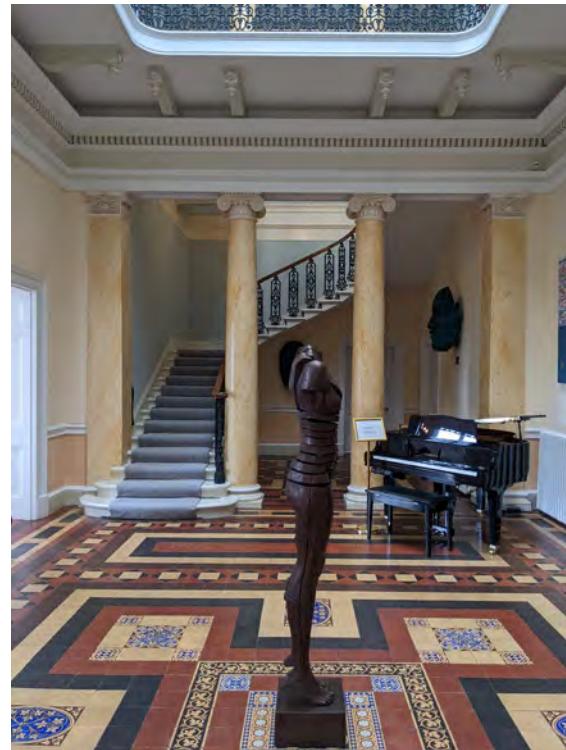
Plate 6.16 - The Main Hall from the North

- Opportunity for change:
There is limited opportunity to change this space as it functions well as the main hall and principal staircase giving access to the many rooms leading off it.

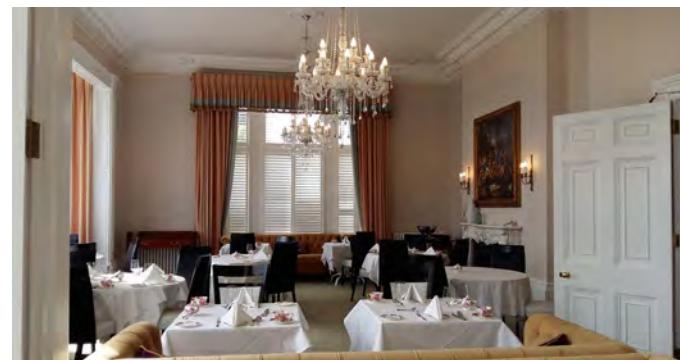
Plate 6.17 - The Function Room, viewed from the north

- Floor:
The floor is laid with a modern green carpet.
- Condition:
The function room is in a good condition having recently been redecorated.
- Significance:
This room is highly significant due to its original form and decorative joinery and plasterwork.

- Opportunity for change:
This room functions well as the exclusive restaurant. Access onto the terrace is currently obstructed with tables and consideration could be given to having these operable.

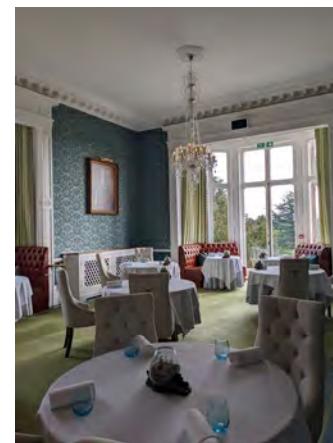
Plate 6.18 - The New Restaurant, viewed from the west

- Significance:
This room is highly significant due to its decorative joinery and plasterwork and largely original layout. The only major change has been to the door arrangement in the north west corner during the period when the billiard room was in existence.

- Opportunity for change:
If an extension to the house was considered where the billiard room once was, there is the potential opportunity for rearranging the doors to the north west end of the room to allow for this.

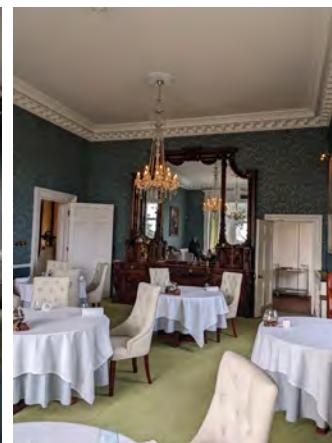
Plate 6.19 - The New Restaurant, viewed from the east

- Floor:
The floor is covered with a modern green carpet with a blue border.
- Condition:
The restaurant is in a good condition, having recently been redecorated.

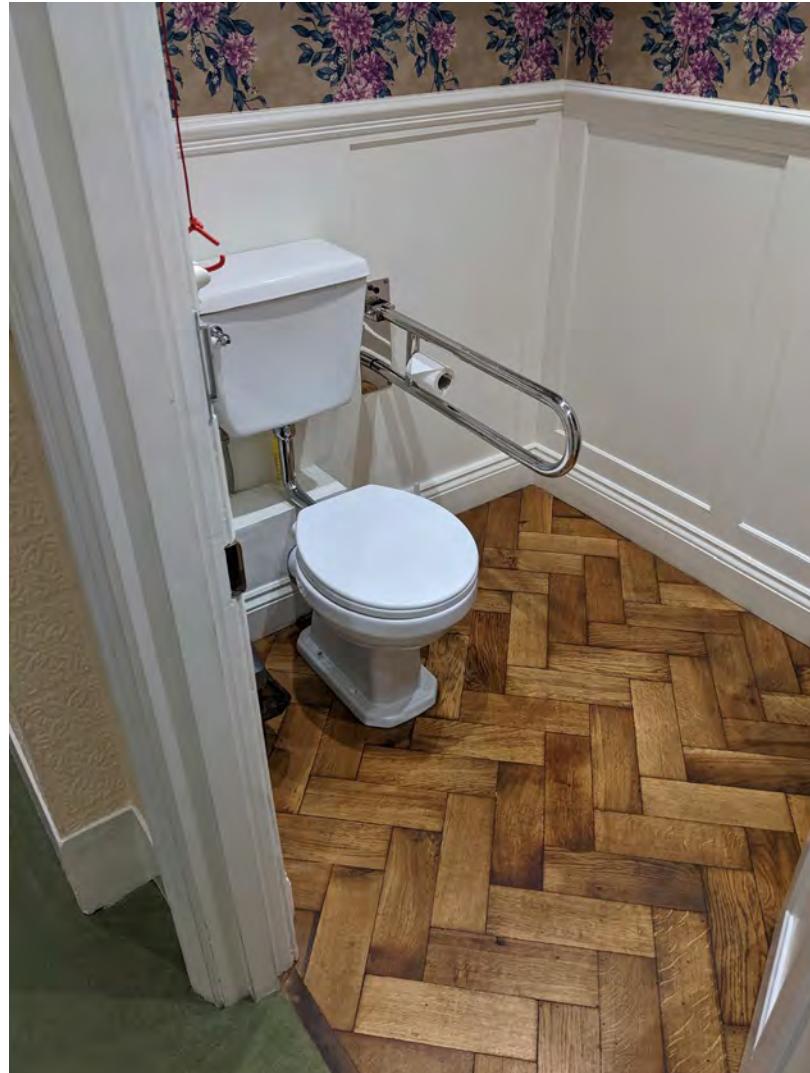
Plate 6.21 - The accessible WC.

- Use:
This is the Accessible WC, a small space with interior decoration matching that of the other WCs on this floors, but with a considerably lower ceiling and no windows.
- Ceiling:
This space has a low, white painted plaster ceiling with recessed spotlight bulbs.
- Walls:
There is a bright floral wallpaper, with the lower walls timber panelled beneath a dado rail.
- Doors:
The door is modern, matching others seen on this corridor. It is four-panelled white-painted timber, with simple brass furnishings.
- Fittings:
All modern fittings, including a WC with steel handrails, and a modern vanity unit.
- Floor:
Polished parquet flooring.
- Condition:
This room is in a good condition.
- Significance:
This room is completely modern fit out and of neutral significance.
- Opportunity for change:
This room is entirely modern.

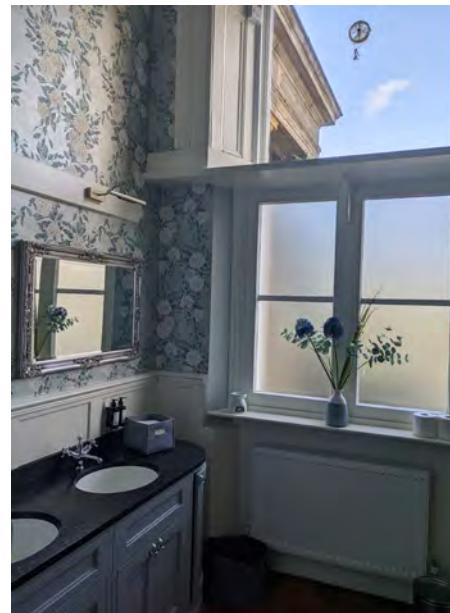
Plate 6.22 - The Gentlemen's WC

- Condition:
Apart from some minor scuffing to the door it is in a good condition generally.
- Significance:
This room is significant, however there are modern interventions of neutral significance including the partitions and sanitaryware. The changes to the window are detrimental.
- Opportunity for change:
This room has had many different uses and as such some of the historic features have been altered. Consideration should be made to put back the window to its original proportions. The modern fit out is of neutral significance and changes to this will have no detrimental impact.

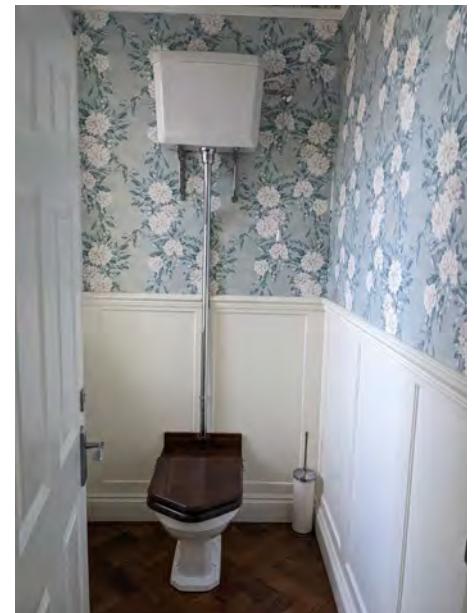
Plate 6.23 - The Gentlemen's WC cubicle.

- The half-height walls forming the cubicles are similarly papered and panelled, with a moulded timber cap atop the wall, painted white.
- Windows:
The window is curious, appearing to have once been a tall, recessed sash window, with the lower half now replaced by frosted mullion and transom window. The two halves are separated by a peculiar shelf.

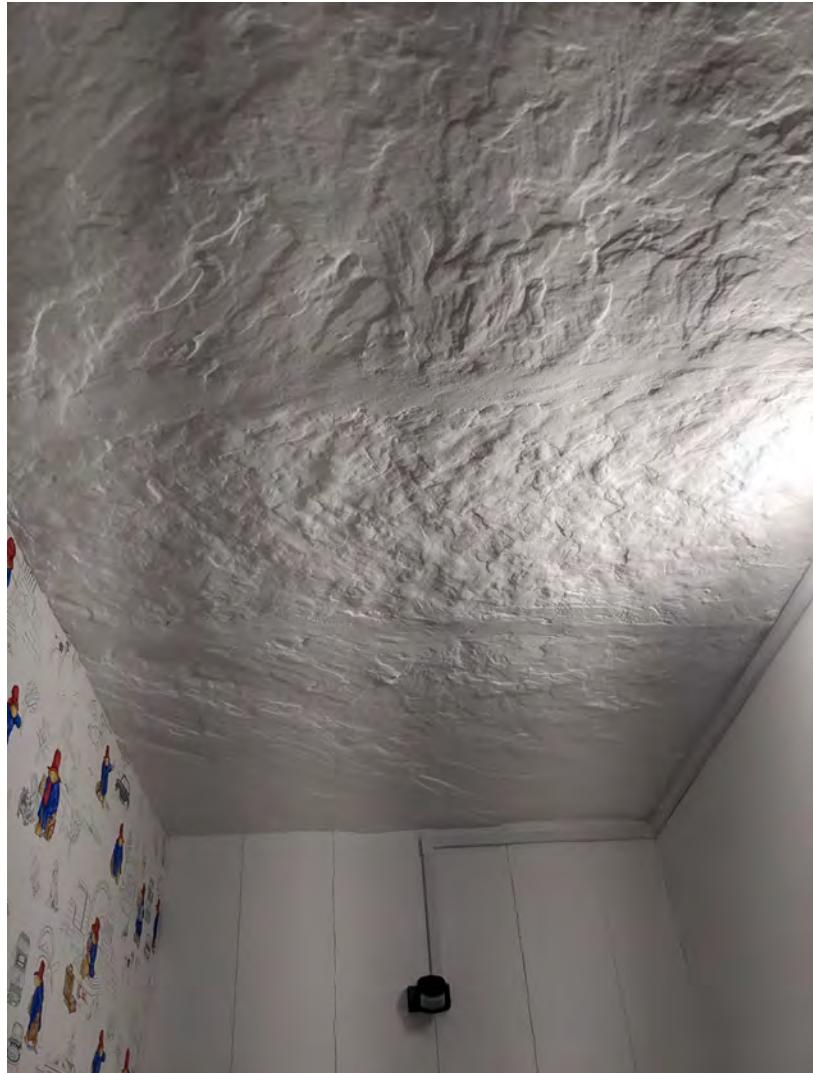
Plate 6.24 - The ceiling of the Baby Changing Area

- Floor:
The flooring is a continuation of the timber parquet seen in G12b
- Condition:
This room has been decorated at the same time as the adjacent WCs and is in a good condition generally.

- Significance:
This room is significant due to its original form. The curious stone ceiling is of high significance, possibly relating to previous use. The fit out is modern and of neutral significance.

- Opportunity for change:
Although this room retains its original layout. There may be an opportunity to relocate the door to allow access from the corridor into the space.

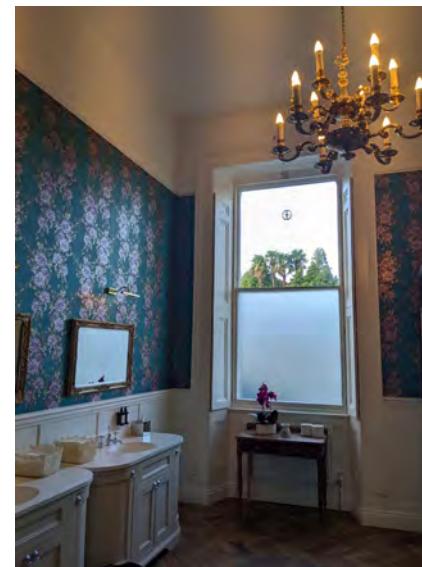
Plate 6.25 - The Lady's WC.

- Windows:
In the west wall is a large sliding sash window. The upper pane has an inset mechanical vent, and the lower is frosted for privacy.
- Doors:
 - As with the other rooms off this corridor, the door is modern four-panelled timber, painted white, with a brass knob.

- Floor:
Polished parquet flooring throughout the space.
- Condition:
The ladies is WC is in a good condition.
- Significance:
This room is significant as it retains its original plan form, except for the now blocked door to the north wall.

- Opportunity for change:
There is the opportunity for the previous door in the north wall to be reopened if this room was to be used for a different purpose.
The fit out within the room is all modern and can be altered with no impact on the significance.

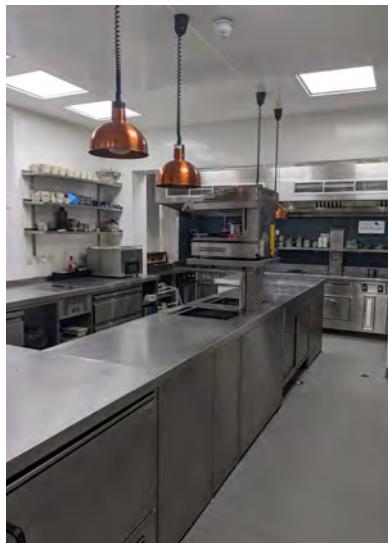
Plate 6.27 - The New Kitchen viewed from the south

- Fittings:
The fittings are all modern, predominantly stainless-steel workstations, with built in sink and hobs. On the north wall of G14a are industrial extractor fans.

- Floor:
The floors throughout are non-slip blue non-slip Altro vinyl.
- Condition:
The kitchens are in a good condition and very clean. However most of the historic fabric of the room is hidden behind the kitchen fit out and could not be commented on.

- Significance:
These spaces are of neutral significance. these once comprised a series of individual rooms they have been merged to create a large open plan kitchen. The only remaining significant features are the windows and their shutters.
- Opportunity for change:
These rooms have been much rearranged and as such opportunities for alterations to them are possible.

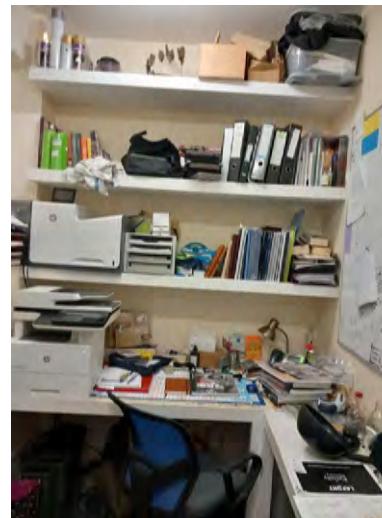
Plate 6.28 - The office space to the west.

- Floor:
Both spaces have blue non-slip linoleum flooring.
- Condition:
These interconnecting rooms appear to be in a good condition, there is a small hairline crack above the doorway into the office. The walls have been lined with storage racking and could not be closely inspected.

- Significance:
This room is significant as part of the remaining wing, however, the only remaining significant fabric is the window and its joinery. The modern fit out and partition wall are of neutral significance.

- Opportunity for change:
The modern fit out and partition in this room present options for its change of use.

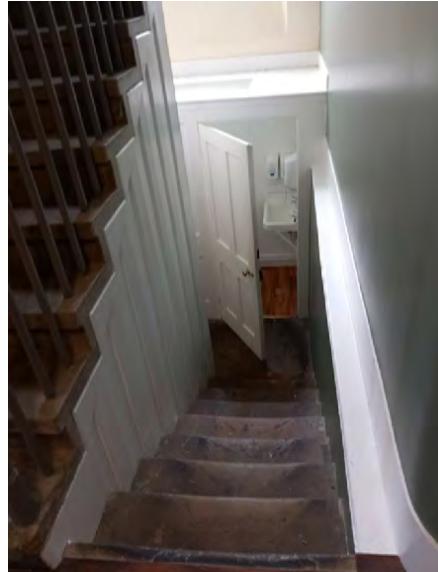
Plate 6.30 - The Service Staircase looking west

- Stairs:
The stairs are well worn stone, with no handrail. There is white painted timber panelling to the inner wall.
- Windows:
On the west wall is a sash window, partially obscured by the landing above.

- Condition:
The staircase appears to be in a good condition. The window behind the WC is showing signs of water penetration to the bottom rail. There is some chipped paint to the panelling on the staircase. The rooflight above the half landing WC would benefit from a good clean.

- Significance:
The staircase is significant due to its original form, including the half landing WC. The sanitaryware fittings are of neutral significance.

- Opportunity for change:
This staircase is intact and any changes should be carefully considered.

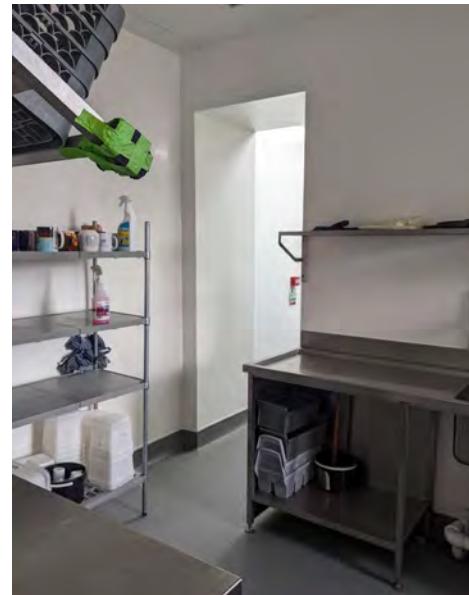
Plate 6.32 - G19 Kitchen

- Doors:
The doors to these spaces have been removed, leaving a timber frame with a wired glass fanlight above.
- Fittings:
The fittings are all modern, generally freestanding, stainless steel kitchen equipment.

- Floor:
Non-slip blue non-slip Altro vinyl flooring throughout.
- Condition:
The kitchens are in good condition. the rooms are lined with modern kitchen fit out so the fabric behind could not be reviewed. The window in G19 has signs of rot externally.

- Significance:
This space is of neutral significance, apart from the retained windows are of significance.
- Opportunity for change:
The spaces have been combined and fitted out with modern kitchen fit out. There are therefore opportunities to reinstate the original layouts to best suit any further use.

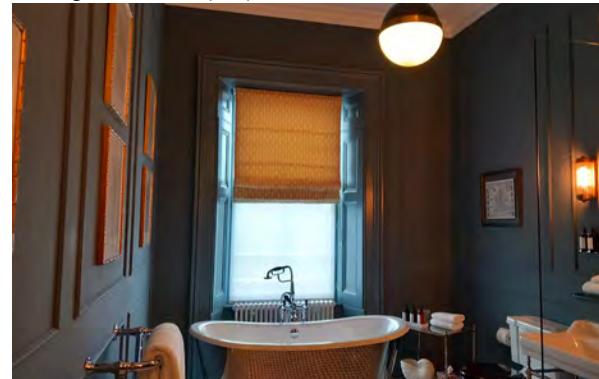
Plate 6.34 - The Pinotage Bathroom, viewed from lobby.

- Condition:
The room is in a good condition generally.

- Significance:
This room has some significance due to its position within the house, however, except for the window the room has entirely modern fit out which is of neutral significance.
- Opportunity for change:
The modern partitions, paneling and fit out are of high quality but neutral significance. This would allow for changes to this room if an alternative arrangement was proposed.

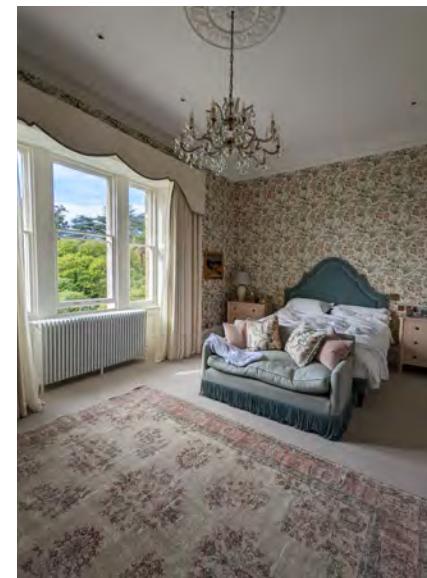
Plate 6.36 - The Sir Edmund Loder Bedroom.

- All other furniture is modern, and there is a white-painted column radiator in front of the window.
- Floor:
The flooring is plain beige carpet.
- Condition:
The bedroom appears in good condition following the recent refurbishment.

- Significance:
This room has high significant as it retains its historic layout of the rooms. The 1890s cupboard is of high significance. The modern fit out is of neutral significance.

- Opportunity for change:
The reinstatement of the fire place and appropriate chimneypiece would enhance this room.

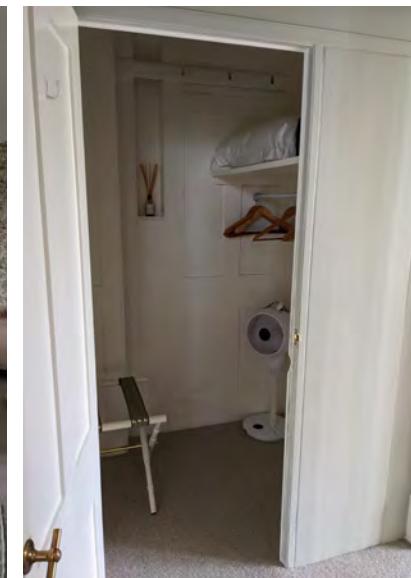
Plate 6.37 - The Sir Edmund Loder Bedroom Cupboard

- Fittings:
 - The space is dominated by a large and complex cupboard installation at its southern end [plate 37]. This appears to be an 1890s alteration. The construction is of high quality, with a six-over-six glazed panel above. Its insertion may have caused the re-positioning of the door into the bedroom F03.

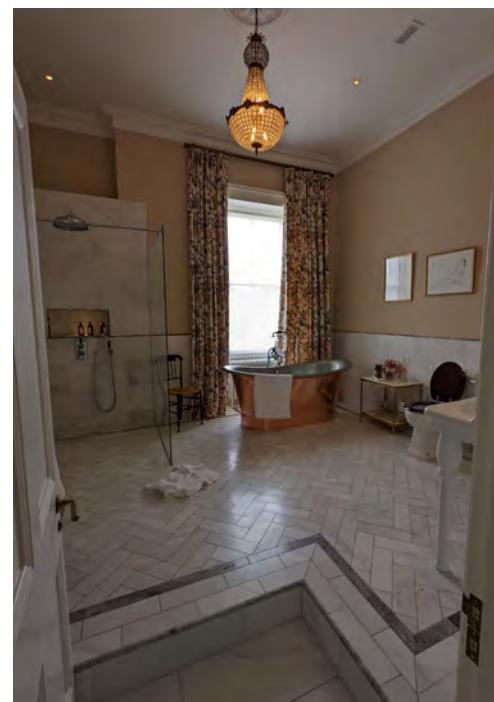
Plate 6.38 - The Sir Edmund Loder Bathroom

- Condition:
The bathroom appears in good condition generally following the recent refurbishment.
- Significance:
This room is highly significant due as the historic layout remains. The modern fit out is of neutral significance.
- Opportunity for change:
The reinstatement of the fireplace with an appropriate chimneypiece should be considered.

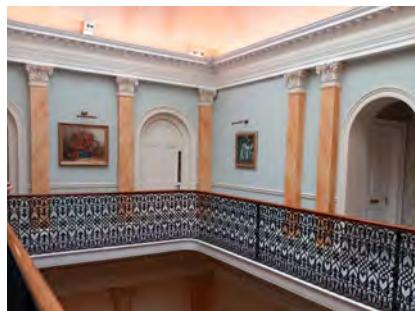
Plate 6.39 -The upper Main Hall, viewed from the southwest corner

- Floor:
The floor is carpeted.
- Condition:
The main hall and staircase appear to be in good condition, however, the scagliola to the columns and pilasters is slightly chipped in places.

- Significance:
This space is highly significant due to the many historic features and layout.
- Opportunity for change:
There are limited opportunities within this space for changes.

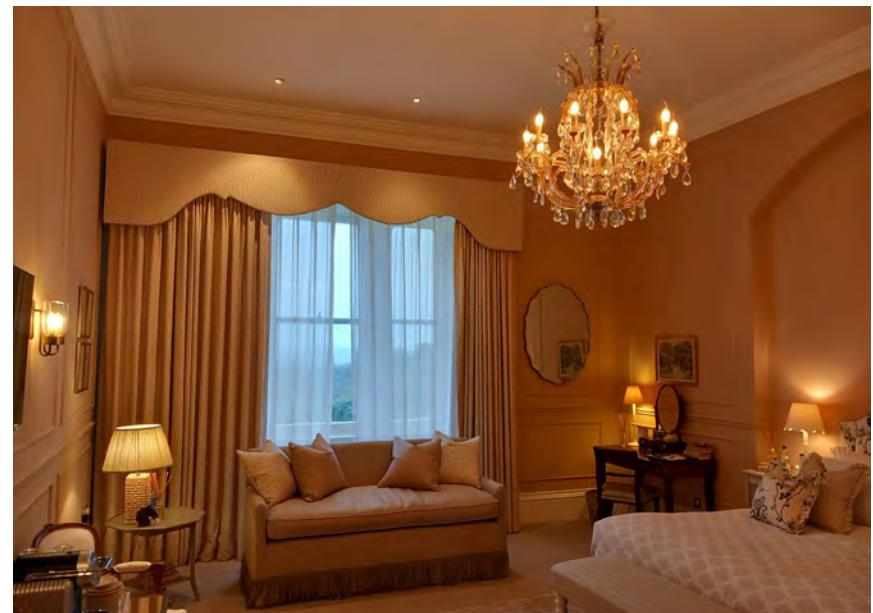
Plate 6.43 - The Rhododendron Bedroom, viewed from the entrance door

- Condition:
The bedroom appears in a good condition.
- Significance:
This room is of significance, although it has been much altered over time with a variety of partition layouts and door positions. The fireplace which was located on the west wall has been blocked up.
- Opportunity for change:
There are opportunities within this room and the adjoining F08d to remove the modern partition wall and rearrange these rooms, with the possibility to reinstate the fireplace. The internal fit out of the room is modern and of neutral historic interest.

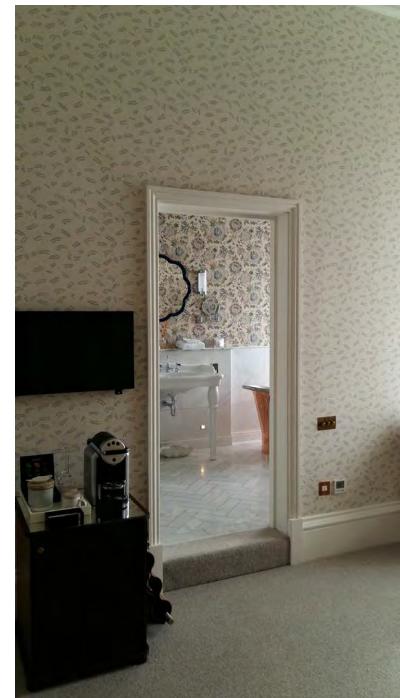
Plate 6.44 - The doorway through the partition into the Eucalyptus Bathroom

- Condition:
There is some minor cracking to the paint finish to the door into the bedroom, and it is generally in a good condition.
- Significance:
This room is of significance, however, has been much altered over time from the original proportions. The fireplace has been blocked up as have original door positions.
- Opportunity for change:
The existing subdivision of this room would allow for potential changes.

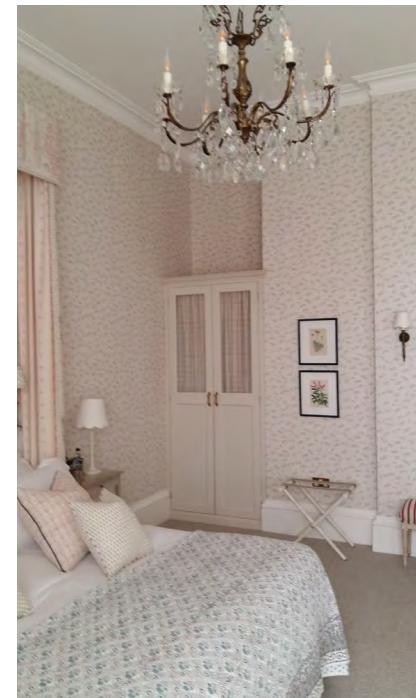
Plate 6.45 - The Eucalyptus Bedroom

- Floor:
The floor is covered with a simple beige carpet.

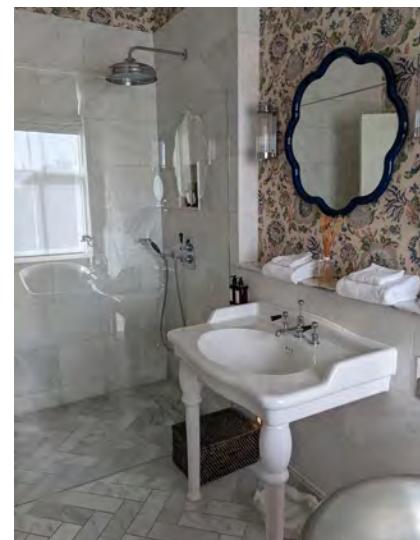
Plate 6.46 Eucalyptus bathroom

- **Doors:**
It has a modern four-panel timber door, painted white, with a brass handle.
- **Fittings:**
All fittings are modern, including a roll-top bath, walk in shower, and WC, and white column radiator.

- **Floor:**
The floor is tiled with white marble in a herringbone pattern.
- **Condition:**
The bathroom is generally in a good condition. The shutters to the bathroom window do not fit tightly into their boxes and there are some small holes to the top of the architrave where a fitting has been removed.
- **Significance:**
This bathroom is of neutral significance, it has been subdivided from the adjacent room with modern partitions and has a completely modern fit out.
- **Opportunity for change:**
As a modern room there are opportunities for change within this space. The modern partitions could be removed to open it back up to the historic layout.

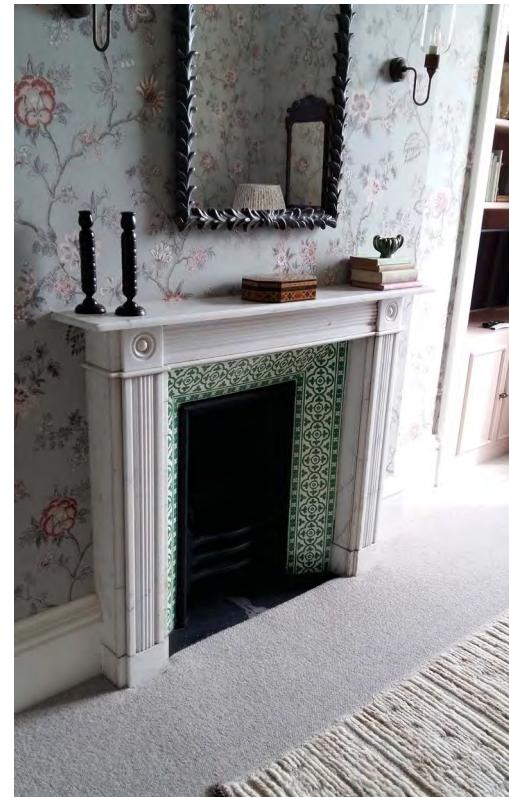
Plate 6.47 - The Magnolia Lounge fireplace

- Floor:
Beige carpet throughout these spaces.
- Condition:
The lounge is generally in a good condition, there is some minor cracking to the door into the room.

- Significance:
This room is significant, however, has been subdivided from the room to the south with modern partitions. The fireplace remains on the north wall.

- Opportunity for change:
There is the opportunity to return this room and the adjacent room to the south to their historic layout.

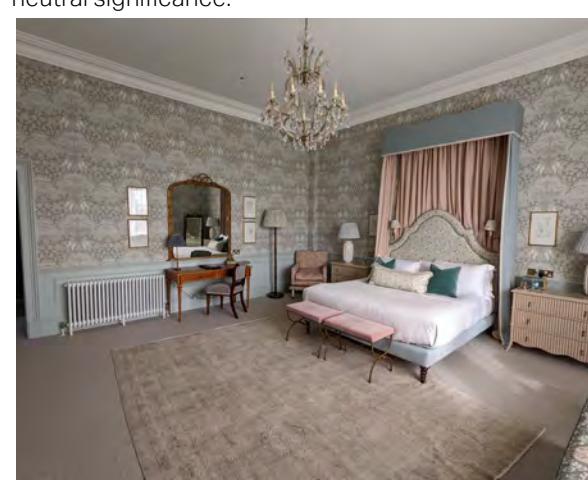
Plate 6.48 - The Magnolia Bedroom

- Condition:
The bedroom is generally in a good condition.
- Significance:
This room is high significance retaining its original proportions. The fit out is modern and of neutral significance.

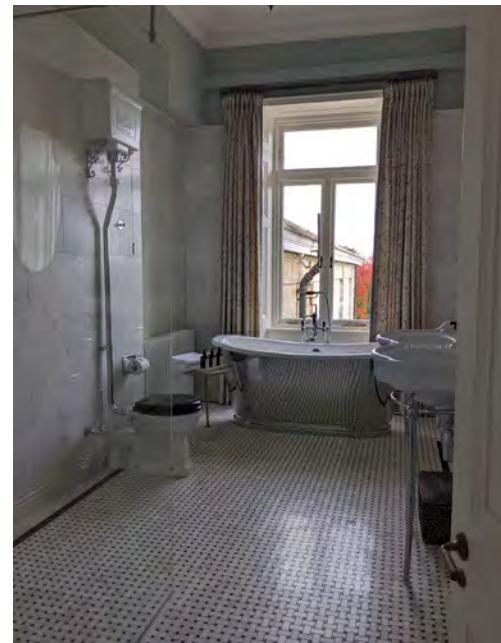
Plate 6.49 - The Magnolia Bathroom

- Condition:
The bathroom is in a good condition.
- Significance:
This room is significant and underwent changes when the wing to the north was built. The partition to the south of the room which separates it from the lobby is modern and of neutral significance. The modern bathroom fit out is of neutral significance.

- Opportunity for change:
The modern sanitaryware and partition wall to the south are of neutral significance.

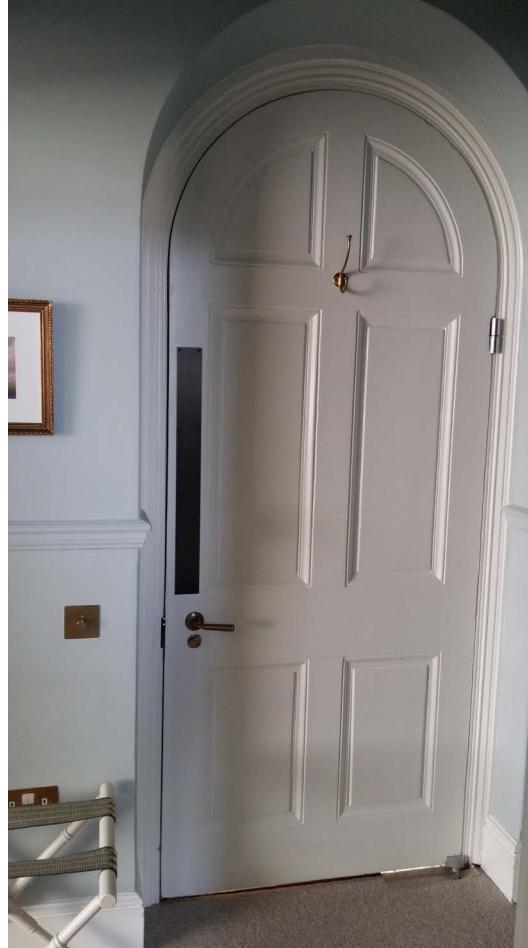
Plate 6.50 – The arched door to the Main Hall in the Magnolia Suite corridor

- Use:
The corridor connecting the Magnolia Bedroom to its Bathroom. It is decorated similarly to the bedroom.
- Walls:
The walls are painted duck egg blue in their entirety, with a modern applied moulded timber dado rail, also painted. The timber skirting is painted white.
- Doors:
There is a modern arched six-panel timber door into the main hall, with an elongated brass fingerplate and handle. This door is kept locked.
- Floor:
Beige carpet throughout.
- Condition:
This area is in a good condition.
- Significance:
This corridor is of neutral significance as it once formed part of the adjacent bathroom.
- Opportunity for change:
The door to the main hall is kept locked so there is the opportunity to remove the modern partition to the adjacent bathroom to form one room.

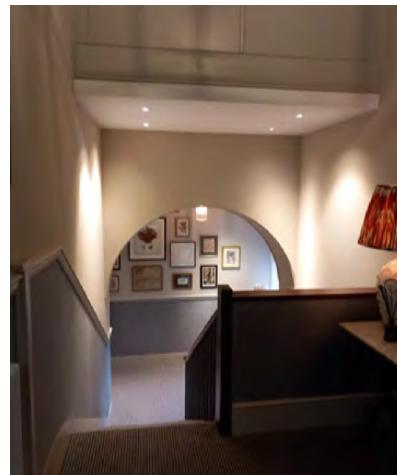
Plate 6.51 - The lobby from the Main Hall

- Use:
The upper part of the back stairs G10.
- Ceiling:
The ceiling is plastered and painted white, with a square loft access hatch. The space is lit with a modern glass pendant light.
- Walls:
The walls are painted green-grey, and beneath a dado rail are painted a darker green. At high level there is a small corbel for the flue from the fireplace in F10a, (now blocked) and a (blocked) access hatch to the central lightwell. There is also a large high level cupboard enclosing the water tanks.
- Fittings:
The space has a modern white column radiator, and a solid and wallpapered rail over the G10 stairs.
- Floor:
Beige carpet.
- Condition:
The lobby is generally in a good condition, having recently been refurbished.
- Significance:
The stairs are significant as a good example of their type. A number of historic features remain at high level in this space.

- Opportunity for change:
The opportunities for change in this space are limited due to its function.

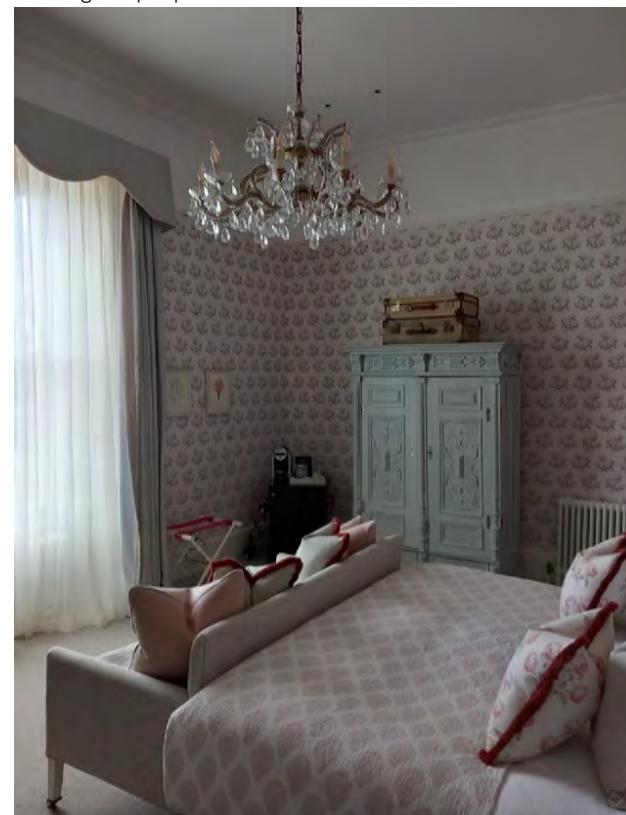
Plate 6.55 - Plate The Rose Bedroom

- Floor:
Beige carpet.
- Condition:
The wallpaper is peeling at the joints.
- Significance:
This room is significant due to its location within the house, however has been altered to provide an en suite and lobby.

- Opportunity for change:
The room could be reconfigured if the use was to change to return it back to the original proportions.

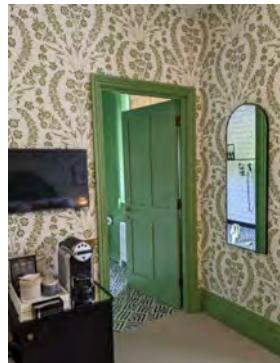
Plate 6.56 - The Maple Bedroom, as seen from the bathroom.

The bedroom is generally in a good condition. There is minor scuffing the skirtings.

If these rooms could be reconfigured to reinstate their original layouts.

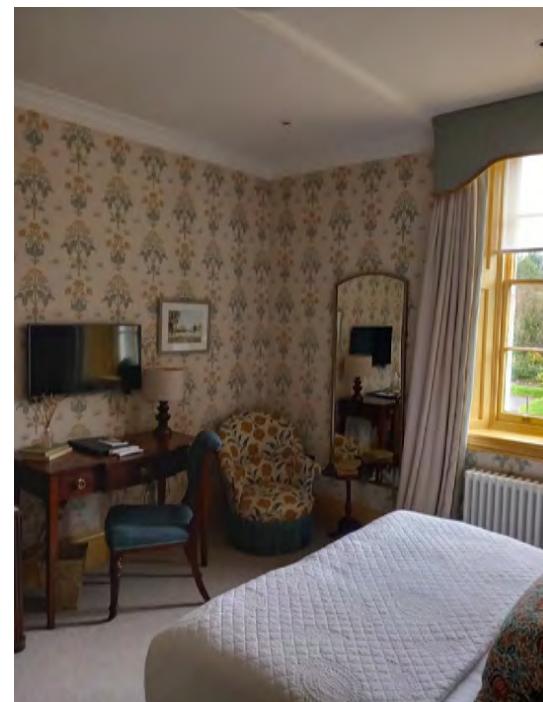
Plate 6.59 - The Meadowsweet Bedroom

- Floor:
Beige carpet throughout.
- Condition:
The bedroom is generally in a good condition. There is a small hairline crack to the cornice in the bedroom.

- Significance:
This room is significant for its location within the north wing.
- Opportunity for change:
This room could be rearranged to take it back to its original proportions as can be seen by the step in the ceiling. The fit out is modern.

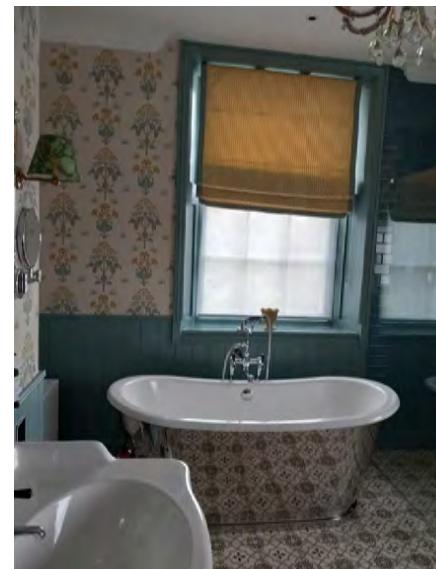
Plate 6.60 - The Meadowsweet Bathroom

- Doors:
The door is modern, timber, and four-panel, painted teal and yellow on either side to match the respective surroundings.
- Fittings:
The bathroom is fitted with a rolltop bath, walk-in shower, and modern ceramic sink and WC. On the north and south walls are white column radiators. The fireplace previously on the south wall has been blocked.

- Floor:
Geometric patterned tile flooring.
- Condition:
The bathroom appear to be in a good condition.
- Significance:
This room is significant for its location within the north wing, it retains its original proportions. The north wall was rebuilt following the removal of the rest of the wing. The fireplace has been blocked and removed.
- Opportunity for change:
The bathroom has completely modern fittings. The fireplace could be unblocked and a new chimney piece inserted in the south wall.
