Leonardslee House and Gardens

Conservation Management Plan 2023

Revision 2 - 13th March 2023

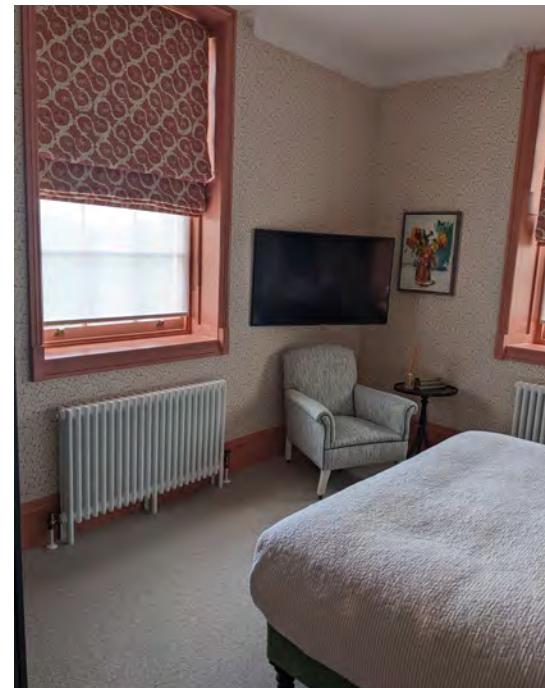
Plate 6.61 – The Camellia Bedroom

- Use:
The Camellia Bedroom. One of the smallest bedrooms in the house, and heavily renovated leaving no historic features of note.
- Ceiling:
White painted plaster, with a modern ogee cornice broken by the windows on the north and east walls. Simple modern glass pendant light, smoke detector, and two additional flush ceiling spotlights.

- Floor:
There is a simple beige carpet throughout.
- Condition:
The bedroom appears to be in a good condition.
- Significance:
This room is significant for its location within the north wing, it retains its original proportions. The north wall was rebuilt following the removal of the rest of the wing.

- Opportunity for change:
The room has modern fittings.

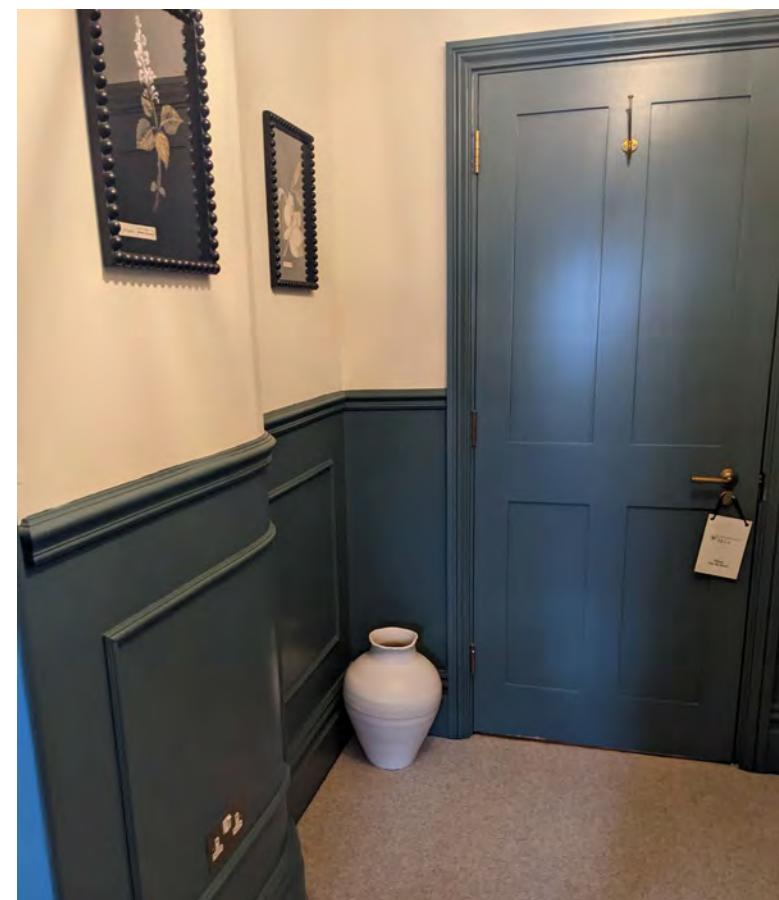
Plate 6.62 - The Camellia Bedroom Lobby, looking towards the front door

- Doors:
The main door to the suite is modern. It is timber, and four panelled, painted navy to match the surrounding joinery, and with a simple brass-coloured handle and coat hook.

- Floor:
Simple beige carpet flooring.
- Condition:
This area appears to be in a good condition.
- Significance:
This lobby is a portion of the corridor with originally led into the rest of the wing. A modern partition has divided the space to the north and south but the corridor walls to the east and west remain. Modern joinery has been fitted within the space.

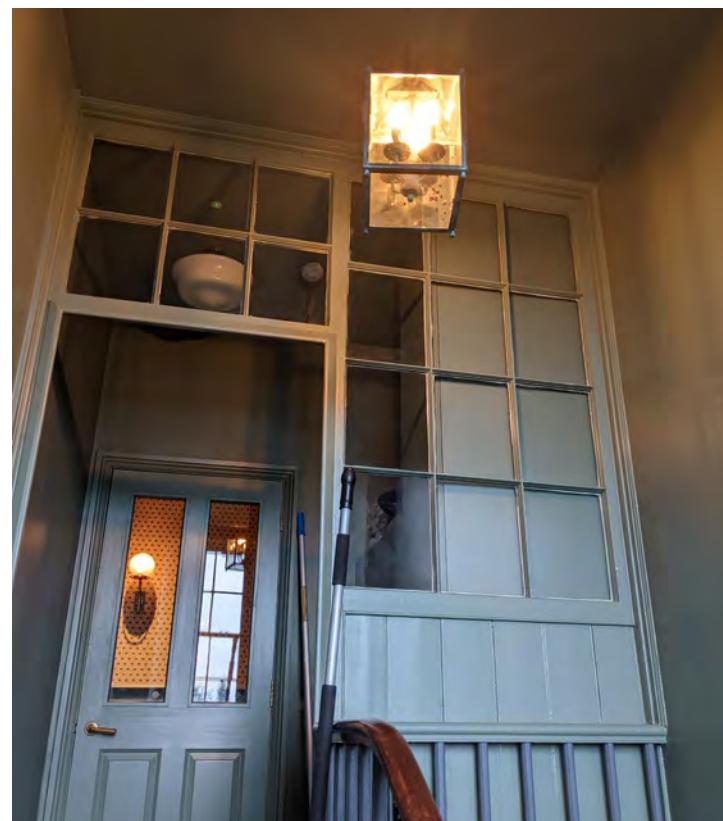
Plate 6.64 - F18 Staircase.

- Walls:
Green painted plaster walls to all sides of the staircase.
- Stairs:
The stairs are well worn stone, with a timber handrail to one side.
- Windows:
On the west wall is a sash window.

- Condition:
The staircase appears to be in a good condition following the recent refurbishment works.

The modern door and partition wall at the top of the stairs could be removed and altered, however it is creating the fire complementation for the staircase.

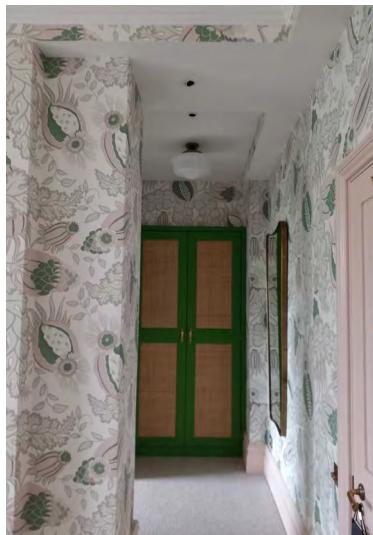
Plate 6.65 - The Azalea Bedroom, looking toward the bathroom

The bedroom appear to be in a good condition.

The fireplace to the south wall could be opened up and a new chimney piece fitted.

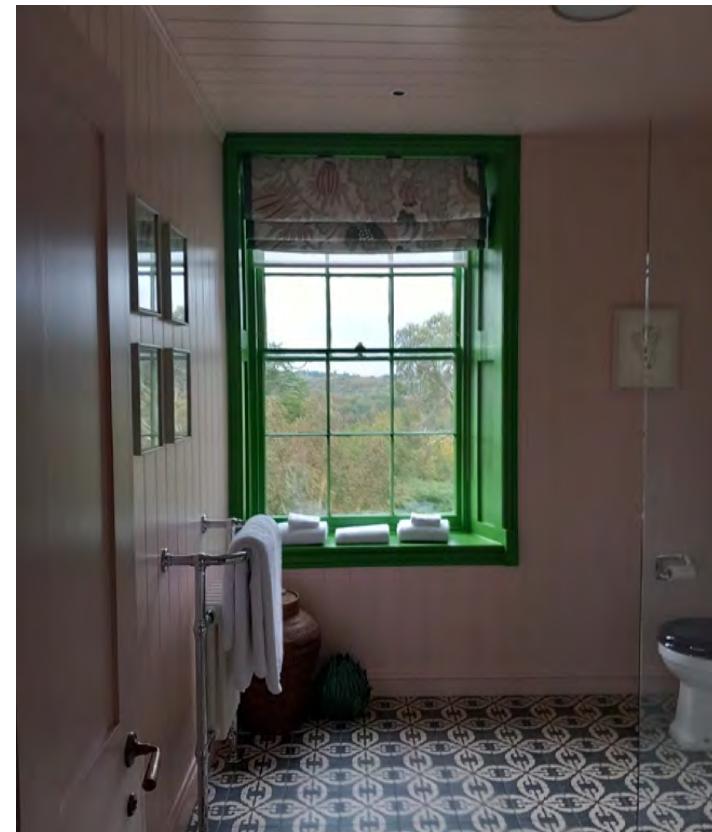
Plate 6.67 - The Azalea Bathroom

- Fittings:
The space has a walk in shower, WC, and column radiator.
- Floor:
Black and white geometric floor tiles.
- Condition:
The window in the bathroom is cracked. Externally the paintwork is cracked and internally there are signs of water ingress and some flaking paint as a result.
