## 6.2.2 Basement Floor

## 6.3 External Buildings

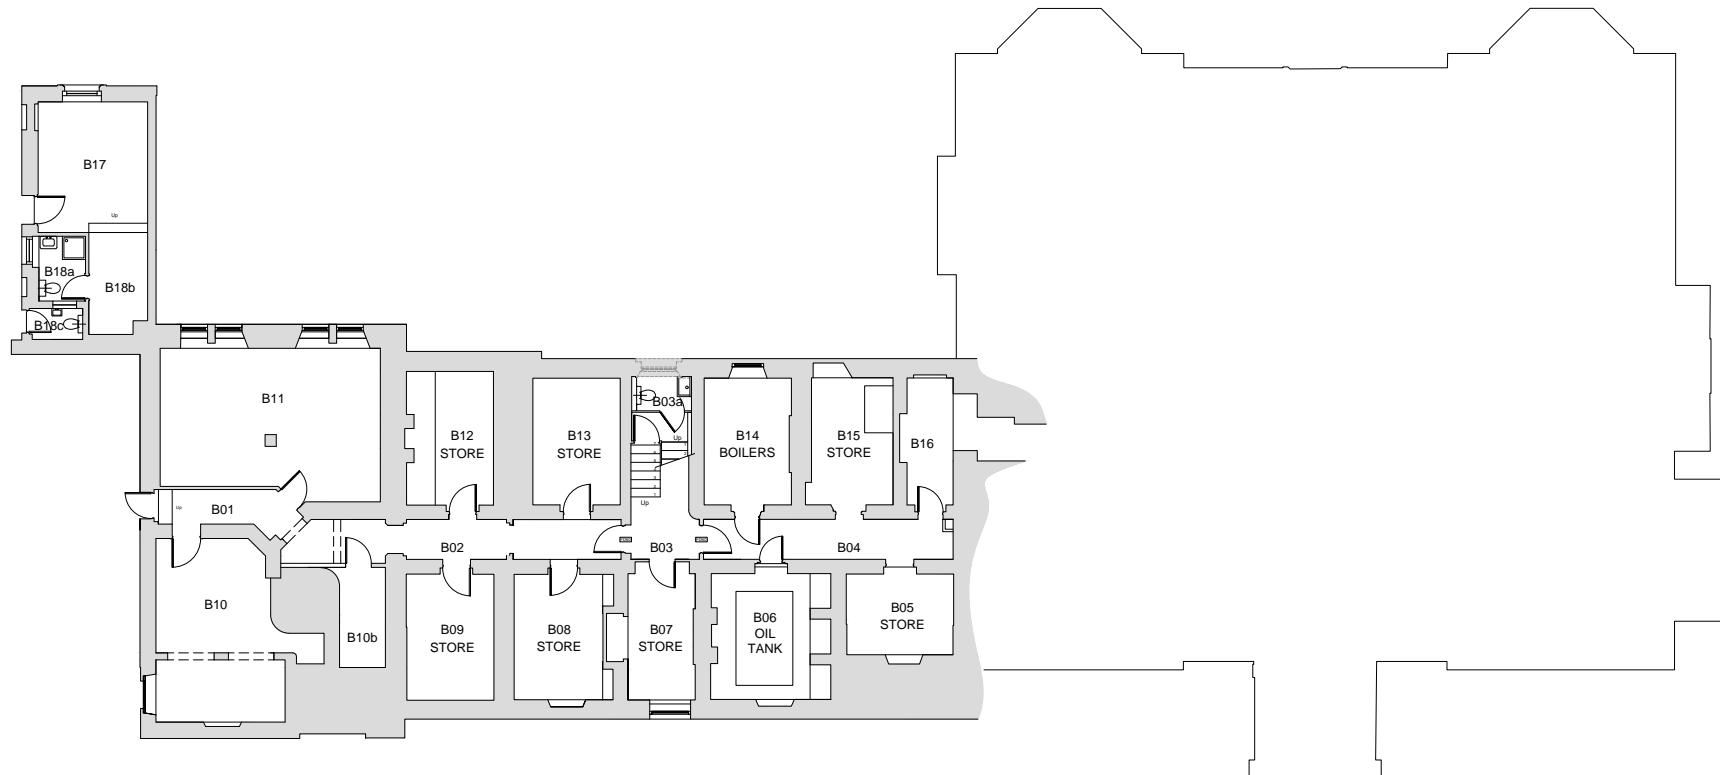
**Basement Plan**

The basement floor incorporates some remains from the early 19<sup>th</sup> century house. These are mostly visible in the remaining sandstone ashlar walls to the western side, and in some of the internal walls. There may be other surviving fragments below floor level, but these are not visible. The major parts of the visible walls are constructed in a large format extruded terracotta brick. The ceilings are generally plaster under the retained parts of the ground floor of the service wing, and an exposed beam and block slab structure under the Terrace. This is known to have been added in 1980s, to replace the temporary timber deck first built over the retained basement beyond the extent of the retained ground and first floor parts of the service wing. The floors are a mixture of stone lags and modern screeded concrete, with cast iron gullies. Modern cable trunking and pipes are fitted to walls and ceilings in a functional manner. Basement Rooms/areas B03-08, B13-16 lie under the retained upper floors; the other rooms B01-02, B09-12 and B17-18 are under the Terrace.

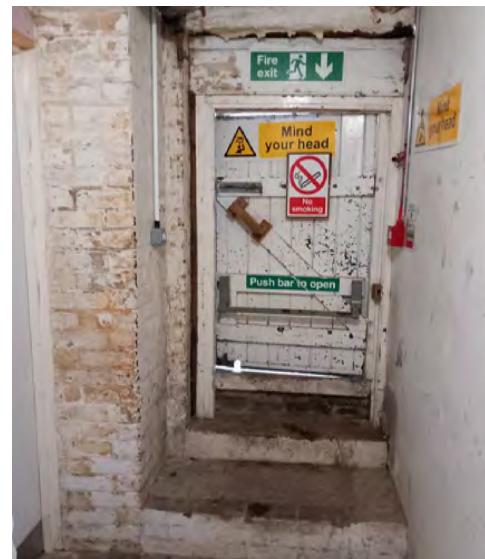
Plate 6.68 - The north door to the basement.

- Use:  
This is the northernmost part of the basement central corridor. It is attached to a further space named F01, which was not accessed at the time of the survey.
- Ceiling:  
This space has a low ceiling, with an exposed beam and block slab structure. Numerous services are affixed overhead.
- Walls:  
The walls are brick, plastered in areas but otherwise covered in a thin, and mostly worn, coat of white paint.
- Doors:  
The north door is ledged and braced, and painted white, with a sliding bolt and various modern signage.

- Floor:  
The floor is concrete. At the north end, simple brick and concrete steps lead up to the door.
- Condition:  
The ledge and brace door to the outside is in a fair condition but it will need redecorating to stop it from deteriorating further, especially to the base. The painted walls are scuffed and chipped but this is largely cosmetic.
- Significance:  
The basement corridor is significant as it is largely as originally was. This section of corridor originally connected into the now demolished rest of the wing to the north.
- Opportunity for change:  
If a new extension was proposed to the north end of the house, the original link at basement level could be reinstated.

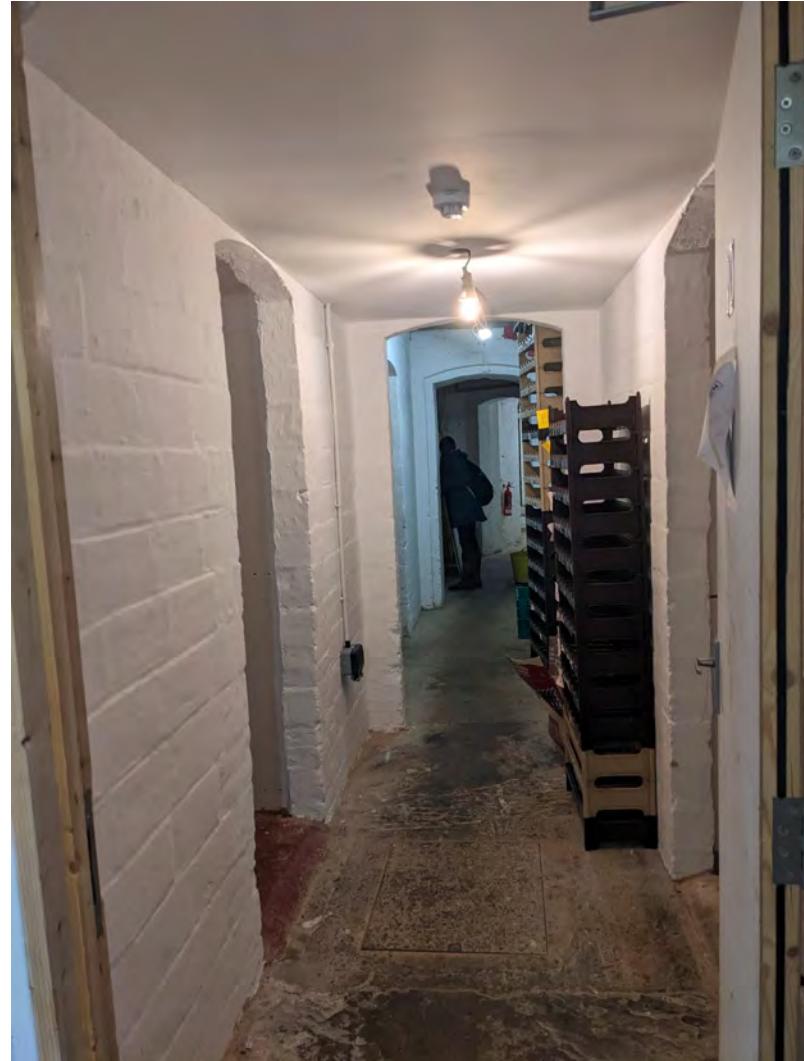
Plate 6.69 - The central corridor looking to the north

- Use:  
This is part of the central corridor of the basement.
- Ceiling:  
The ceiling is low, plastered, and painted white, seemingly recently. The space is lit by a number of bare bulbs hanging from the ceiling.
- Walls:  
The walls are white painted brick.
- Doors:  
The doors to the adjacent rooms are set behind low rounded arches within the brickwork. They are otherwise plain. At the south end of the corridor is a modern timber panel door with metal handles.
- Fittings:  
The corridor is used for general storage, with crates stacked against the walls.
- Floor:  
The floor is of stone flags.
- Condition:  
There is some minor scuffing and marks to the painted brick walls.
- Significance:  
The corridor is significant as it is largely as it originally was. The doors into the rooms are modern.
- Opportunity for change:  
Changes to the fittings within the corridor could be explored.

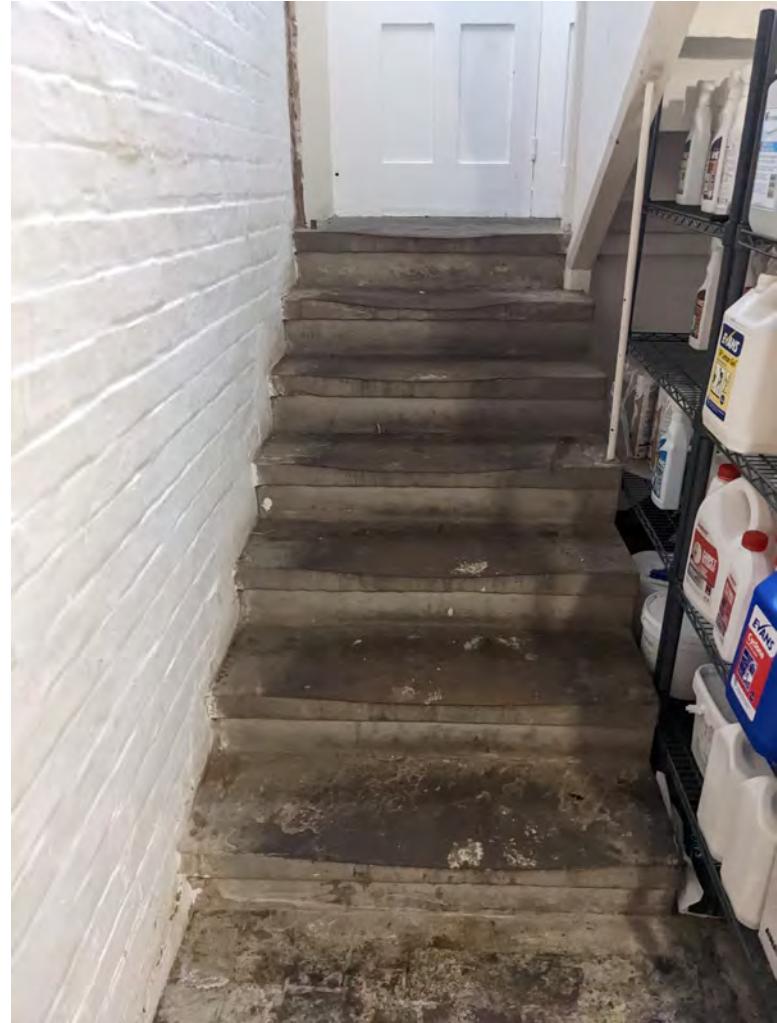
Plate 6.70 - The staircase leading from the basement

- Use:  
This is the bottom part of the stair G17 and F18 rising to the second floor.
- Walls:  
The walls are white painted brick.
- Fittings:  
A modern metal shelving unit sits below the upper stairs, used for general cleaning storage.
- Floor:  
The floor is stone flags, now very worn on the treads.
- Condition:  
The staircase is in a fair condition, there is some minor scuffing and marks to the painted brick walls.
- Significance:  
The staircase is significant as it is as it originally was, leading up to first floor.
- Opportunity for change:  
Changes to the fittings within the corridor could be explored.

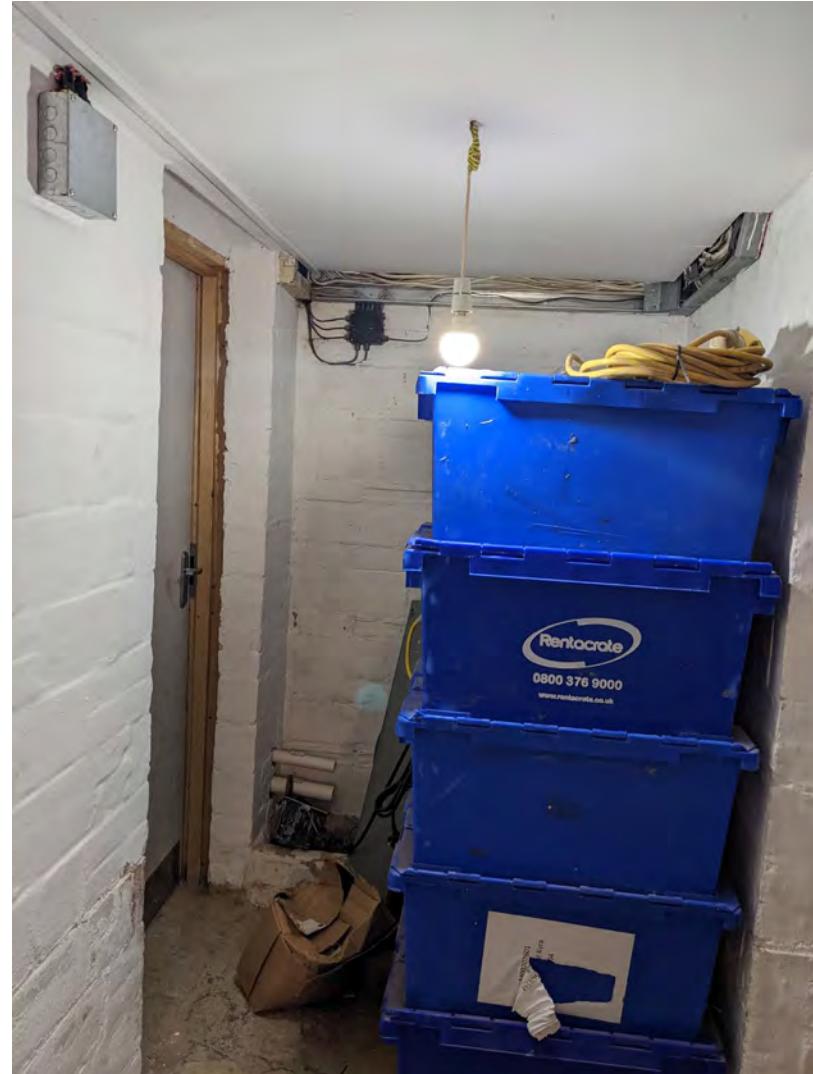
Plate 6.71 - The southern most end of the basement corridor

- Use:  
This is the southern most section of the corridor.
- Ceiling:  
The ceiling is white painted plaster with a variety of light fittings and cables fixed to it.
- Walls:  
The walls are white painted brick.
- Floor:  
The floor is of stone flags.
- Condition:  
This section of corridor appears generally to be in a good condition.
- Significance:  
The corridor is significant as it is as it originally was.
- Opportunity for change:  
Changes to the fittings within the corridor could be explored.

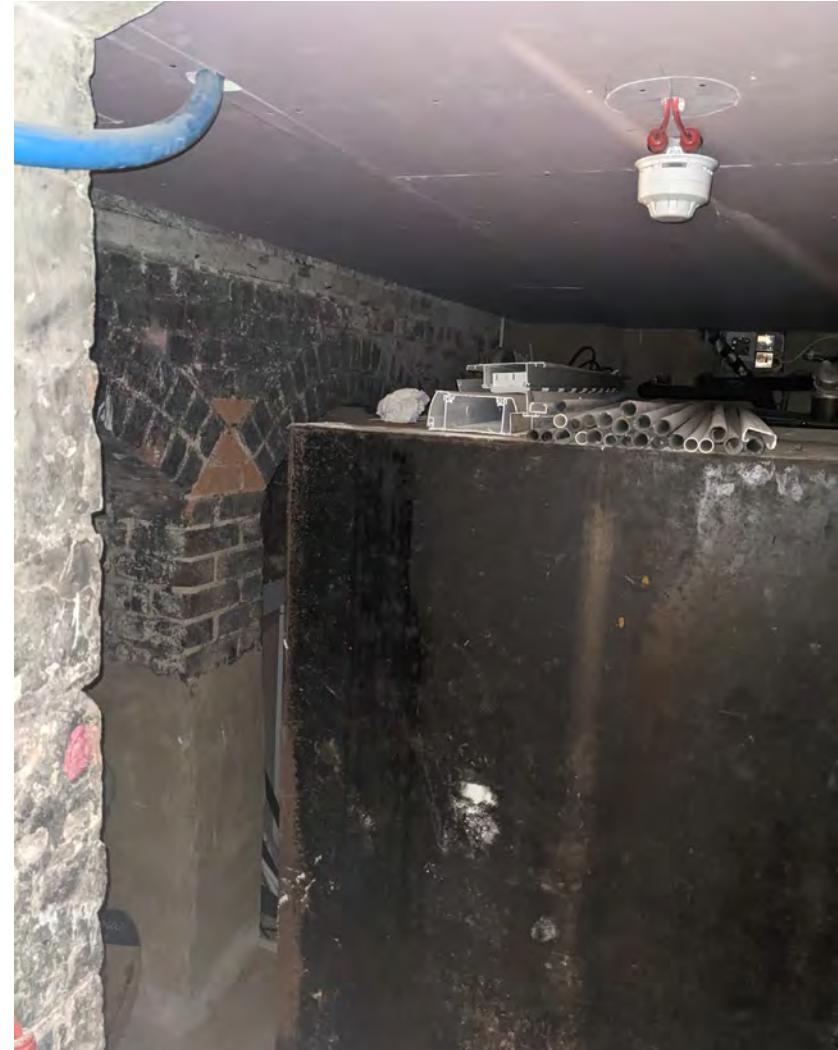
Plate 6.72 - Basement Oil Tank Room

To comply with modern legislation, the tank should be surrounded by a bund wall to contain any leaks from the tank. The stone flag floor is visible here.

- Use:  
The room is used to contain the oil tank.
- Ceiling:  
Bare plasterboard to the ceiling.
- Walls:  
Exposed brick walls with some rendered sections at low level.
- Doors:  
The door is a modern flush fire door with metal handle.
- Fittings:  
The tank takes up the entirety of this room.
- Floor:  
Stone flag floor.
- Condition:  
This room appears to be in a good condition.
- Significance:  
The room is significant as it is as it originally was with arched brickwork openings to the south wall.
- Opportunity for change:  
Changes to the fittings within the room could be explored. The large tank which takes up the majority of the room could be removed if not in use.

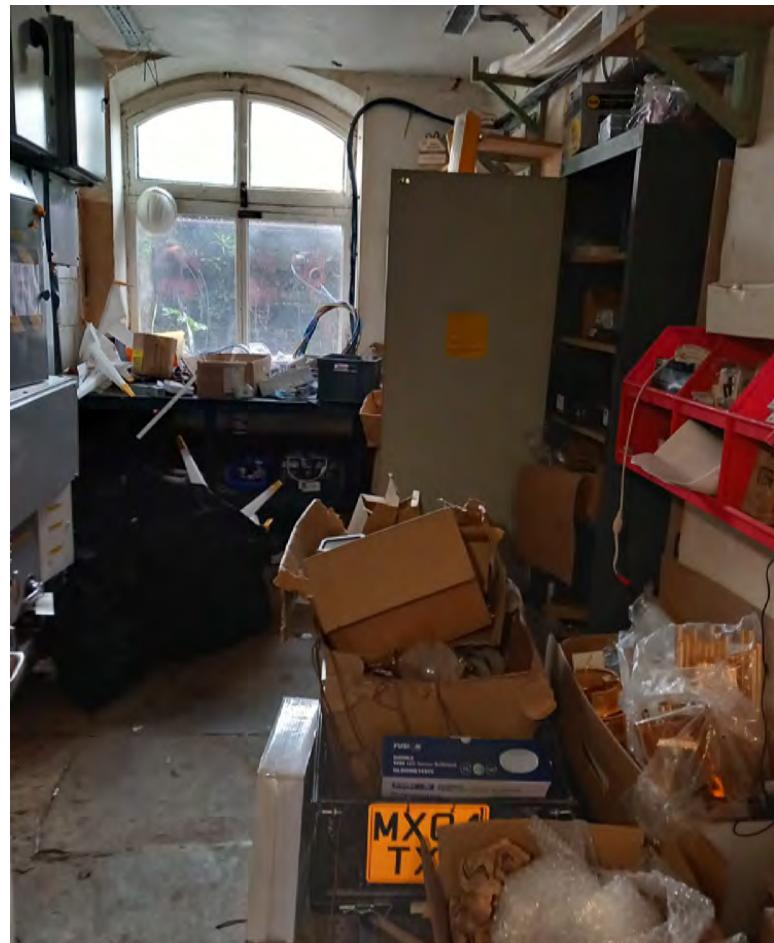
Plate 6.73 - B07 Basement Store

- Floor:  
Stone flag floor.
- Condition:  
There is some cracked paint to the window and some large cracks between the frame and the wall.
- Significance:  
The room is significant as it is as it originally was. Much of the walls are now lined with modern shelving.

- Opportunity for change:  
Changes to the fittings within the room could be explored. the door and partition to the west are modern and could be altered.

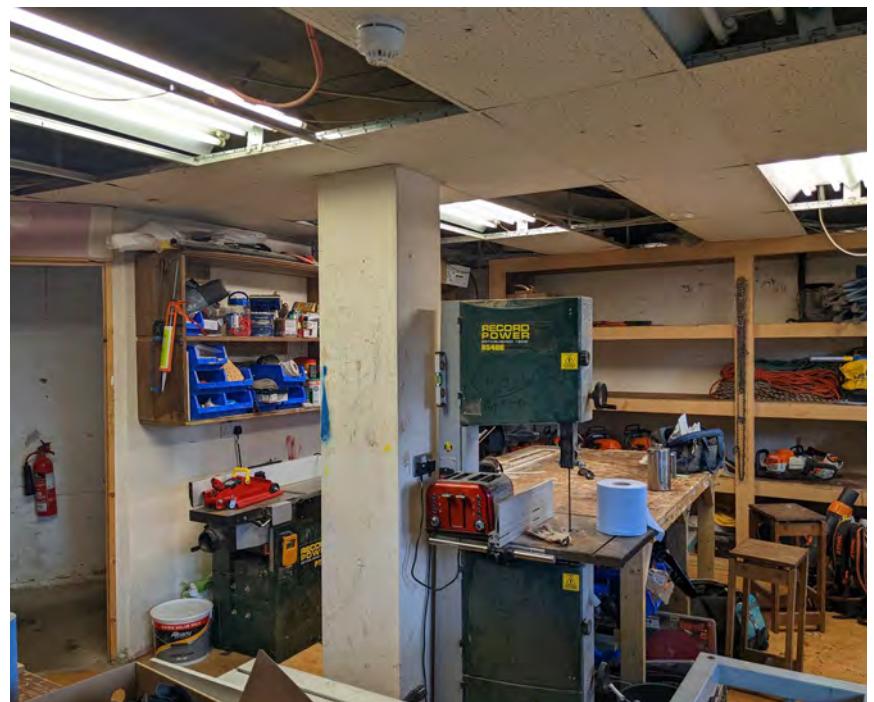
Plate 6.74 - Basement workshop

Fitted with new windows and a suspended ceiling. The partition to B01 is modern studwork, and has been inserted since 1980s. This room once had a row of arches along its length, to support the floor structure to the room above. These have been removed and replaced by a modern beam supported on a column at mid-span.

- Use:  
The room is currently used as a workshop by the Estate team.
- Ceiling:  
The ceiling has a modern suspended grid system fitted, with a number of the tiles missing. Above this a beam and block floor construction. Fluorescent tube lights are fitted within the suspended ceiling system.
- Walls:  
The walls are white painted plaster, with open timber shelving units to all walls.
- Windows:  
There are two timber framed windows to the east elevation, these have been fitted internally with metal security bars.
- Door:  
The door to this room from the corridor B01 is a modern flush fire door with modern keycode lock.
- Floor:  
The floor covering is lino
- Condition:  
The workshop appears to be in a good condition. There are a number of suspended ceiling tiles missing however this is aesthetic only.

This room is significant however it was originally open to B01 separated by a row of brick arches. A modern stud wall now replaces these. The room has largely been fitted out with modern racking, suspended ceiling and a large central structural pier.

The modern fit out is of neutral significance as is the stud wall separating the room from B01.

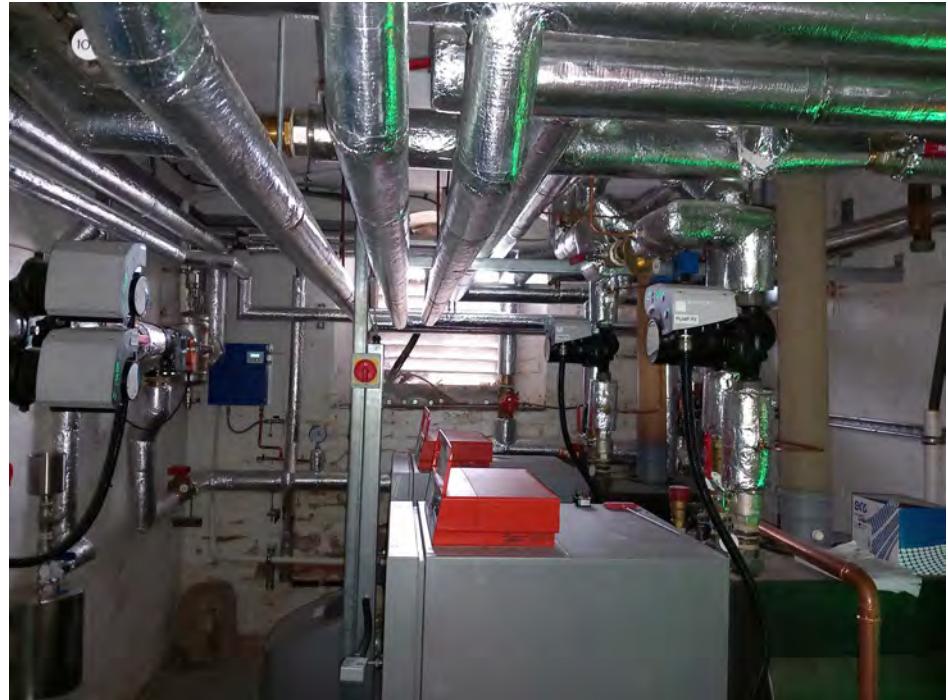
Plate 6.75 - boiler room

- Use:  
This room currently houses the boiler and associated plant.
- Ceiling:  
The ceiling is white painted plaster.
- Walls:  
The walls are painted blockwork, except for the east wall which is painted brick to the external wall.
- Windows:  
The window to the east wall has been fitted with louvres and an internal fine metal mesh to provide combustion air.
- Door  
The door is modern flush door.
- Floor  
The floor is concrete screed.
- Condition:  
There appears to be some damp and loss of paint finish to the wall below the window.
- Significance:  
This room is significant due to its original form. Modern louvres have been fitted to the windows and the room is fitted with ductwork and plant.

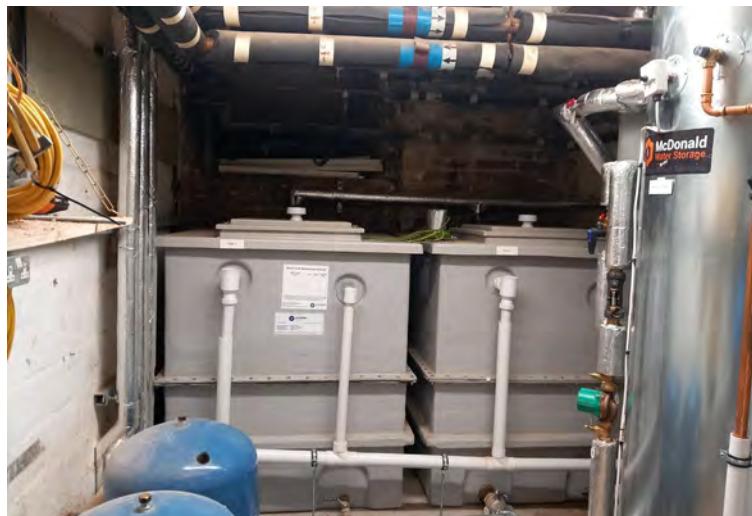
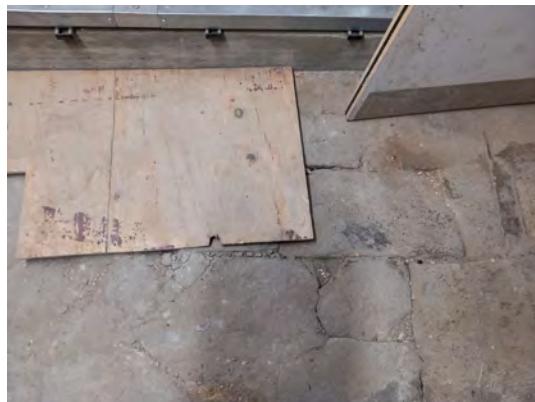
Plate 6.76 - B15.

- Doors:  
The door is a modern flush door.
- Fittings:  
The room currently houses a number of tanks.
- Floor:  
The stone flag floor survives.
- Condition:  
There are some large holes in the wall from previous installations, it would be beneficial to make these areas good if they are no longer in use. There are a few hairline cracks to the wall which should be monitored for any change to these.

- Significance:  
This room is significant due to its original form. The window to the east wall has been blocked up and the room currently houses a number of tanks.

- Opportunity for change:  
There is the possibility to re-open the east window if desired in the future. The holes in the walls from previous installations could be repaired and made good.

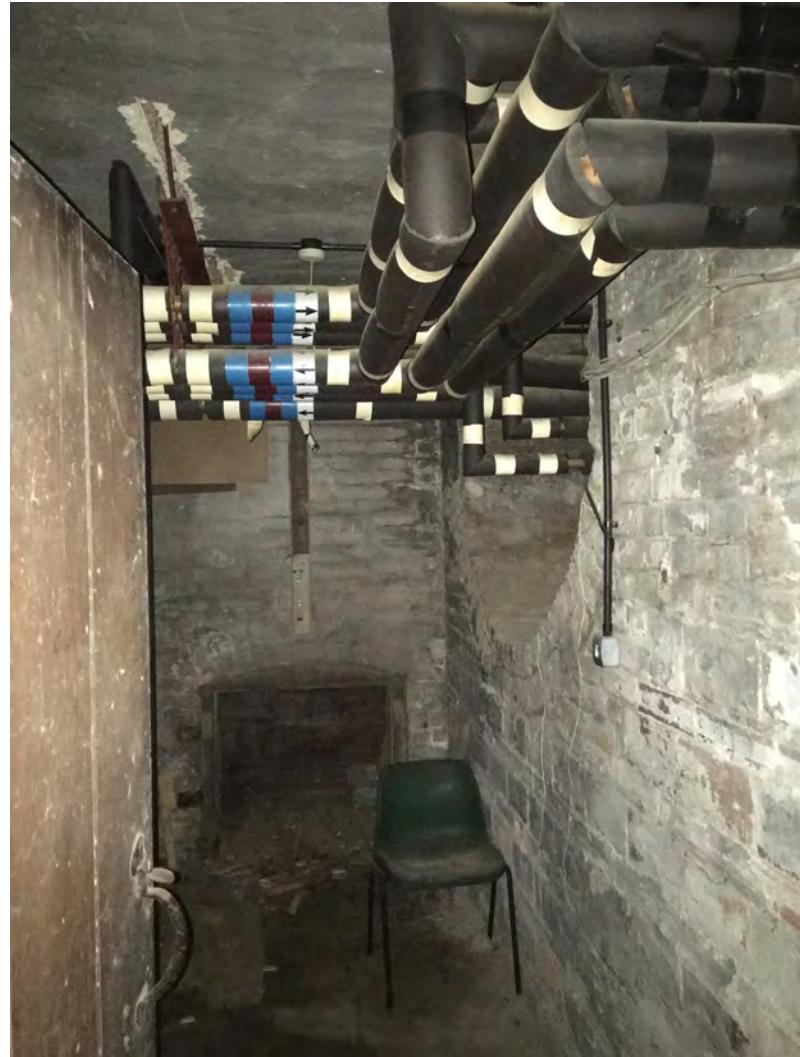
Plate 6.78 - B16

- Use:  
There is a modern re-planned area covered by a pavement light at the east end, arising from the removal of the stairs down to the Billiards Room. An inverted arch, which forms part of the foundations to the main house, gives access to a large void, which runs under the whole of the House

- Condition:  
This room appears to be in adequate condition for its purpose. Currently a chair gives access up to the tunnels, it would be better to change this for a step/ hop up.

- Significance:  
This space is significant, although much altered the original arched opening to the voids below the house remains.
- Opportunity for change:  
The altered east end could be reconfigured if desired to accommodate a new room where the billiard room once stood with access to the basement. A more permanent access to the voids below the house could also be investigated.

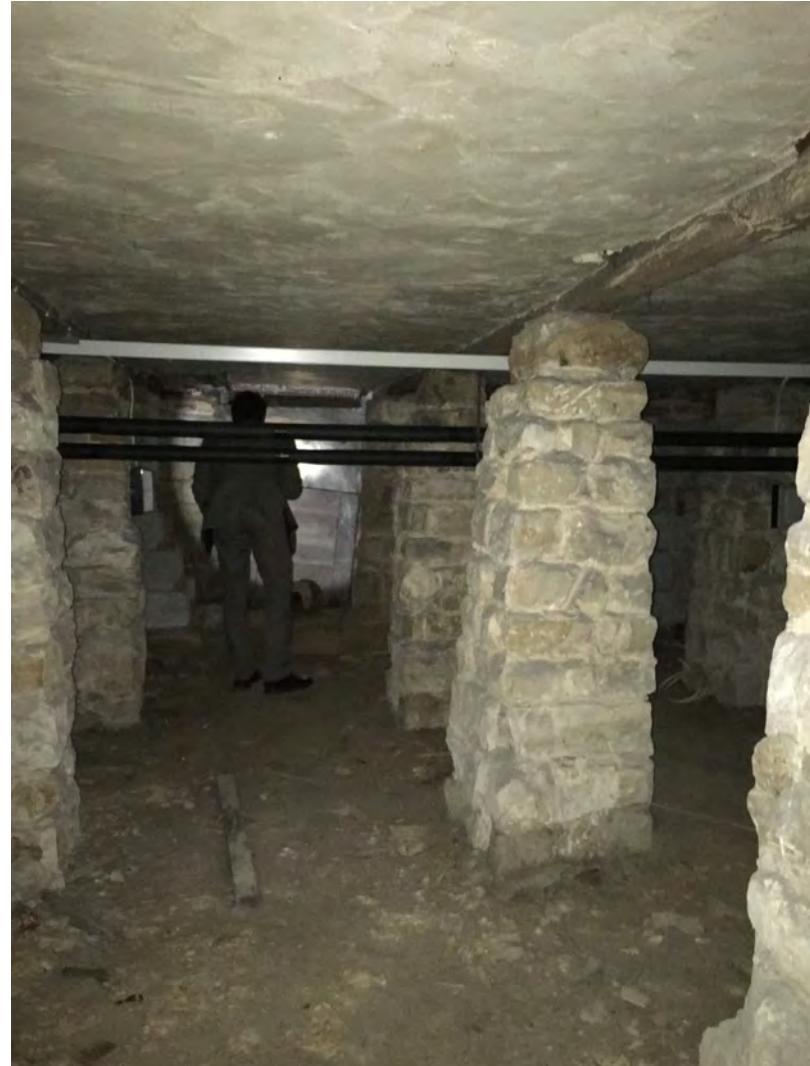
Plate 6.79 - Void under house

This is about 1400mm high, and is divided by walls which rise to form the main structure of the house. The floors have intermediate support in the form of columns of stone on a grid of about 1500mm. There are also a number of ducts formed in terracotta brick, which probably distributed the warm air from the boilers. The underside of the ground floor joists are plastered over, either to prevent draughts rising through the floorboards or (less likely), because there were plans to form rooms within this part of the basement. Another interesting feature visible within the basement is found under the dining room G09 east window: there are sash boxes with staff and parting beads which would once have accommodated shutters which would have risen through a slot (otherwise covered by a hinged lap) in the sill to the French windows, the bay format of the window making a side-hinged design impractical.

This room appears to be in a good condition. Currently a chair gives access up to the tunnels, it would be better to change this for a step/ hop up.

The voids are currently used for services to the house and should continue in this use, as originally designed, when the move away to more sustainable heating is reviewed.

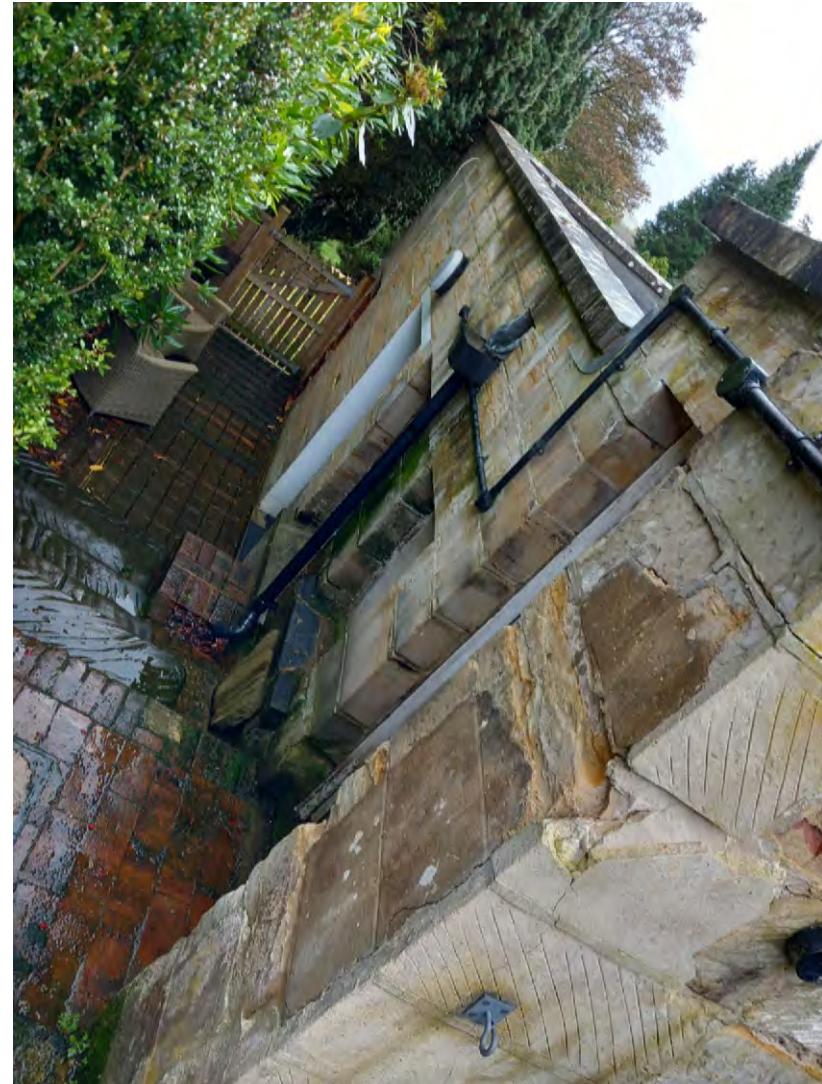
Plate 6.80 - B17-18.

Externally these rooms are in a fairly poor condition. The hopper below the gutter on the front elevation is blocked and overflowing. The stonework to the elevations is in a very poor condition.

These rooms are much altered and there is the opportunity to convert them into usable spaces for the gardens.

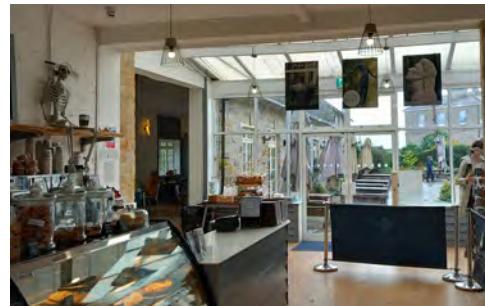
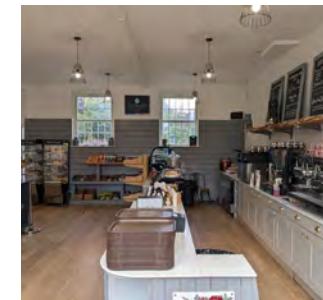
Plate 6.81 - Clock Tower Cafe

The café is generally in a good condition. There is a small area of damp on the ceiling to the southern side, indicating there may be problems at roof level which need investigating.

There is the opportunity to make changes to the cafe area internally to re-imagine the layout or change the use if the cafe was to be relocated elsewhere on the estate.

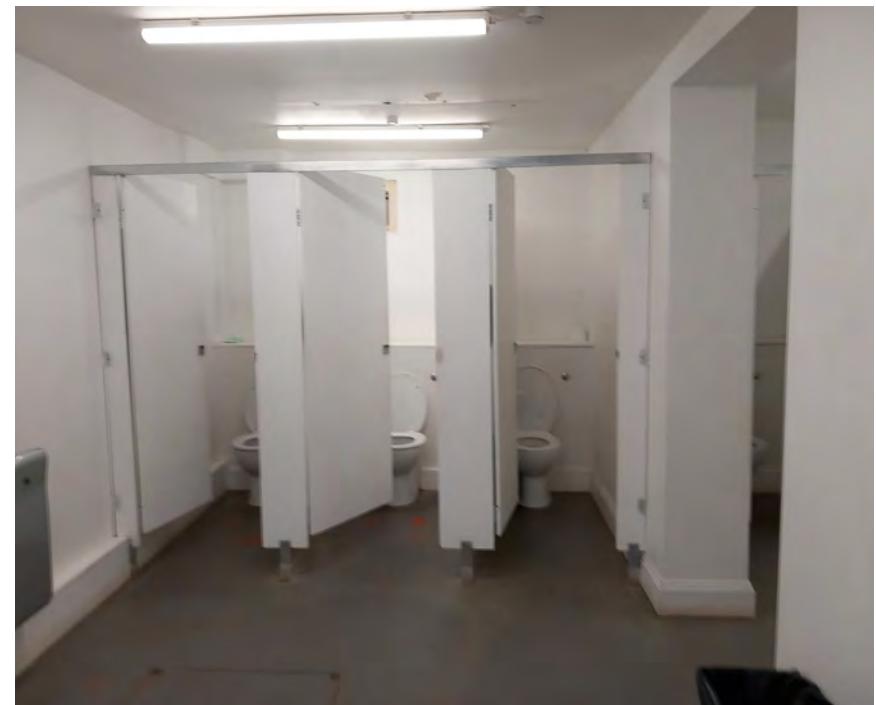
Plate 6.84 - Ladies WC

- Fittings:  
The sanitary ware fittings are white modern with modern cubicles.
- Floor:  
The floor covering is modern lino.
- Condition:  
The WCs are in a poor condition generally and compared with the presentation of the rest of the site worn and dated, these would benefit from refurbishment. The male WC outside is in a fair condition, however like the ladies and accessible WC the fittings would benefit from upgrading to match the level of finish in the rest of the estate.

- Significance:  
The WCs have neutral significance. They have been subdivided with modern partitions and modern fittings. Modern lobbys have been introduced giving access from the cafe.

- Opportunity for change:  
There is the opportunity to overhaul these facilities or remove and relocate them.

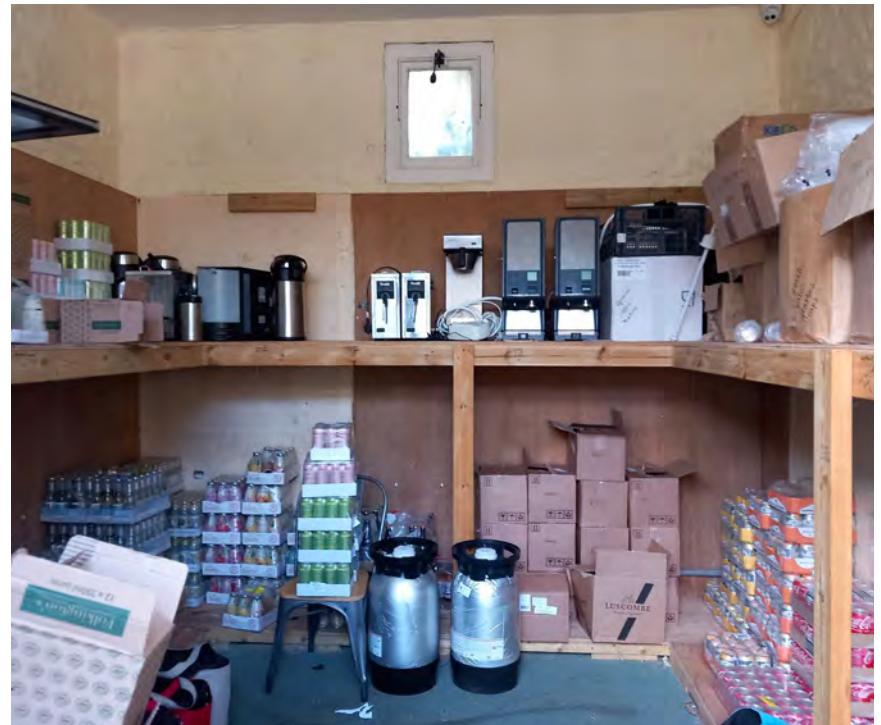
Plate 6.85 - Stables stores

- Fittings:  
There is simple timber racking to the walls to provide storage for the products.
- Floor:  
The floor is carpeted.
- Condition:  
These appear to be in good condition having recently been refurbished, however, there is stock and equipment lining the walls so much of it could not be seen. The carpet floor covering needs to be replaced in the larger of the stores.

- Significance:  
The store rooms are of neutral significance. They have been fitted out with new modern inner doors to allow for climate control of the stock along with modern fit out. The historic high level window to the west and large stable doors to the east remain.

- Opportunity for change:  
These rooms are very spacious for stock rooms and could be arranged to provide additional cafe space.

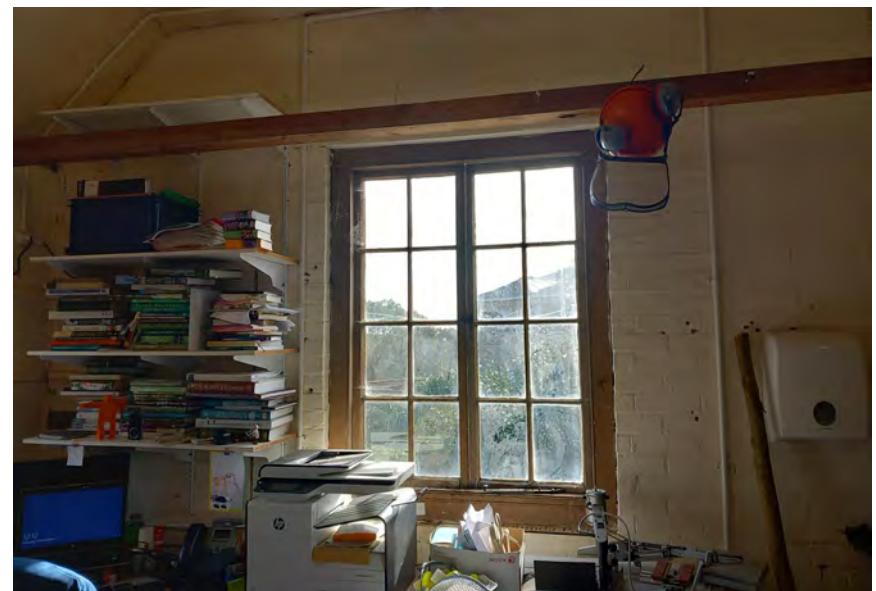
Plate 6.86 - Gardeners Office

- Fittings:  
Shelving is fitted to the walls and a desk runs most of the way around the room.
- Floor:  
The floor is timber boards.
- Condition:  
This room is in poor condition with large horizontal cracks at ceiling level and patches of damp along the edge of the dormer windows, one large significant patch. Some areas of vertical cracking to the walls.

- Significance:  
This office has neutral significance. The historic windows remain as does the external door, however the room has been fitted out with modern partitions to the north end and modern fittings.

- Opportunity for change:  
This is a good size office but could be combined with the adjacent office to create one large space.

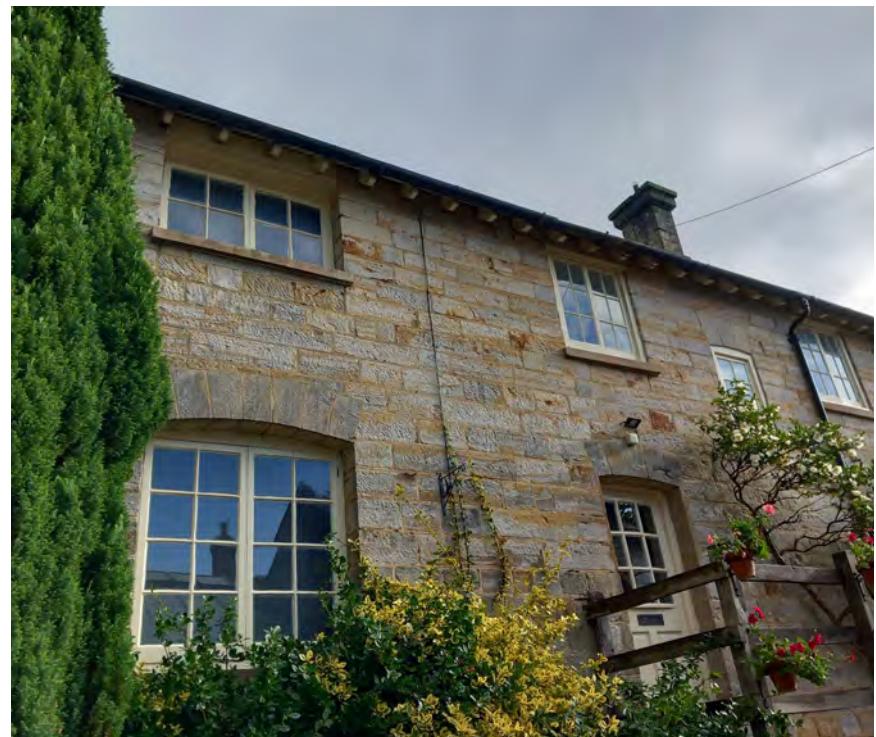
Plate 6.87 - Elevation of residence

- Condition:  
This flat is in a fair condition generally but is tired and would benefit from refurbishment. The kitchen ceiling has damp staining and cracking which is extended down the internal wall and there are some signs of damp at high level on the internal walls, this is indicating a possible problem with the roof coverings. The windows would benefit from redecoration.

- Significance:  
The interior of the residence is of neutral significance. It has modern fit out although the plan form is largely unchanged.
- Opportunity for change:  
This works well as a residence, however some rooms feel a little cramped due to modern partitions dividing the space to accommodate more bedrooms. Removal of these could be considered. Updates to the internal decor and fit out could be considered.

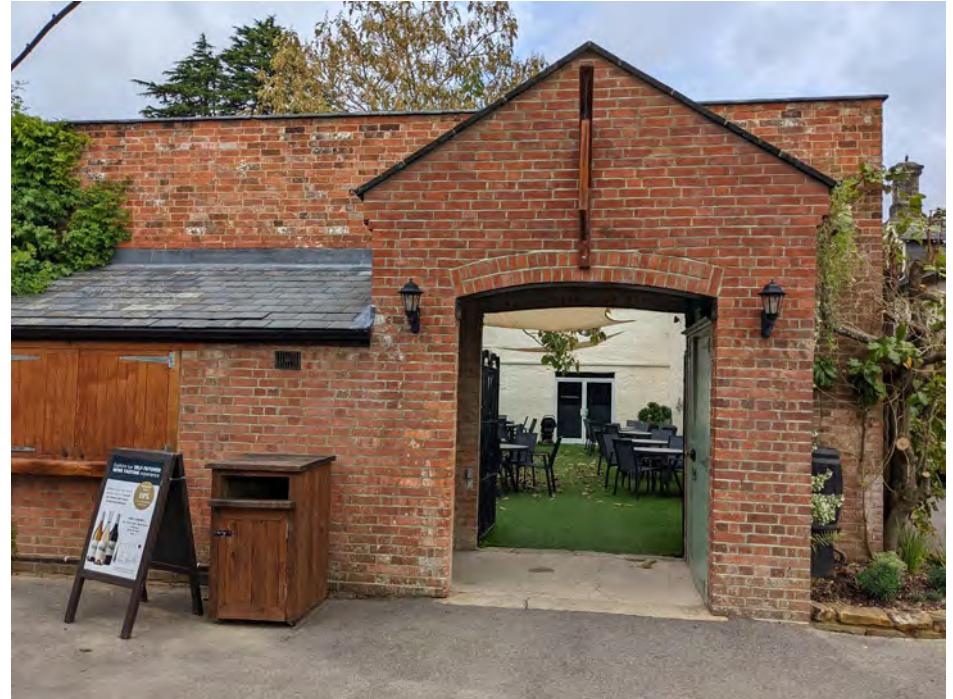
- Description:  
Through a gabled entrance with a depressed open arch is accessed the Wine Garden – a courtyard with astroturf flooring used for tasting of the estate's wines. A new slate roof has been put over the store room to the north of the wine garden, this abuts the garden wall with new lead flashings. To the north is the Doll House Museum which houses a series of display cases containing dollhouse models and scenes. The garden wall forms the eastern wall of the museum block and there is an additional door on this external façade of the Museum Block. To the west is the Courtyard Café. This has an entirely modern internal fit out, with a translucent glass roof and large double doors at its southern end.

Plate 6.88 - Entrance through to wine garden

- Significance:  
The museum block is significant due to its position within the gardens and the layout of the estate.
- Opportunity for change:  
The museum block has recently been updated to create a cafe and wine tasting garden, however there are opportunities to further enhance this area with upgrades to the greenhouse.

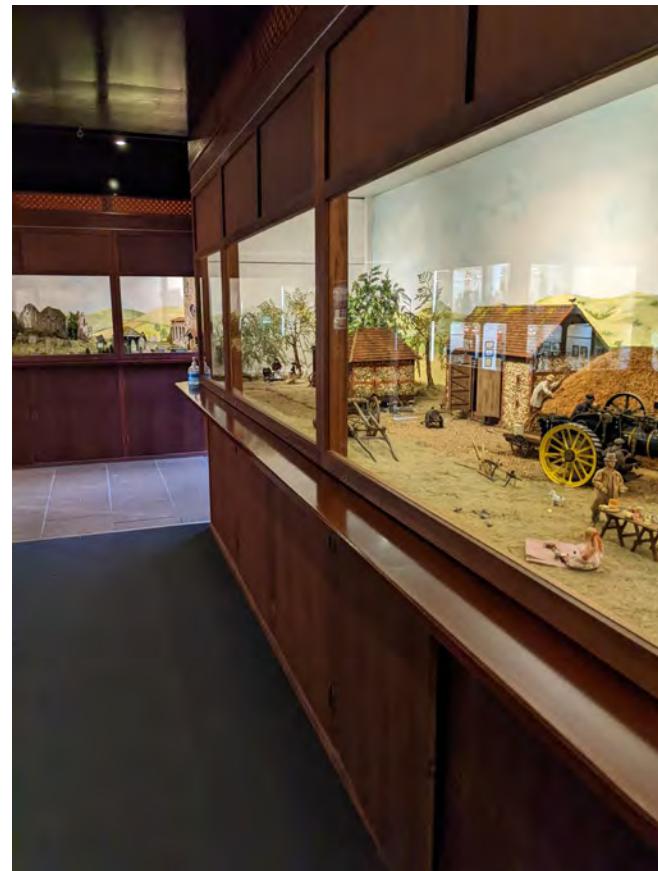
Plate 6.89 - Dolls House Museum

There are opportunities to possibly re-present the displays and scenes within the museum and upgrade the lighting and display units. This will need input from specialists.

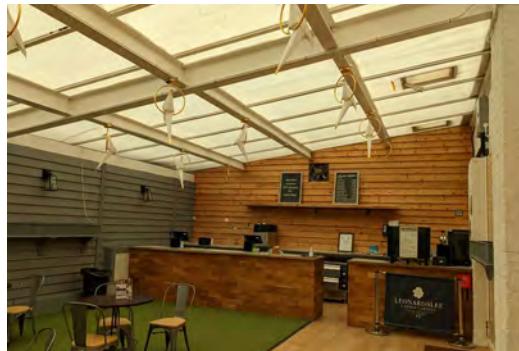
- Floors:  
The floor is timber boards with a large outdoor style mat below the tables and chairs.
- Condition:  
The Courtyard Café external seating area appears to be in a good condition, having recently been refurbished.

Plate 6.90 - Courtyard Cafe

- Significance:  
The cafe has neutral significance and is modern construction with modern fit out inside.
- Opportunity for change:  
This area has access to the courtyard as well as to the rear of the building giving it possibilities for a change in use if desired.

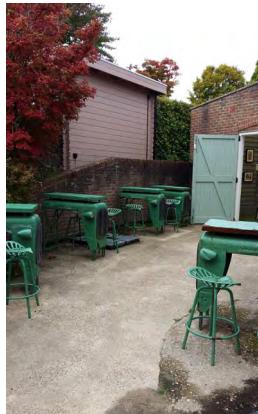
Plate 6.90a - Bespoke Tables

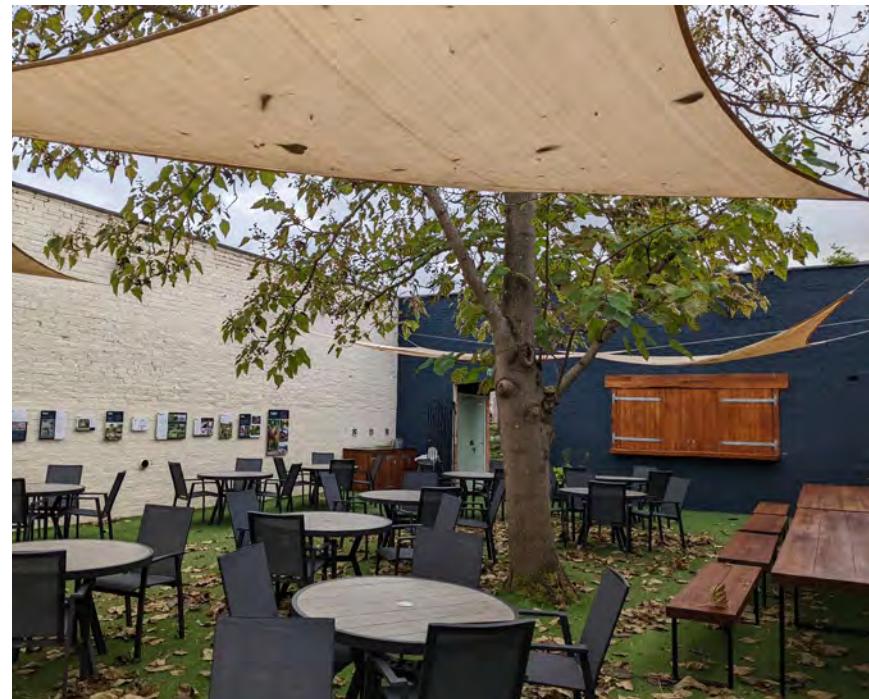
Plate 6.91- Wine Garden

- Floors:  
The floor is astroturf.
- Condition:  
The garden wall which forms the eastern wall of the museum block is in a good condition generally. However a large portion is covered with planting so cannot be viewed fully. There are a few areas of open joints especially along the top.

- Significance:  
The courtyard is significant. The original walls are retained with modern seating and cloth shading hung across it.

- Opportunity for change:  
This space set within the historic walls has opportunities for many outside uses.

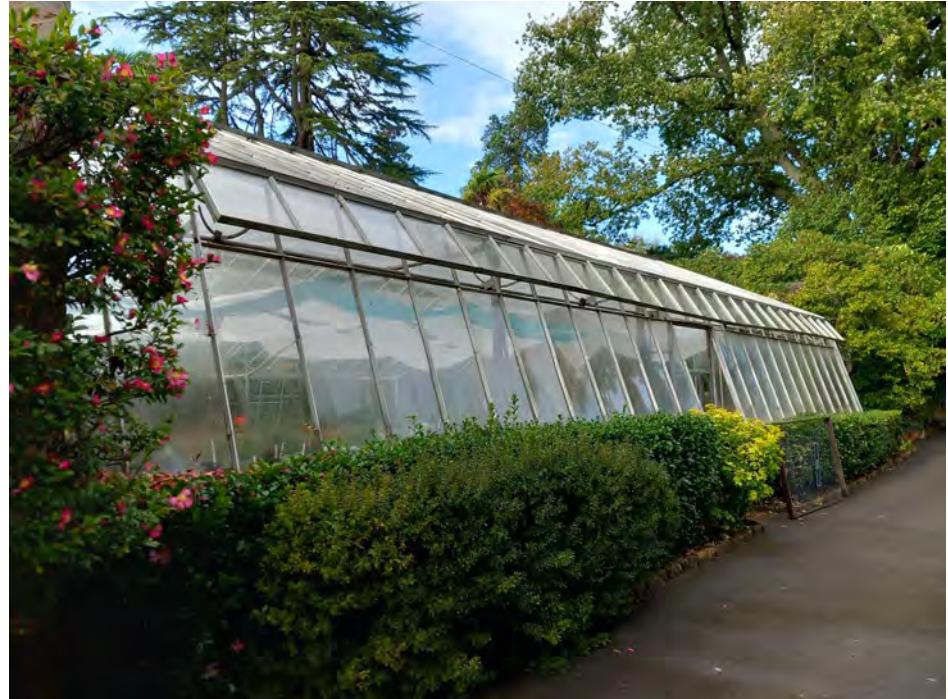
*Plate 6.92 - Gardeners Greenhouse.*

- Fittings:  
The greenhouse is fitted out with timber staging.
- Condition:  
The greenhouse appears to be in a fair condition for its current use.
- Significance:  
The greenhouse has neutral significance.

- Opportunity for change:  
The greenhouse is not in a great condition and there is the opportunity to upgrade and change the greenhouse to suit.

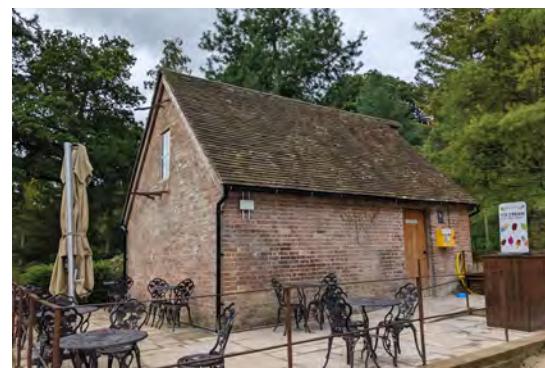
Plate 6.93 - Engine House.

- Condition:  
The door would benefit from being refinished where it has weathered at the bottom. Some small areas of open joints to the brickwork. Windows appear to be in a good condition. Roof appears to be in a good condition. Internally is in good condition, however the floor is showing signs of wear and would benefit from being replaced.

- Significance:  
The engine house is significant for its previous use and position within the gardens.
- Opportunity for change:  
The engine house has recently been refurbished to create a small take away cafe in the gardens. There is possible opportunity to increase the size of this and to potentially provide toilet facilities and a seating area. Dependant on obtaining the relevant consents.

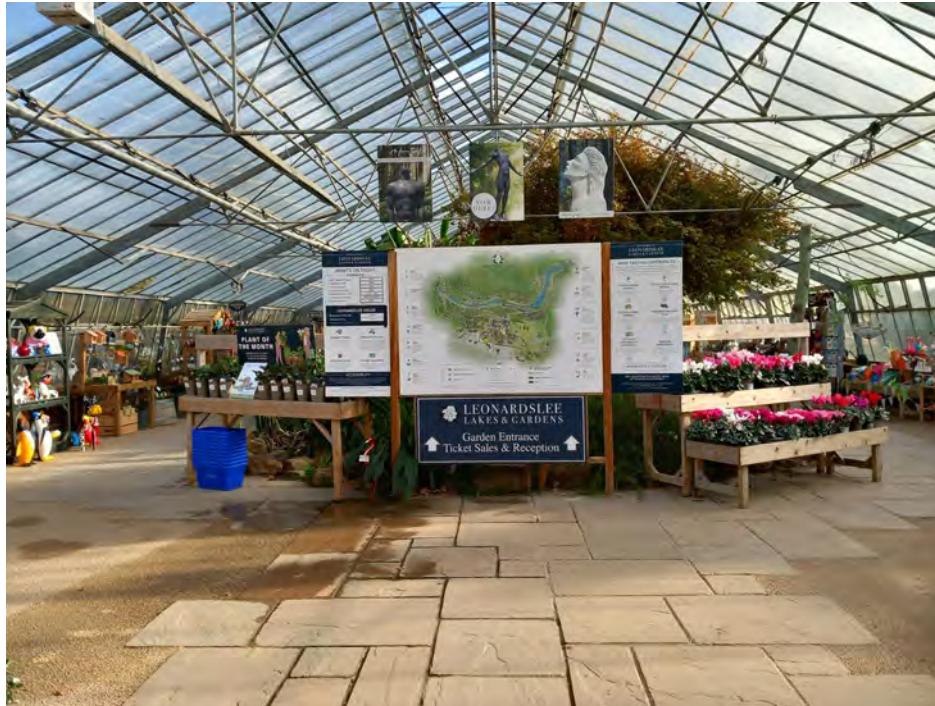
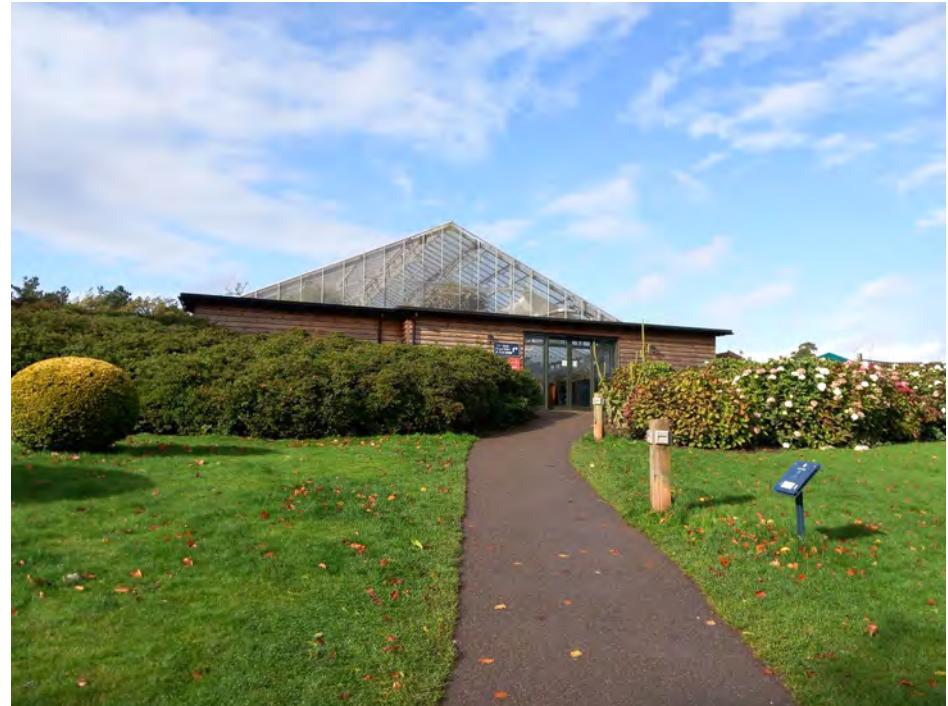
Plate 6.94 - Greenhouse.

- Condition:  
The green house is generally in a poor condition with many of the Perspex panes coming away or broken. The new timber clad extensions are what appears to be in a good condition generally.

- Significance:  
This greenhouse has neutral significance. It is a modern greenhouse.
- Opportunity for change: there is potentially the opportunity to redevelop this area to create a new entrance building with potentially more space for retail/ cafe. Dependant on obtaining the relevant consents.
