## GEOTECHNICAL INVESTIGATION - HIGH BARN, CRAYS LANE, GOOSE GREEN PULBOROUGH RH20 2LR

Jolliff Developments Limited

Report Number: YEX2150, Date: May 2021

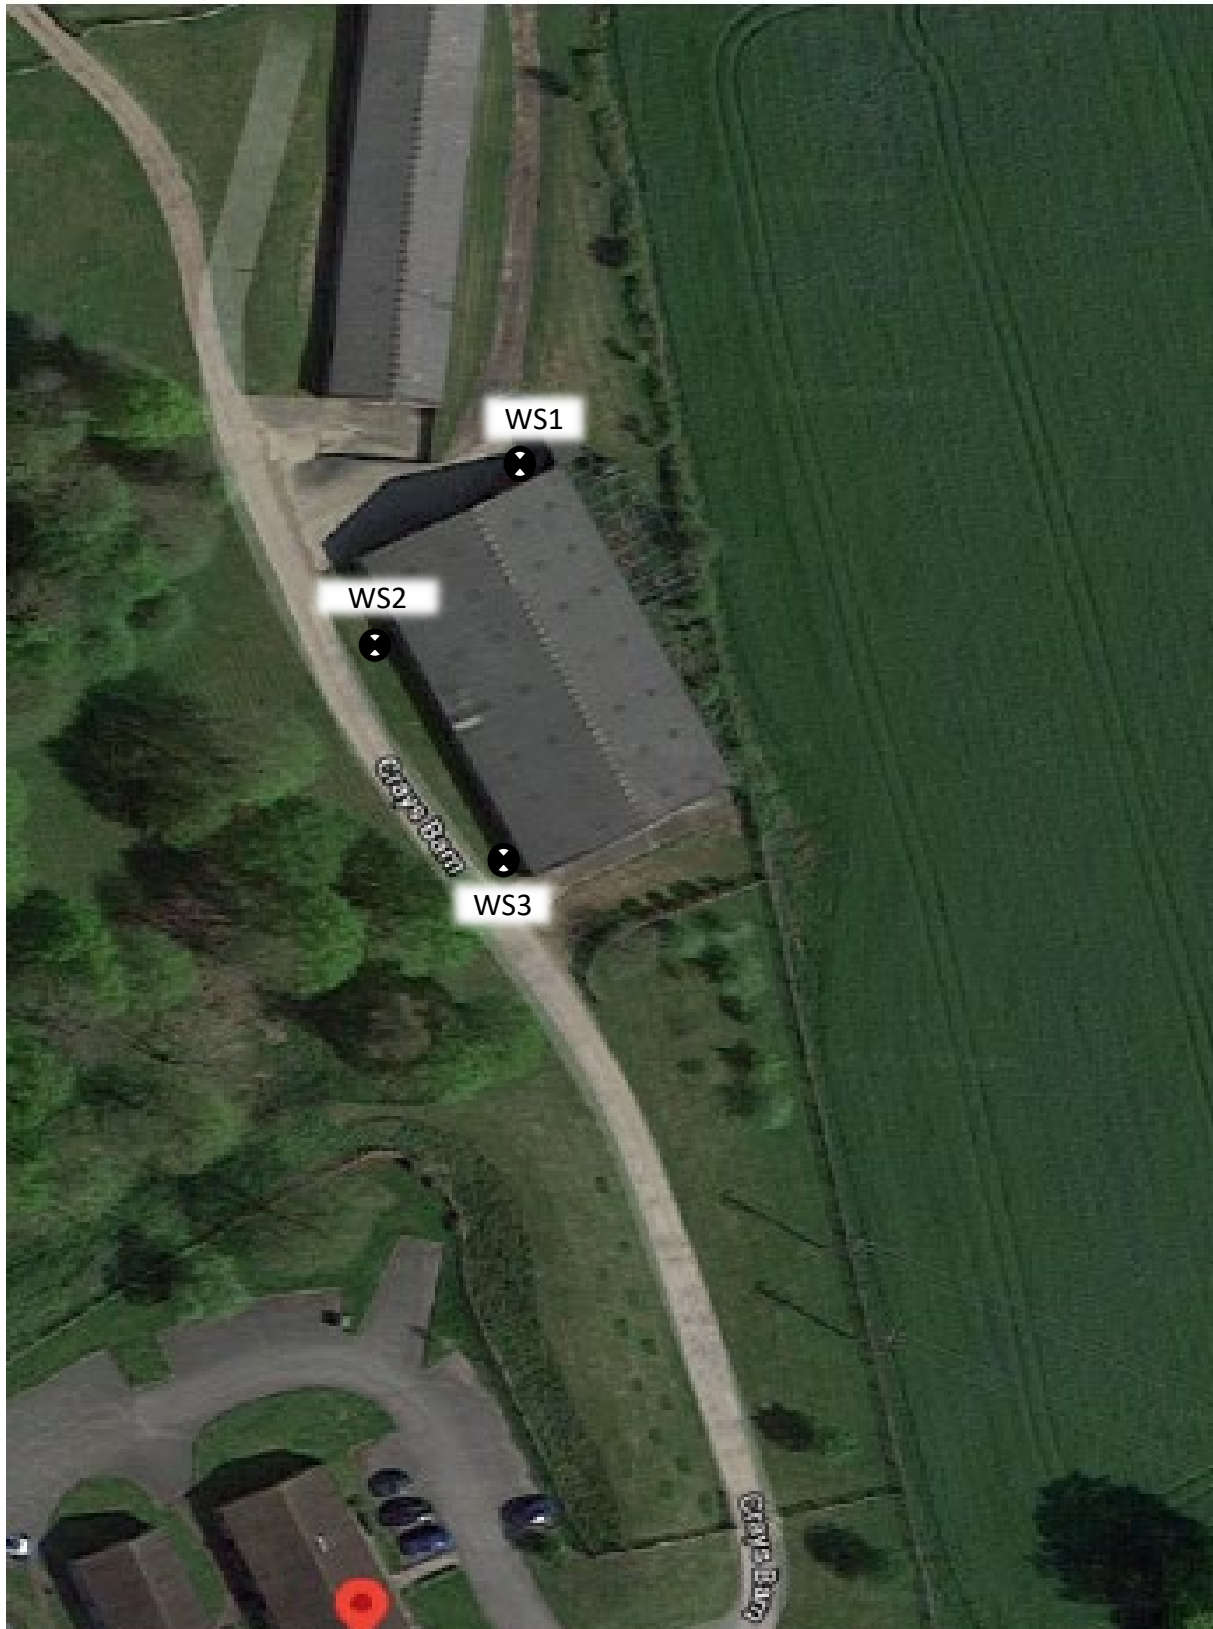
Title: **Investigation Location Plan**

The positions of exploratory holes in relation to the existing site layout can be reviewed within [Appendix B](#). Exploratory mini percussive borehole logs are located in [Appendix C](#).
