ARBORICULTURAL IMPACT ASSESSMENT

LAR2510-ARB-REP-0140

**Land at Lower Perrylands Farm
Perrylands Farm, Dial Post, Horsham**

Lower Perrylands Limited

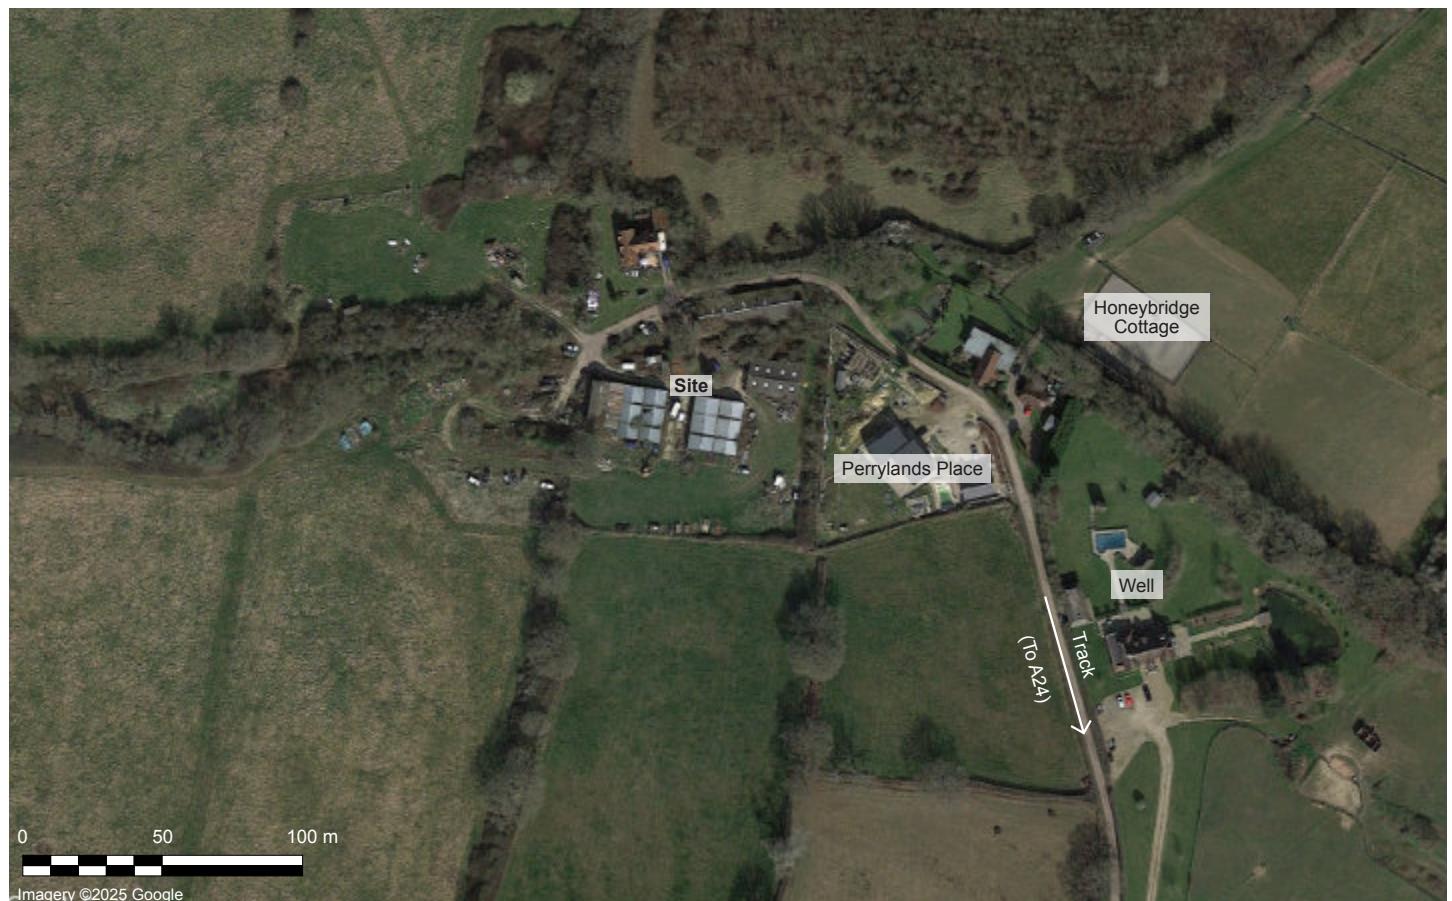
Figure 1. Site location and context

The proposed development site is part of Lower Perrylands Farm located to the south-west of the village of Dial Post, near Horsham (Grid Ref.: TQ14451882), accessed via a private rural track leading west off the A24.

The site comprises a traditional farmhouse and a group of redundant agricultural buildings in derelict condition. The farmhouse is located in the northern portion of the farm while the redundant buildings are clustered in the southern portion across the access track and a narrow watercourse. Behind the buildings, to the south, there is a substantial area of open grassland bordered by a post and rail fence and a gappy hedgerow.

The site context is illustrated in **Figure 1**.

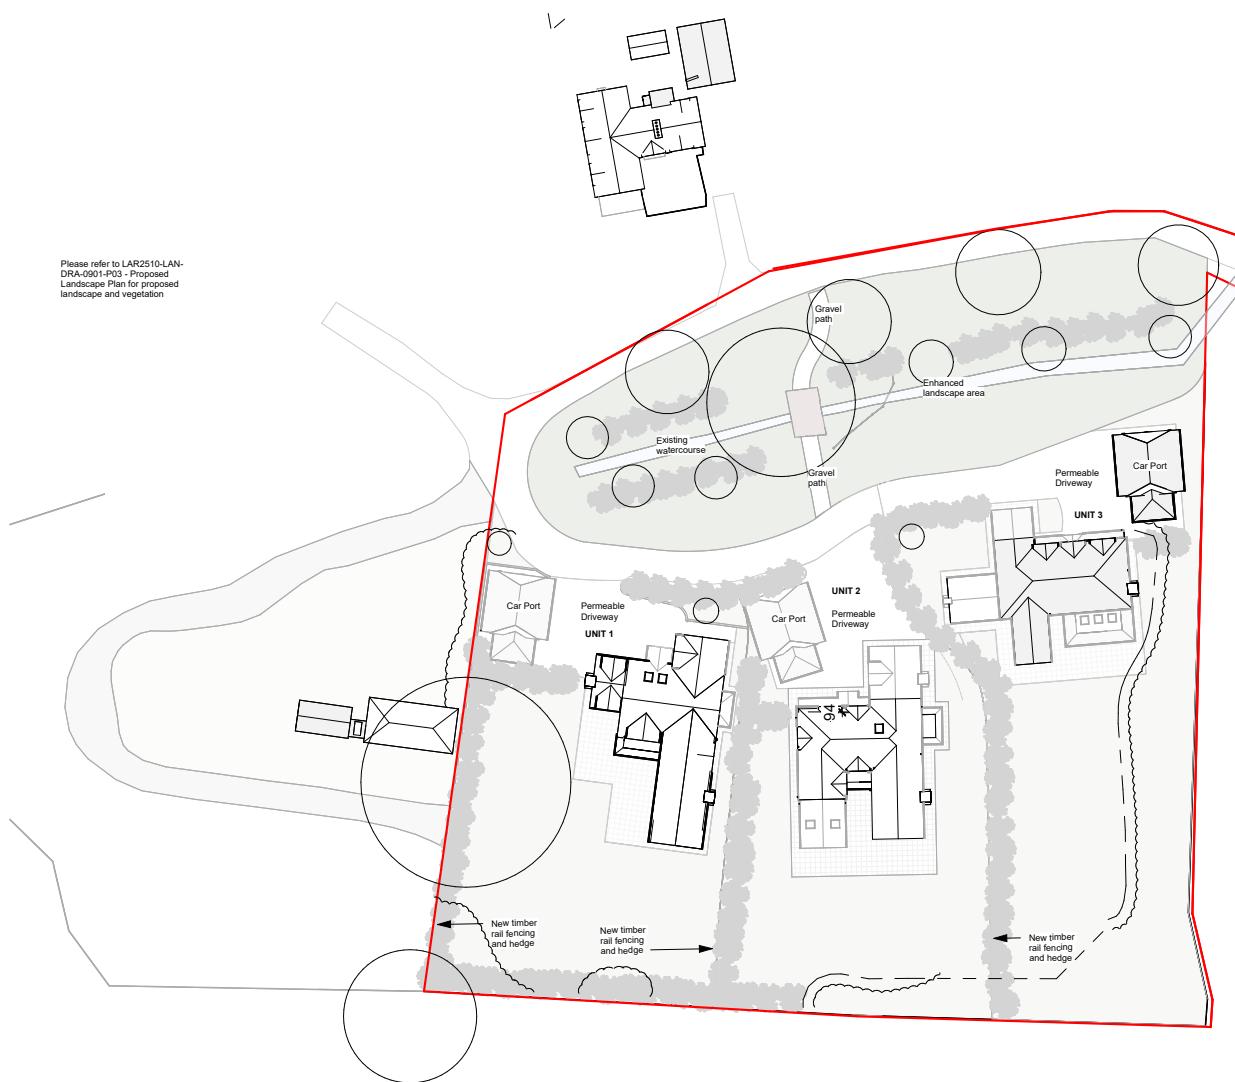
Figure 2. Proposed Site Plan (Fresh Architects, June 2025)

The proposed development is understood through reference to the architectural scheme by Fresh Architects and comprises the demolition of the redundant agricultural buildings and the construction of three detached dwellings, each with an associated double car port and a private garden.

The existing farm access track would comprise the means of access to the development while the proposed private drives would be formed as permeable surfacing and dressed with natural unbound aggregate.

The Proposed Site Plan (Fresh Architects, June 2025) is illustrated in **Figure 2**.

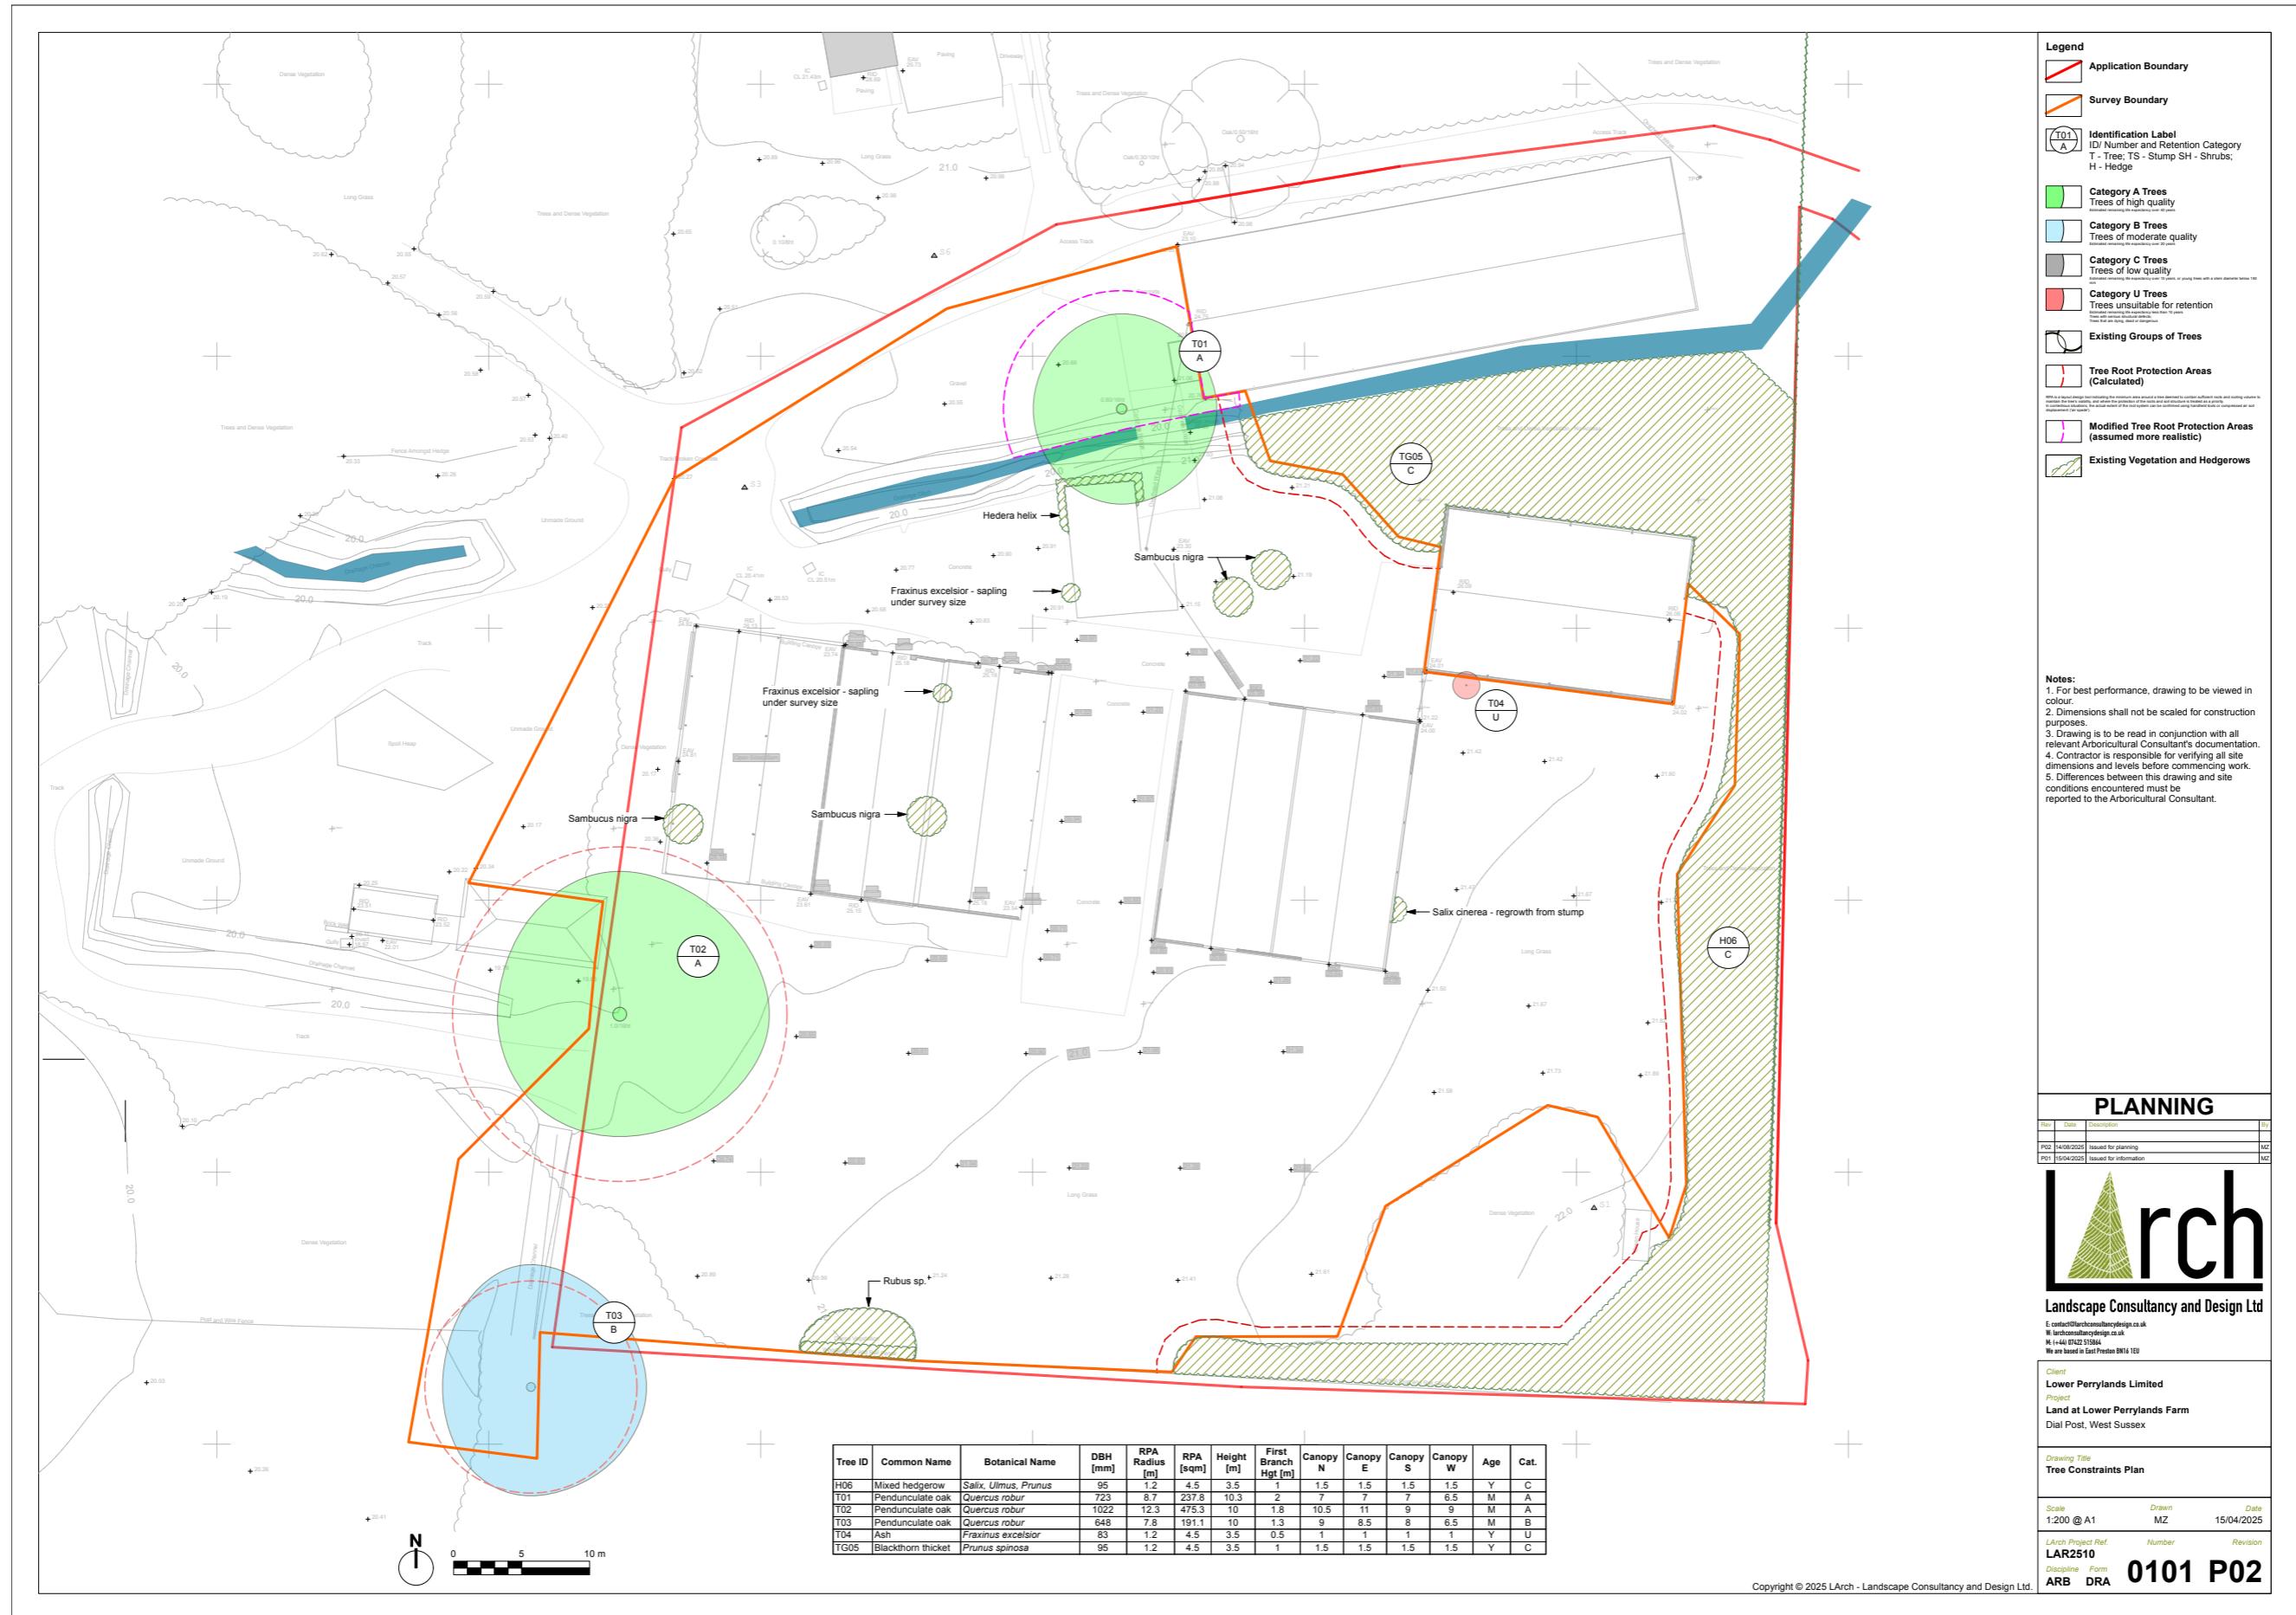
APPENDIX 3. TREE CONSTRAINTS PLAN (EXTRACT)

The underground constraints are represented by Root Protection Areas (RPAs) around the trees. An RPA is a layout design tool indicating the minimum area around a tree deemed to contain sufficient roots and rooting volume to maintain the tree's viability, and where the protection of the roots and soil structure is treated as a priority. Because of that, RPAs must be observed and safeguarded to minimise any adverse impact on the trees' viability.

- ▶ LAR2510-ARB-DRA-0101 - Tree Constraints Plan - attached in [Appendix 3](#)
- ▶ LAR2510-ARB-DRA-0110 - Tree Protection Plan - attached in [Appendix 4](#).

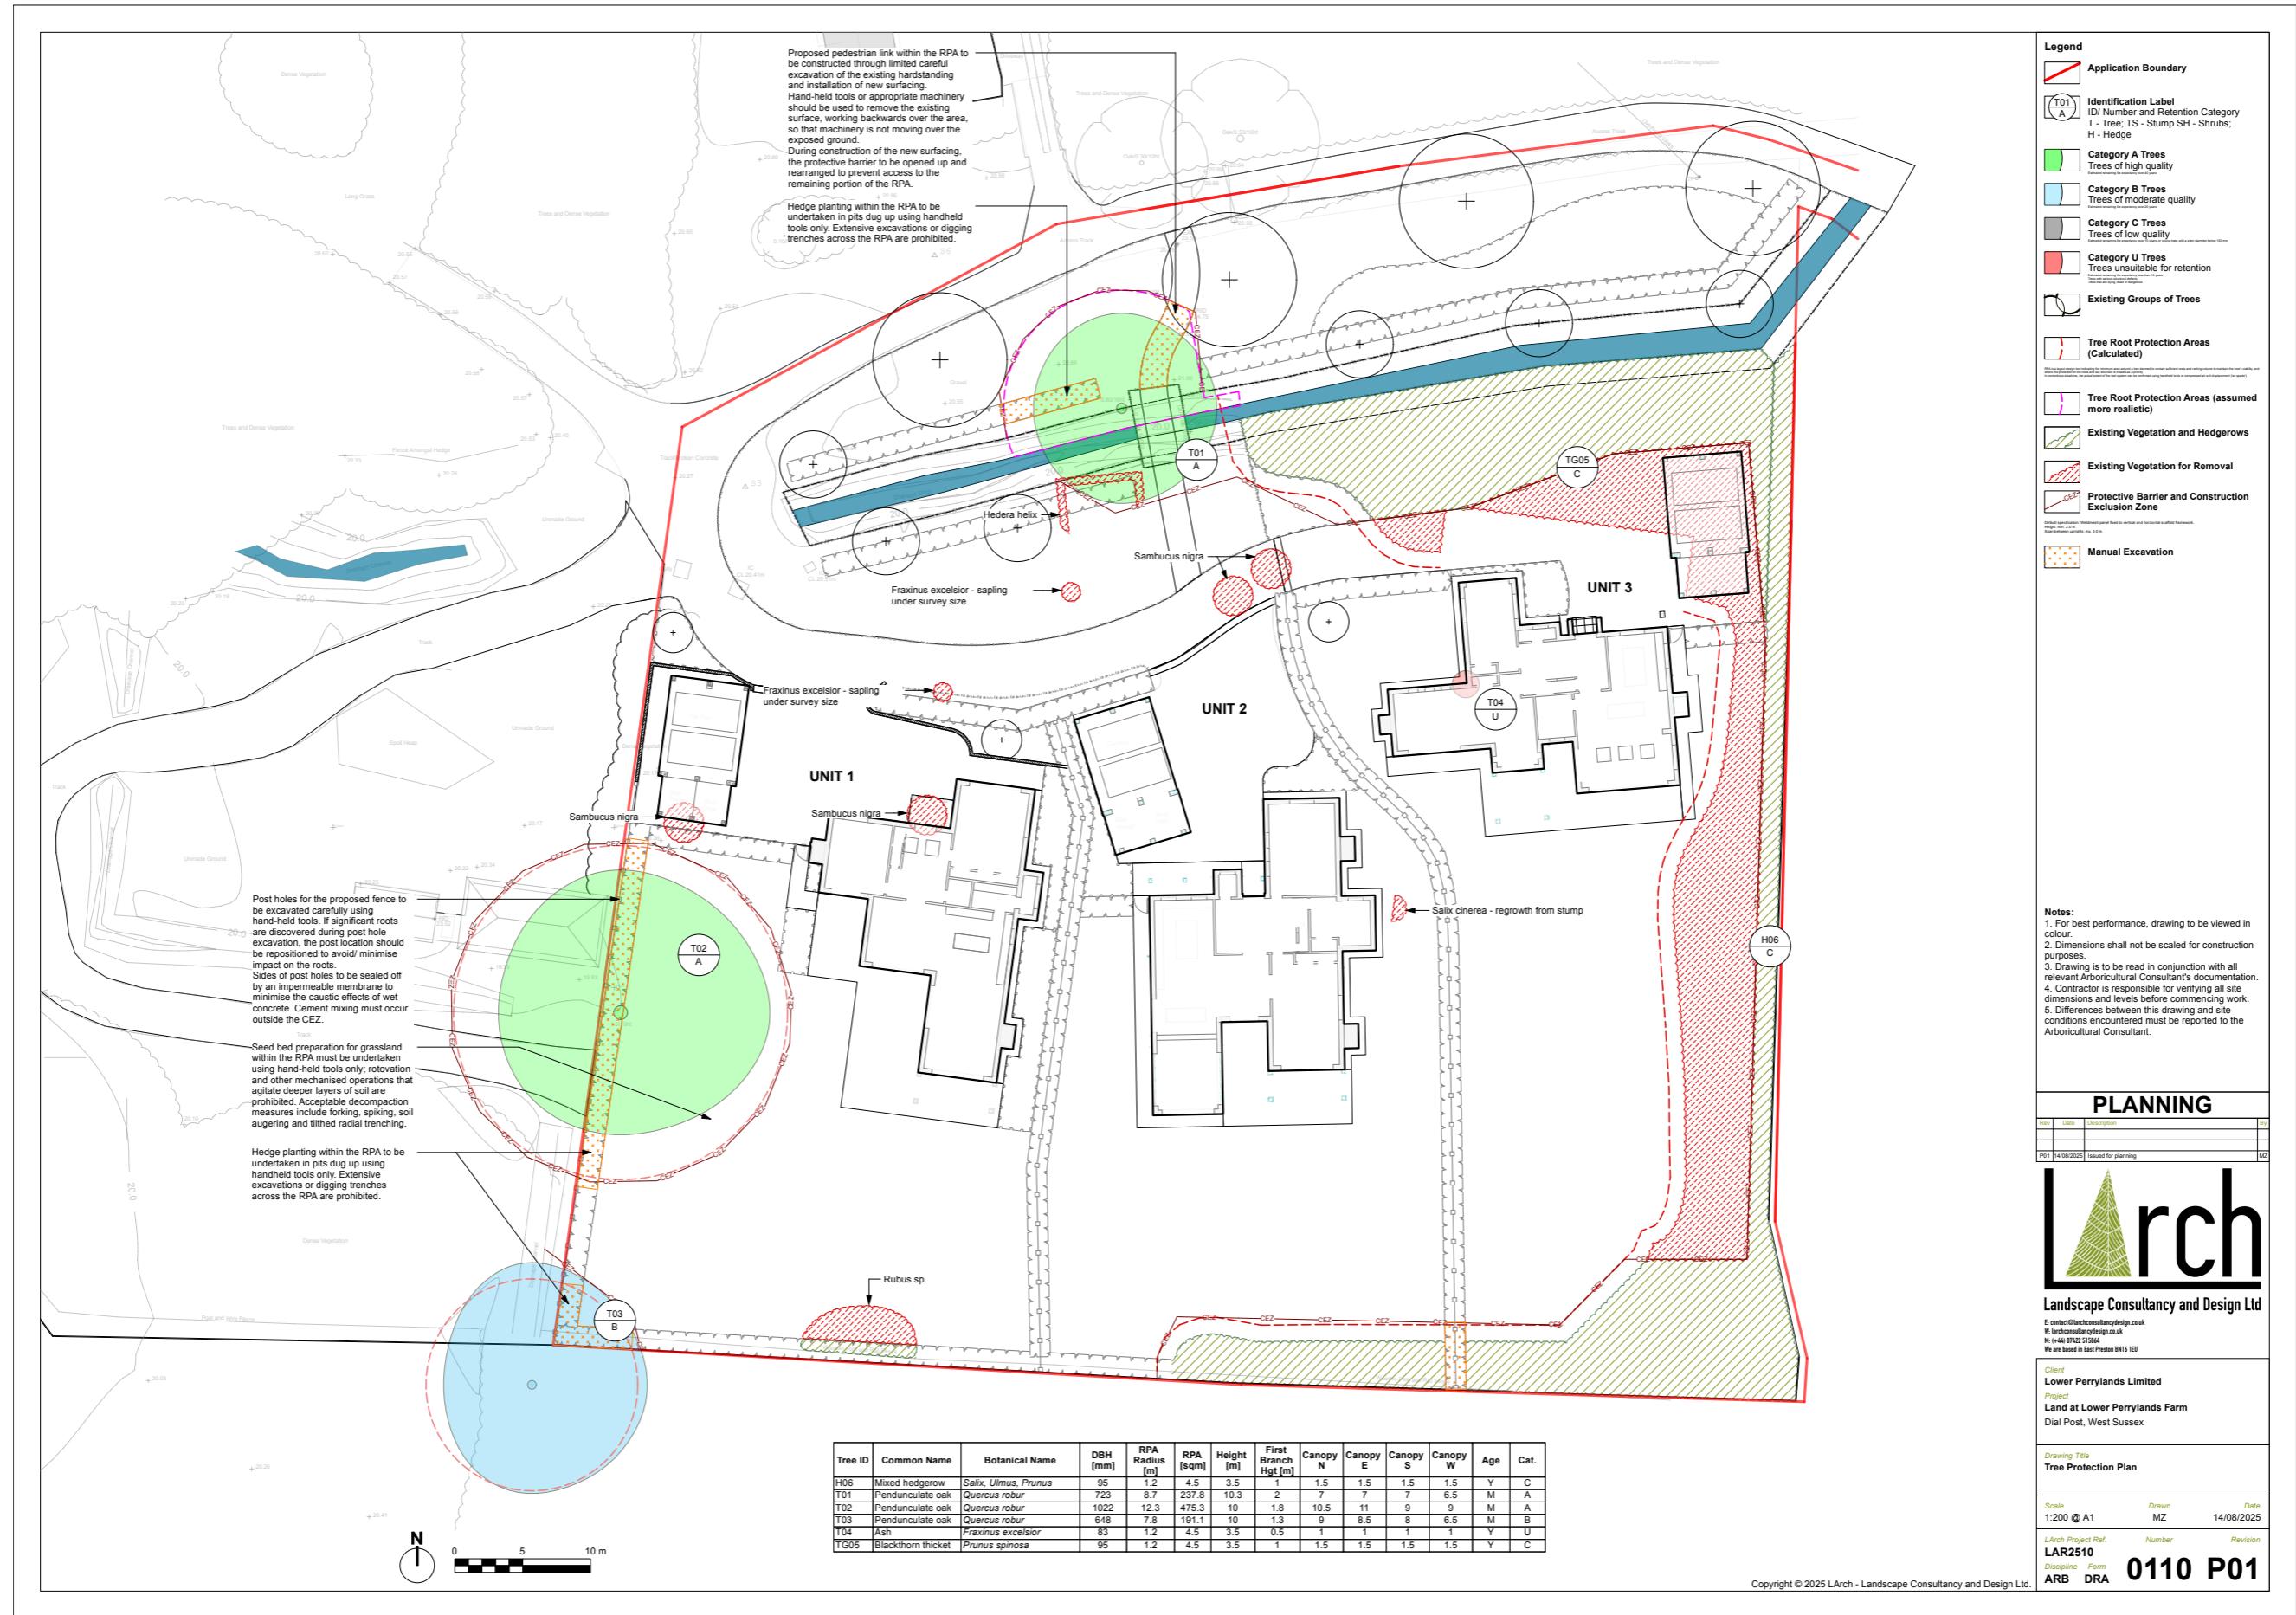
APPENDIX 4. TREE PROTECTION PLAN (EXTRACT)

The purpose of tree protection barriers is to demarcate the protected areas treated as Construction Exclusion Zone (CEZ) to safeguard the RPAs or the area below the drip line (whichever is bigger).

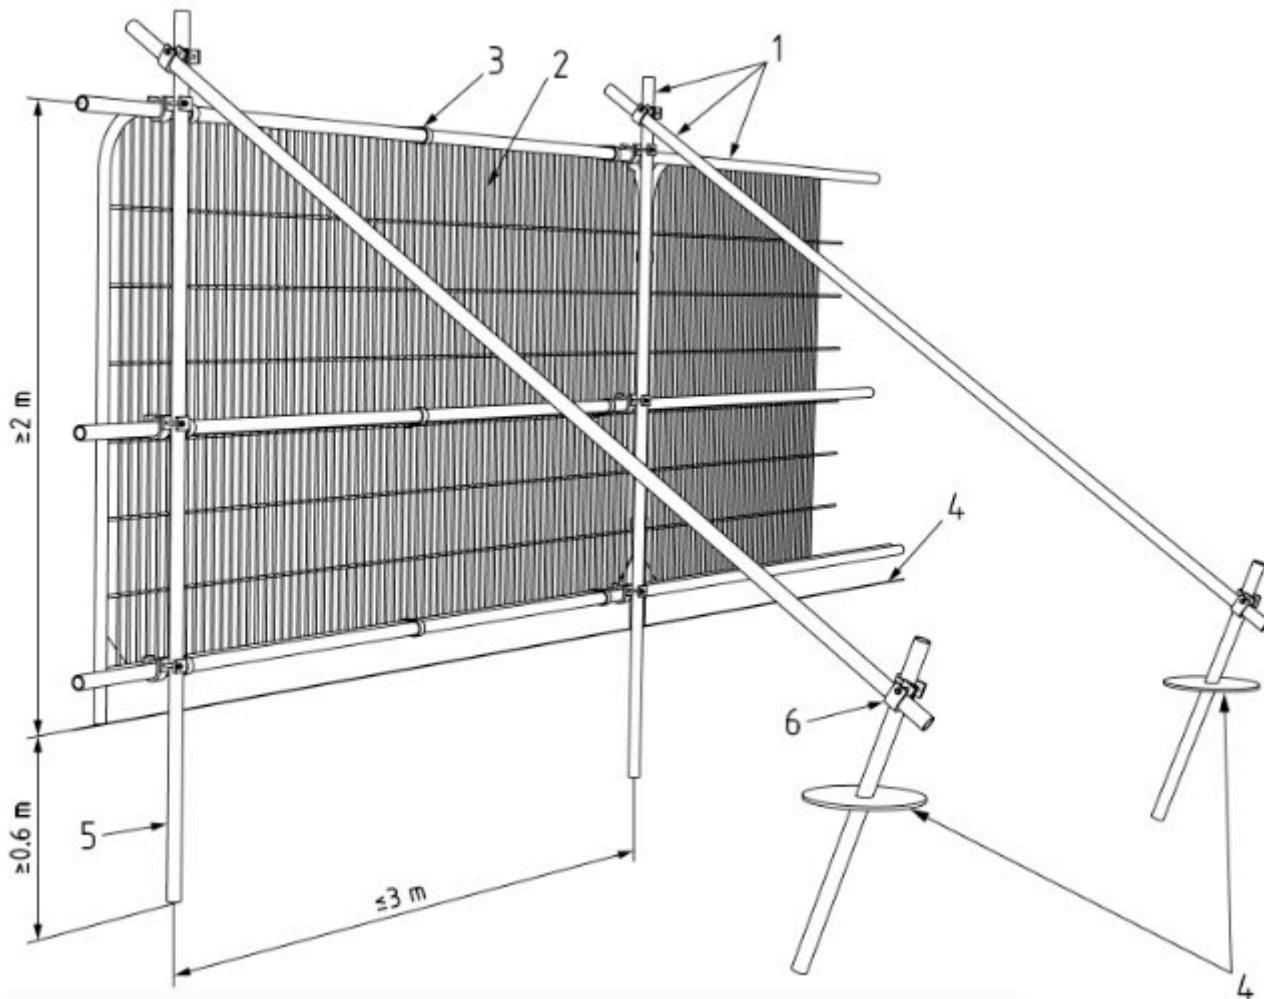
Appendix 5. Tree Protection Barrier - Options

- 1 Standard scaffold poles
- 2 Heavy gauge 2 m tall galvanised tube and welded mesh infill panels
- 3 Panels secured to uprights and cross-members with wire ties
- 4 Ground level
- 5 Uprights driven into the ground until secure (minimum depth 0.6 m)
- 6 Standard scaffold clamps

- ▶ min. 2 m high vertical and horizontal scaffold framework, well braced to resist impacts.
- ▶ The vertical tubes should be spaced at a maximum interval of 3 m and driven into the ground.
- ▶ The panels should be supported on the inner side by stabiliser struts, which should be attached to a base plate secured with ground pins. Where the barrier is to be installed over existing hard surfaces, the barrier and the stabiliser struts may be affixed into rubber or concrete feet and clipped together with anti-tamper couplers.

The described options of the default protective barriers are illustrated in accordance with Figures 2 and 3 of the BS 5837:2012 and attached in **Appendix 5**.

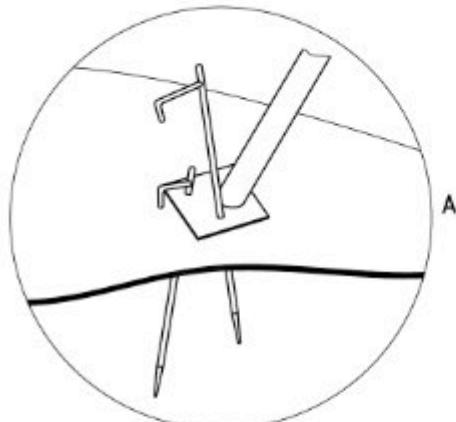
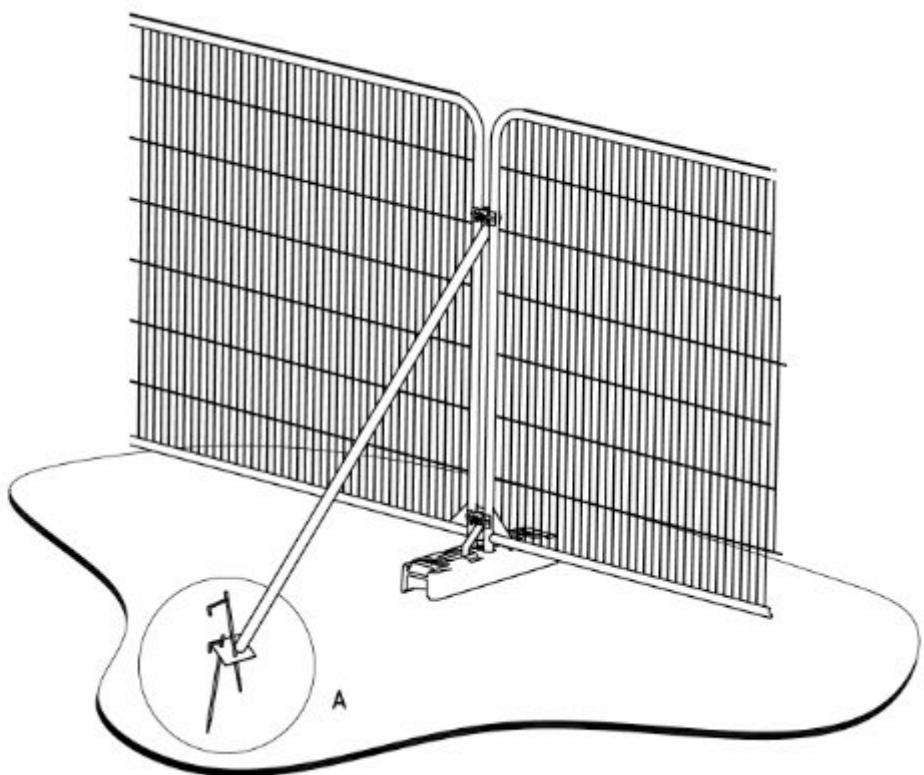
Default specification of above-ground protective barrier - Stabiliser strut with base plate secured with ground pins

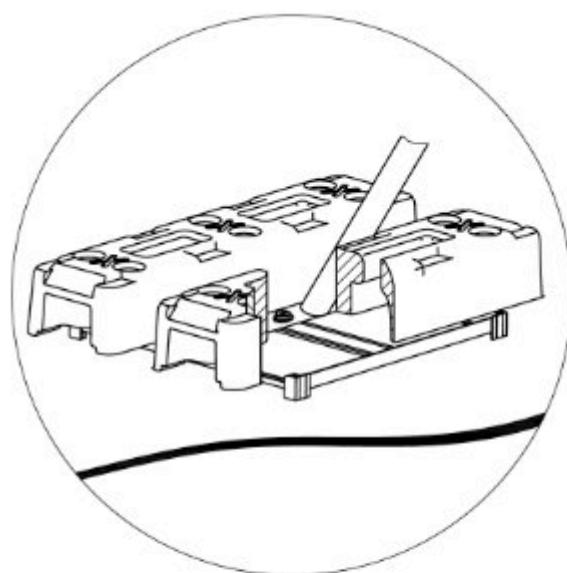
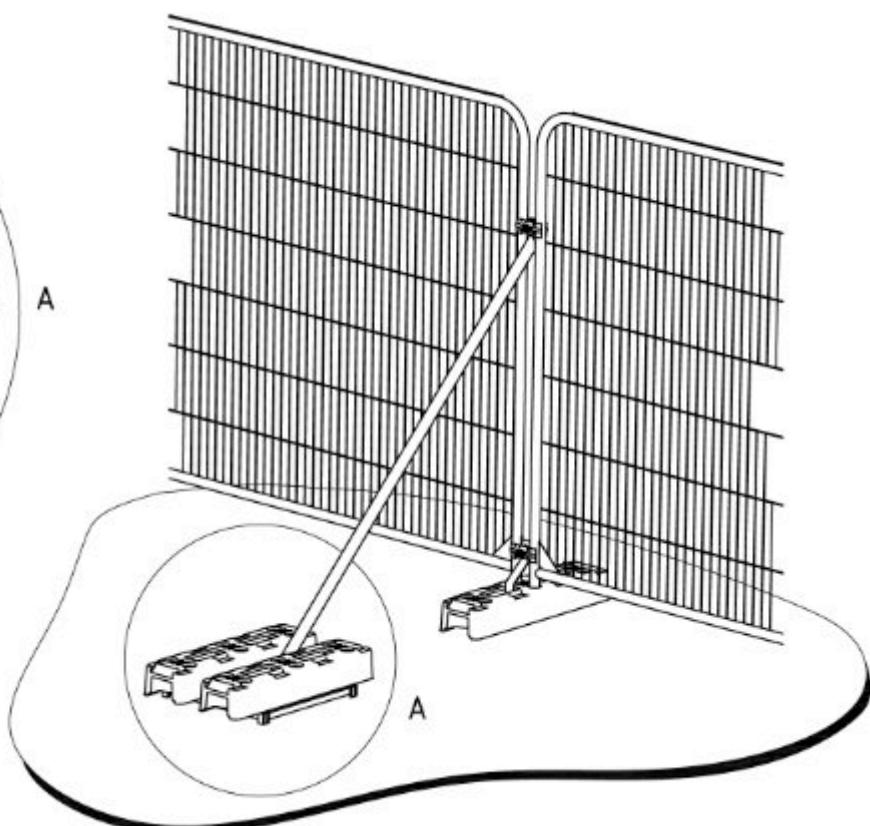
Default specification of above-ground protective barrier - Stabiliser strut mounted on block tray
