Phase II Site Investigation Report

**Lower Perryland Farm, Basing Hill, Dial Post,
West Sussex**

Document Reference: ON251030-ON-PD-XX-RP-G-713-C01

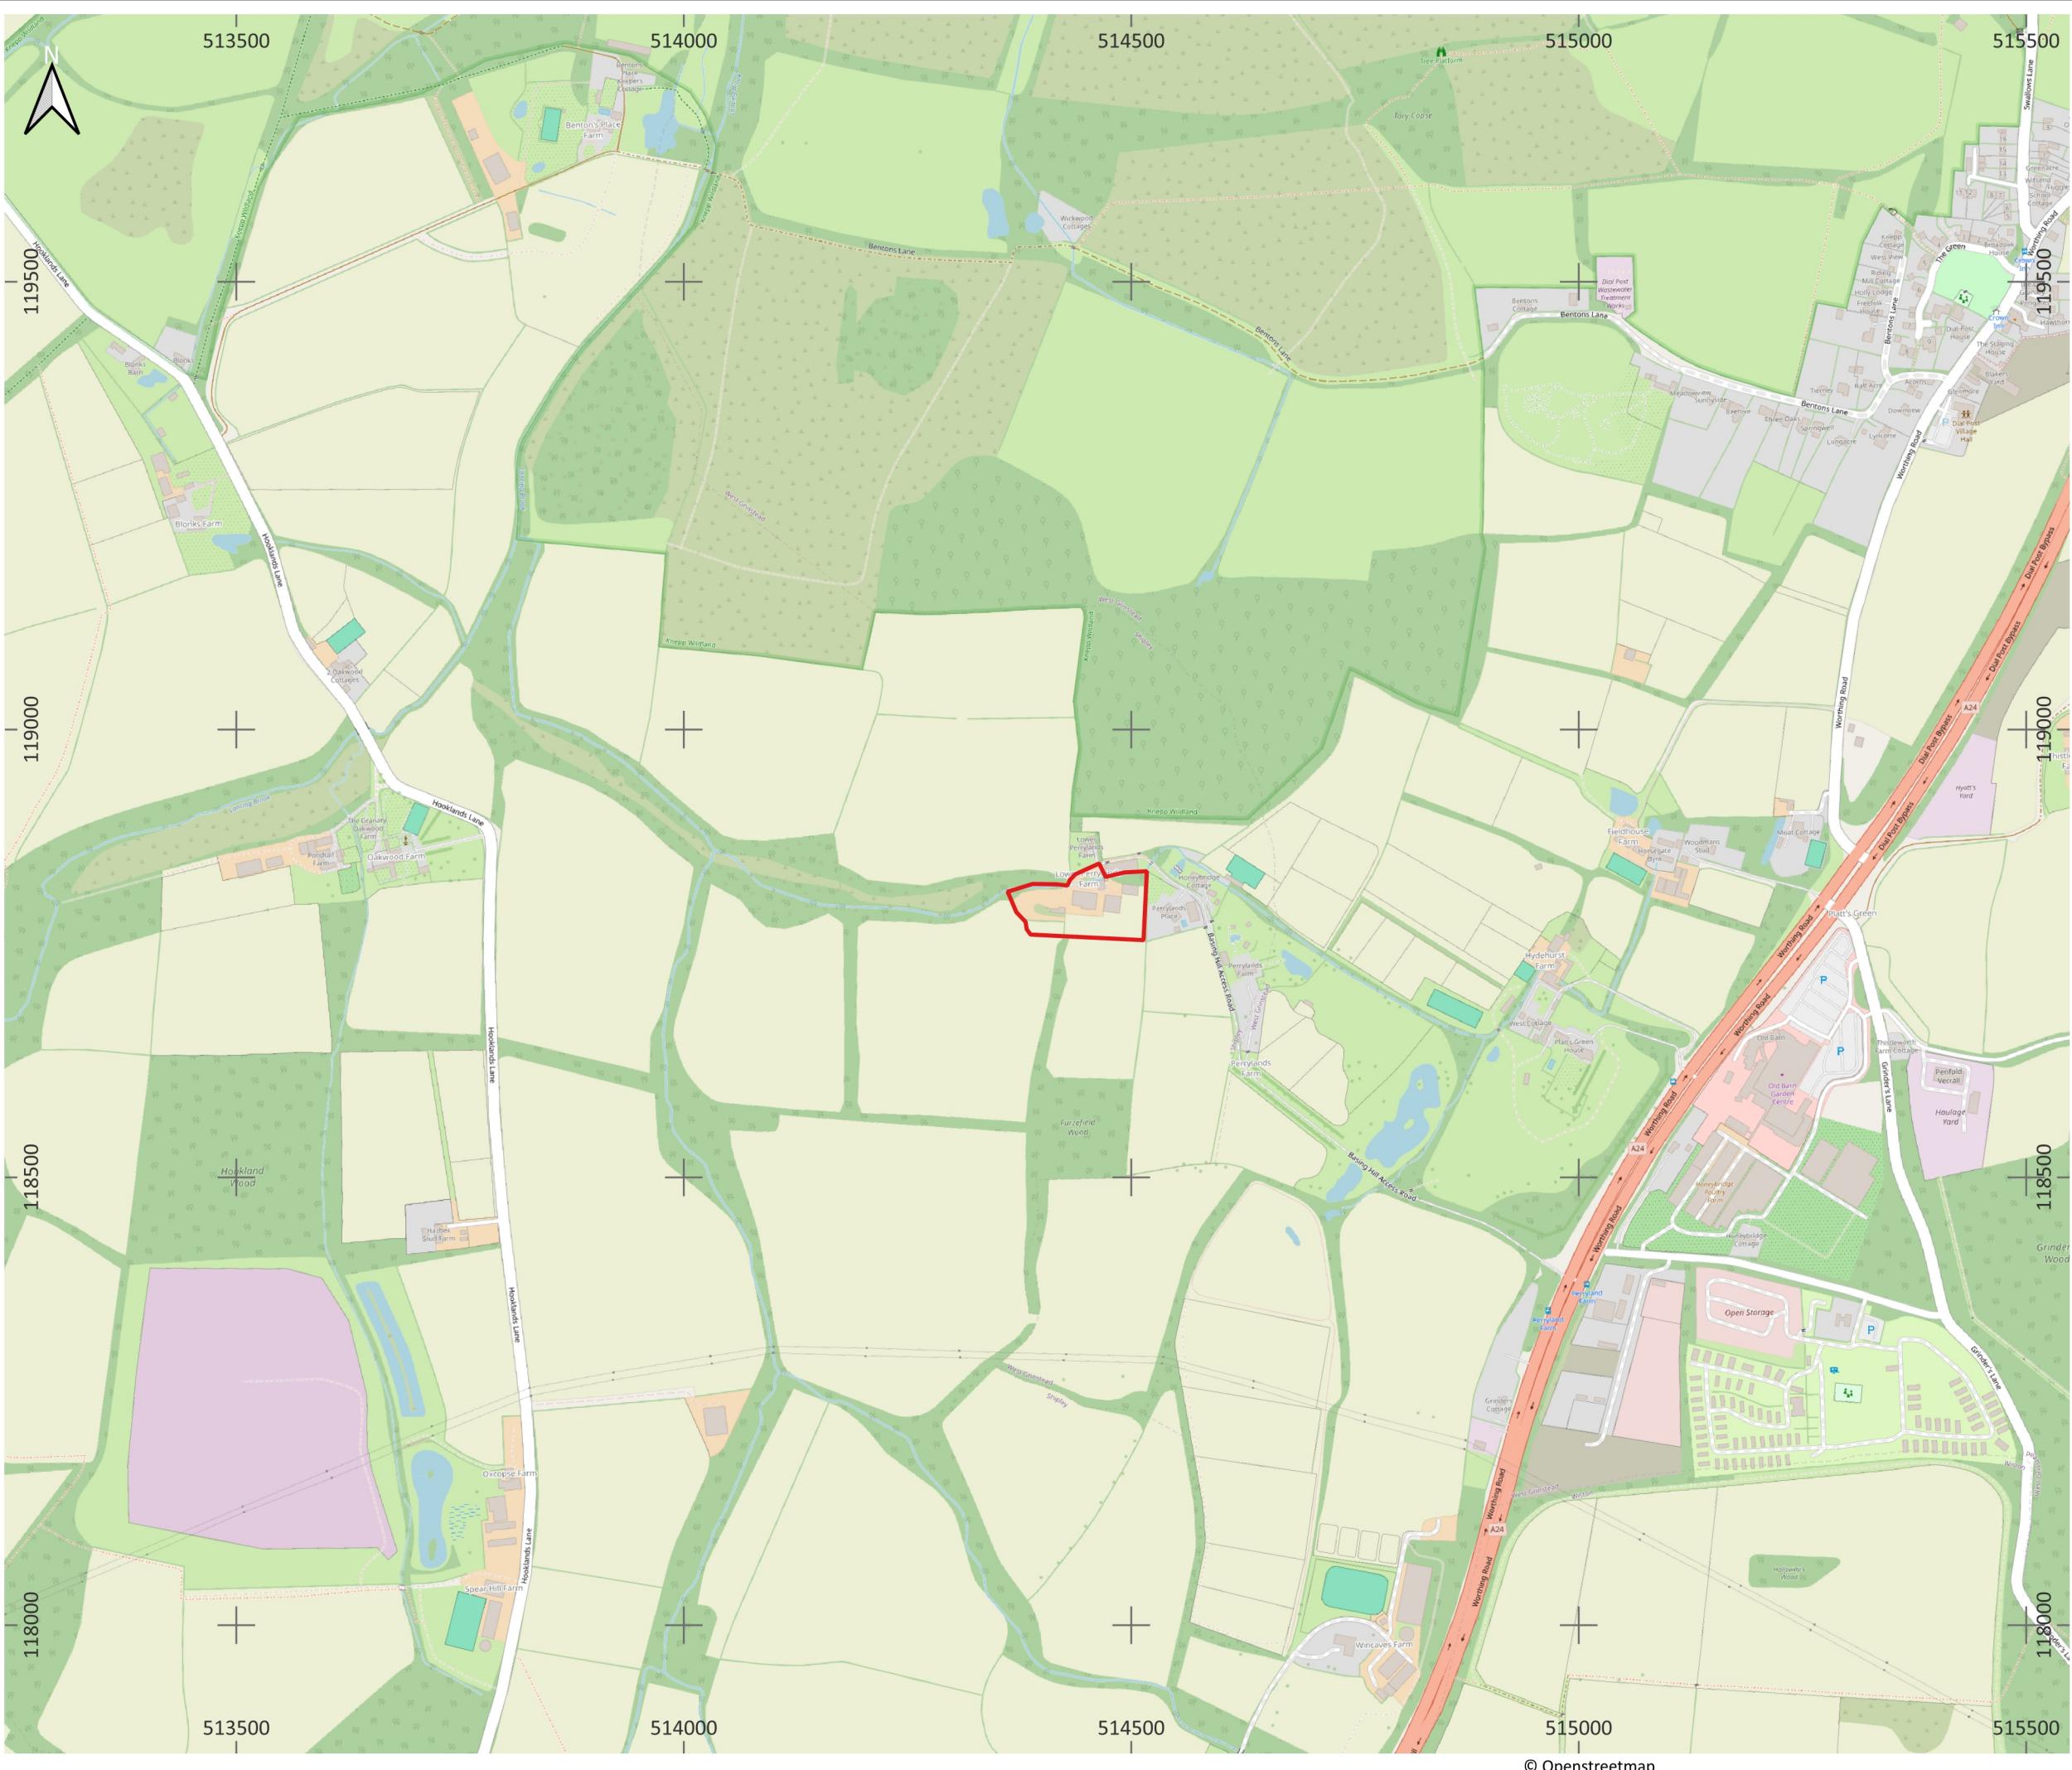
The site comprises an irregularly shaped 0.95 ha plot of land situated to the southwest of the village of Dial Post and to the west of the A24 centred on grid reference 514471, 118810. A site location plan is included as Figure 1 within Appendix B. The current layout is shown in Figure 2.

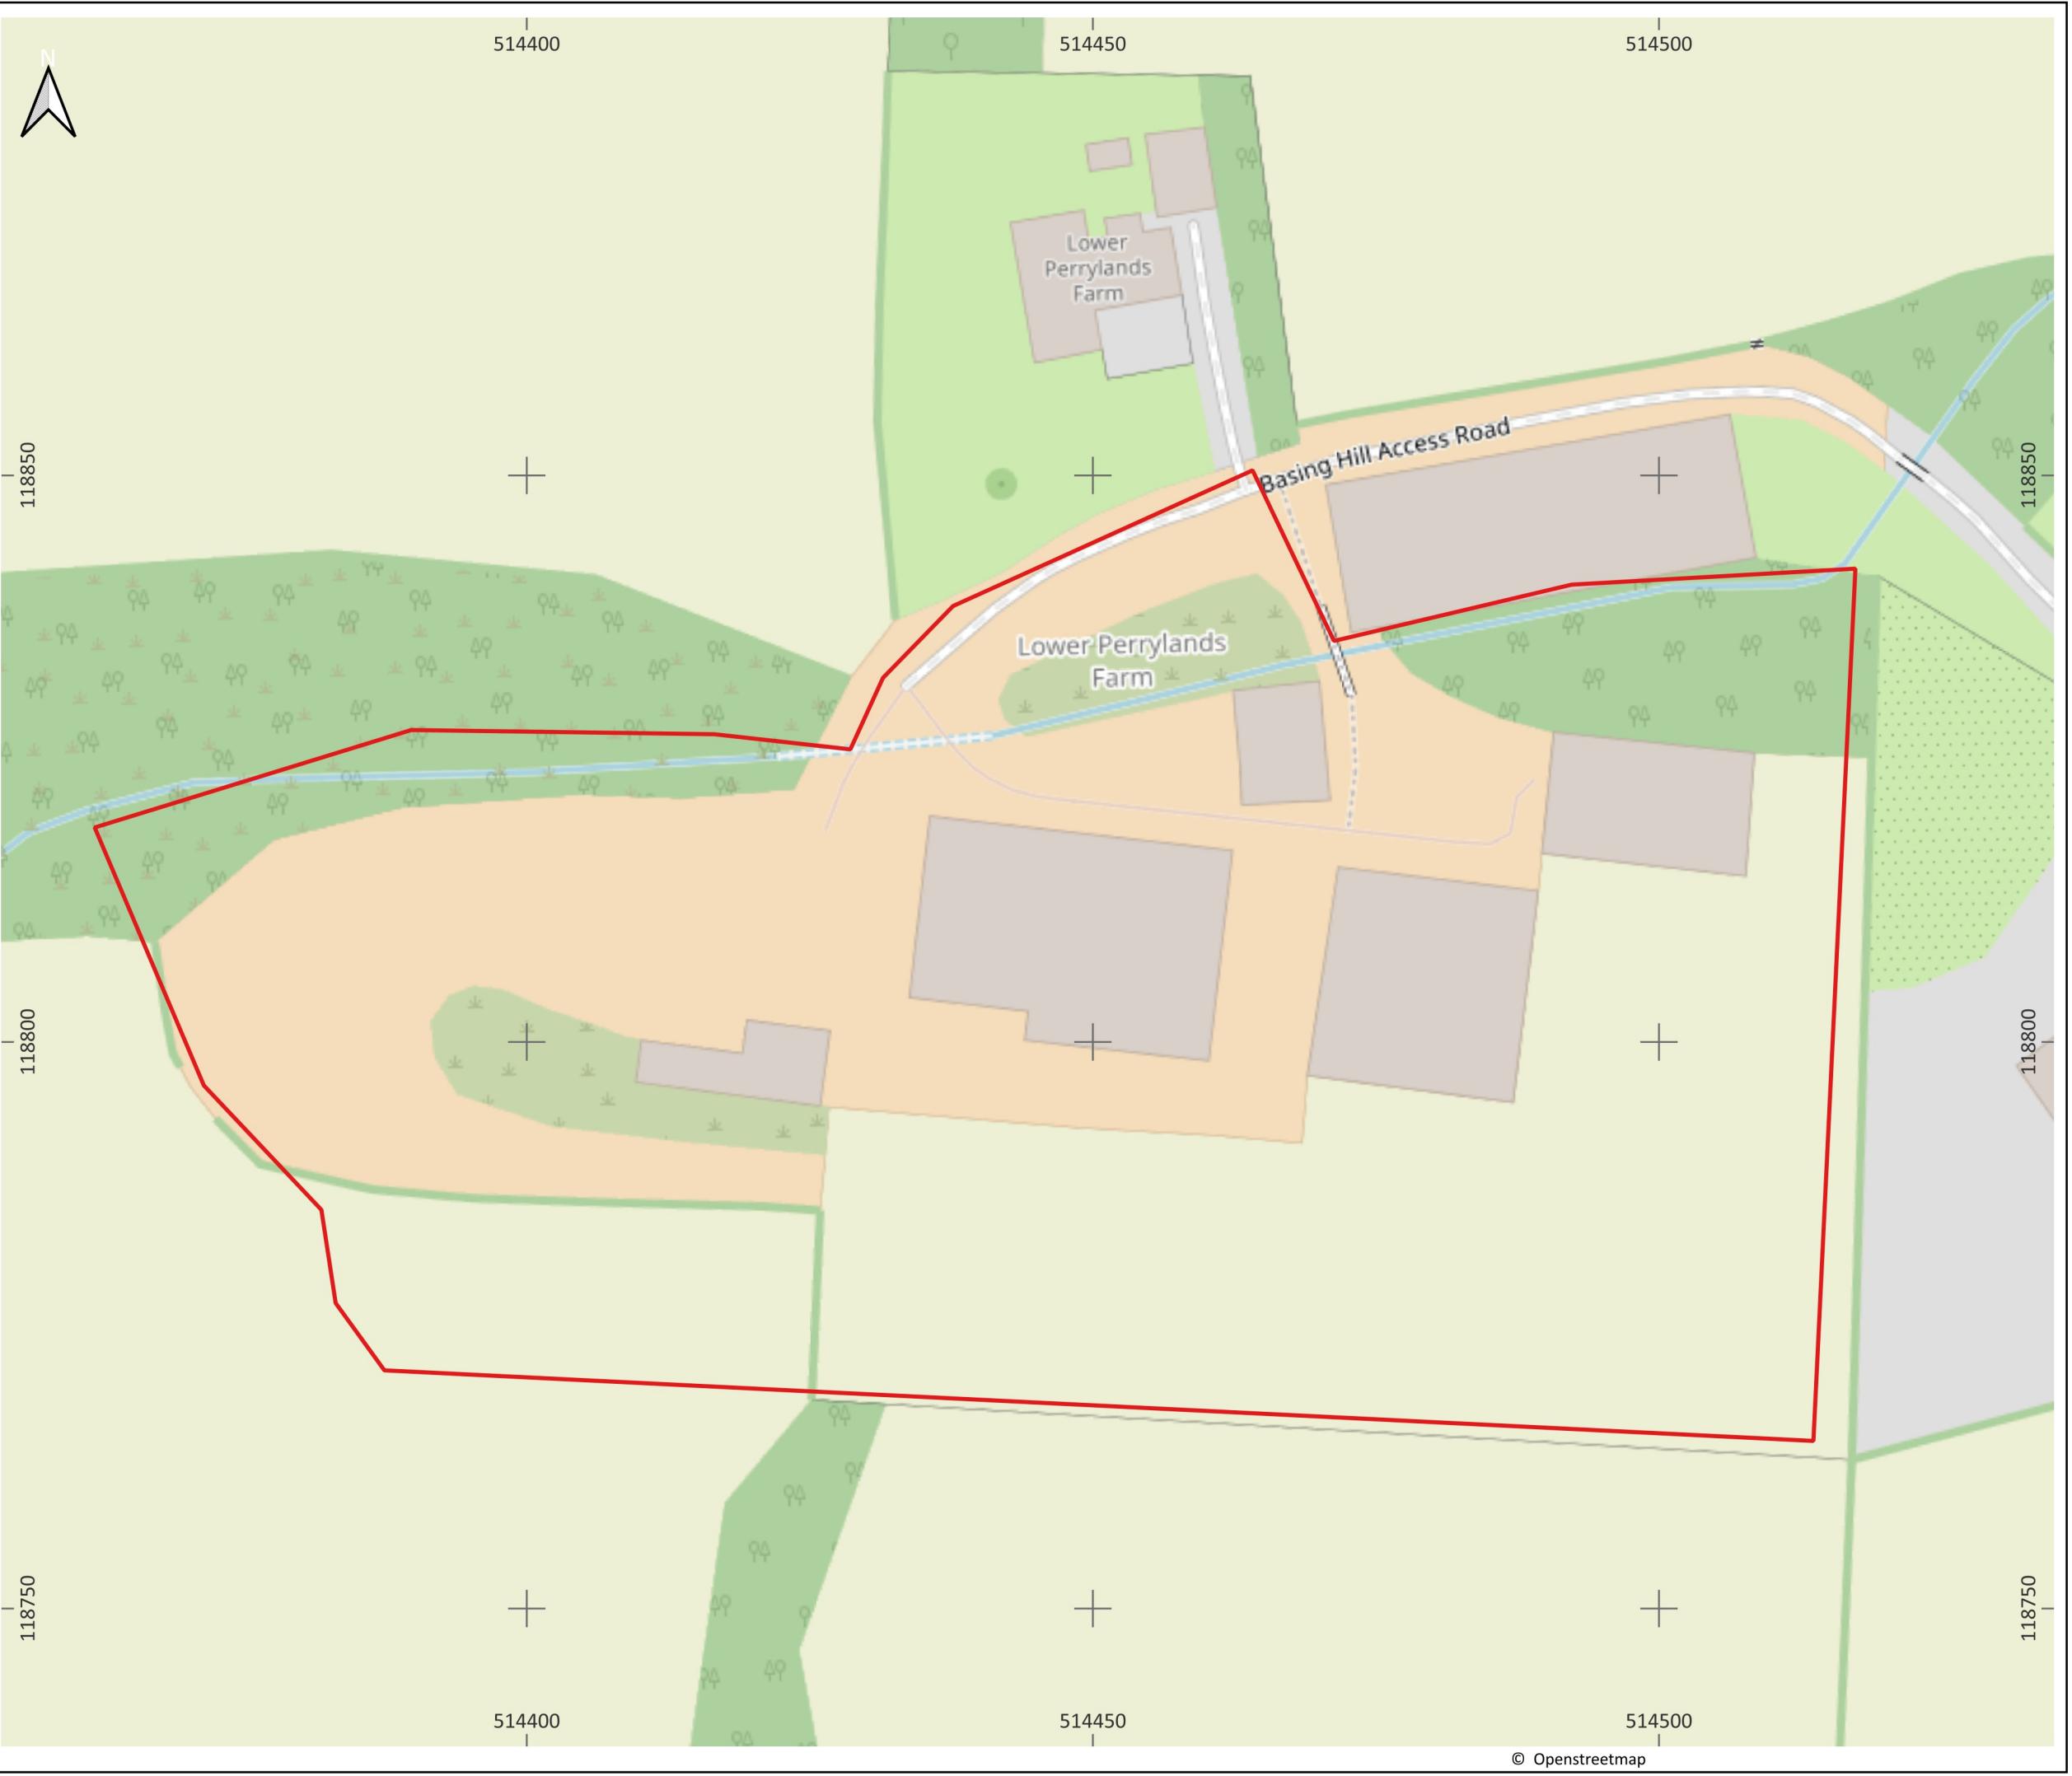
ONYXGEO CONSULTING LTD.		
46 Victoria Road, Burgess Hill, RH15 9LR		
e: info@onyxgeo.co.uk		
w: www.onyxgeo.co.uk		
Project name:		
Lower Perryland Farm		
Client:		
Lower Perrylands Limited		
Drawing No:		
ON251030-ON-PD-XX-DR-G-112-C01		
Description:		
Figure2 current site layout		
Project no:		Rev:
ON251030		C01
Date:		Scale:
29/05/2025		1:550
Drawn	Checked	Approved
ADC	SC	SC

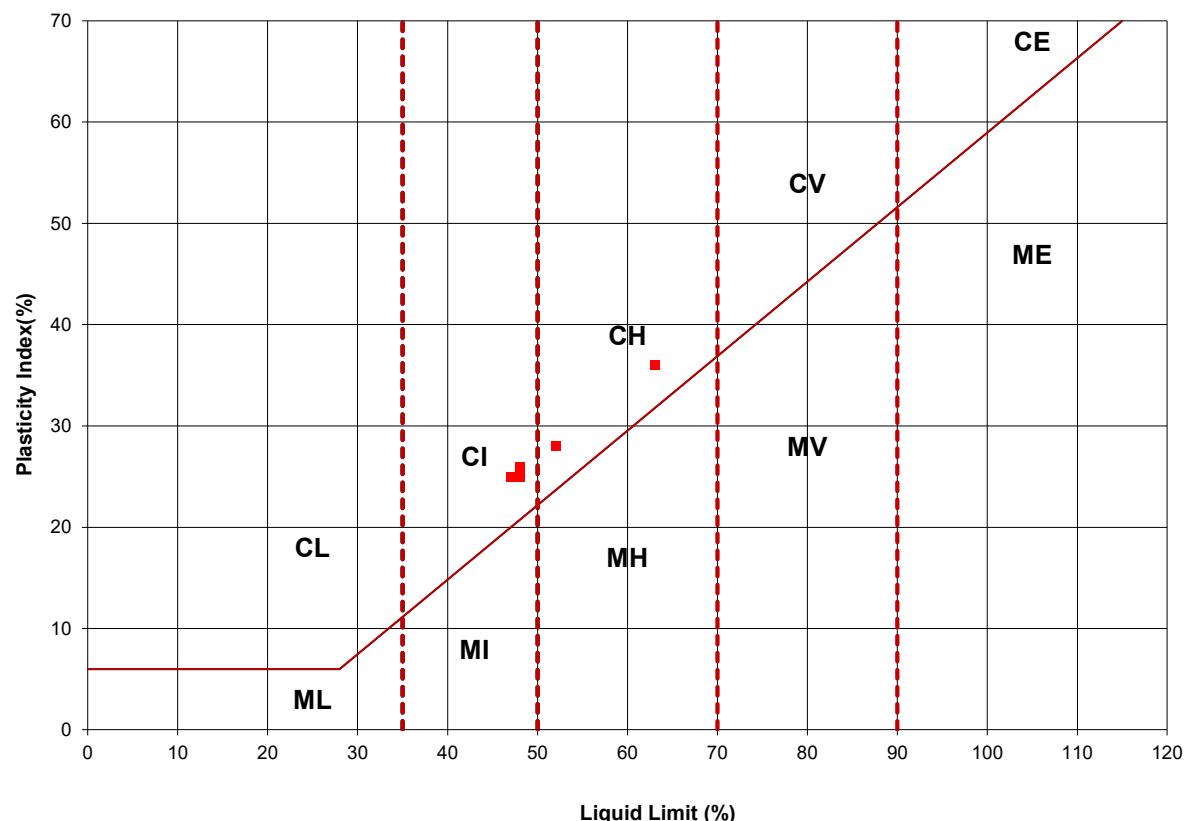
Atterberg Limits A-Line Plot

Test Type	Unit	Test Results Range
Moisture Content	(%)	21 – 25.9
Liquid Limit	(%)	47 - 63
Plastic Limit	(%)	22 - 27
Plasticity Index	(%)	25 - 36
Water Soluble Sulphate Content	mg/l	34 - 2600
Acid Soluble Sulphate	%	0.077 – 8.0
Total Sulphur	%	0.025 – 2.2

The NHBC² provides guidance for the construction of foundations on soils subject to shrinkage and swelling due to their volume change potential (VCP) and the impact of trees and other vegetation. Based on the results of Atterberg limit testing the soils on site are classified as **High VCP**. Deepening may be terminated where intact mudstone is encountered.

Based on the results of Atterberg limit testing the clay soils are non frost susceptible as the plasticity indices exceed 20% for poorly draining soils.

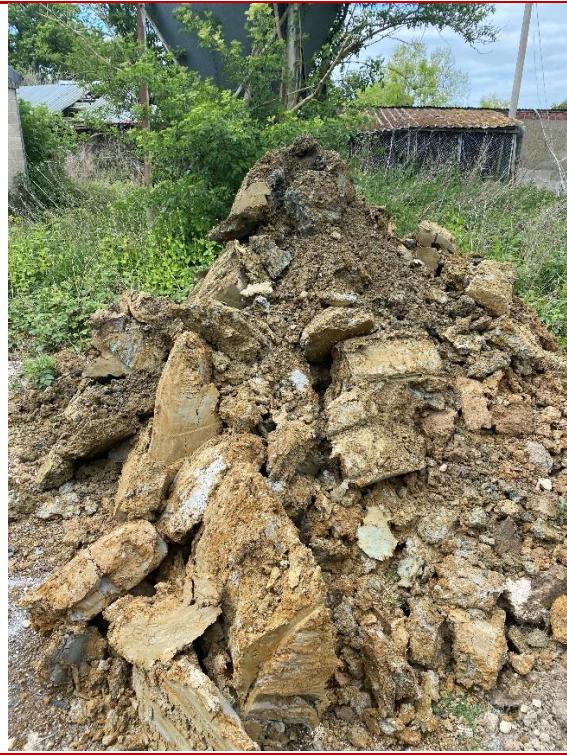
Photo 2 – TP01 arisings.

Sulphate and sulphur testing returned highly variable results with significantly higher concentrations recorded within one sample taken from TP01. It is noted that this sample contained significant amounts of selenite and therefore the elevated sulphate concentrations are to be anticipated.

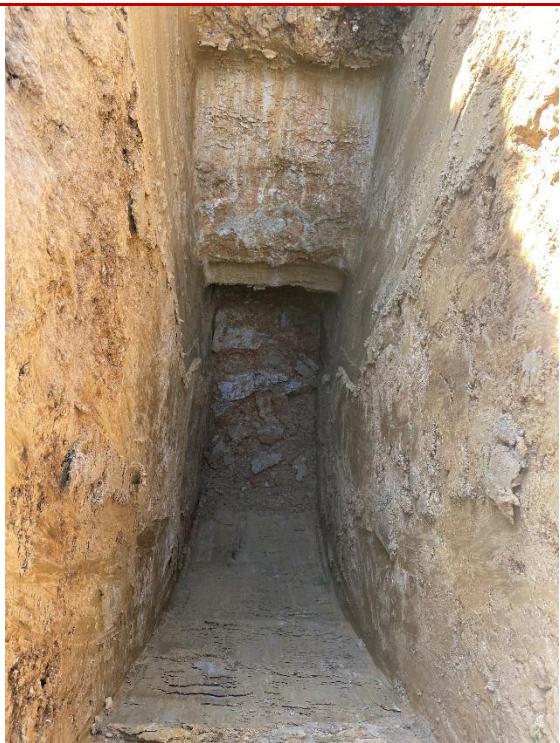
Photo 4 – TP03 prior to reinstatement.

A slight groundwater seepage was recorded at 2.8 m bgl in TP05 while the arisings were noted to be damp below 2.3 m in TP03. In both cases these levels broadly correspond to the boundary between the stiff clay and the underlying mudstone.
