Preliminary Ecological Appraisal and Roost Assessment

Site 2, 1 Hilltop Cottages, The Mount, Ifield, Crawley, West Sussex RH11 0LF

This report is prepared to inform a planning application with the Horsham District Council. The proposal is described as:

The construction of five residential dwellings with associated landscaping.

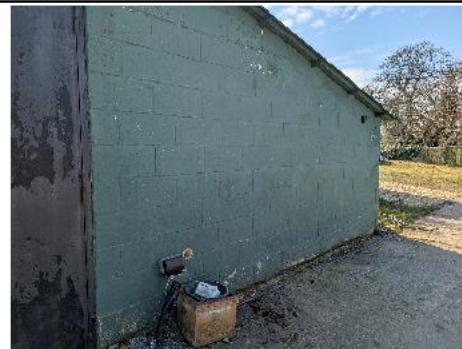
Fig 3

<p>Fig 2</p>
B1 – exterior	<p>The breezeblock and mortar walls appear to be in good condition (Fig 3), leaving no gaps. The windows (Fig 4) and doors (Fig 5) appear to be tightly fitting and in good condition, leaving no gaps.</p>

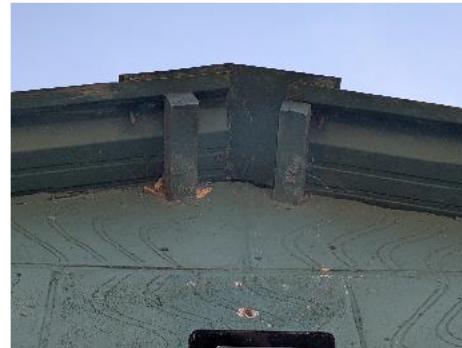
Fig 6

There is a small gap between the overhanging eaves and wall on the northern elevation (Fig 6), however, this does not appear to be big enough to provide a suitable roosting feature or internal access. Eaves along the eastern and western elevation are filled (Fig 7), preventing access to the interior of B1. The metal ridge is lifted in places (Fig 8), providing a potential roosting location for crevice dwelling bat species. Due to the metal construction, however, this is considered to be sub-optimal due to high fluctuation in temperature. It is therefore unlikely that bats will be roosting in this location.

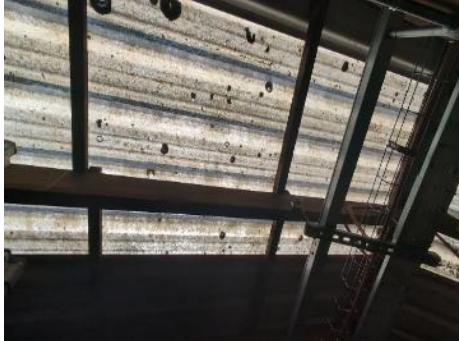
B1 – interior	Due to the corrugated plastic sheets on the roof (Fig 9), the light levels within B1 are very high, resulting in this being an unsuitable roosting location for void dwelling bat species. No internal roosting features were identified for crevice dwelling bat species, and no points of access were identified internally or externally.
---------------	--

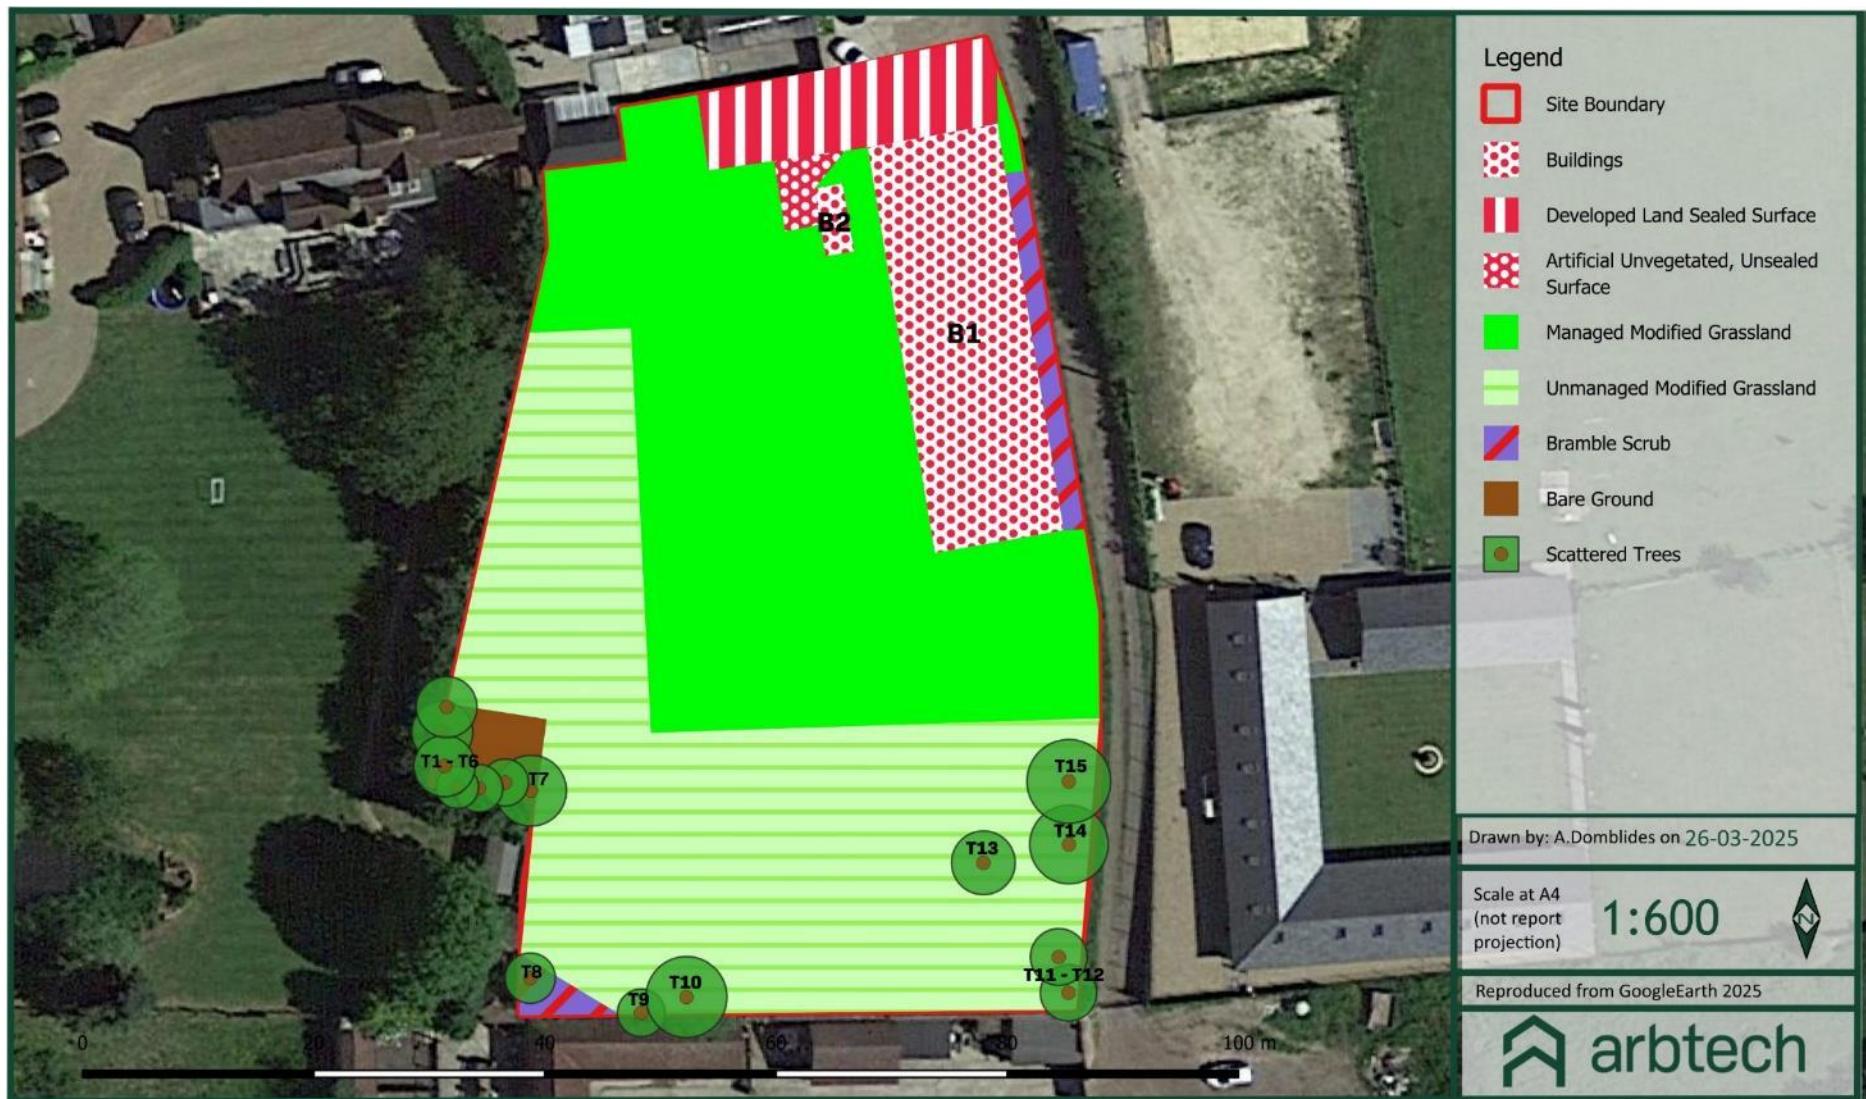
Appendix 1: Survey/Habitat map

<p><u>UK Habs Description and Codes:</u></p> <p><u>Developed Land; Sealed Surface [u1b]</u> There is a concrete driveway to the northeast of site.</p> <p><u>Artificial unvegetated – unsealed surface [u1c]</u> There is a small area of shingle connecting the driveway to B2.</p> <p><u>Bramble Scrub [h3d]</u> There is a long, thin strip of bramble scrub between B1 and the site boundary along the east of site. In addition, there is a small area of bramble scrub to the far northeast of site, with a small amount of cherry laurel present.</p> <p><u>Scattered trees [u1.32]</u> Fifteen scattered trees were identified on site. Trees of the same species within close proximity of each other have been grouped together.</p>

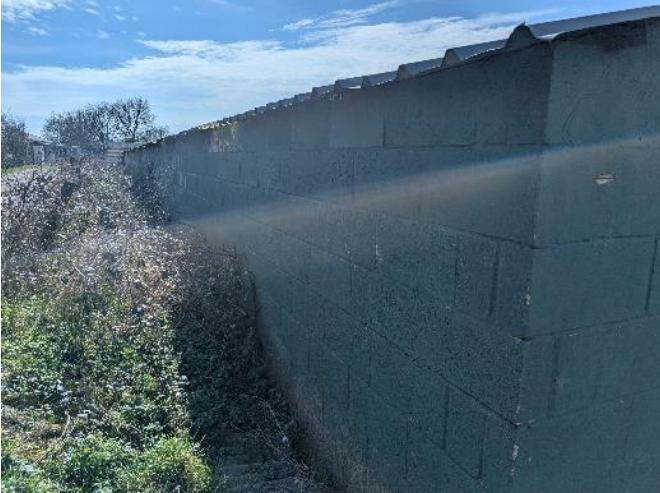
Picture 1: Bramble scrub to the east of site	Picture 2: Managed modified grassland with areas of bare ground in the centre of site

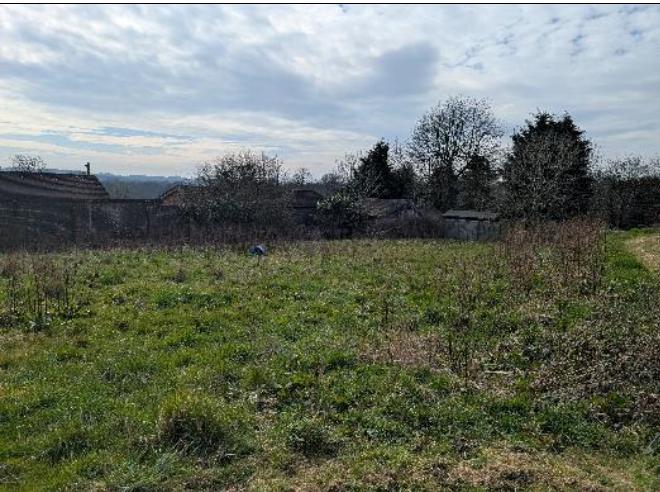
Picture 3: Unmanaged modified grassland to the south of site	Picture 4: Unmanaged modified grassland to the south of site with scattered trees

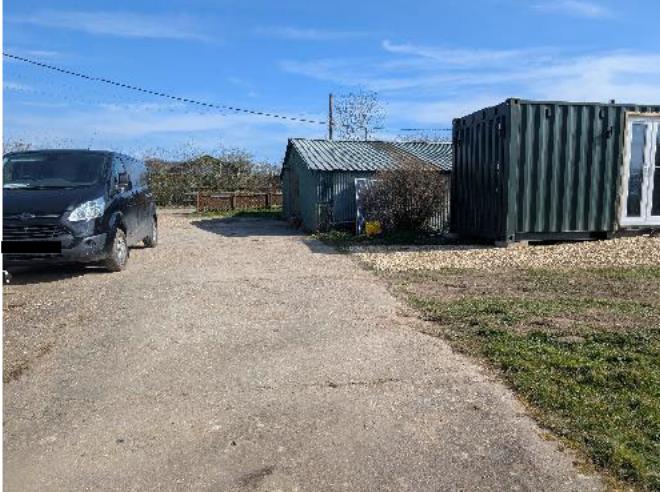
A photograph of a grassy field with a white boat and some buildings visible in the background under a blue sky.
Picture 5: Hardstanding and unvegetated unsealed surface to the north of site	Picture 6: Site overview
