**LAND NORTH-WEST OF  
SOUTHWATER, HORSHAM**

**ENVIRONMENTAL STATEMENT,  
PRELIMINARY MINERAL RESOURCE  
ASSESSMENT**

**FEBRUARY 2026**

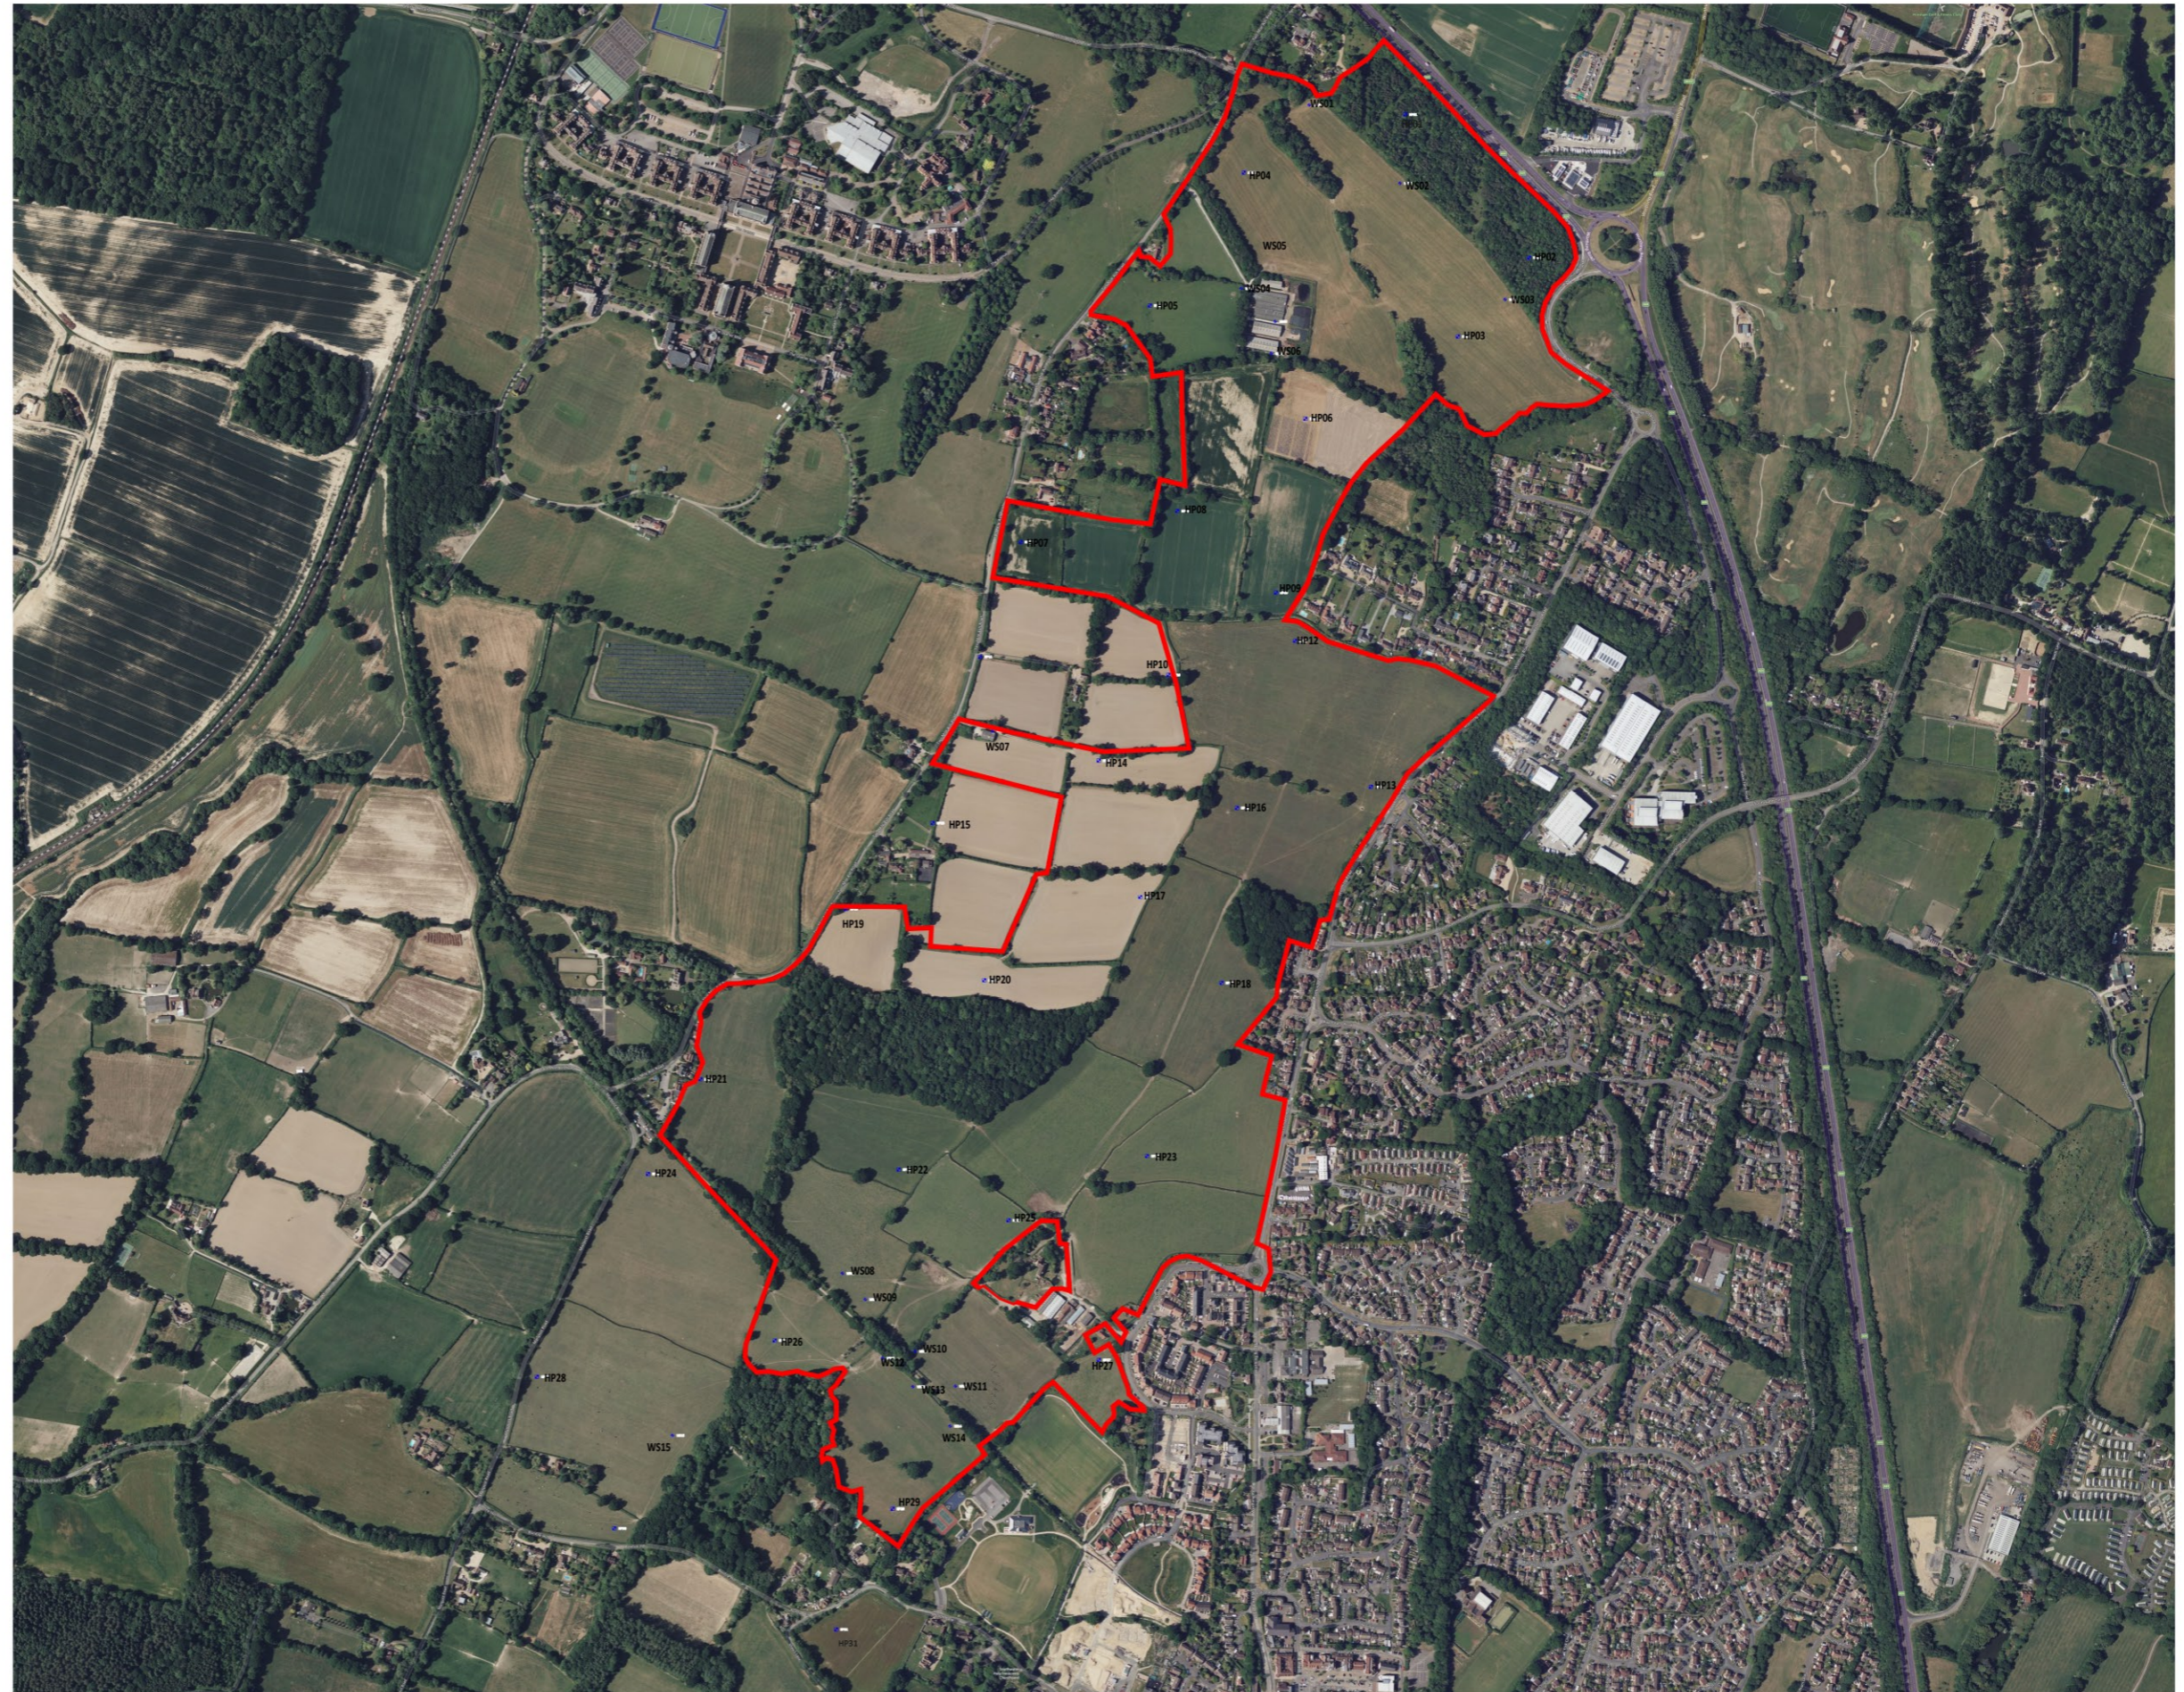
Project No.	UK0043490.9681	Scale	NTS
Date	January 2026	Figure No.	3-1
Project	Land North-West of Southwater	Drawn by	WB
Title	Borehole location plan – Car Park Site	Checked by	AM

- SITE BOUNDARY
- HAND PIT LOCATIONS
- WINDOW SAMPLING LOCATIONS

Locations are noted on **Figure 2-1 and 3-1** in **Appendix A** and a copy of the BGS logs are presented in **Appendix C**.

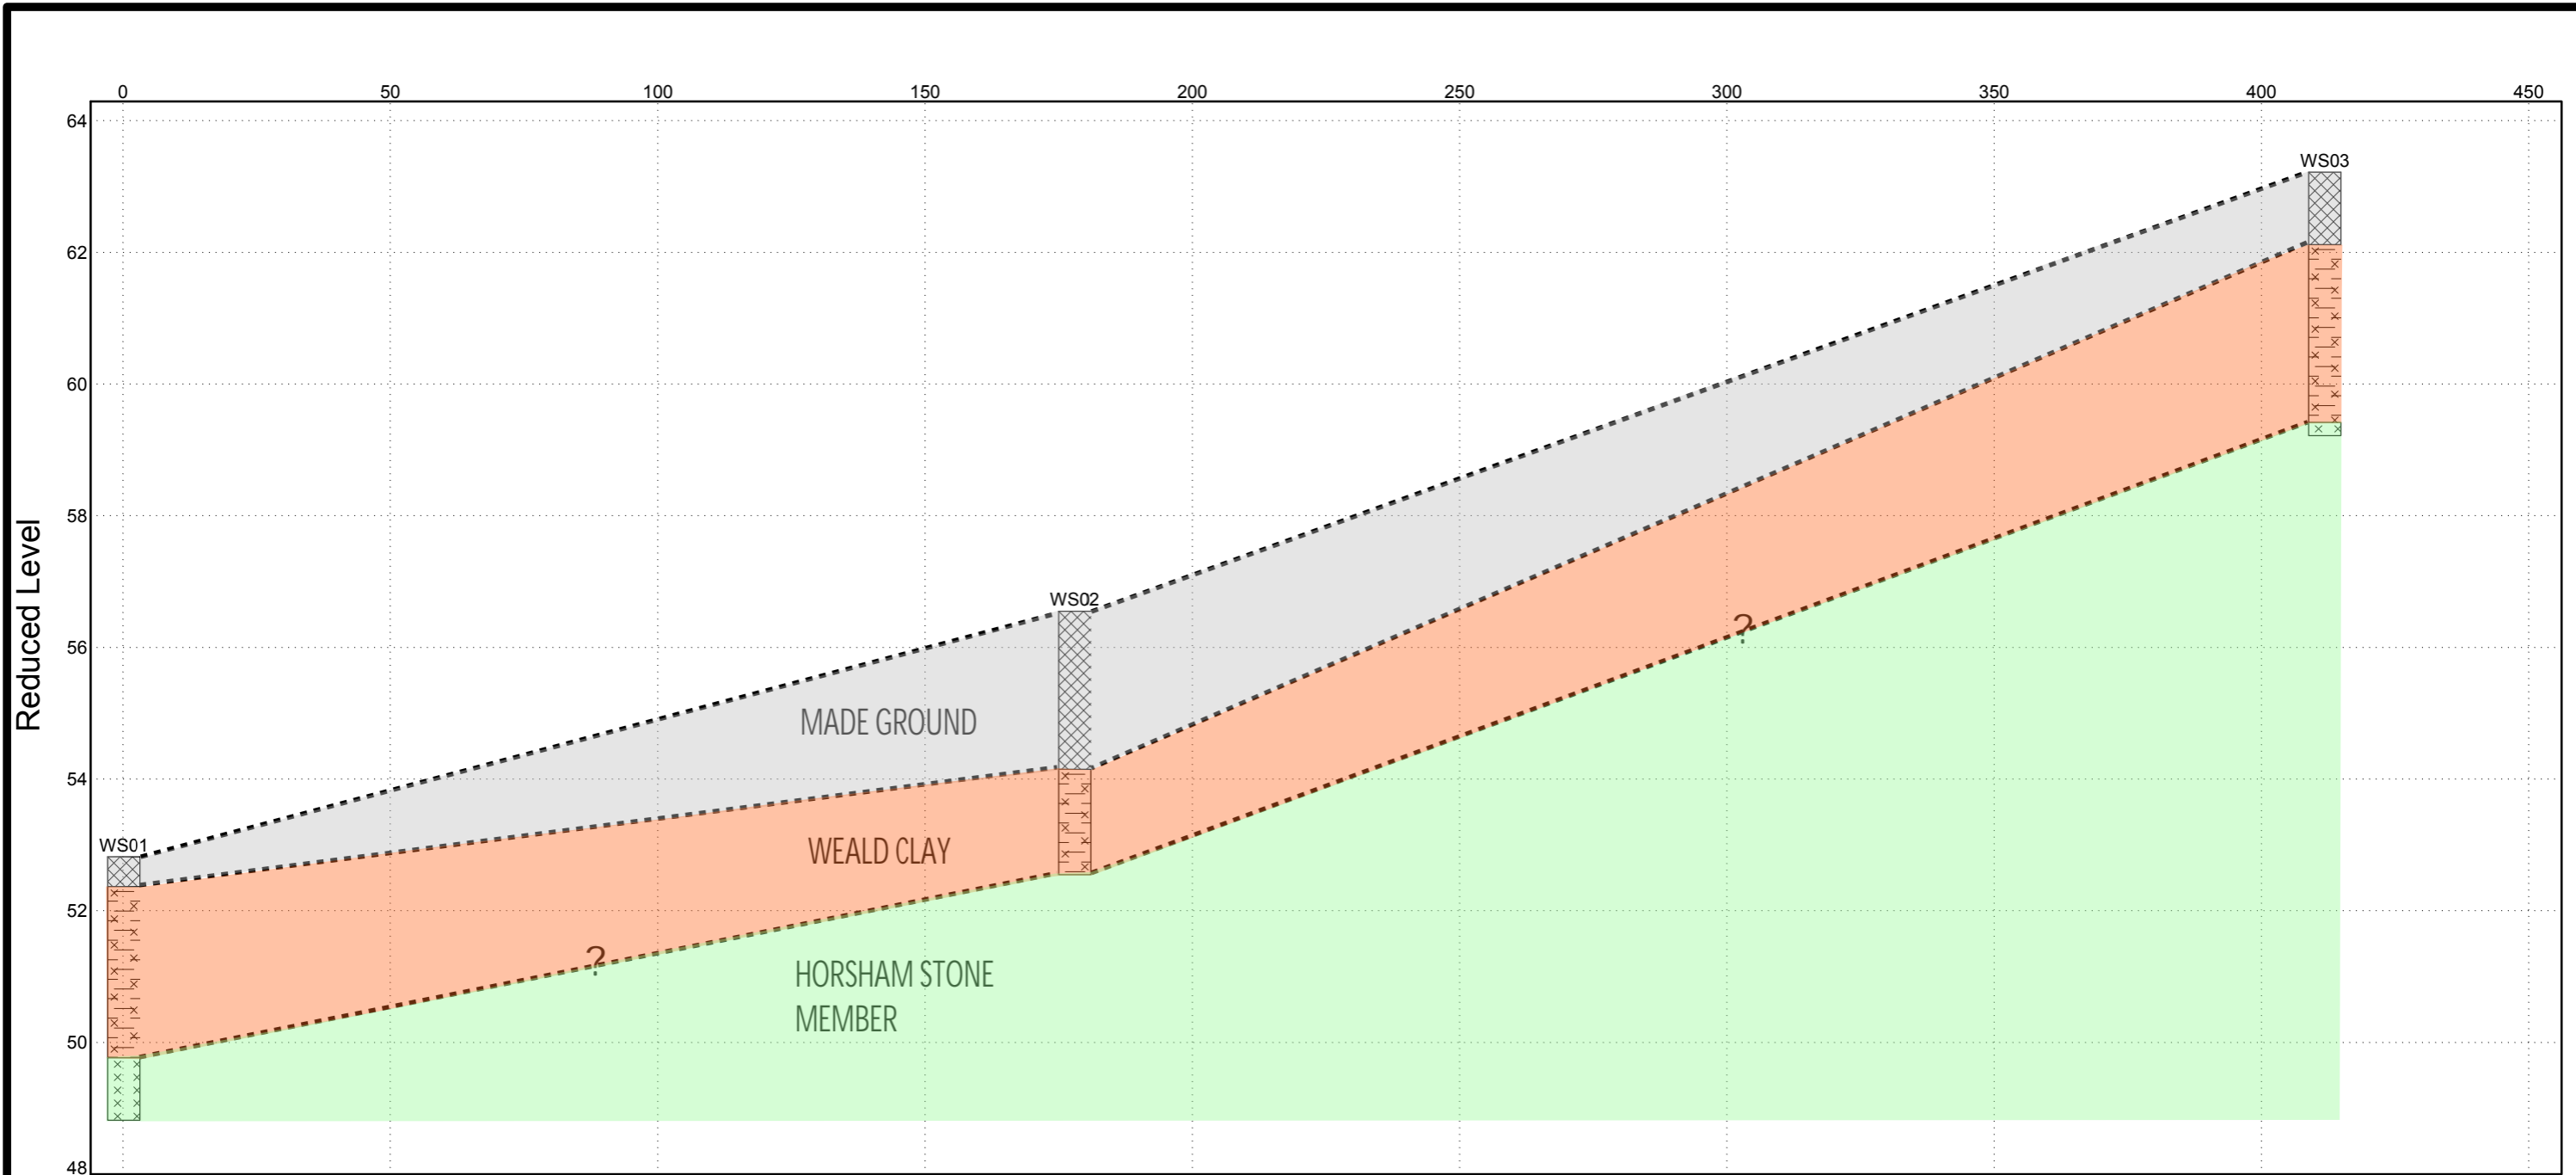
**Figure 5 - SECTION A to B**  
 Client: Berkeley Strategic  
 Project: Land North-west of Southwater  
 Number: UK0043490.9681

This is a generalised section based on ground conditions encountered in exploratory holes. Actual ground conditions including depths and the properties of strata may vary.

COHESIVE MADE GROUND	Silty CLAY
SILTSTONE

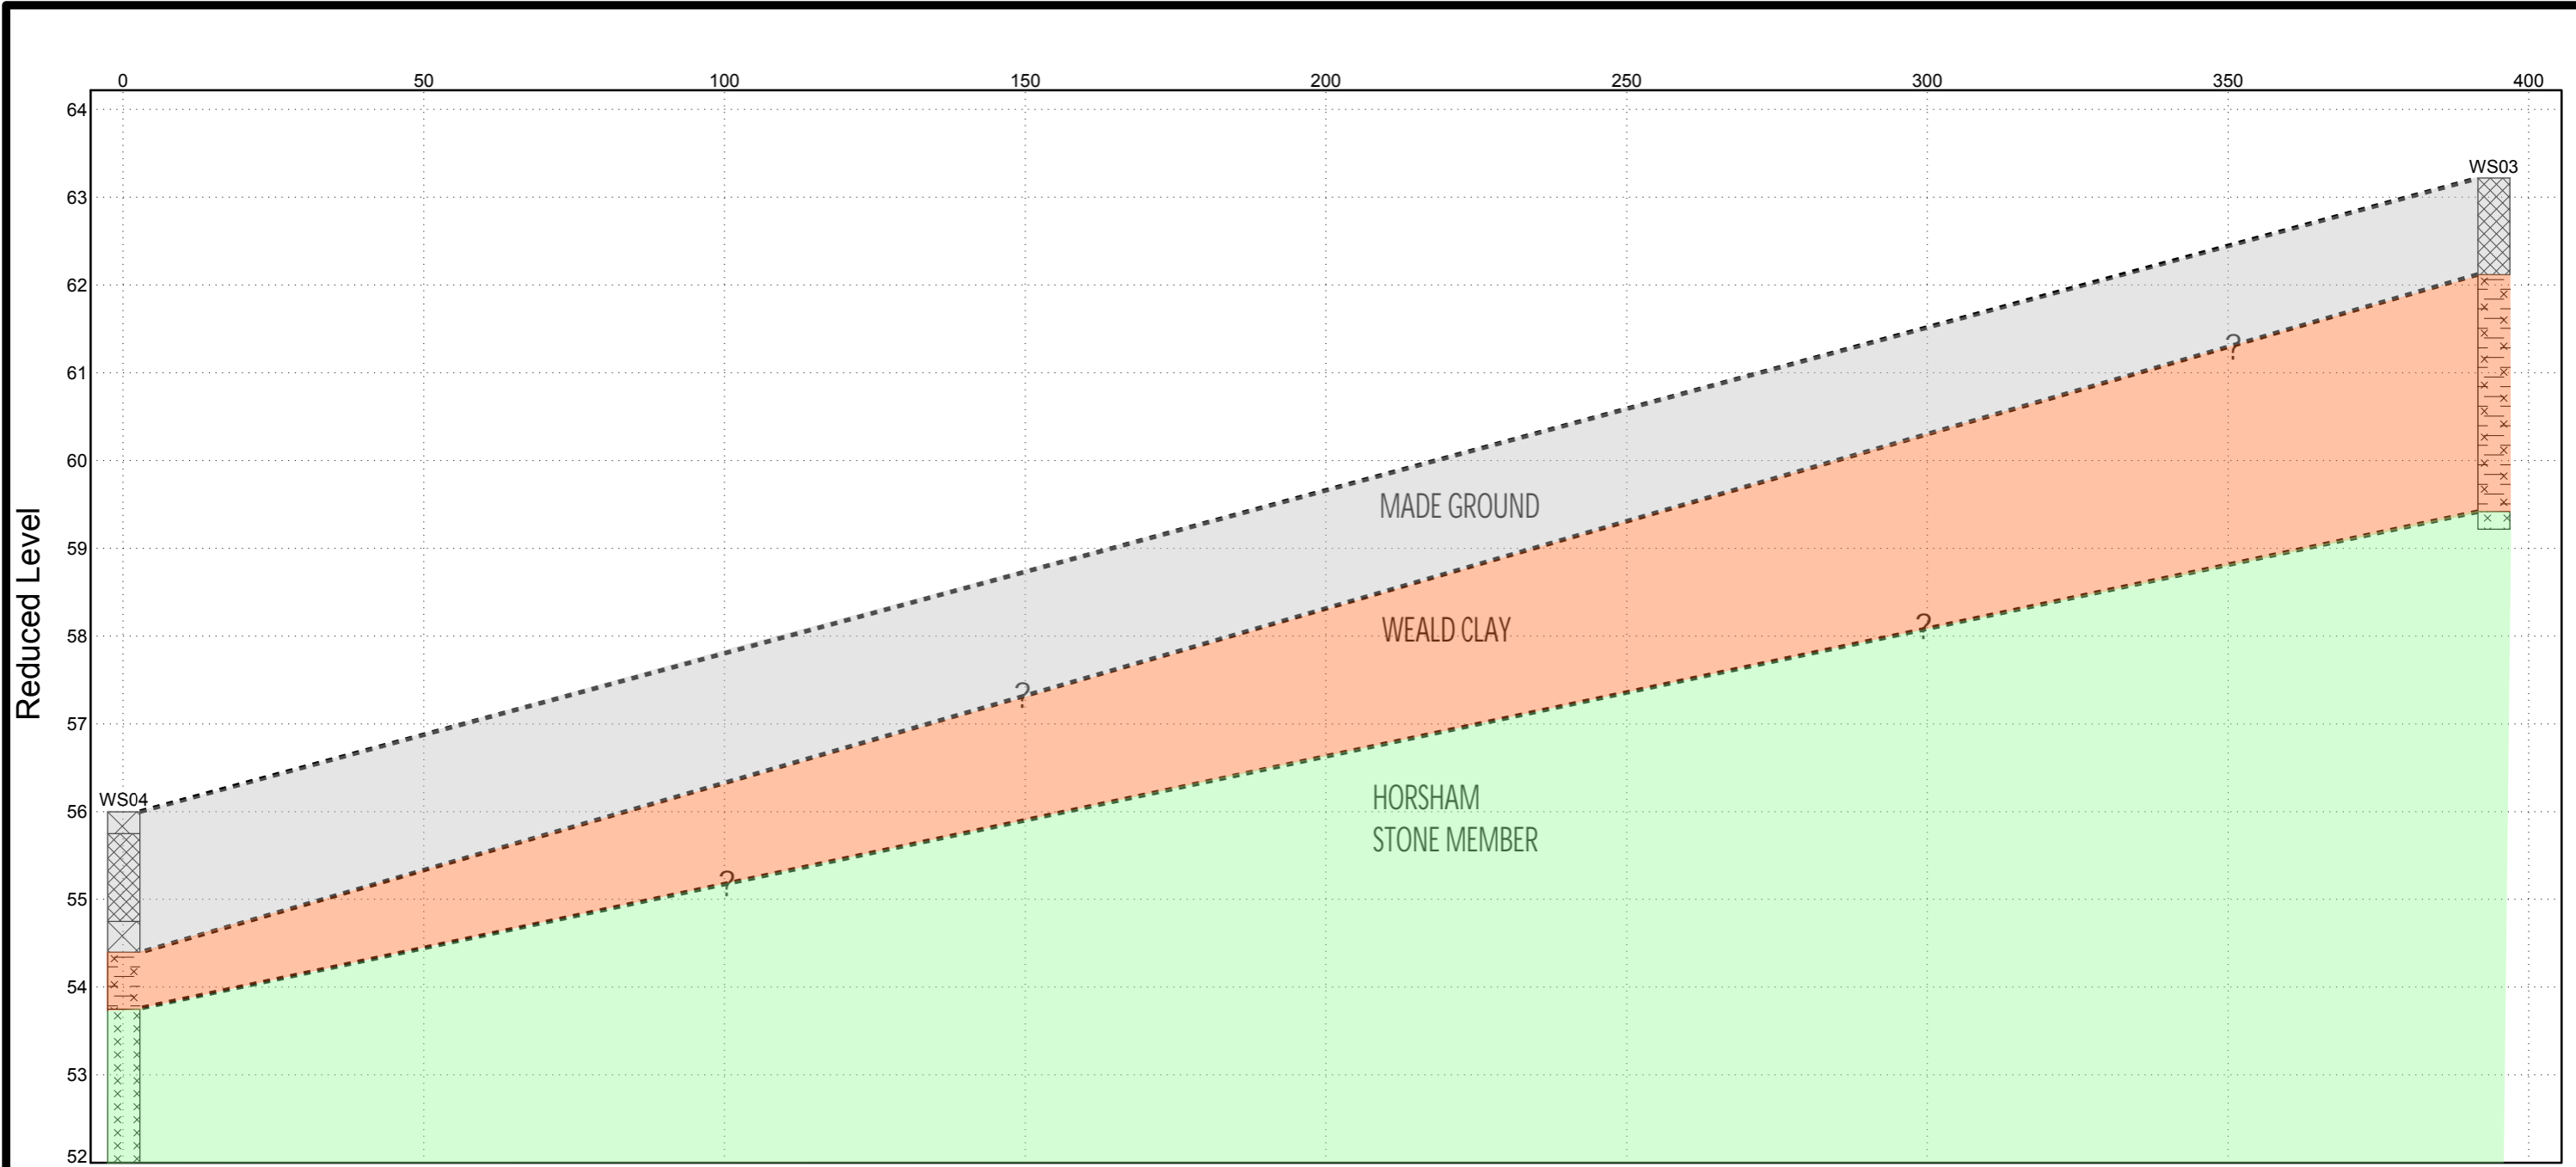
**Figure 5 - SECTION C to D**  
Client: Berkeley Strategic  
Project: Land North-west of Southwater  
Number: UK0043490.9681

This is a generalised section based on ground conditions encountered in exploratory holes. Actual ground conditions including depths and the properties of strata may vary.

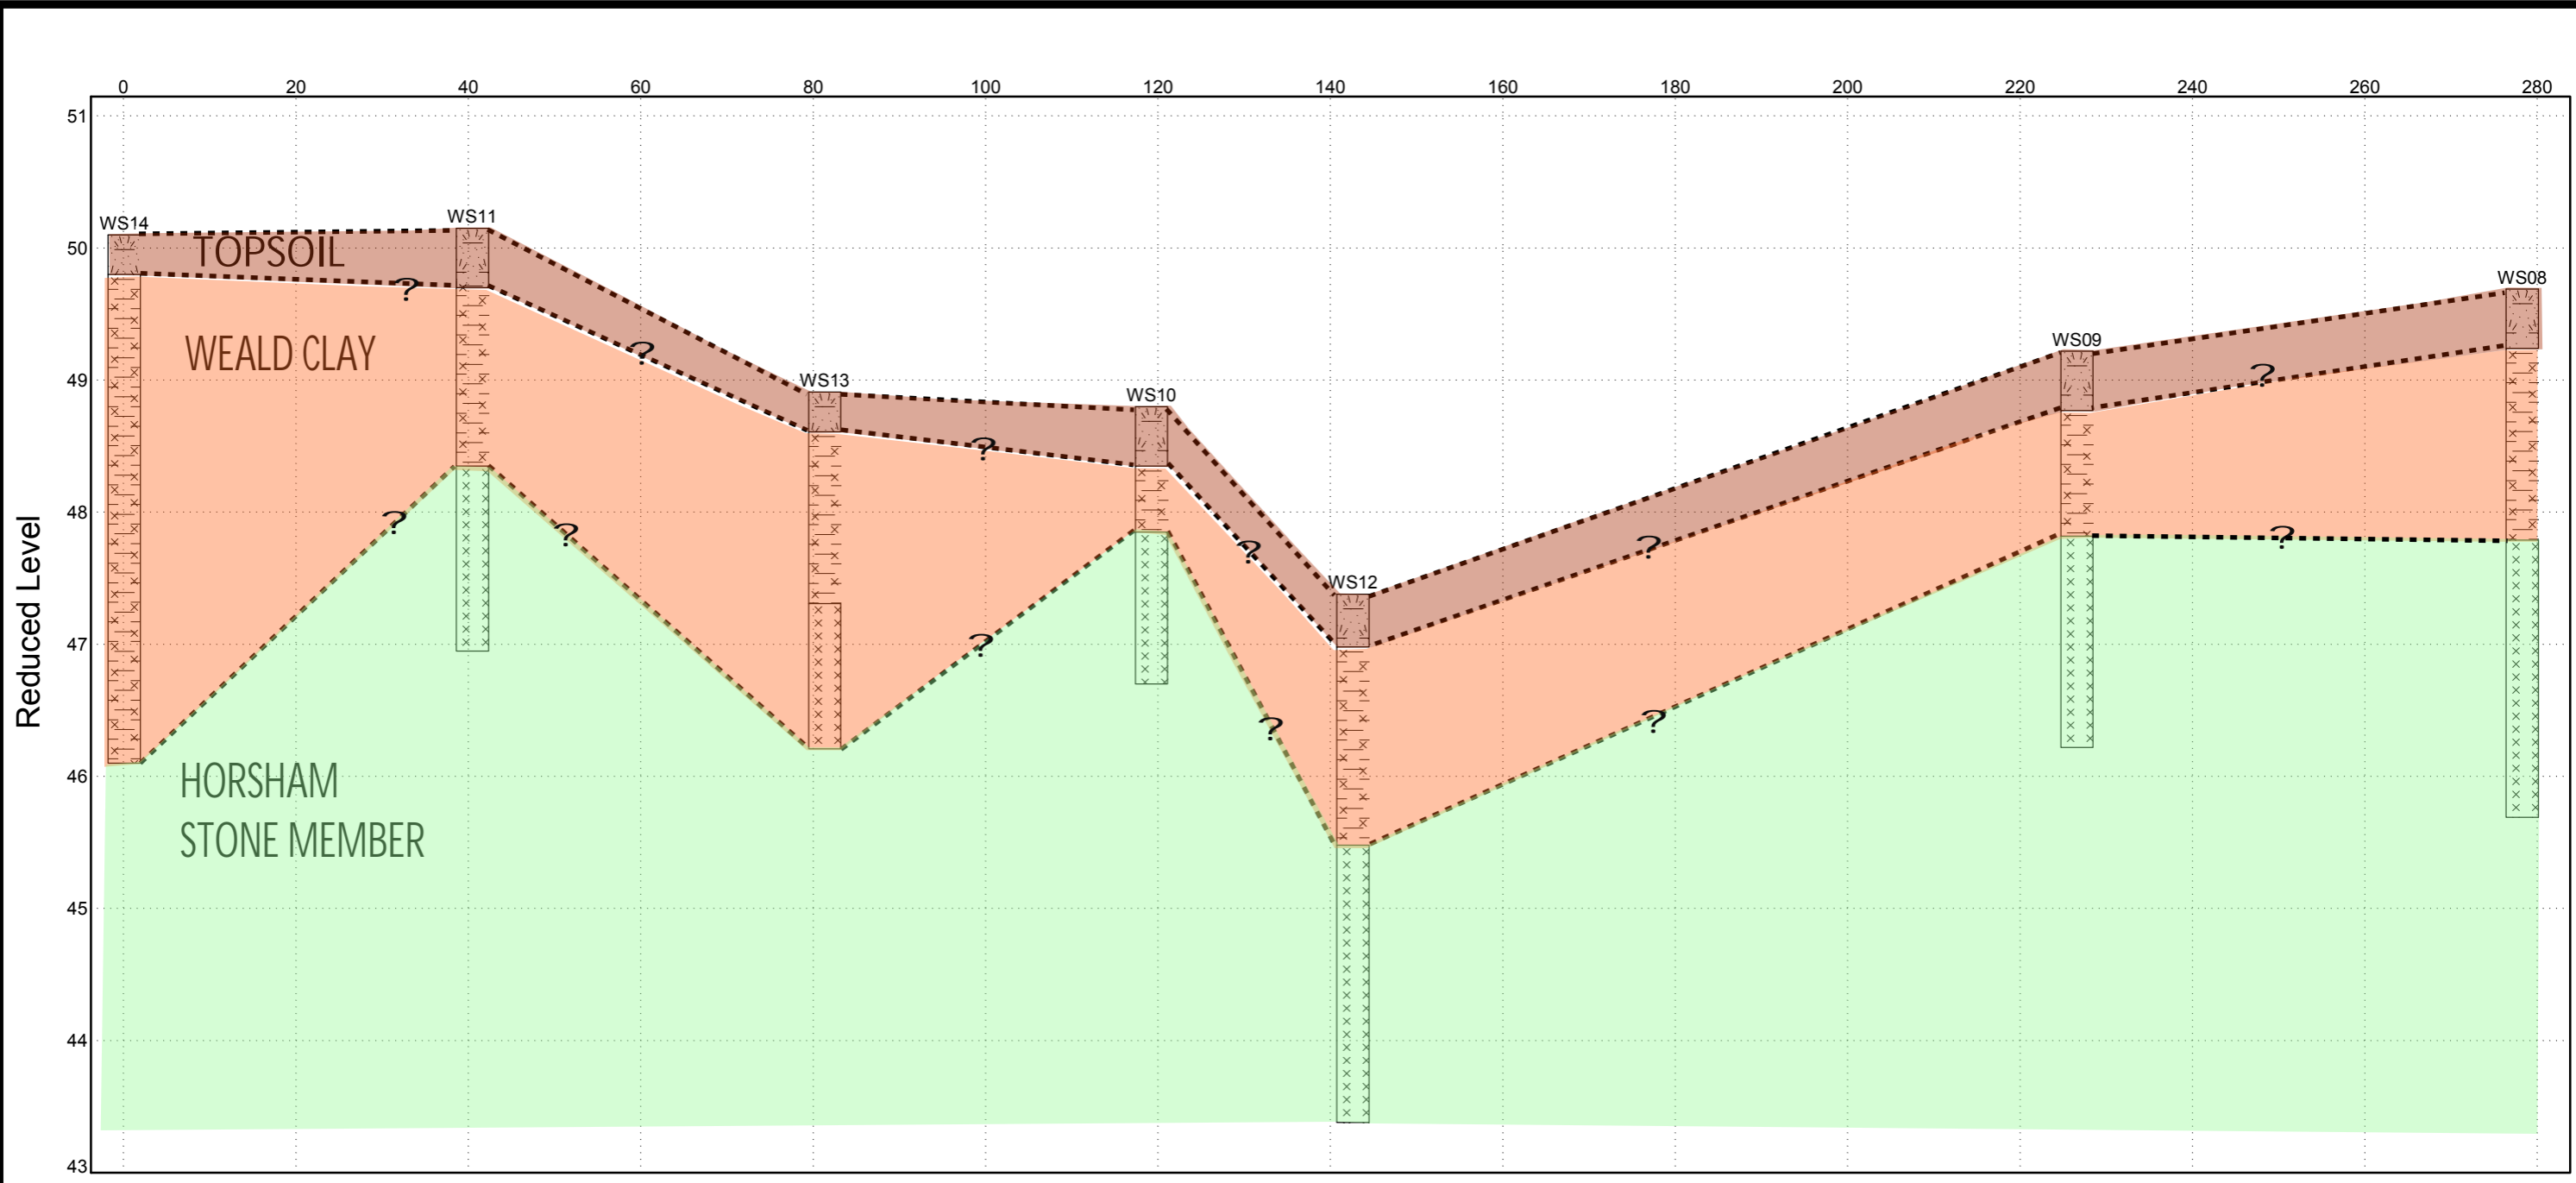
**Figure 5 - SECTION E to F**  
 Client: Berkeley Strategic  
 Project: Land North-west of Southwater  
 Number: UK0043490.9681

This is a generalised section based on ground conditions encountered in exploratory holes. Actual ground conditions including depths and the properties of strata may vary.

TOPSOIL		Silty CLAY
	SILTSTONE
