Bat Survey Report
Threal's Farm Cottages,
Threal's Lane, West
Chiltington

Leith Ecology Consulting Ltd. conducted a preliminary bat roost assessment (PRA) and bat emergence survey at Threal's Farm Cottages, West Chiltington, Pulborough, RH20 2RF. This assessment was commissioned to support a planning application for the demolition of the existing cottages and the construction of three new residential properties with associated land use.

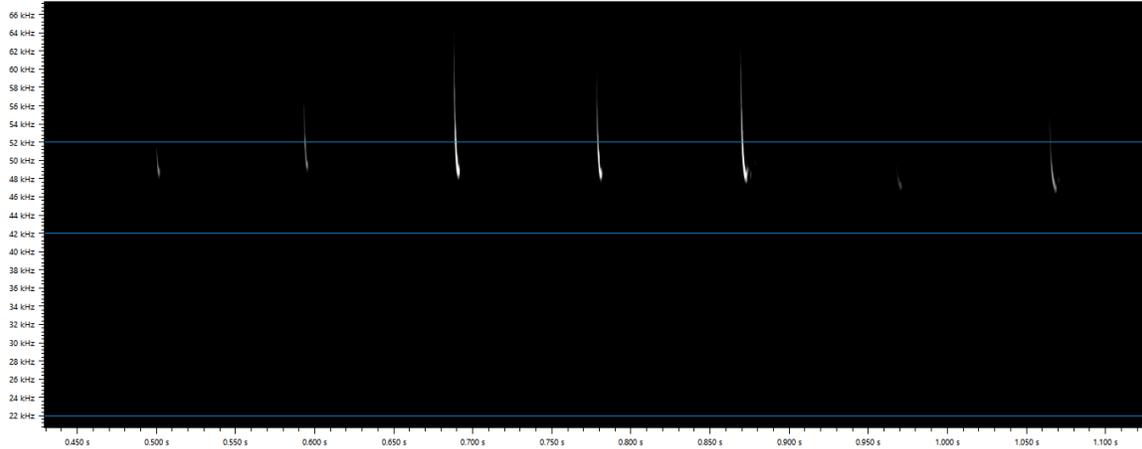
Two bats were observed emerging from the apex of the property's western gable end at 21:28hrs (approximately 23 minutes after sunset) in short succession to each other, flying directly to the west. Post survey sonogram processing concluded these were common pipistrelle bats (see *Figure 1*).

Figure 1: Sonogram of common pipistrelle bat emerging from the building during survey 1.

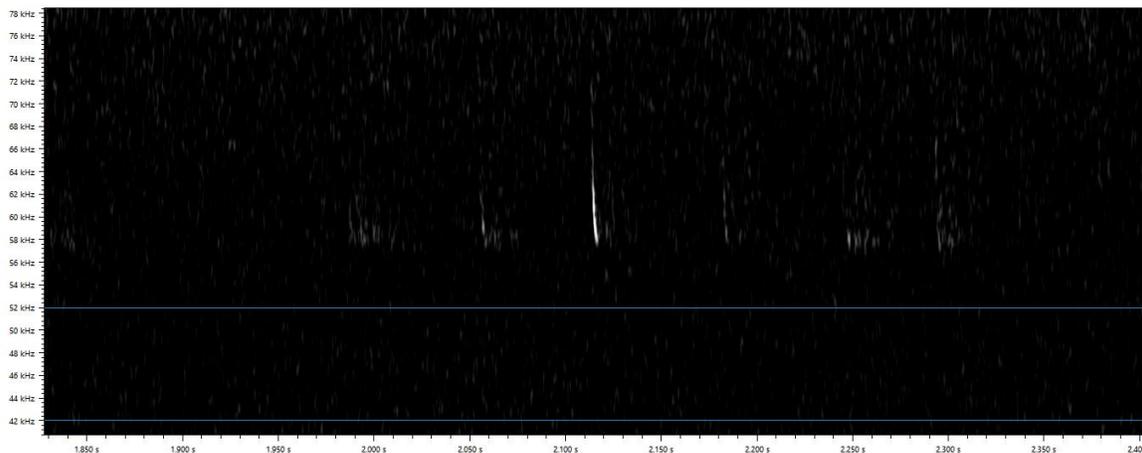
A single bat was observed emerging from the property's western gable end at 20:29hrs (approximately 4 minutes before sunset) flying north over surveyor located beneath the western gable end. Post survey sonogram processing concluded this was a soprano pipistrelle bat (see Figure 2).

Figure 2: Sonogram of soprano pipistrelle bat emerging from the building during survey 2.

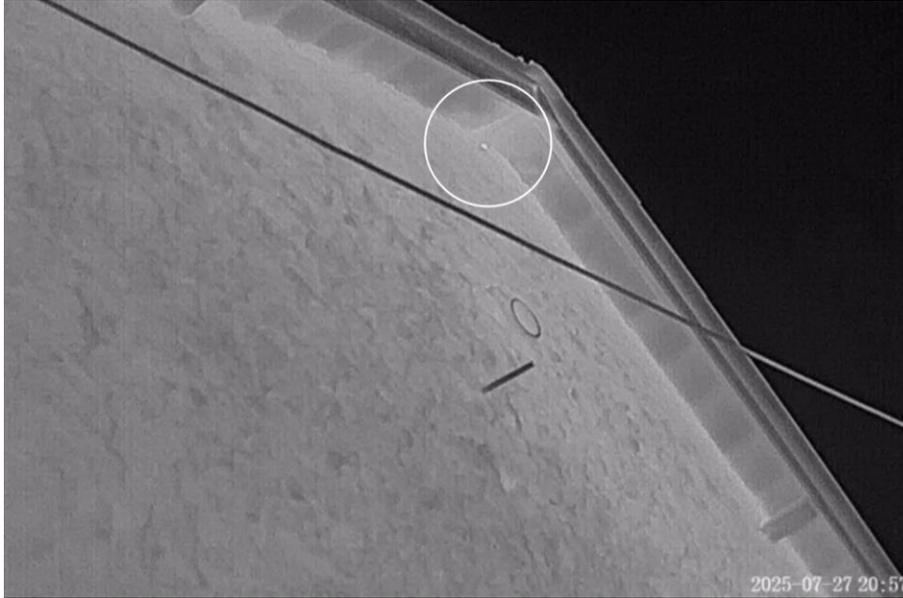
The NVA recorded a heat source at the apex of the building's western gable end at approximately 20:49hrs (approximately 7 minutes before sunset), the source remained until 20:57hrs (approximately 1 minute after sunset – see Figure 3), following which it became apparent that this was a bat, as it flew swiftly to the west. Post survey sonogram processing concluded this was a common pipistrelle bat (see Figure 4).

Figure 3: Heat source at western gable end apex

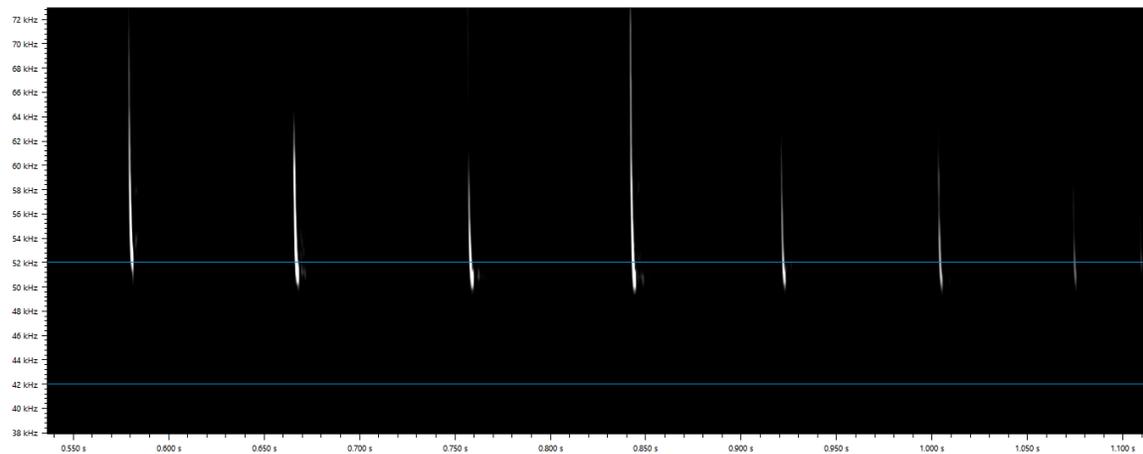
Figure 4: Sonogram of common pipistrelle bat emerging from the building during roost characterisation survey.

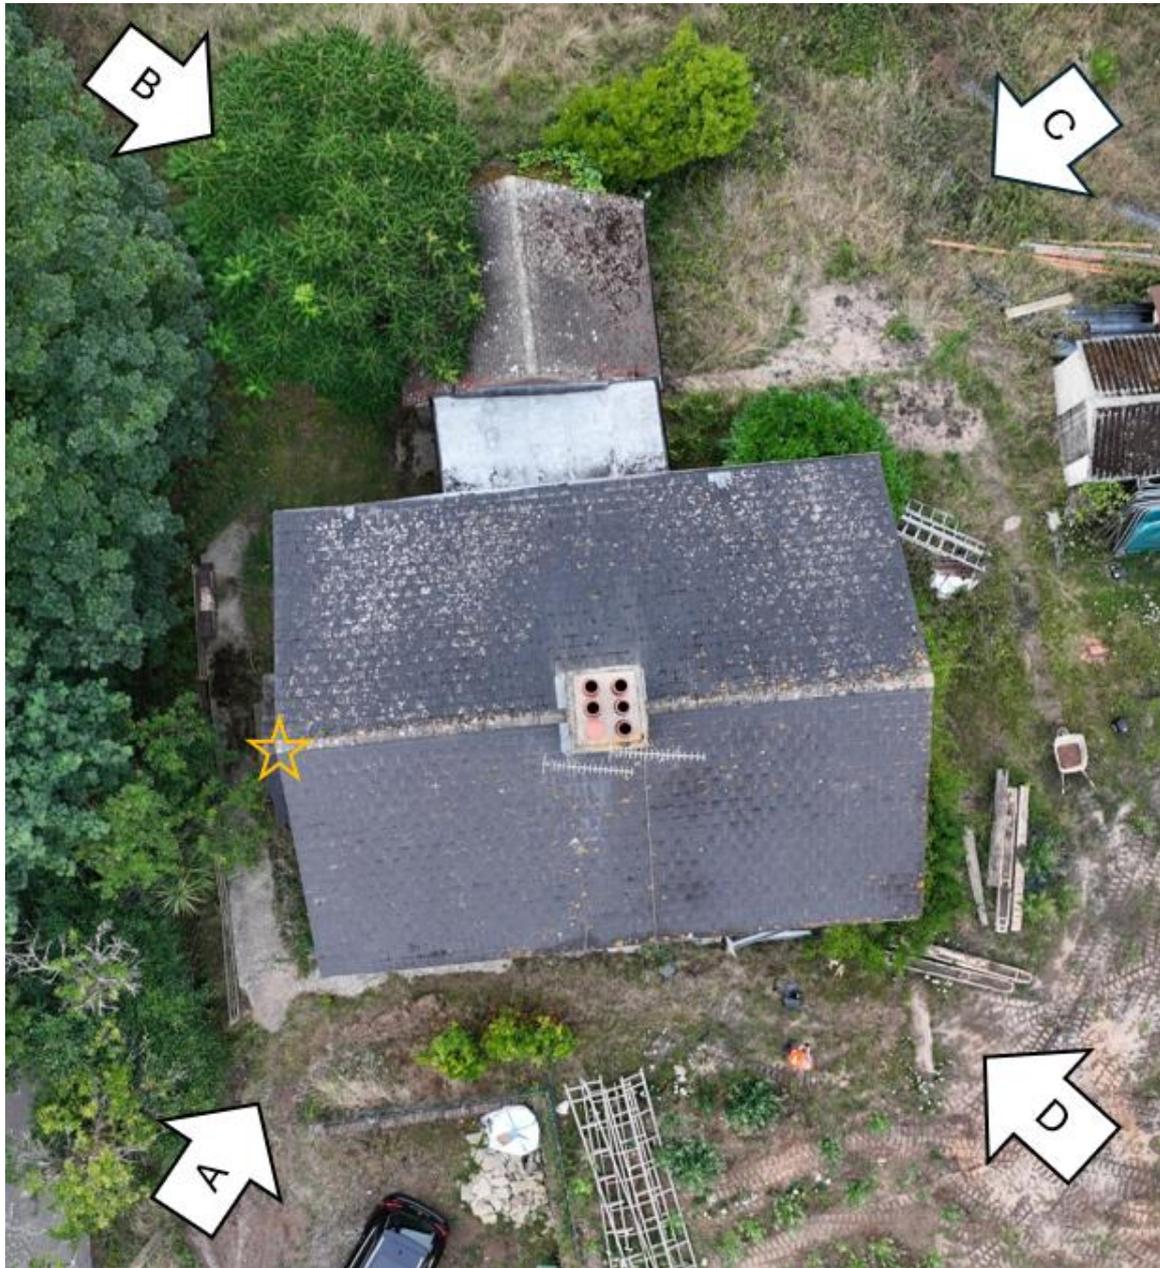
Surveyor and equipment deployment

Note: North to top of photo. Non-attended bat detector and NVA located at point 'D'.
Star indicates location of bat emergences.

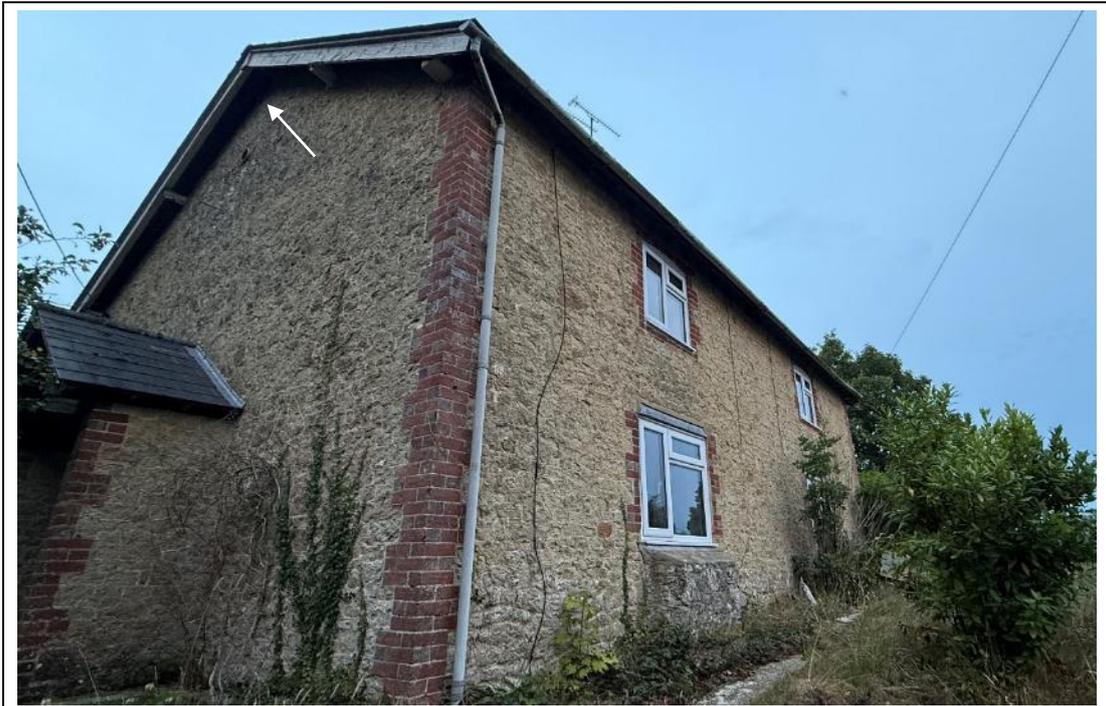
Photo 1 – South and west aspects. Arrow indicates bat emergence location.

The proposed development supports a confirmed common and soprano pipistrelle day roost. As such, the demolition of the property and loss of the roost site will require a European protected species licence from Natural England (NE) prior to its disturbance and ultimate loss.

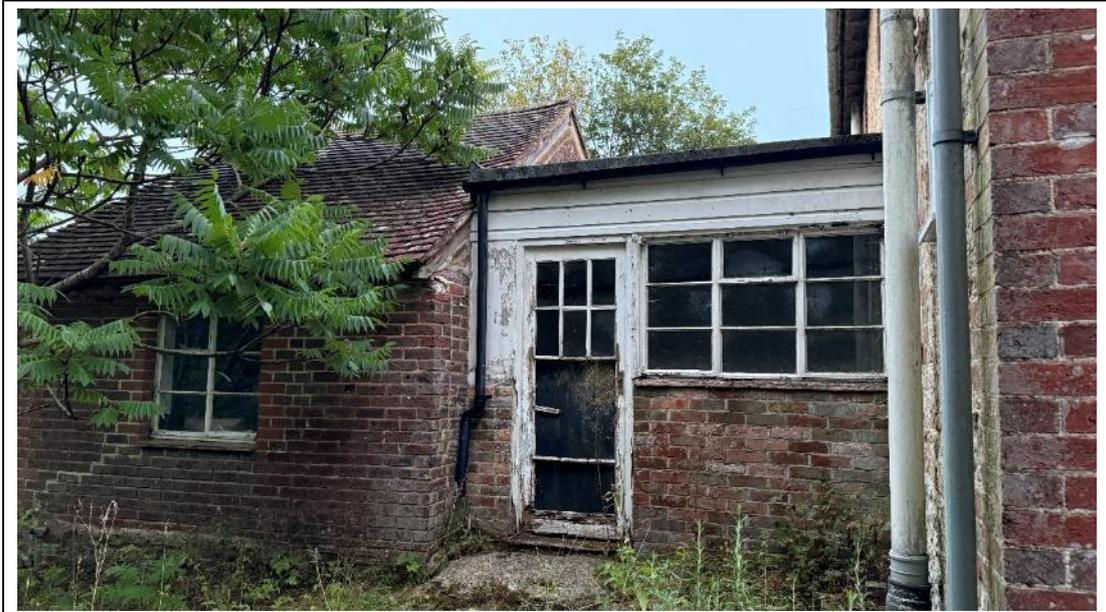
A single storey brick extension, which appears of more recent construction, adjoins the northern wall of the main building with a flat roof lined with bituminous sheeting connected to an east/west pitched roof (*Photo 3*). The flat roof section offers negligible suitability; with the pitched roof section offering a number of potential bat exit/entry points via timber roof detail and missing and slipped clay roof tiles.

Photo 3 – Single storey extension to north, west aspect

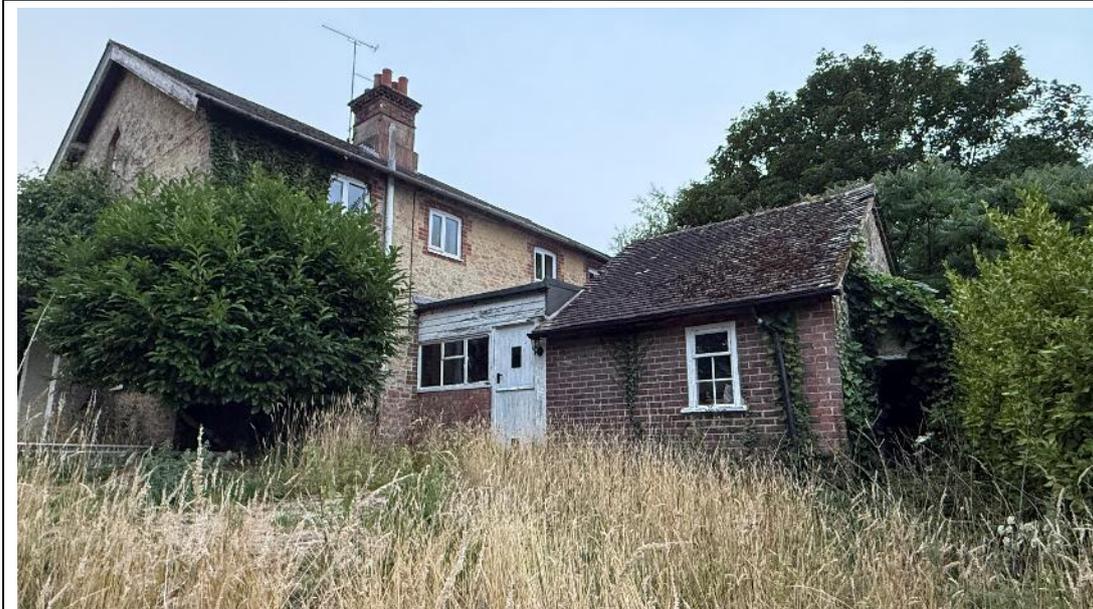
The location provides highly suitable habitats for roosting, commuting and foraging bats (see *Appendix D, Photos 4 and 5*).

Photo 4 – Extension and north aspect of the property

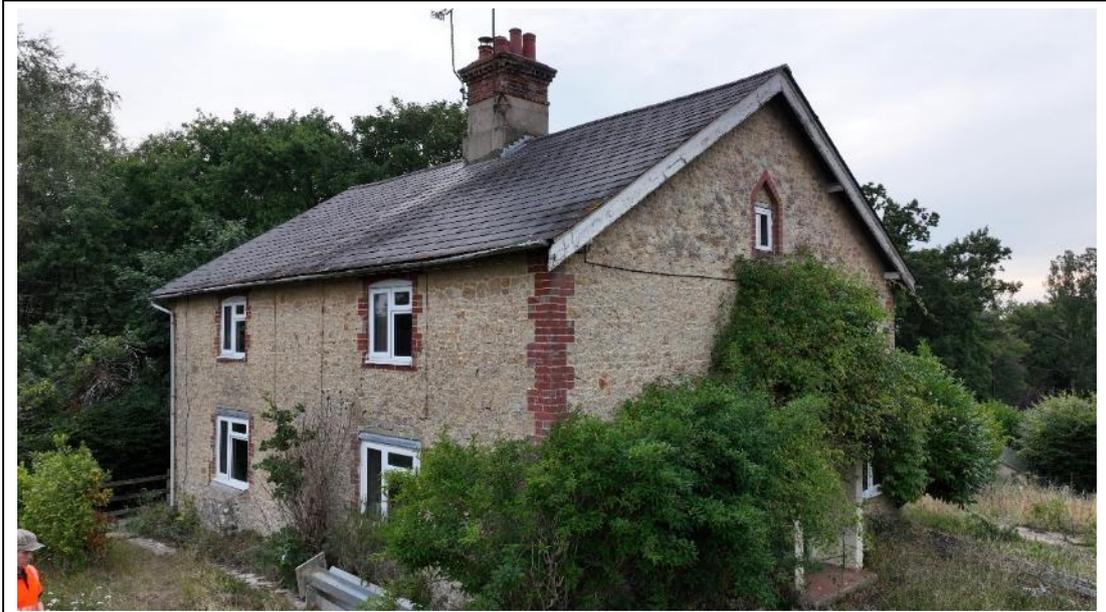
Photo 5 – East and south aspect

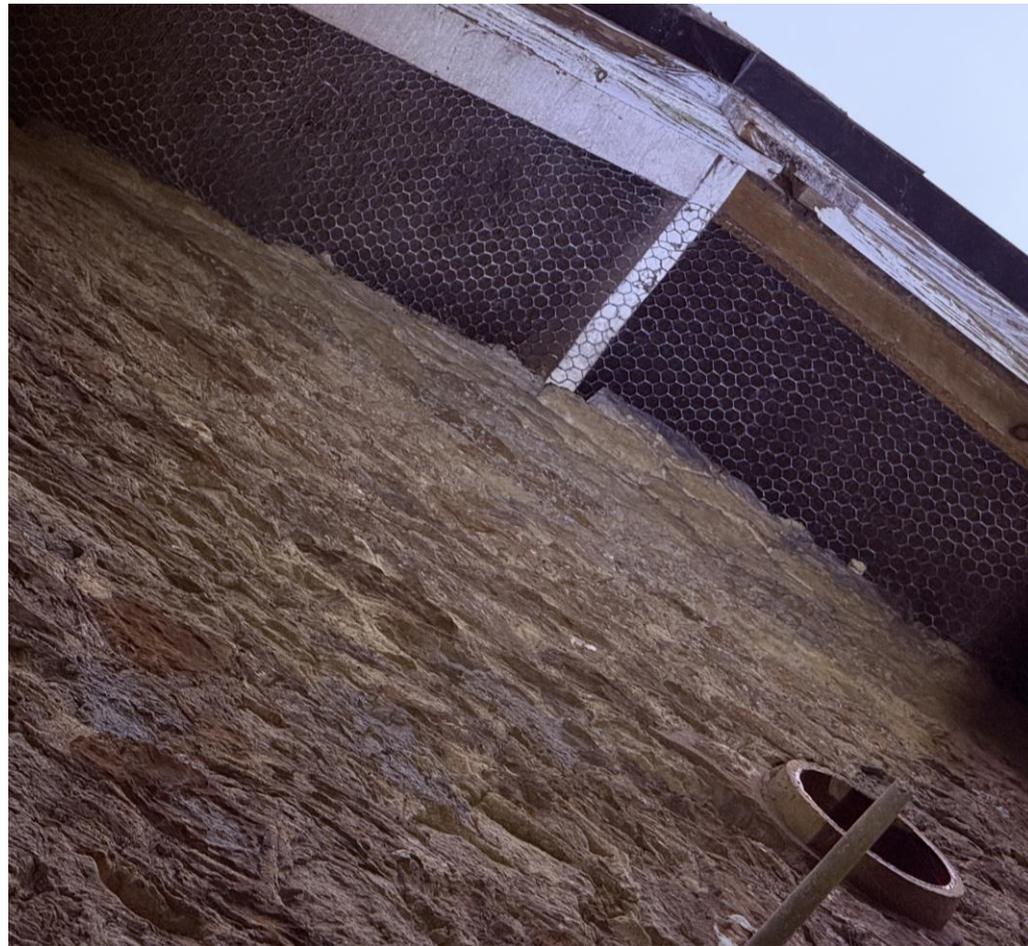
Photo 6 – Example of chicken wire soffits

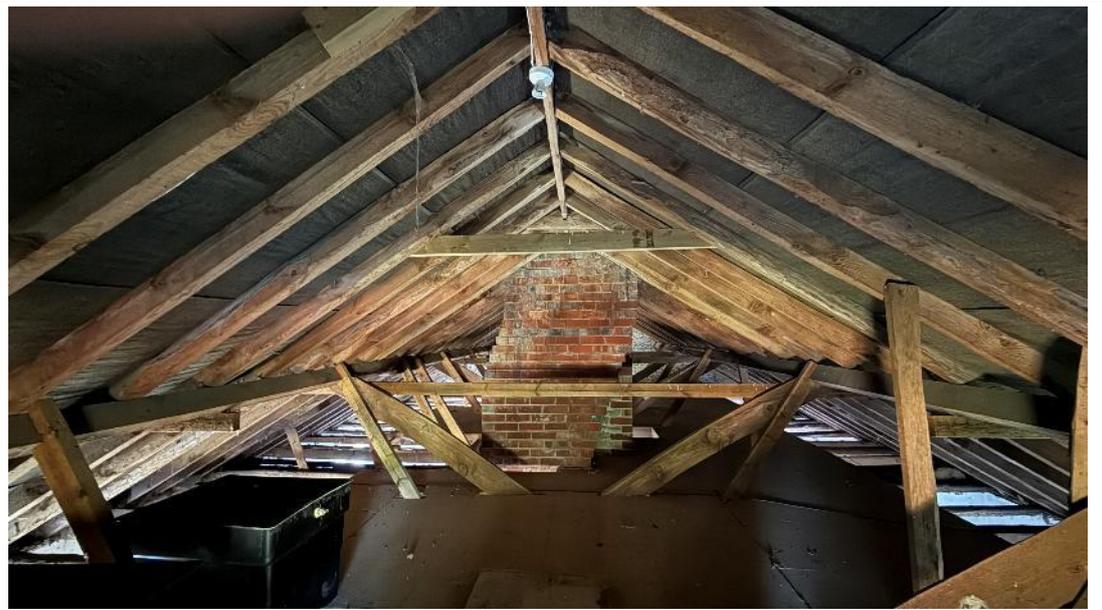
The internal loft is a collar beam roof with timber sarking and bituminous sheeting below. The loft void is open at the eaves to rooms below and appears to have been cleared of furniture, belongings etc. Crawl boards permitted access to the main loft void area, with features explored where possible with endoscope and torches including a large crack in the western gable wall (*Photo 8*), and occasional gaps at the wall/roof interface. Rafters,

Photo 7 – Internal loft void, note missing crawl boards at eaves

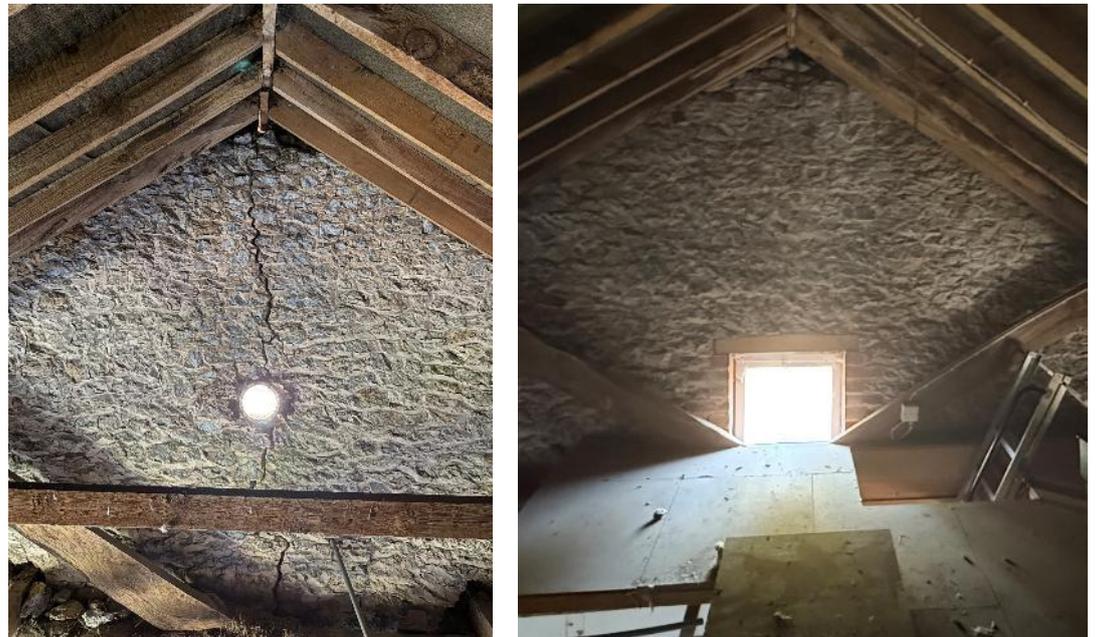
The internal roof space is largely unsuitable for bat occupation with high daytime light levels through missing floor boarding at the property's eaves and a window and clay pipe to the east and west respectively (*Photo 8*)

Photo 8 – West (left) and east (right) internal gable ends. Note crack in stone wall on western gable and high levels of external light from underlying rooms, pipe and window on respective gables.

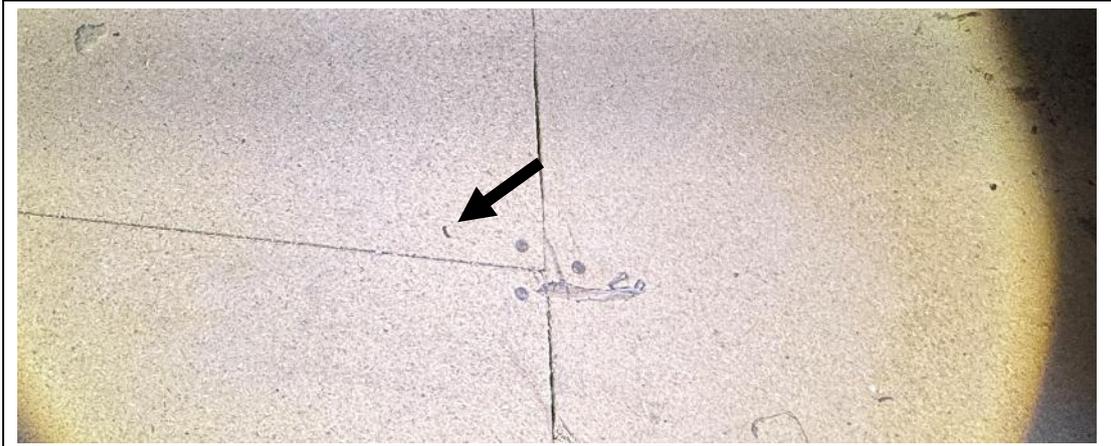
purlins etc. were reviewed, no signs of bats were seen. Four bat droppings were seen across the crawl boards; these were likely pipistrelle species (see *Photo 9*).

Photo 9 – Probable Pipistrel sp. dropping to east of loft space on crawl board
