20 November 2024

**Re: Geoenvironmental Investigation at: the Bund to the South Side of Stonehouse Farm Barn,
Handcross Road, Plummers Plain, Horsham, West Sussex, RH13 6NZ
National Grid Reference: TQ 22721 28234
Geology: Made Ground, Upper Tunbridge Wells Sand**

Analytical Report Number : 24-049440-2A

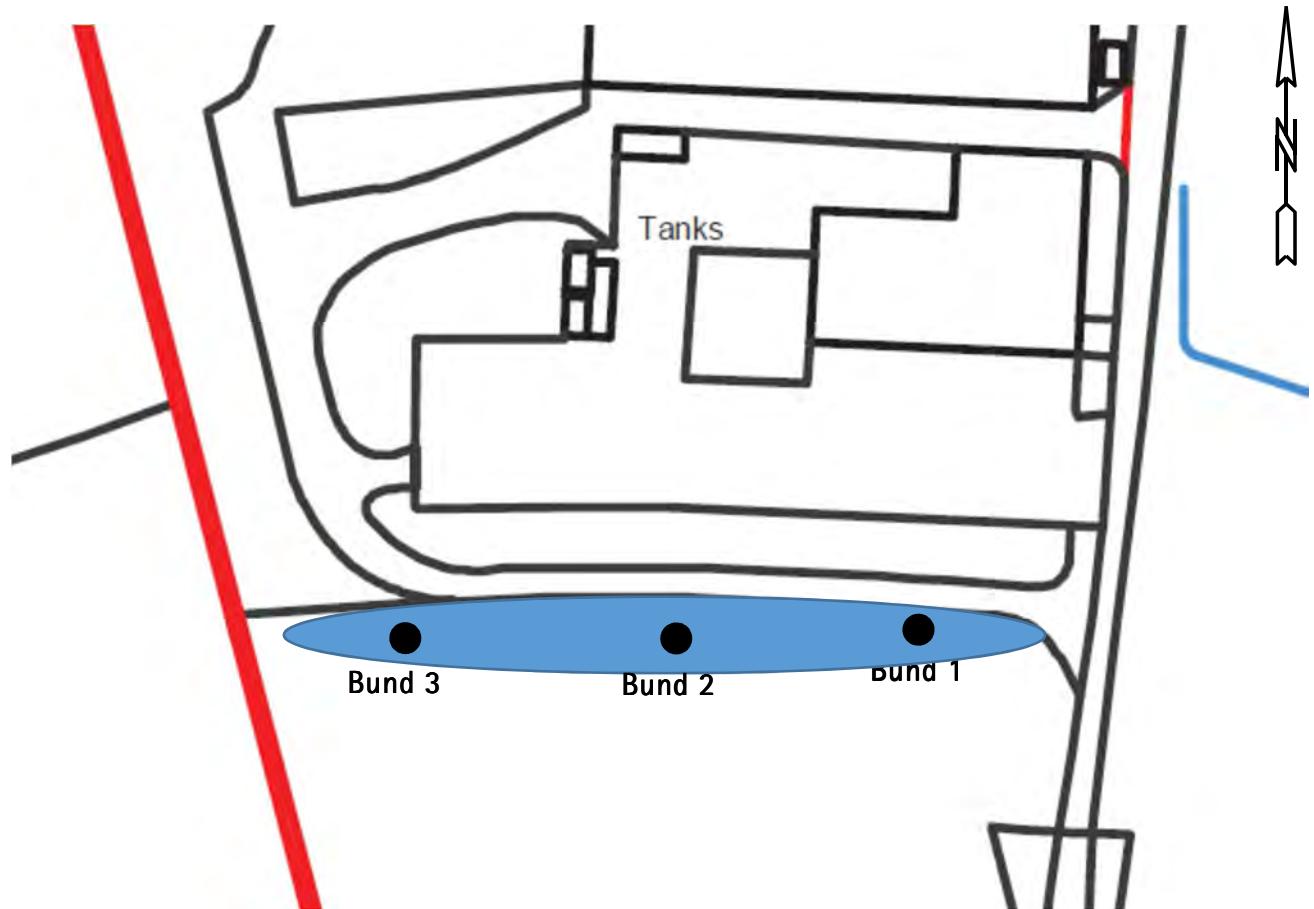
Fig No: 2

The area subject to this investigation (referred to from here as 'the bund'), comprises the bund, which was installed on the south side of the large barn. See enclosed Figure 2 for details.

A representative from Southern Testing attended site on the 21 October 2024, to undertaken an intrusive investigation of the bund, which was located to the south of the existing agricultural barn. The area of bund subject to this investigation is shown on the enclosed Figure 2.

● **Bund soil sample location**

Bund Soil Sample Locations – Not to scale

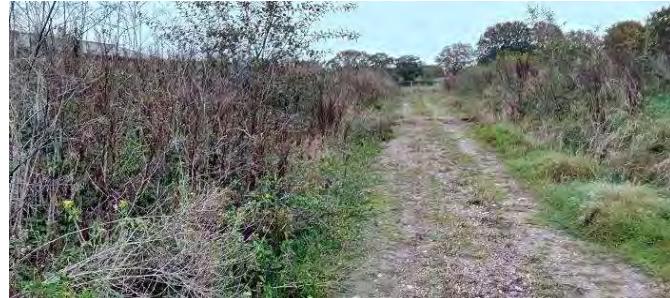
Plate 1: Track to south side of bund.

The bund was around 120m in length, about 5 to 6 metres in width and 2 to 3 metres high. It was vegetated with self-sown weeds.

At the time of the site works, the bund was vegetated with self-sown weeds, with occasional pieces of protruding building rubble noted.

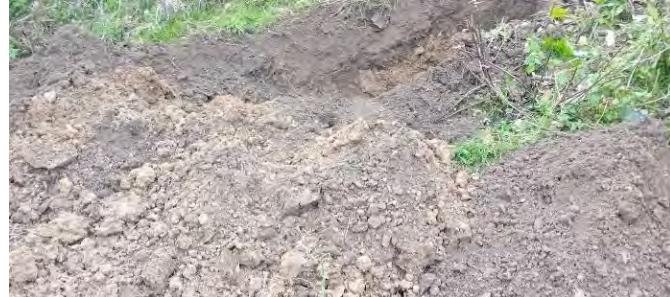
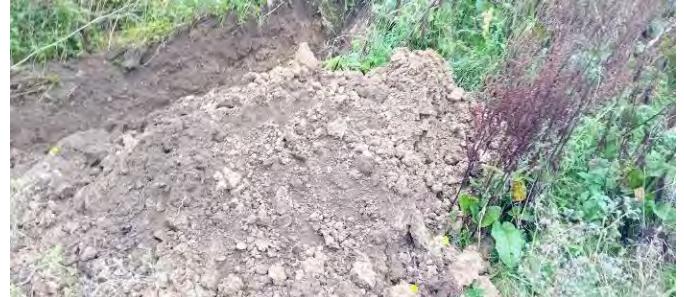
Plate 1: Bund 1.

Bund	Depth in Bund (m)	Soil Type	Description
Bund 1	0.3	MADE GROUND	Soft dark brown silty CLAY with occasional fine to coarse angular to sub-angular flint, brick, concrete, occasional plastic, concrete fragments.
Bund 1	0.8	MADE GROUND	Soft brown with grey mottling silty CLAY with occasional fine to coarse angular to sub-angular flint, brick, concrete, occasional plastic, concrete fragments. Gravel of Chalk noted.
Bund 2	0.8	MADE GROUND	Soft brown silty CLAY with occasional fine to coarse angular to sub-angular flint, brick, concrete, occasional plastic, concrete fragments. Gravel of Chalk noted.
Bund 3	0.9	MADE GROUND	Soft brown silty CLAY with occasional fine to coarse angular to sub-angular flint, brick, concrete, occasional plastic, concrete fragments. Gravel of Chalk noted.

Evidence of possible contamination, in the form of Made Ground, was encountered in all of the bund trial holes. Photographs showing these soils are enclosed. No visual or olfactory evidence of any petroleum hydrocarbon or other organic chemical contamination was noted, and no suspected asbestos containing materials were observed.

Levels of PAH compounds (benzo(a)pyrene) would be considered elevated for a residential setting, in one bund sample only, (Bund 1 at 0.3m). Given the proposals for the site, this would be classed as low risk.

Plate 2: Bund 1.

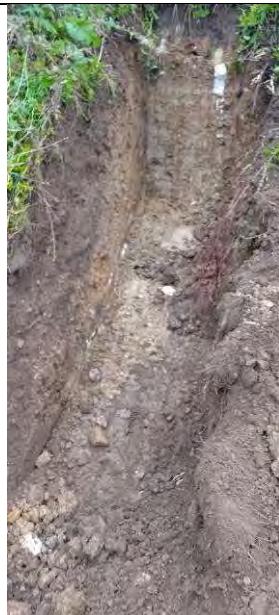
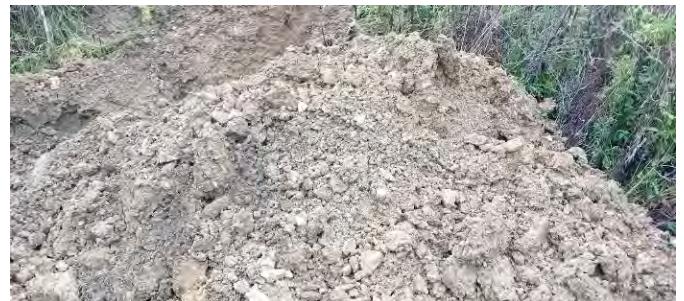
Plate 3: Bund 2.

Plate 4: Bund 2.

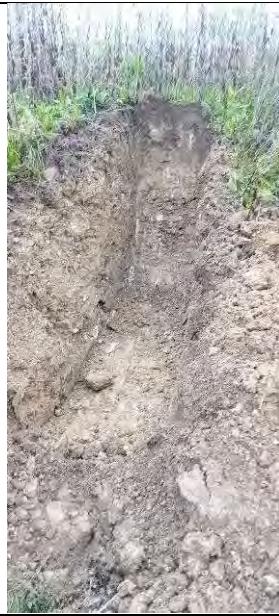
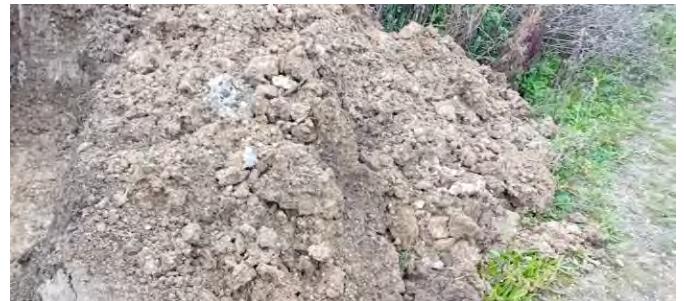
Plate 5: Bund 3.

Plate 6: Bund 3.
