ACCESSIBILITY AUDIT

PROPOSED DEVELOPMENT AT MERCER ROAD, HORSHAM.

AUGUST 2025

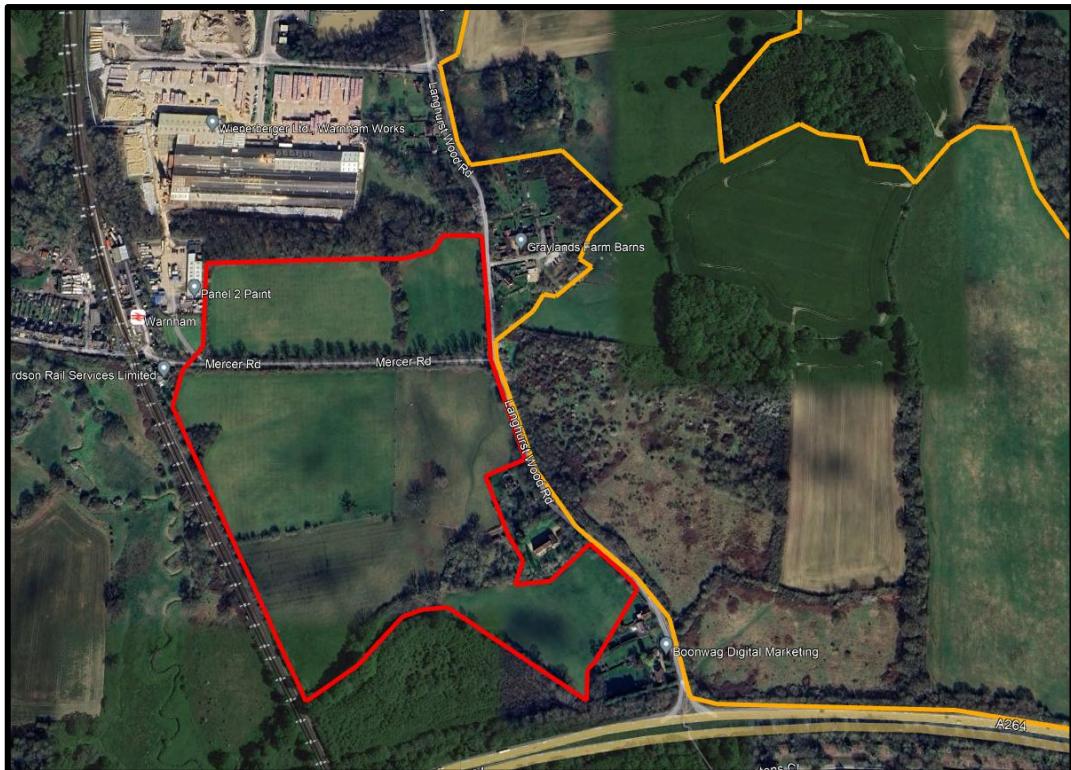
Figure 3.2 – Site in its Local Context

Source: Google Earth. The Site is indicated by the red boundary and the Land of North Horsham Development is indicated by the orange boundary.

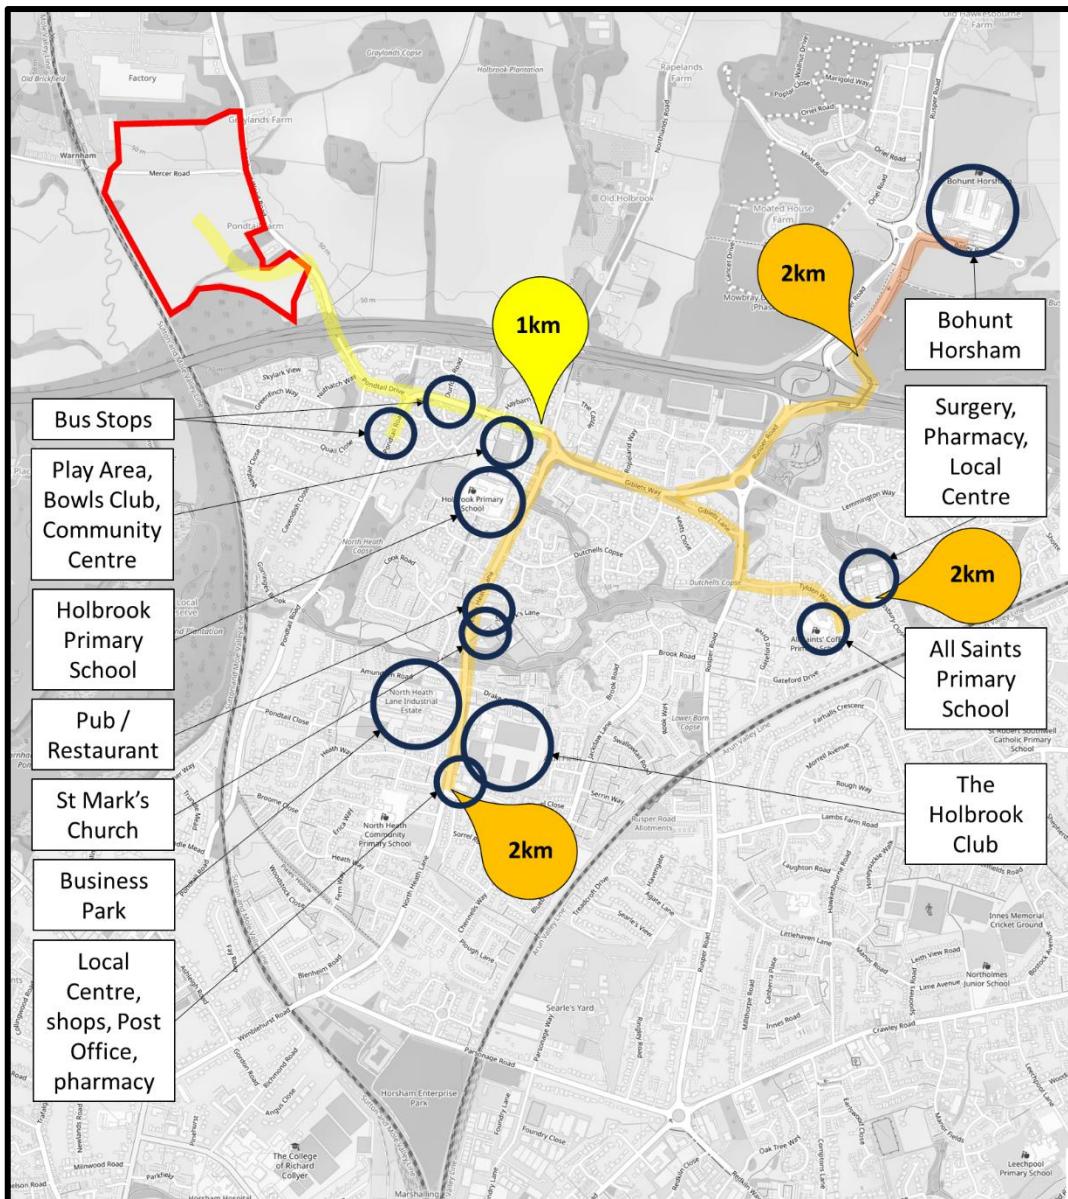
Figure 4.1 – Study Area

- 4.7 On the basis of the key local trip generators described above, the study area is shown at Figure 4.1 below. The distance markers show the approximate distance from the centre of the Site, following the routes identified on the plan.

Source: OpenStreetMap.org N.B. the approximate proposal site boundary is denoted by a red line.

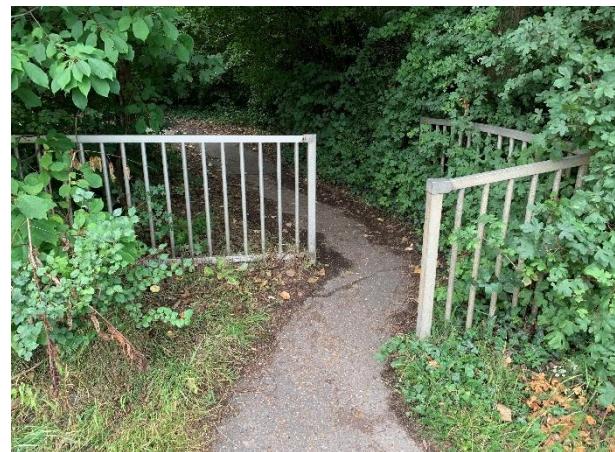
IMG_2267

Photo facing south from the A264.

6.4 The route through the vegetation is clear and level, with a dropped-kerb access to the northernmost end of Pondtail Drive. There is streetlighting present, although partly obscured by vegetation.

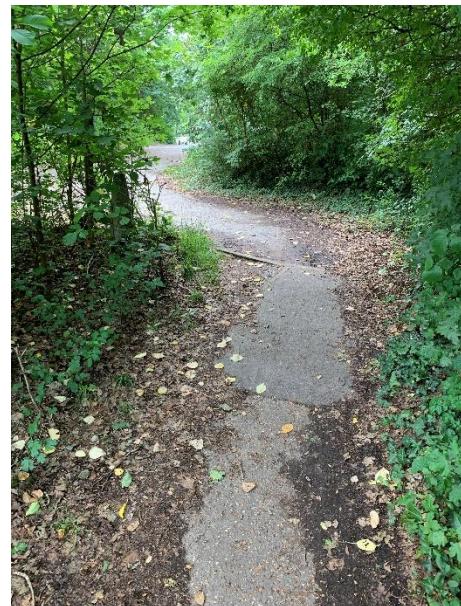
IMG_2268

Photo facing south from guard railings towards Pondtail Drive.

6.5 The northernmost end of Pondtail Drive is closed to vehicular traffic. There is streetlighting present, although partly obscured by vegetation.

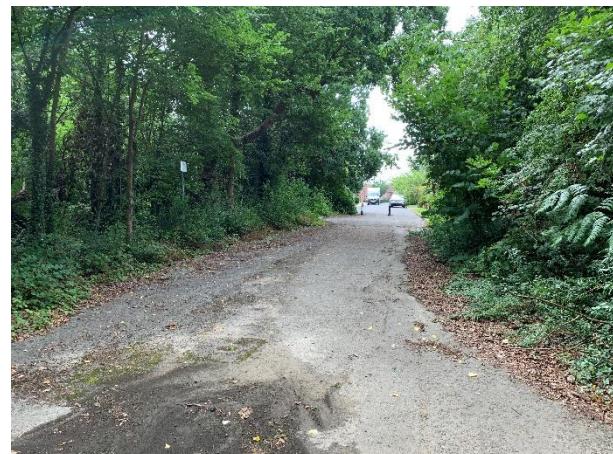
IMG_2269

Photo facing south along Pondtail Drive.

6.6 Bollards prevent vehicular traffic passing north of the junction of Pondtail Drive / Westons Close.

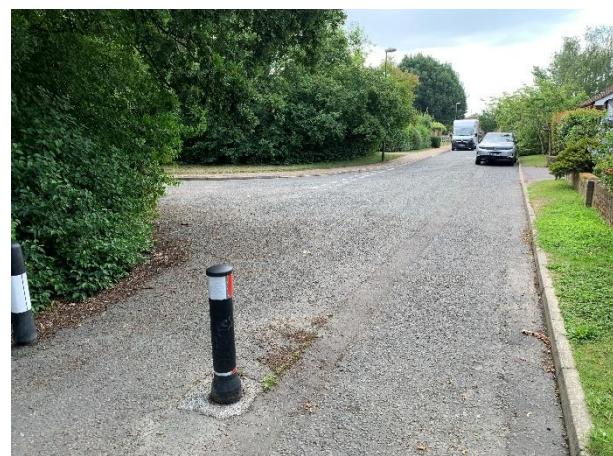
IMG_2270

Photo facing south along Pondtail Drive.

6.7 A dropped kerb at the junction of Pondtail Drive / Westons Close allows access to the footway on the eastern side of Pondtail Drive.

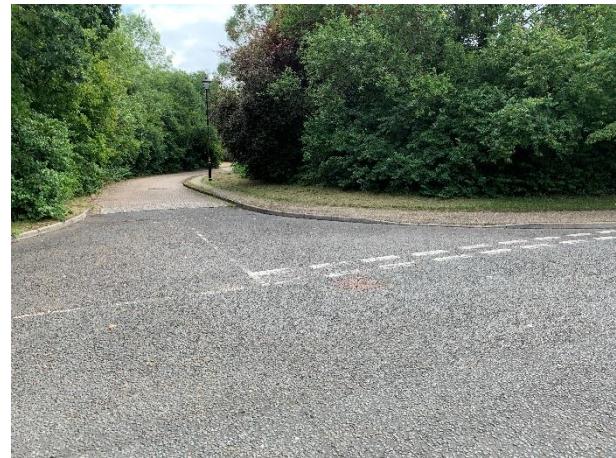
IMG_2271

Photo facing east towards Westons Close.

6.8 Overhanging vegetation obstructs the footway on the eastern side of Pondtail Drive adjacent to Westons Close. The footway is street-lit.

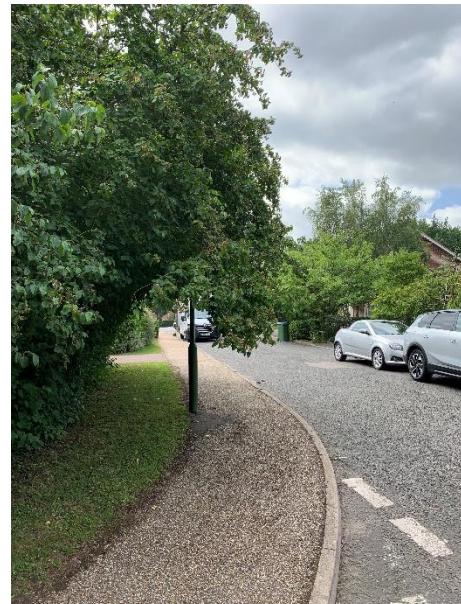
IMG_2272

Photo facing south along Pondtail Drive.

6.9 The remainder of the route along Pondtail Drive is possible via existing footways on both sides of the road, of c.2m width with street lighting.

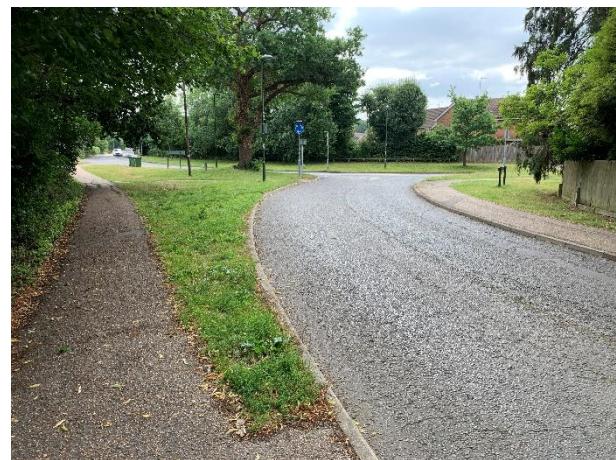
IMG_2274

Photo facing east along Pondtail Drive towards roundabout junction with Pondtail Road.

6.10 At the roundabout junction of Pondtail Drive and Pondtail Road, crossings with tactile kerbs are present across Pondtail Drive and Pondtail Road south, with refuge island present in the centre of Pondtail Road south. The footway on the west side of Pondtail Road continues south to the bus stop 'North Heath, opp Quarterbrass Farm Road'.

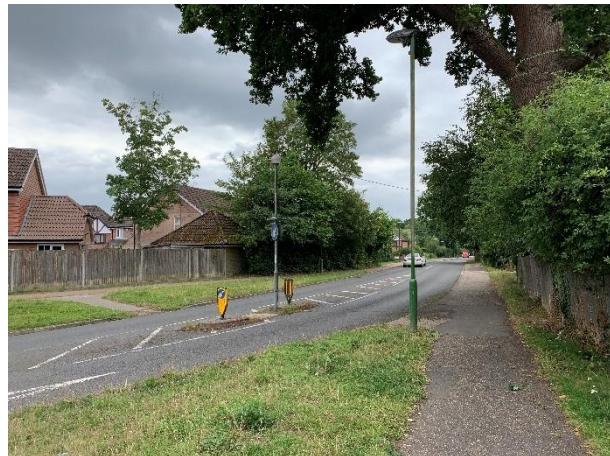
IMG_2334

Photo facing south along Pondtail Road from the roundabout junction with Pondtail Road.

6.11 East of the roundabout junction of Pondtail Drive and Pondtail Road, on the north side of Pondtail Road, immediately west of the junction with Durfold Road, the footway is separated from the road by a strip of vegetation extending c.45m

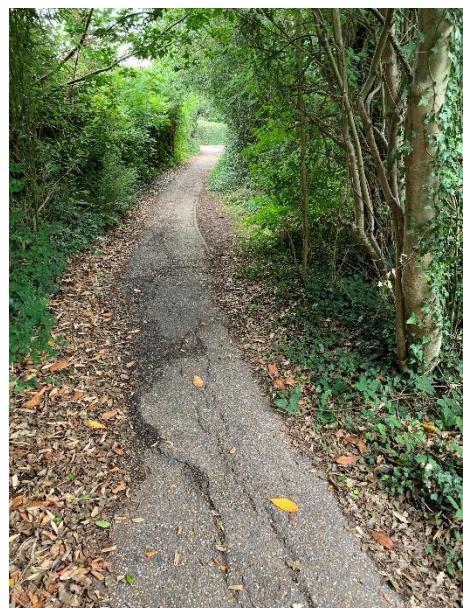
IMG_2275

Photo facing east along Pondtail Drive towards Durfold Road.

6.12 There are dropped-kerbs providing a crossing east/west over Durfold Road, but no tactile paving is present.

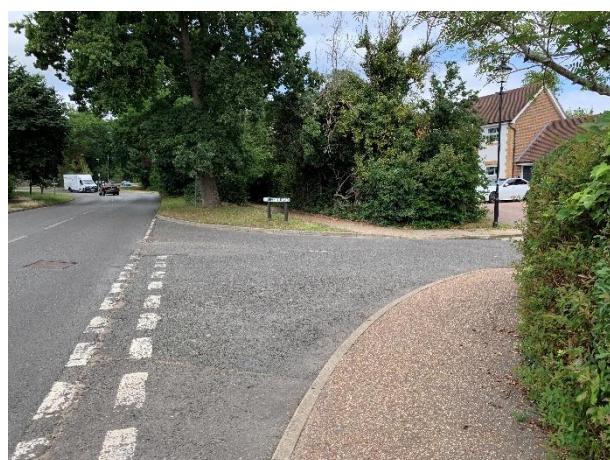
IMG_2281

Photo facing west along Pondtail Drive across Durfold Road.

6.13 The eastbound bus stop pole and sign at Durfold Road are obscured by vegetation (in July).

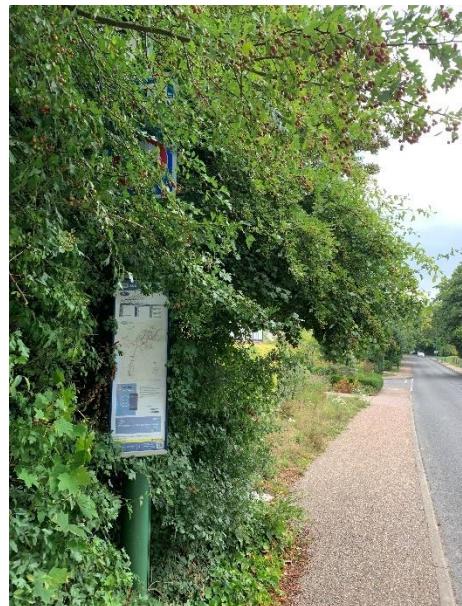
IMG_2282

Photo facing east along Pondtail Drive at Durfold Road bus stop.

6.14 Tactile paving is present at the crossing over Bakehouse Barn Close, but the two sides are not aligned

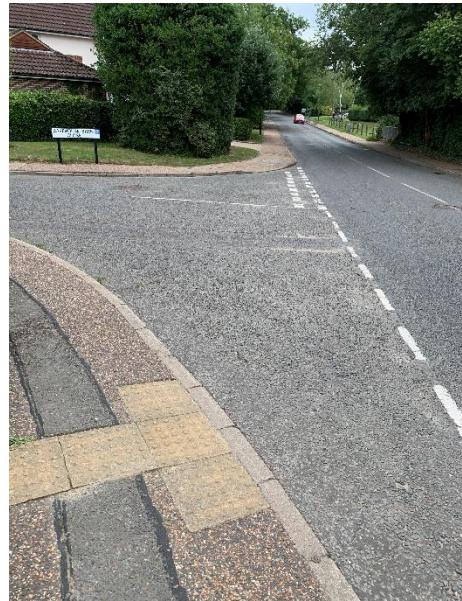
IMG_2283

Photo facing east along Pondtail Drive across Bakehouse Barn Close.

6.15 No tactile paving is present at the crossing over Haybarn Drive.

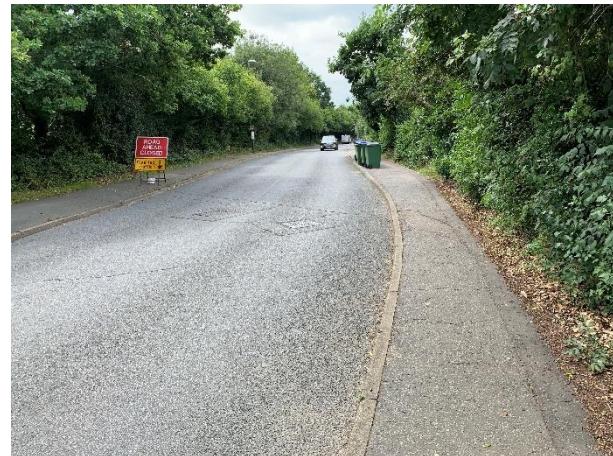
IMG_2308

7.3 The footway continues southwards along the eastern side of North Heath Lane with street lighting. A footway is also present on the eastern side of the road.

Photo facing south along North Heath Lane.

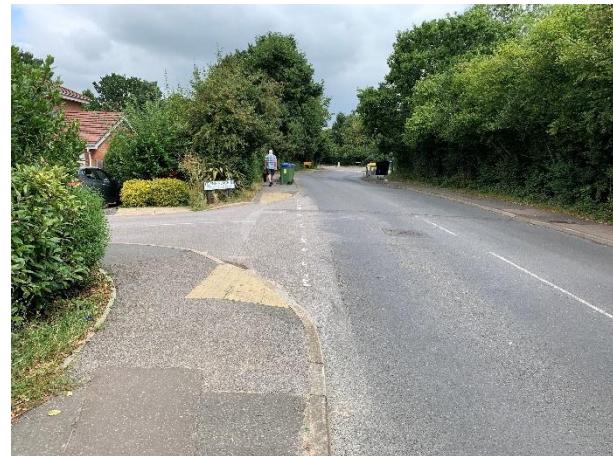
IMG_2309

7.4 Tactile paving is present at the crossing over the entrance to Fivens Place.

Photo facing north.

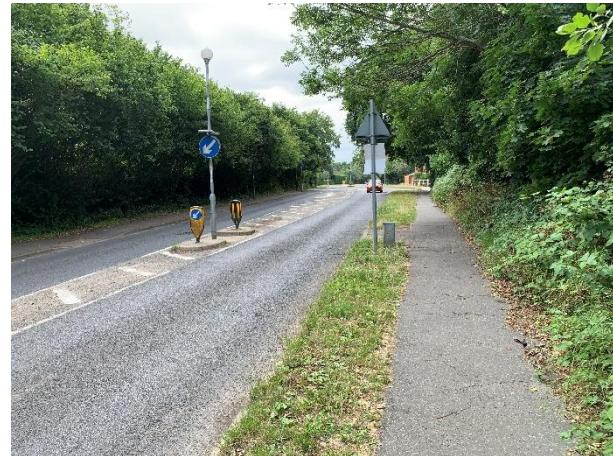
IMG_2310

7.5 A pedestrian crossing with central refuge island and lighting is present across North Heath Lane located c.40m north of the junction with Holbrook School Lane.

Photo facing south along North Heath Lane.

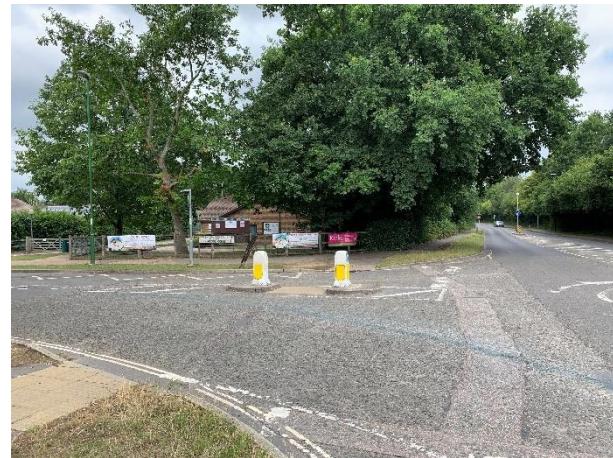
IMG_2311

7.6 Holbrook Primary School is accessed from Holbrook School Lane where there are pedestrian footways, street lighting, and crossing points present.

Photo facing north at the junction of Holbrook School Lane with North Heath Lane.

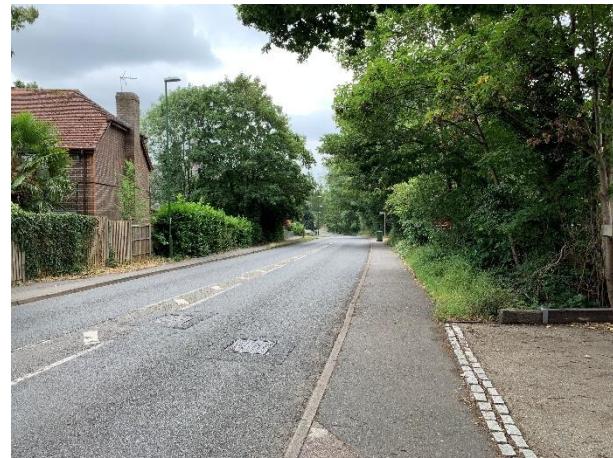
IMG_2312

7.7 The footways continue south along both sides of North Heath Lane, with street lighting present.

Photo facing south along North Heath Lane.

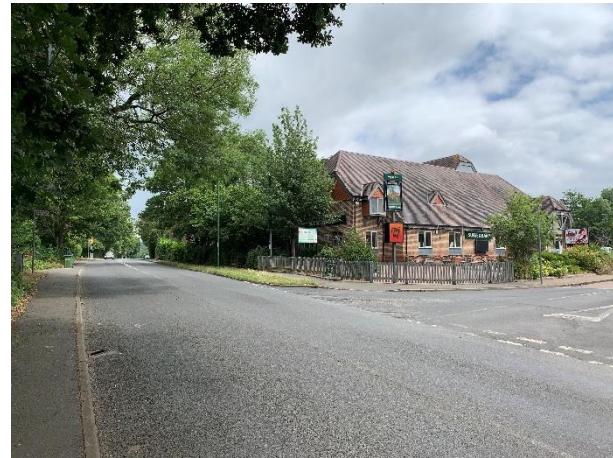
IMG_2313

7.8 The Sussex Barn pub/restaurant and St Mark's Church are on the east side of North Heath Lane, both accessible via the footway on the east side of the road.

Photo facing northeast from North Heath Lane.

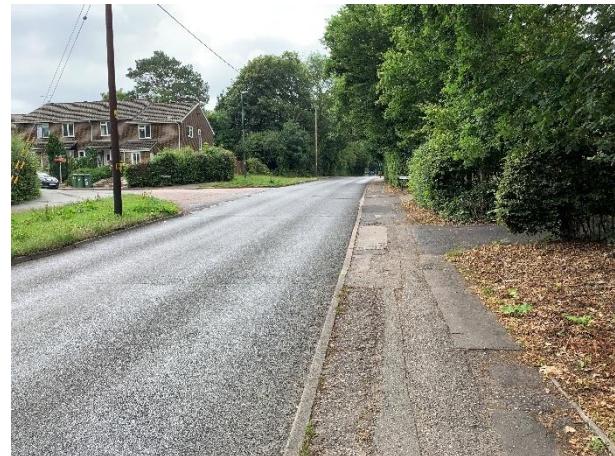
IMG_2314

7.9 The footways continue south along North Heath Lane with street lighting.

Photo facing south along North Heath Lane.

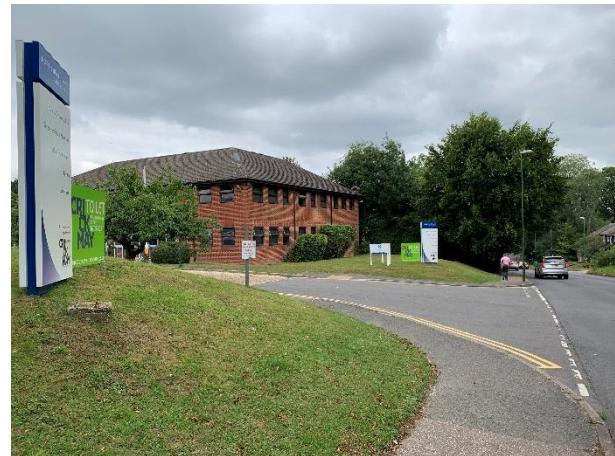
IMG_2316

7.10 North Heath Lane Business Park is accessed from North Heath Estate Drive on the western side of North Heath Lane, where footways, lighting, and crossings are present.

Photo facing north across North Heath Estate Drive entrance.

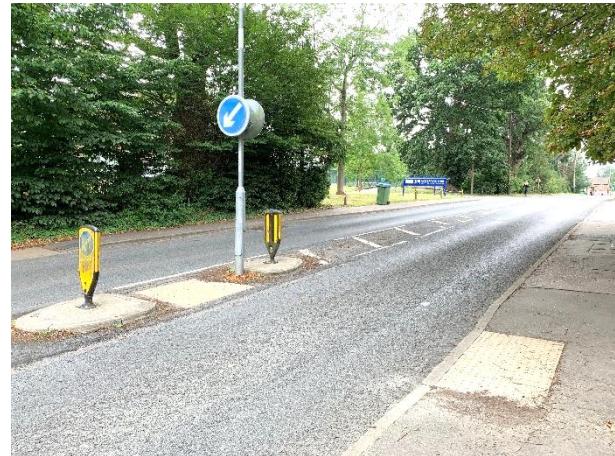
IMG_2317

7.11 A pedestrian crossing with central refuge island and lighting is present across North Heath Lane c.25m south of the junction with North Heath Estate Drive and c.30m north of The Holbrook Club.

Photo facing southeast across North Heath Lane towards The Holbrook Club.

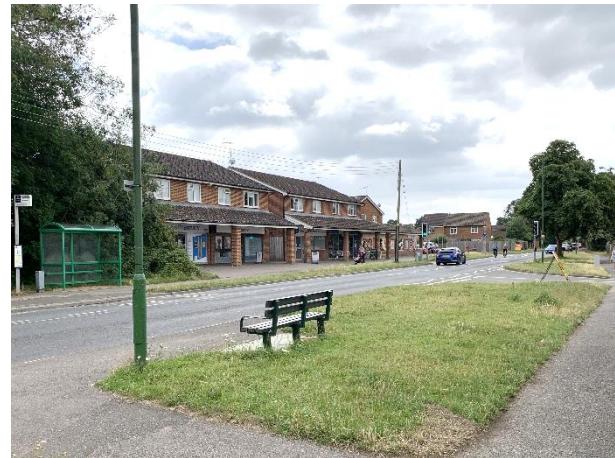
IMG_2318a

7.12 The local centre shops and facilities are located on the east side of North Heath Lane accessible from the footway on the east side of the road, and by a signal-controlled pedestrian crossing over North Heath Lane.

Photo facing southeast across North Heath Lane towards the local centre shops.

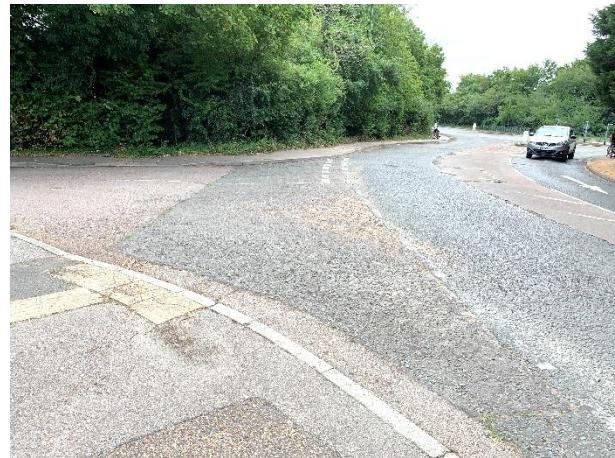
IMG_2285

8.3 Tactile paving is present at the crossing over Northlands Road, but the two sides are not aligned

Photo facing east across Northlands Road.

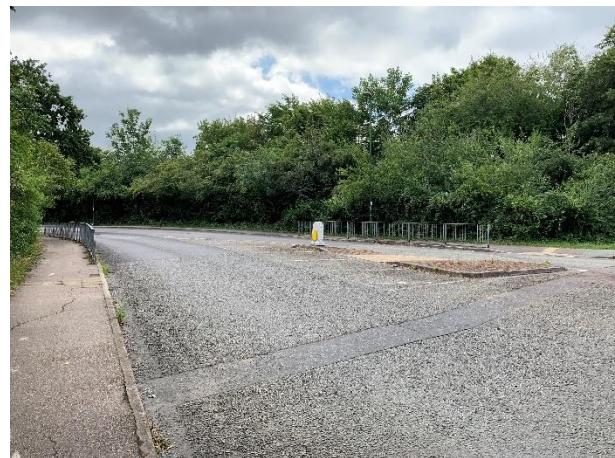
IMG_2286

8.4 Crossing facilities with lighting, tactile paving, and guard railing are present across the Giblets Way arm of the roundabout junction of Pondtail Road / Giblets Way / North Heath Lane.

Photo facing east on Giblets Way.

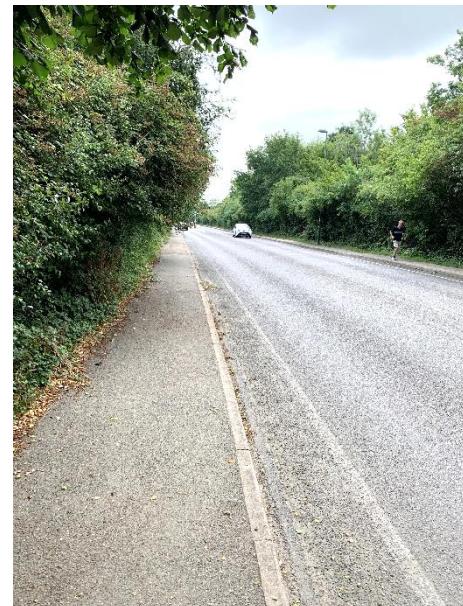
IMG_2287

8.5 Overhanging vegetation presents an obstruction over the footway on the north side of Giblets Way

Photo facing east on Giblets Way.

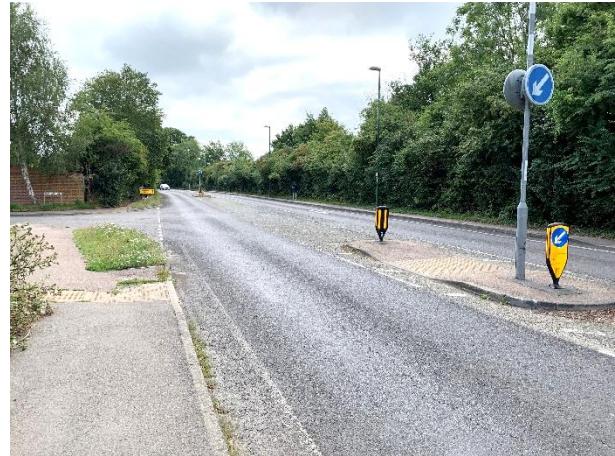
IMG_2288

8.6 Crossing facilities are present over Giblets Way both to the east and west sides of the junction with Ropeland Way.

Photo facing east on Giblets Way.

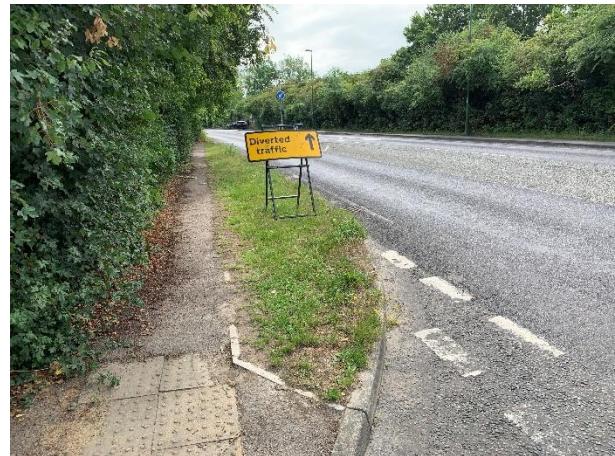
IMG_2289

8.7 Immediately east of the junction with Ropeland Way the footway leading to the crossing point is obstructed by overgrown vegetation.

Photo facing east on Giblets Way.

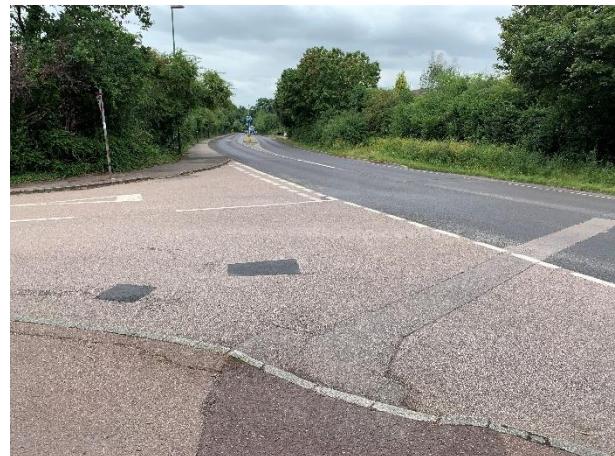
IMG_2291

8.8 The pedestrian route continues along the footway on the southern side of Giblets Way and crosses Dutchells Copse. Dropped kerbs are present with no tactile paving.

Photo facing west along Giblets Way across the entrance to Dutchells Copse.

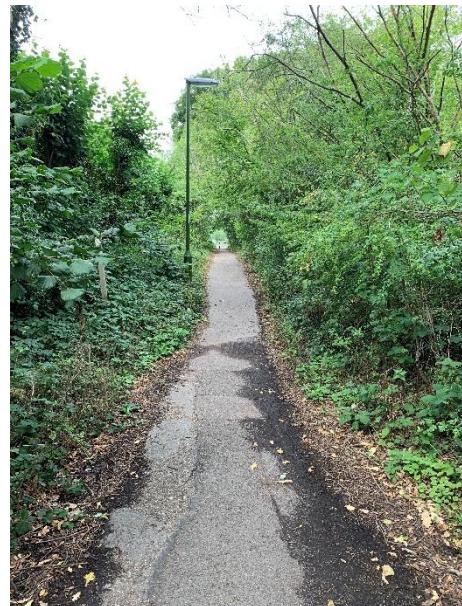
IMG_2306

8.9 The pedestrian route continues via a lit footway leading from Dutchells Copse to Giblets Lane.

Photo facing west along footway between Giblets Lane and Dutchells Copse.

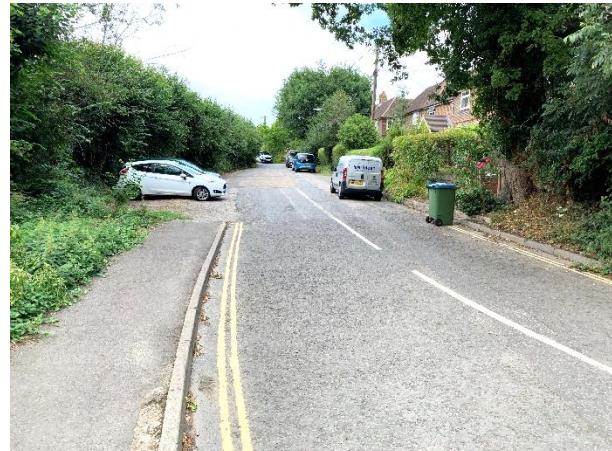
IMG_2304

8.10 The pedestrian route continues along Giblets Lane. No footway is present on Giblets Lane until the southeastern end where it connects to Rusper Road.

Photo facing northwest along Giblets Lane from Rusper Road.

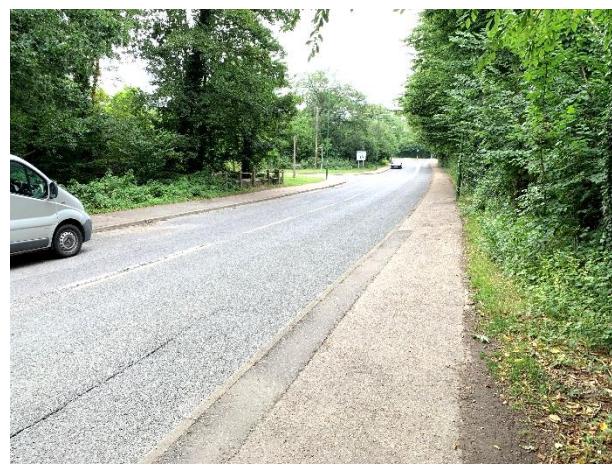
IMG_2299

8.11 From Giblets Lane, footways continue south on both sides of Rusper Road. Lighting is present but there are no crossing facilities over Rusper Road between Giblets Lane and Tylden Way.

Photo facing north along Rusper Road towards Giblets Lane.

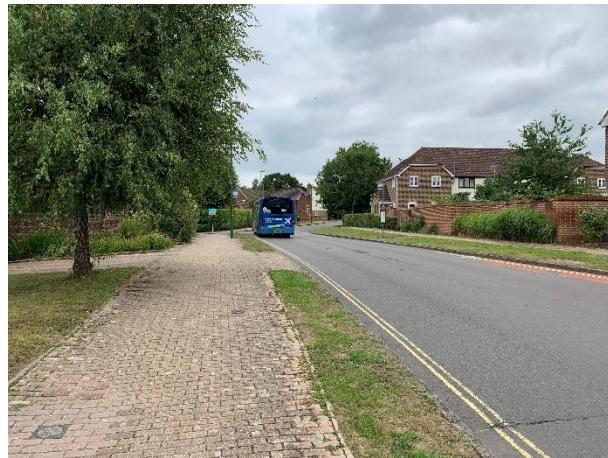
IMG_2301

8.12 Footways with lighting continue eastwards along both sides Tylden Way.

Photo facing east along Tylden Way.

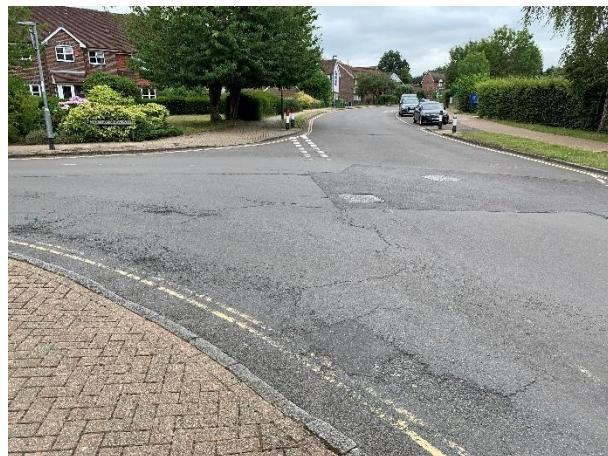
IMG_2302

8.13 At the junction of Tylden Way with Bartholomew Way there is a crossing point over Bartholomew Way with dropped kerbs but no tactile paving. A crossing is present over Tylden Way with dropped kerbs and tactile paving located immediately east of Bartholomew Way adjacent to the entrance to All Sains Primary School.

Photo facing southeast along Tylden Way across the entrance to Bartholomew Way.

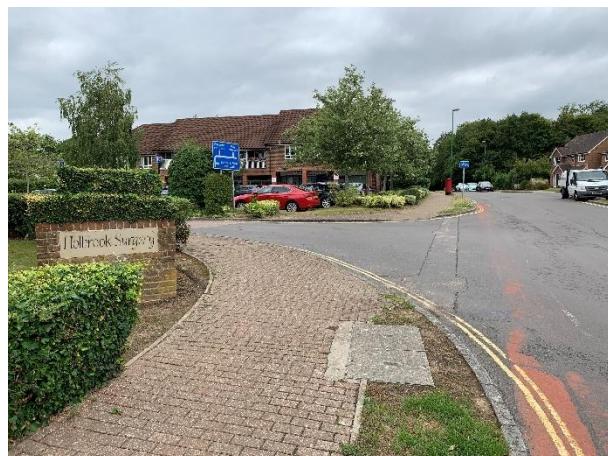
IMG_2303

8.14 Footways continue along both sides of Bartholomew Way. On the northern side, the footway leads into the local centre and Holbrook Surgery site.

Photo facing east along Bartholomew Way across the entrance to the local centre.

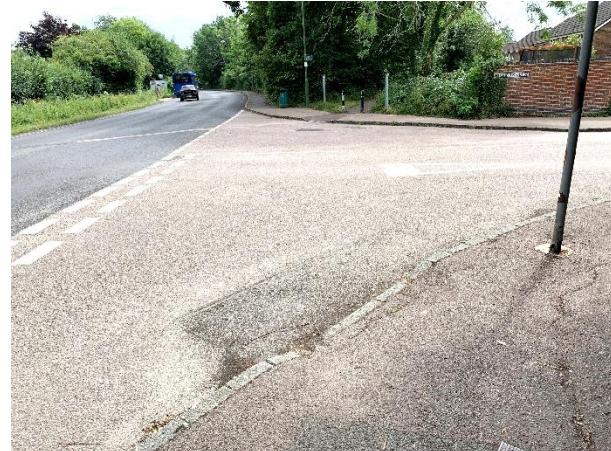
IMG_2291

- 9.1 The northwestern part of this route is the same as the route described in section 6.0 and in paragraphs 8.3 to 8.8 inclusive.
- 9.2 The pedestrian route on the southern side of Giblets Way crosses Dutchells Copse and continues east along the southern side of Giblets Way towards the roundabout junction with Rusper Road.

Photo facing east along Giblets Way across Dutchells Copse.

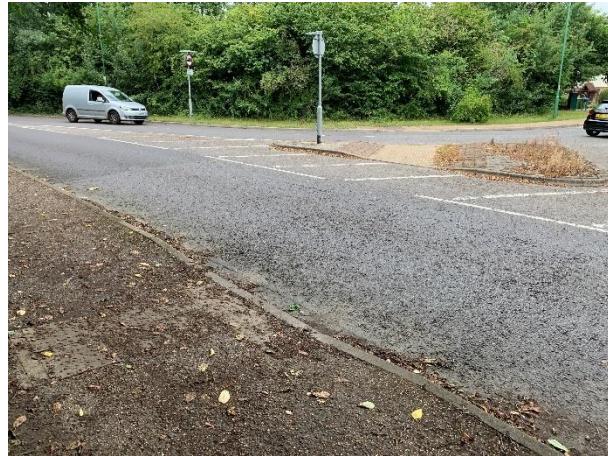
IMG_2293

9.3 At the roundabout junction of Giblets Way / Rusper Road / Meadow Farm Lane / Lemmington Way, there are crossing facilities over Giblets Way, providing lighting, dropped kerbs and tactile paving.

Photo facing north across Giblets Way.

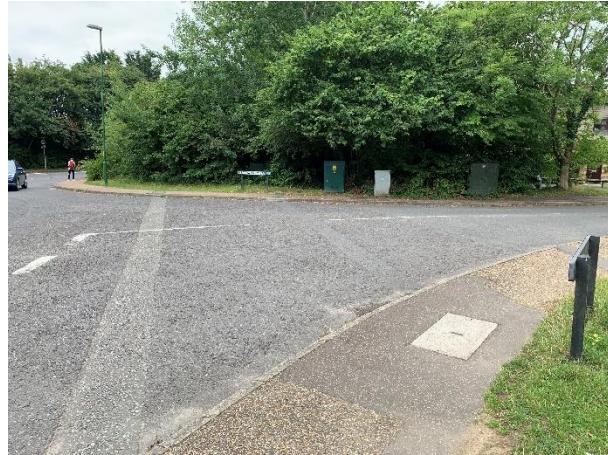
IMG_2294

9.4 The footway continues around the western side of the roundabout junction of Giblets Way / Rusper Road / Meadow Farm Lane / Lemmington Way. The pedestrian route crosses Meadow Farm Lane however there is no crossing facility present adjacent to the junction.

Photo facing south across Meadow Farm Lane.

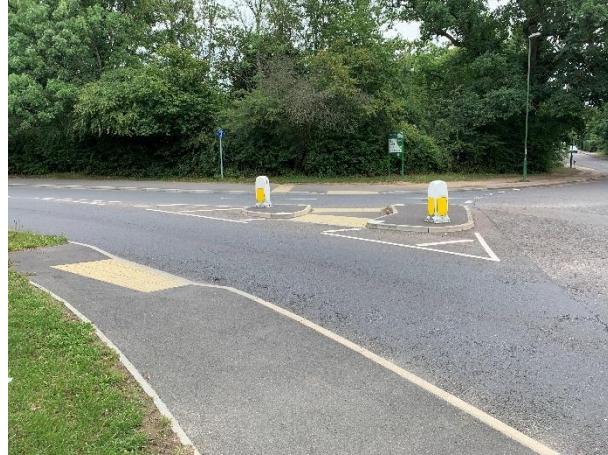
IMG_2295

9.5 Crossing facilities with lighting and tactile paving are present across Rusper Road north of the roundabout, leading to a shared footway/cycleway on the eastern side of Rusper Road.

Photo facing east across Rusper Road north of the roundabout.

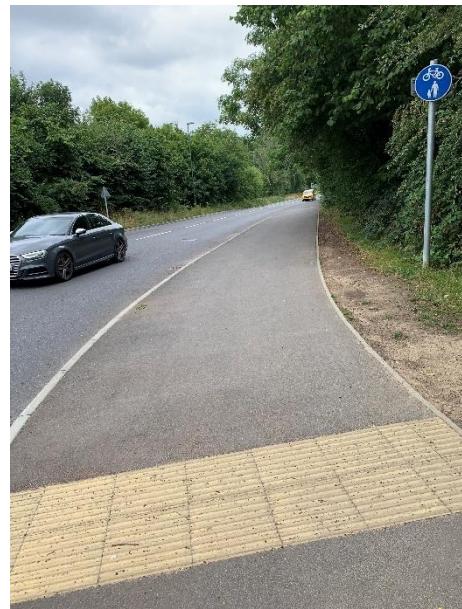
IMG_2296

9.6 A shared footway/cycleway extends north from the roundabout along the eastern side of Rusper Road.

Photo facing north along Rusper Road.
