Thakeham Tiles, Rock Road

Phase 1 Desk Study Report

For *Thakeham Concrete Products Ltd*

Doc ref 37212-HYD-XX-XX-RP-GE-1000

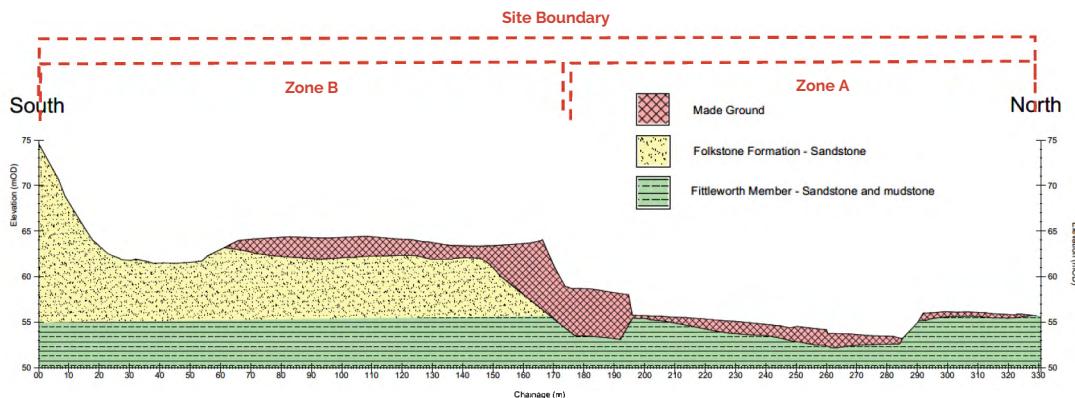
Figure 3.1: Indicative geological cross section of site

The conditions varied across site (Zone A – the northern area and Zone B - the southern area) and three types of Made Ground were identified:

- » **“Surface covering”** which included concrete hardstanding/paving slabs within the northern area of site and reinforced concrete within the southern area which was found at a maximum depth of 0.30m bgl;
- » **‘General’** Made Ground which was found in the northern area to a maximum depth of 5.55m bgl; and,
- » **‘Quarry backfill/Landfilled’** Made Ground which was found in the southern area to a maximum depth of 5.45m bgl. This Made Ground within the southern area contained occasional visible asbestos and rare asbestos fibres. An investigation into the extent of the asbestos contamination has been undertaken and these findings can be found in report 08347-HYD-XX-XX-RP-GE-1004.

The ground conditions identified to date within the original boundary of site has been summarised below, in Table 3.1 and in Figure 3.1.

In the south of the site is a former quarry area (sandpit) and historic landfill recorded as a licensed inert landfill between 1970 and 1982. Hydrock investigations have identified Made Ground to extend up to 5.45m bgl, with an average thickness of 2.39m. This comprised of cream, light brown sand over reddish brown and grey brown gravelly sand with occasional clay layers. Gravel noted to be of concrete, brick, metal, plastic and wood. Frequent asbestos containing materials and loose fibres were also encountered within the quarry area Made Ground.

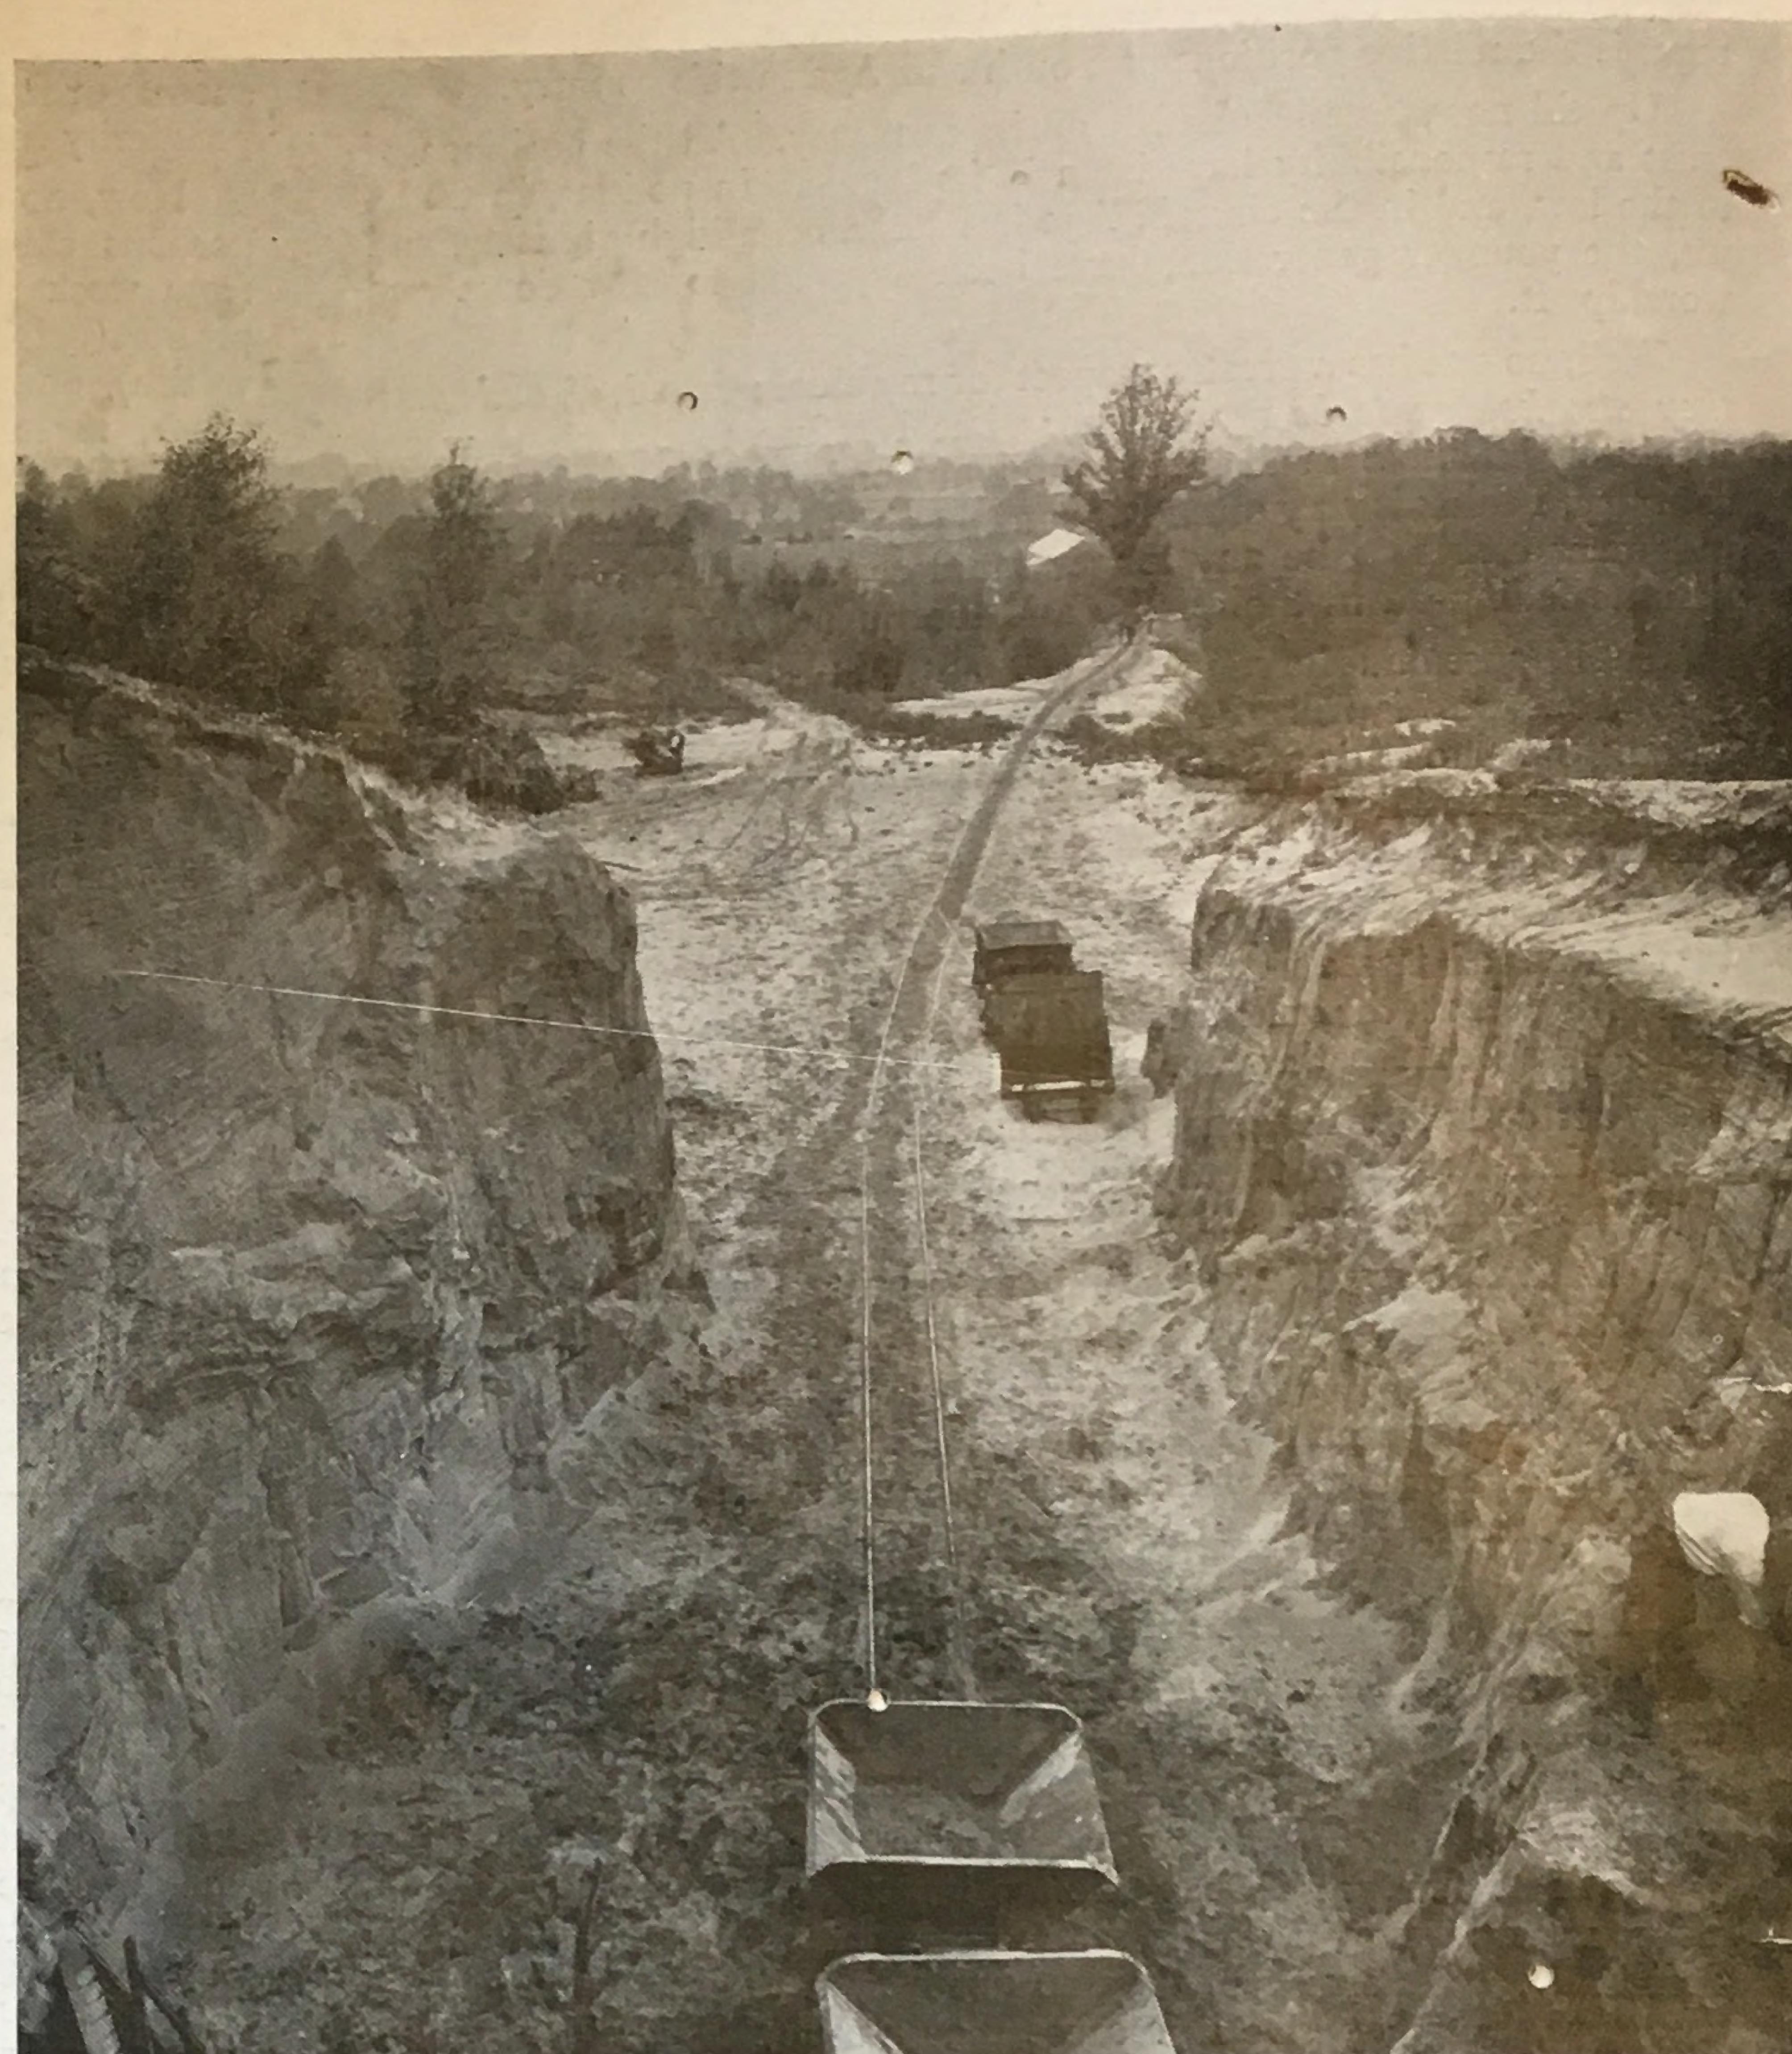
General view of the works which cover 14 acres, from the noted Sussex sand quarries of Mr. F. Knight.

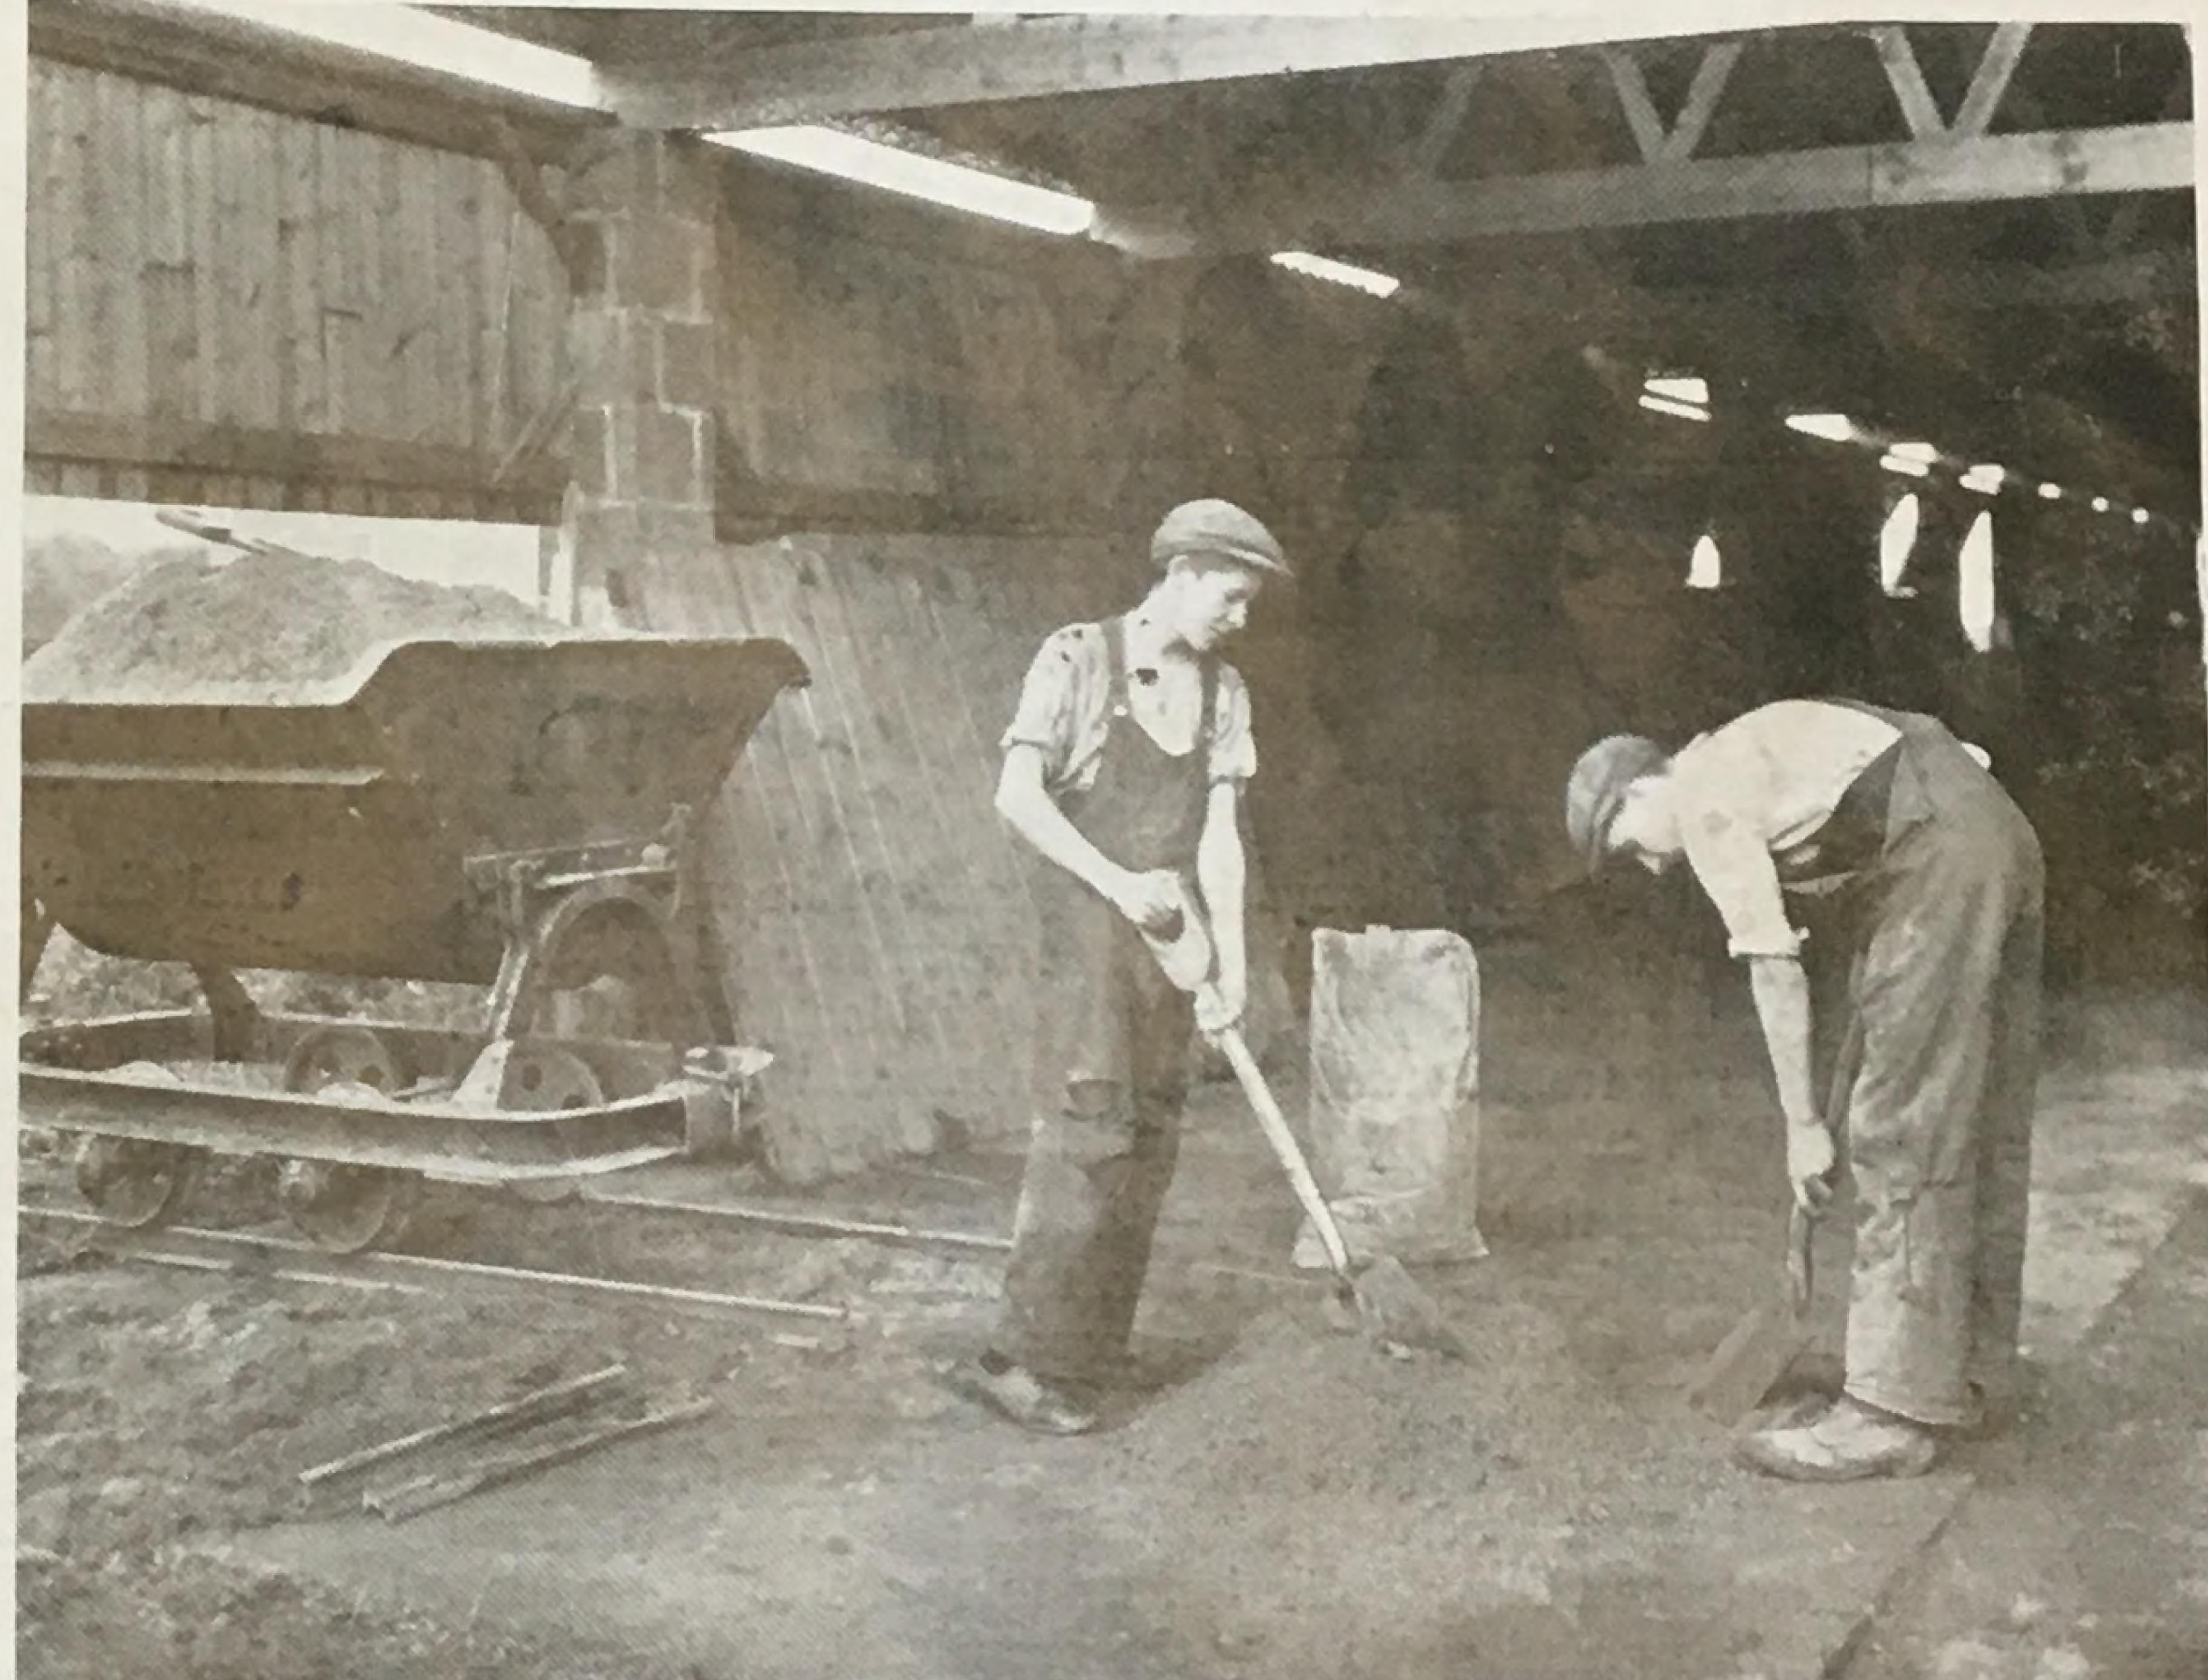
Mixer for the tile maker.
