**GROUND CONTAMINATION
RISK ASSESSMENT AND
REMEDiation STRATEGY**

**NASH MANOR
NUTBOURNE LANE
NUTBOURNE
WEST SUSSEX**

PROJECT REFERENCE: P17336

REPORT REFERENCE: R16834

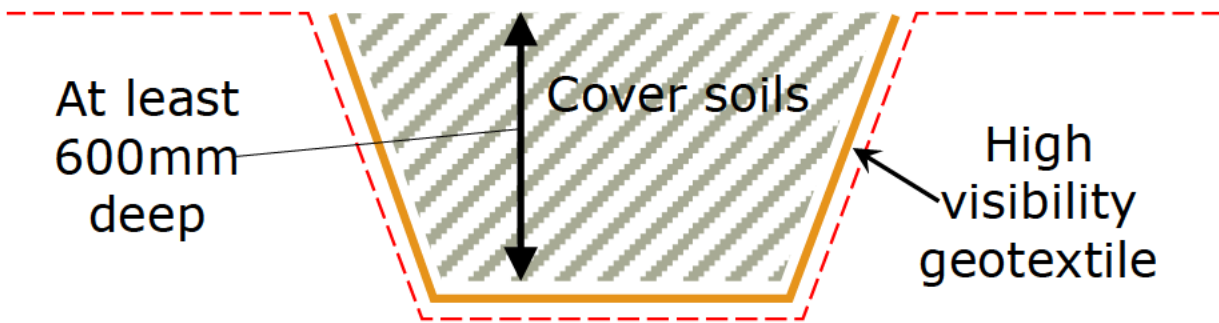
A schematic cross section of the cover system construction is shown below.

The depth of the cover system specified represents “two spade depths” to allow for planting of trees, shrubs etc. without residents coming into contact with the contaminated soils remaining at depth.

Within all proposed areas of garden that are to be created beneath the footprint of the current barn, the made ground soils will be removed either to expose the undisturbed soils, or to a sufficient depth to allow the placement of a cover system of at least 600mm of verified "clean" imported soils. The cover system soils must be underlain by a high visibility geotextile marker which laps up the sides of the excavation to prevent future intermixing between the cover system soils and the residual made ground.

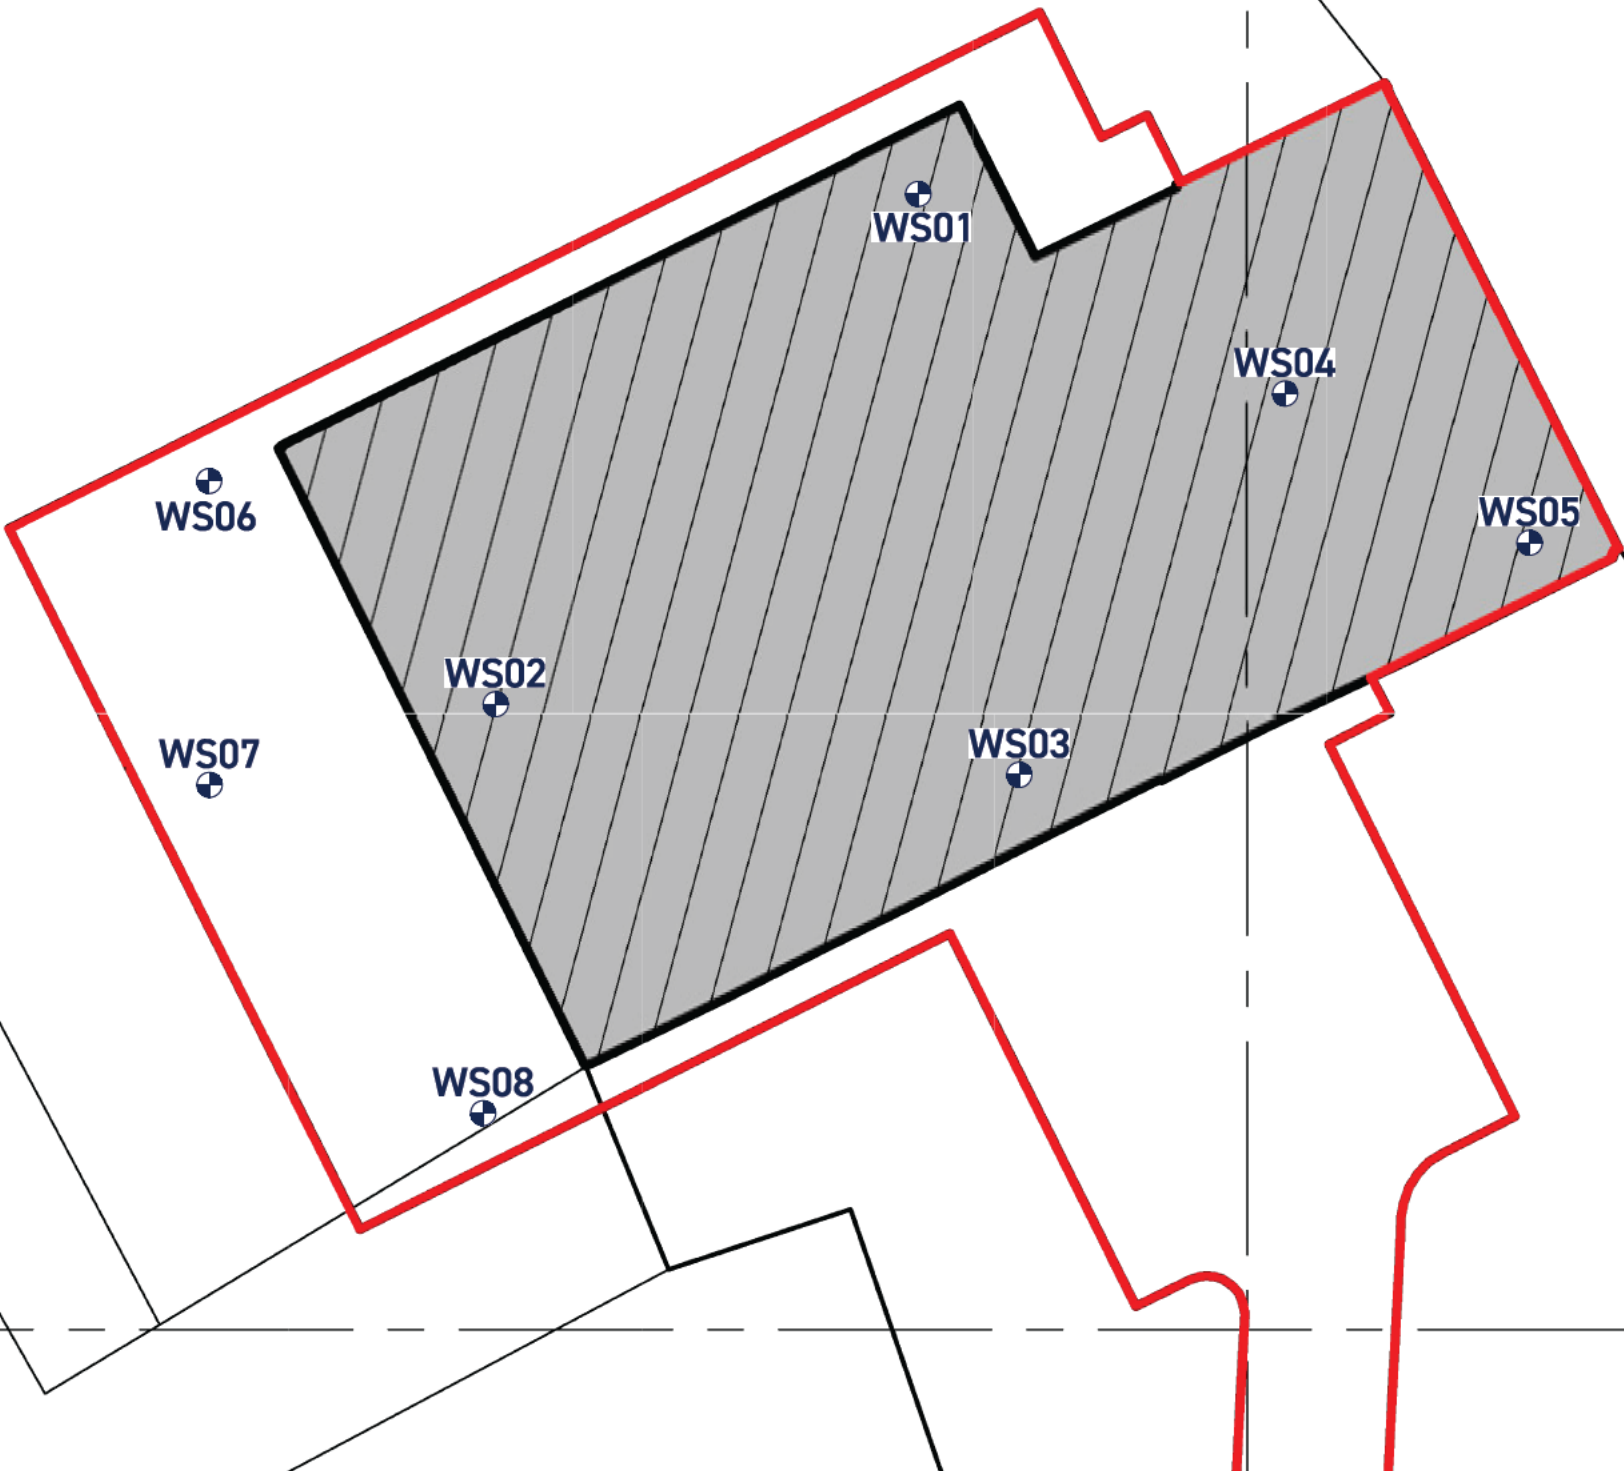
The intrusive site works comprised the drilling of a series of dynamic sampler boreholes to enable the logging and sampling of soils. The intrusive work was carried out on 20th August 2025. The exploratory hole locations are shown on Figure 2.

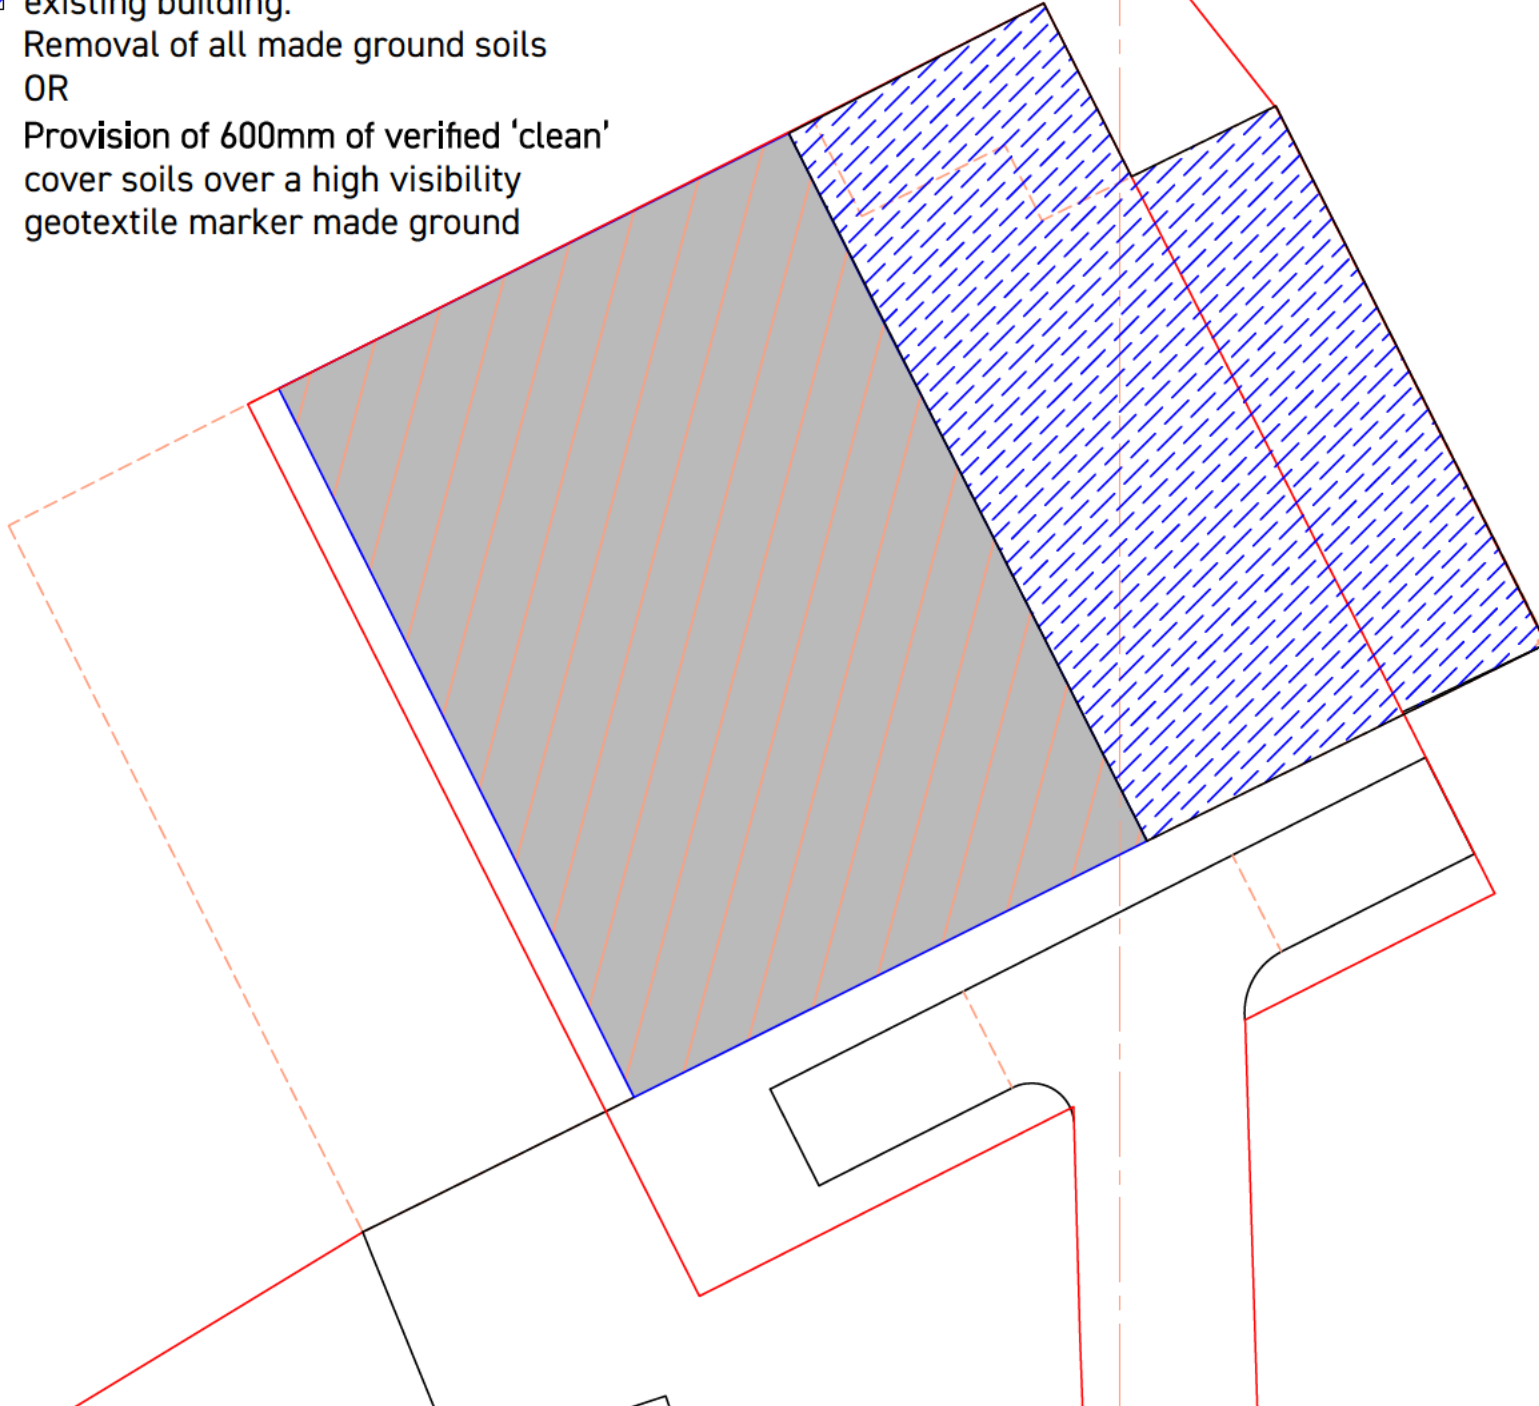
Removal of all made ground soils
OR

Provision of 600mm of verified 'clean' cover soils over a high visibility geotextile marker made ground

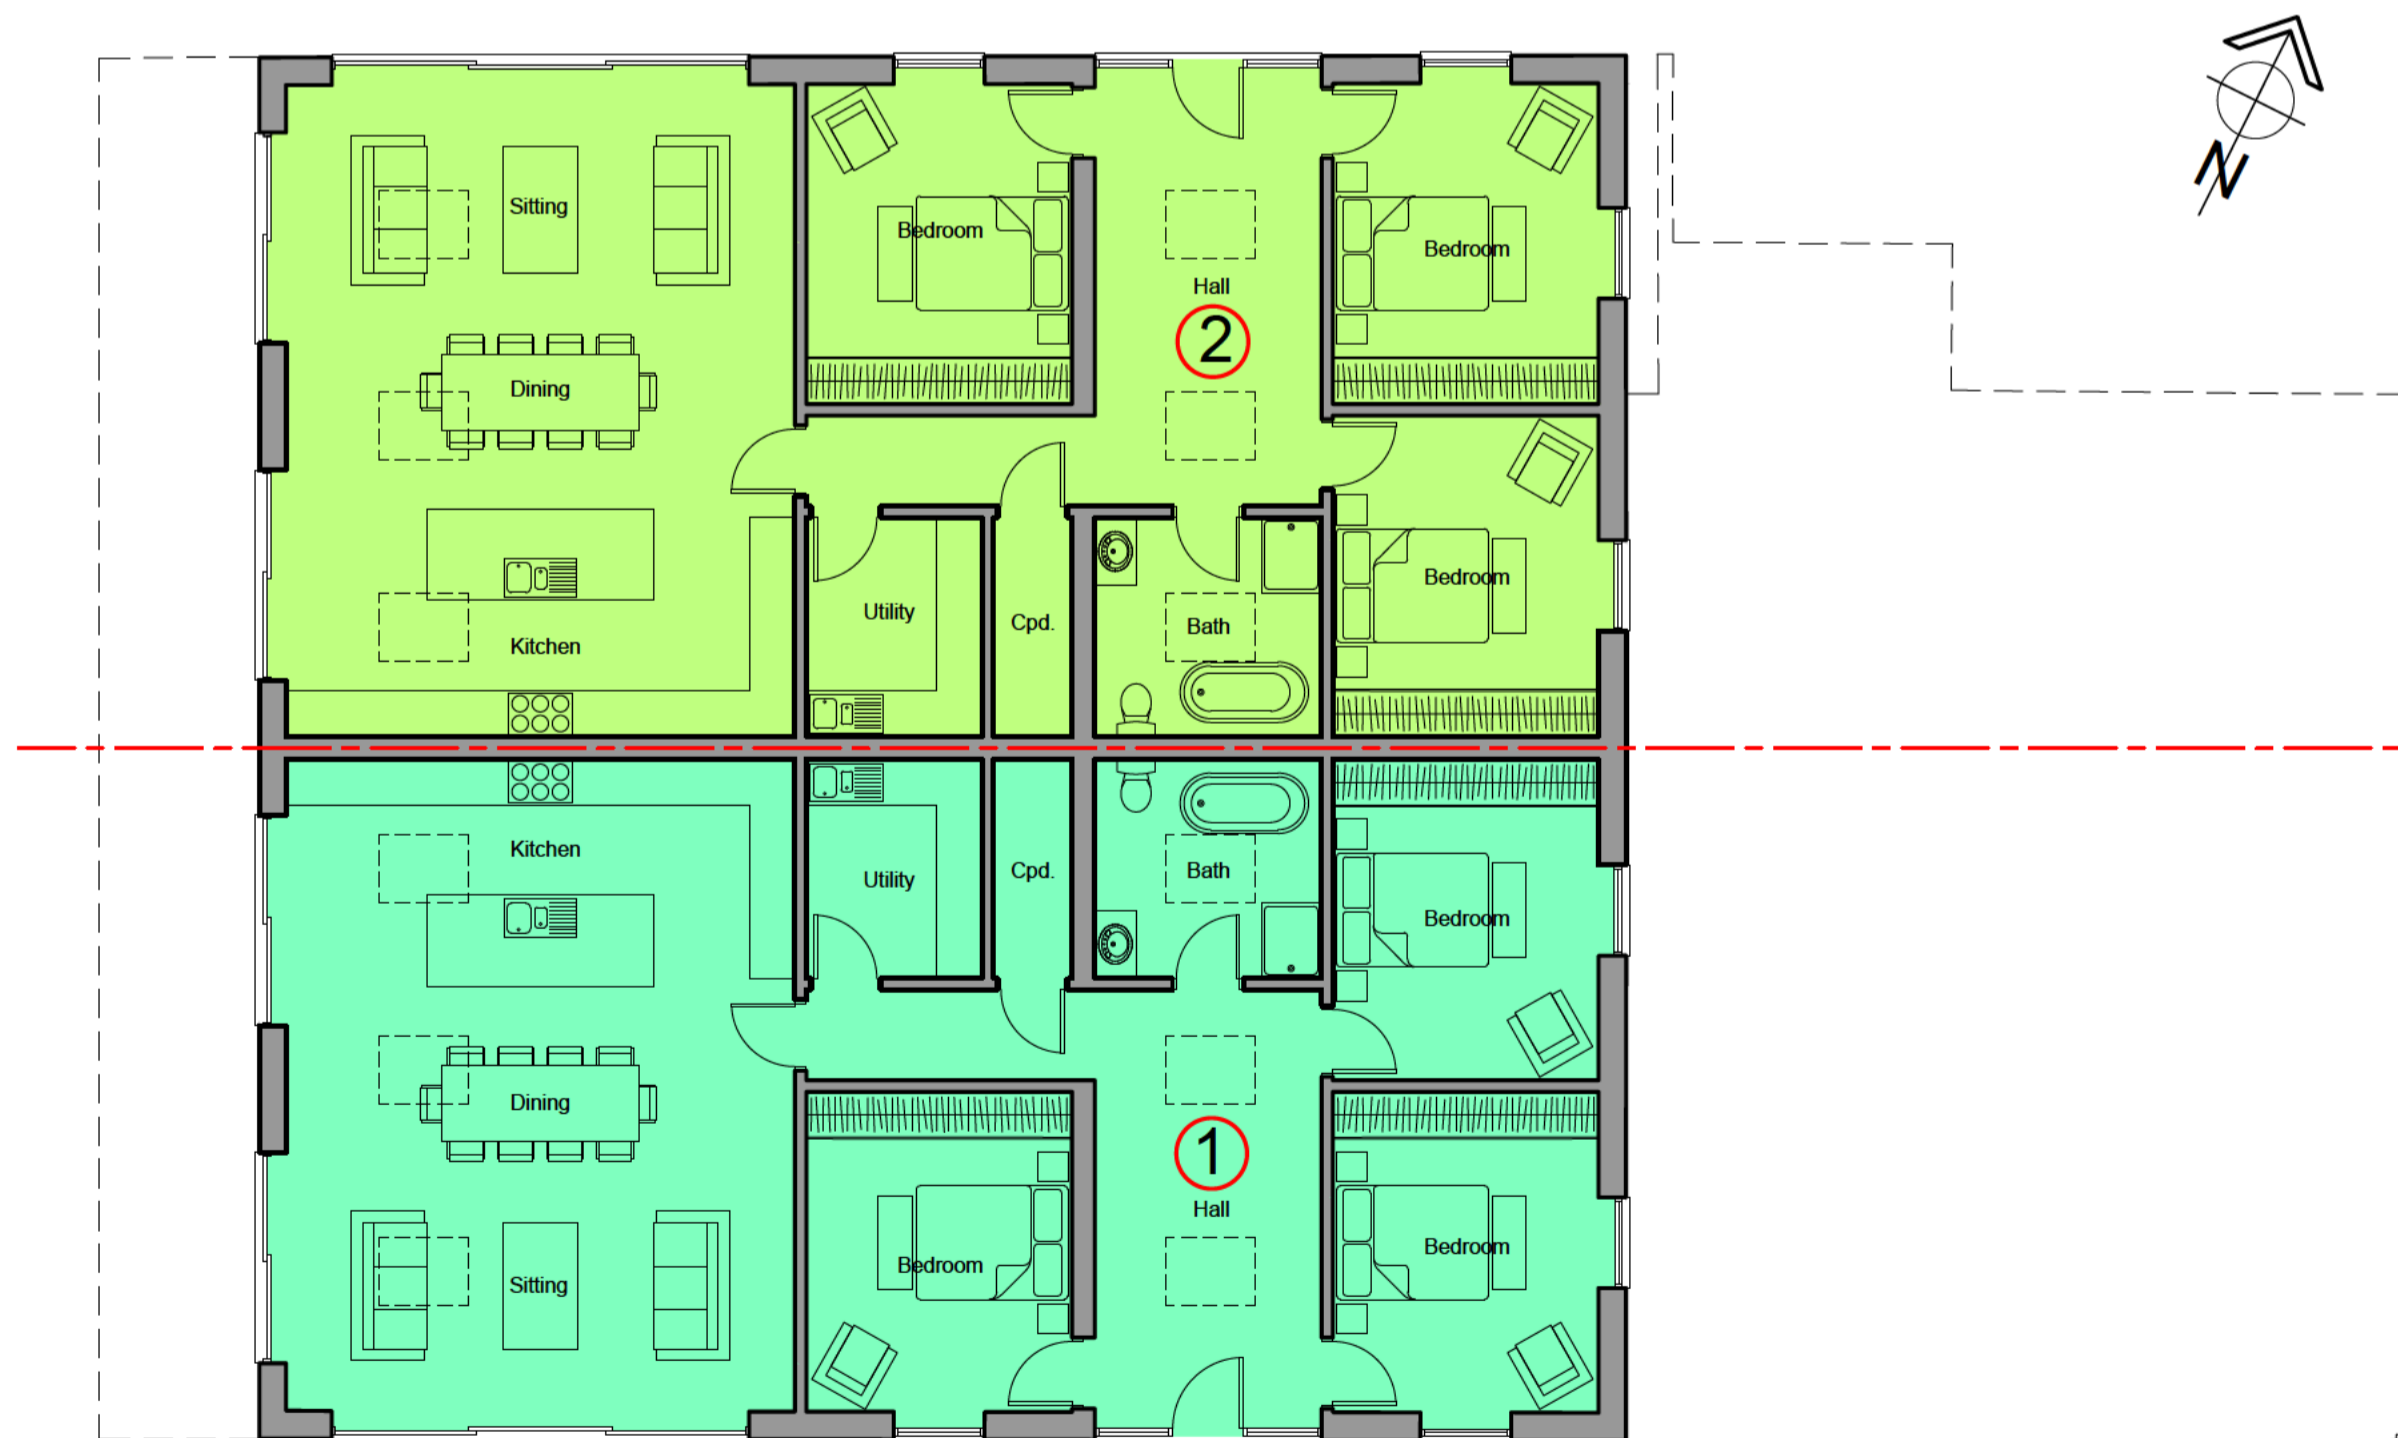
Ground Floor General Arrangement Plans

Plot 1 & Plot 2 G.I.A = 150sq.m
