NASH MANOR INC

NASH MANOR, LOWER NASH, NUTBOURNE LANE,
NUTBOURNE, WEST SUSSEX

Tree Report

Requirement	Data
Report Ref:	858/LG/NashManor/Arb
Date	November 2025
Client	Nash Manor Inc
Report type	Tree Survey and Arboricultural Impact Assessment
Purpose	Planning submission
Revisions	-
Prepared by	Lucy Monday BSc (Hons), ACIEEM

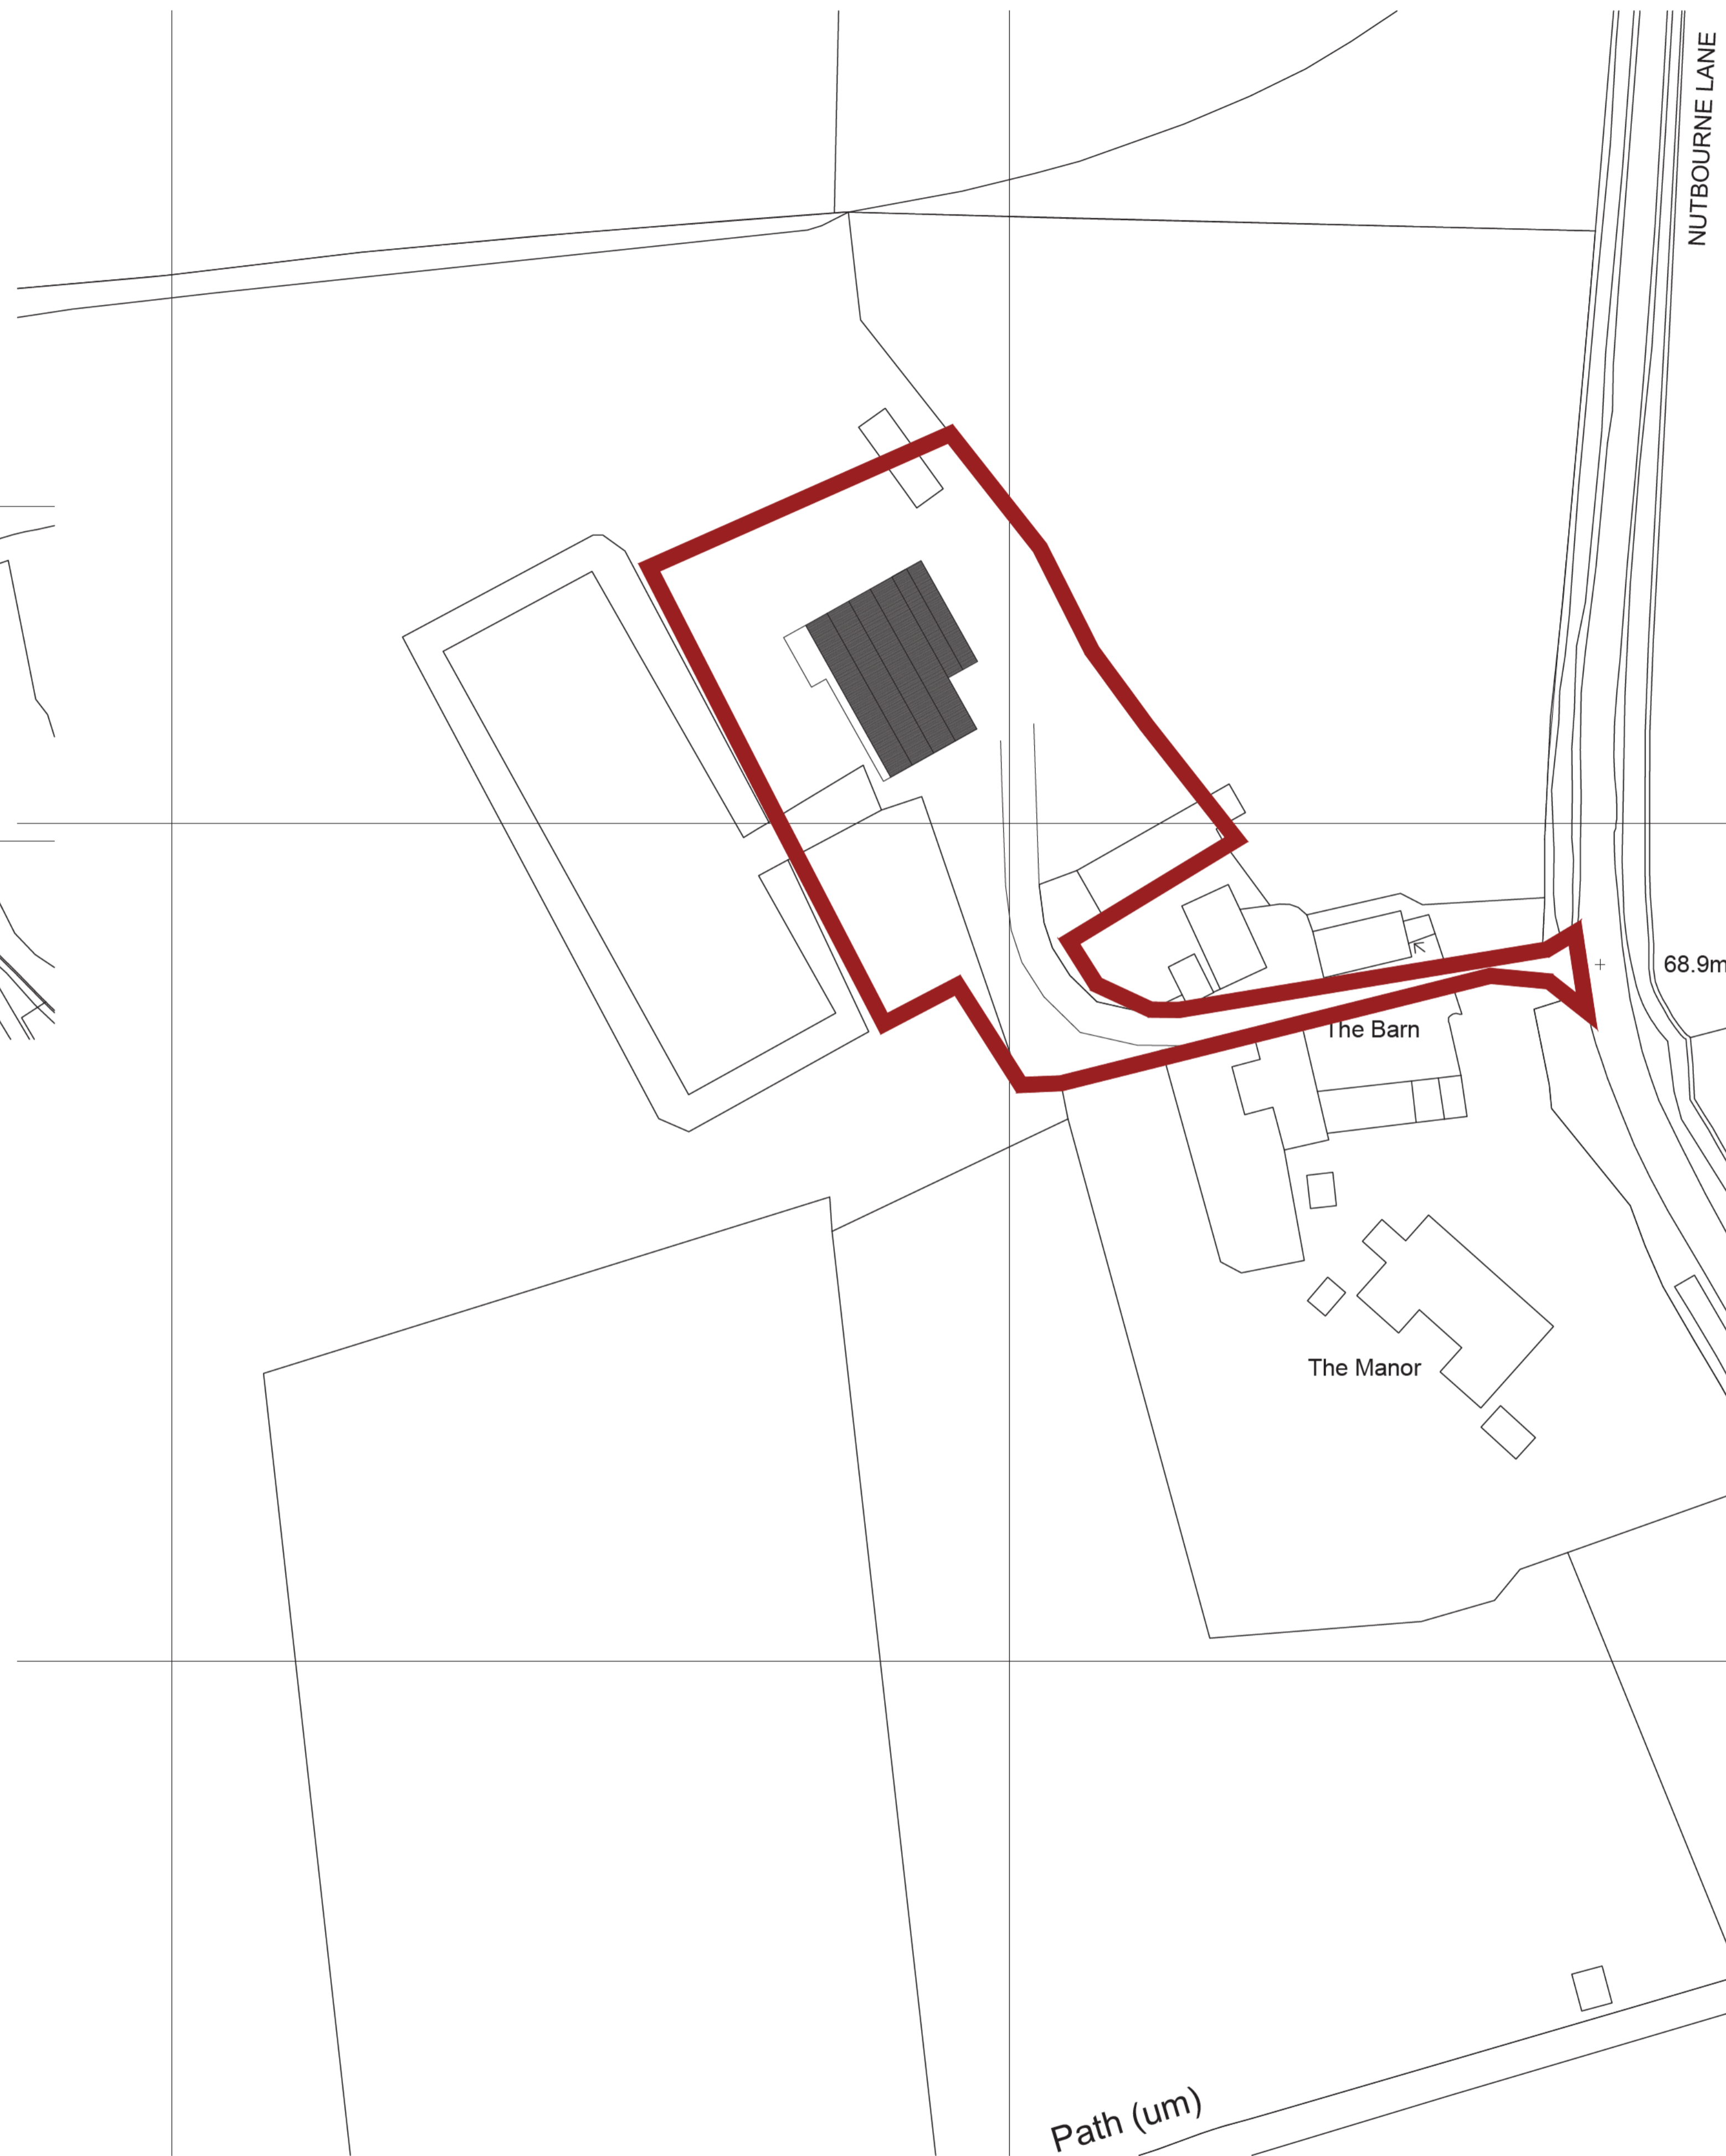
Proposed Block Plan - 1:500

- 1.1 Environmental Assessment Services Limited has been instructed by Mr L Goossens to undertake a tree survey and prepare an arboricultural impact assessment in relation to the proposed redevelopment of land at Nash Manor in Nutbourne, West Sussex. See Appendix A for Site Location Plan.
- 1.2 The site comprises land developed for agricultural use including a large barn, yard area, a small store and dilapidated green house. It is proposed to redevelop the site to comprise a single residential dwelling within the footprint of the existing barn, utilising the existing access, and reducing the existing hard standing to provide additional soft landscaping within the calculated root protection area of the existing trees within and adjacent to the site. See Appendix A for the existing and proposed site plans.
