BS:5837 ARBORICULTURAL REPORT

ARBORICULTURAL SURVEY, IMPACT ASSESSMENT &
METHOD STATEMENT

LYNCORTE
BENTONS LANE
DIALPOST
WEST SUSSEX
RH13 8NW

Project: Proposed new residential dwelling

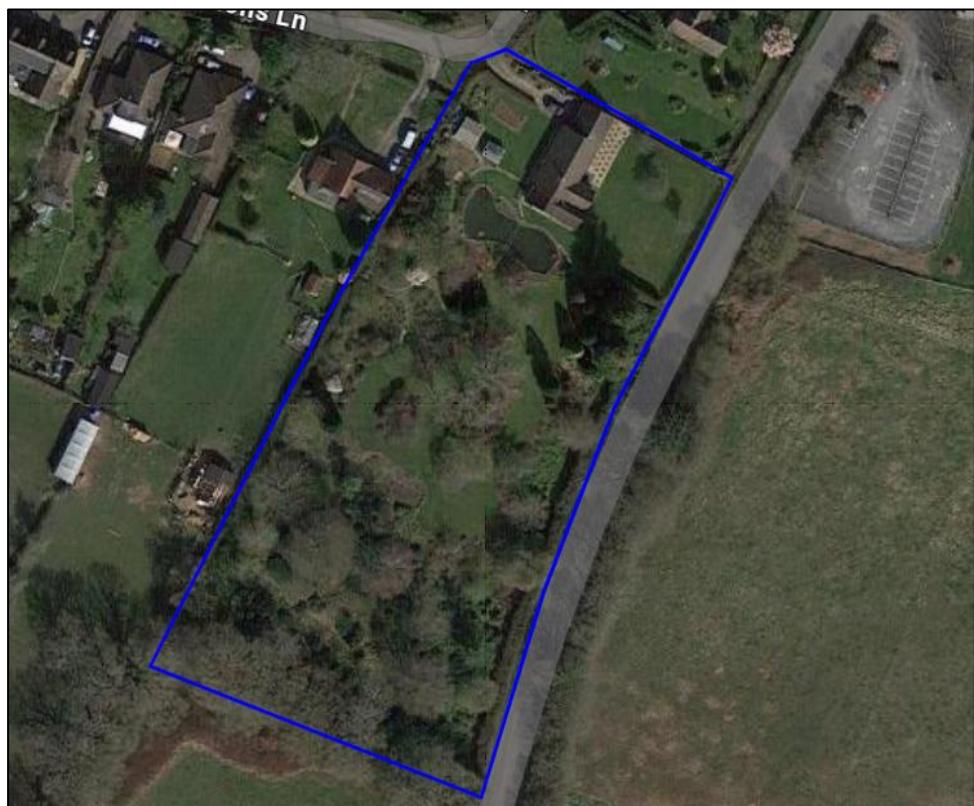
Figure 1 – Google aerial photo of Lyncorte (Imagery @2025 Maxar Technologies Map data © 2025)

Lyncorte is a detached bungalow set within a large property curtilage of approximately 2.2 acres. The original dwelling is located at the far north of the plot and accessed off Bentons Lane.

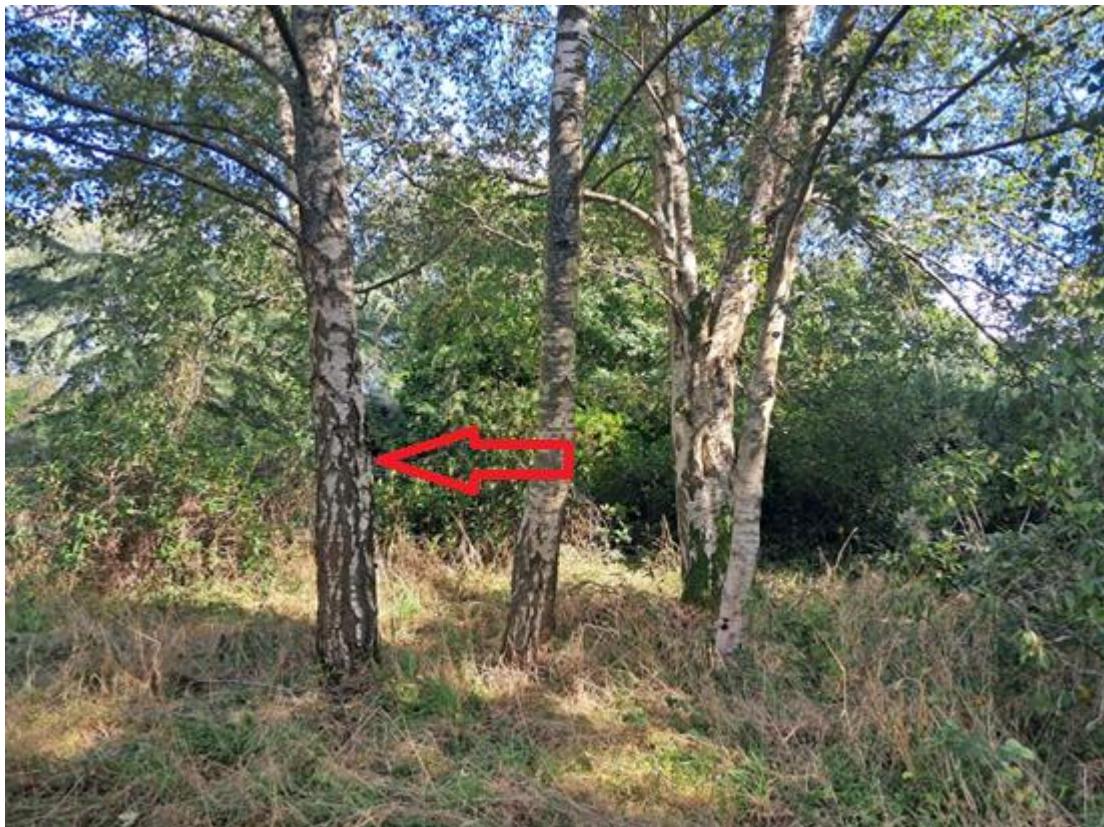
Photo 1 – Category 'B' Silver Birch (T041)

Of the trees to be removed, T041 (Birch) is a category 'B2' tree because it forms part of a larger and more significant group of Silver Birch. However, as an individual specimen the tree is small with an asymmetrical crown and is of no particular arboricultural merit, such that it might pose a reasonable constraint to the planning proposals.

Four small trees are to be removed to create adequate parking and for access, and a gap will be created through the boundary hedge for the entrance driveway off Worthing Road.

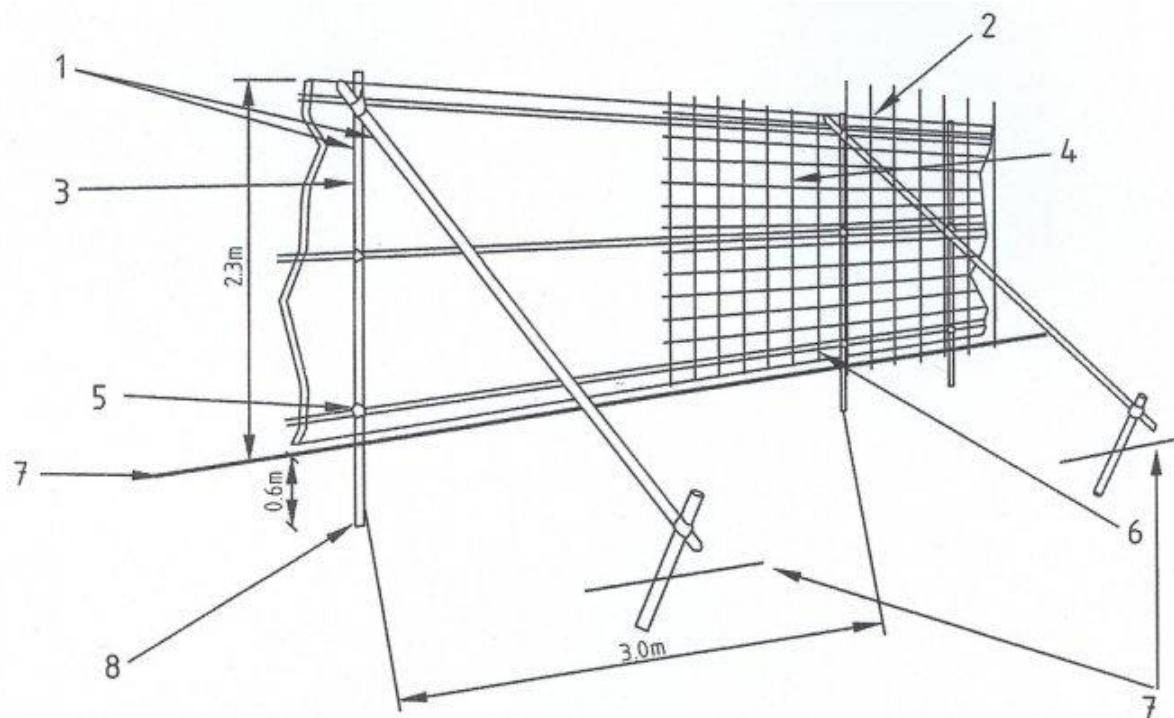
Figure 2. – Protective fencing for RPA

- 1 Standard scaffold poles
- 2 Uprights to be driven into the ground
- 3 Panels secured to uprights with wire ties and, where necessary, standard scaffold clamps
- 4 Weldmesh wired to the uprights and horizontals

- 5 Standard clamps
- 6 Wire twisted and secured on inside face of fencing to avoid easy dismantling
- 7 Ground level
- 8 Approx. 0.6m driven into the ground

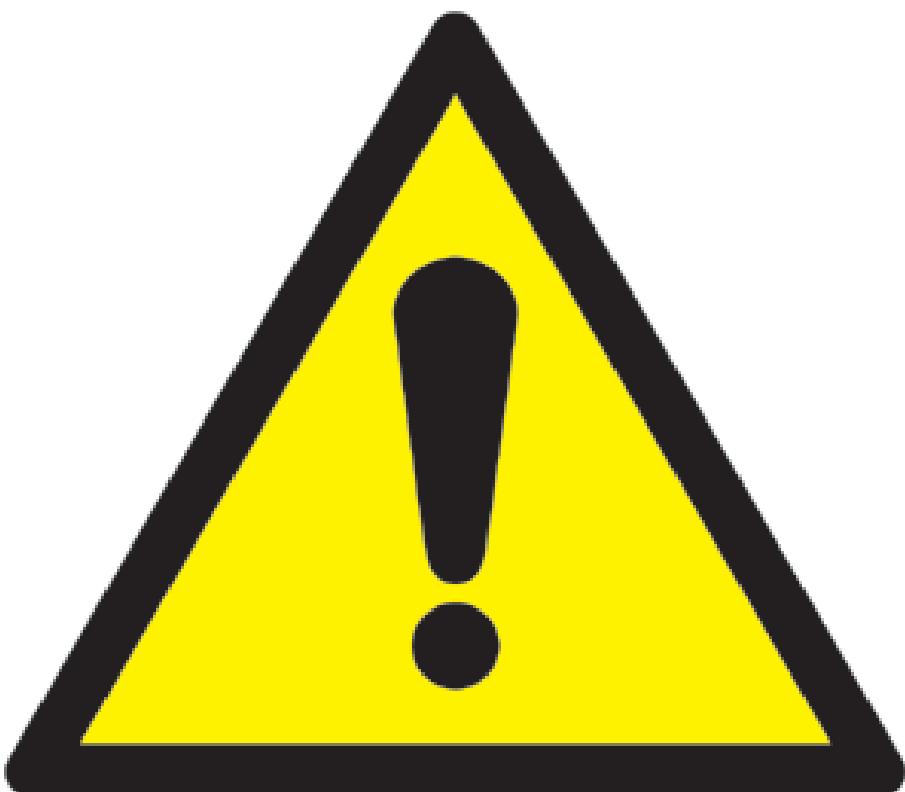
APPENDIX I - TREE PROTECTION BARRIERS SIGNAGE

TREE PROTECTION AREA KEEP OUT !

(TOWN & COUNTRY PLANNING ACT 1990)
