Brighter strategies
for greener projects

Client: Lovell Homes
Project: Novartis Phase 1&2
Report: Preliminary Roost Assessment

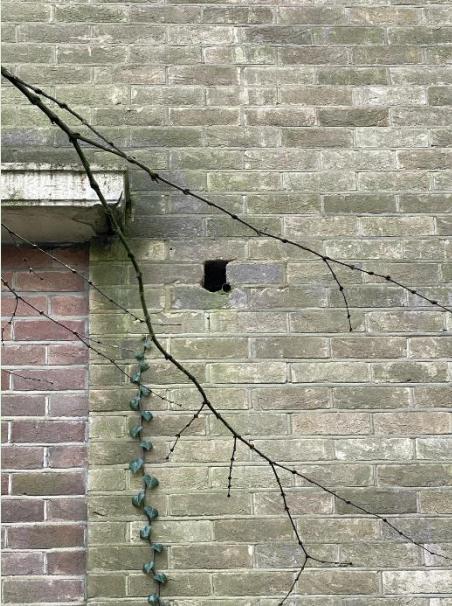
PRF No.	PRF Description	Photograph	Suitability
Internal Courtyard			
F001	<p>Hole in brickwork at approximately 4.5m from ground level within the internal courtyard, with a northern aspect. Approximately 10cm tall and 7cm wide. Likely a surface feature with no large cavity space that is exposed and open and therefore thermally unstable.</p>

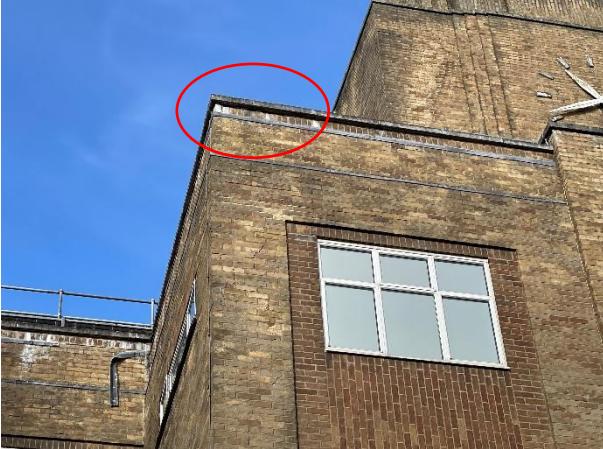
Low
F002	<p>Missing mortar under the concrete eave on the eastern aspect within the internal courtyard at roof level. Likely a surface feature with</p>

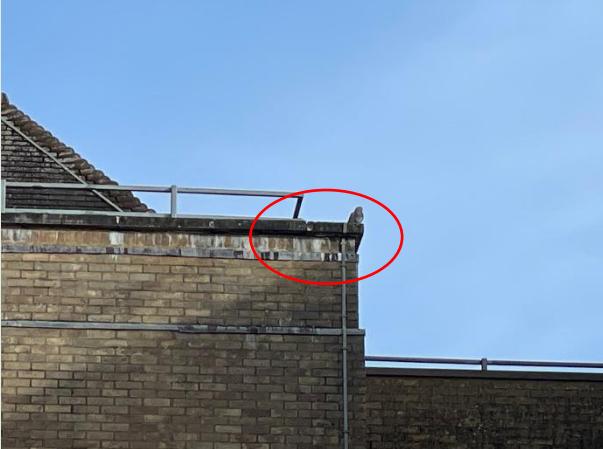
PRF No.	PRF Description	Photograph	Suitability
	no large cavity space that is exposed an open and therefore thermally unstable.		
F003	<p>Missing mortar under the concrete eave with a southern aspect within the internal courtyard at roof level.</p> <p>Likely a surface feature with no large cavity space that is exposed an open and therefore thermally unstable.</p>

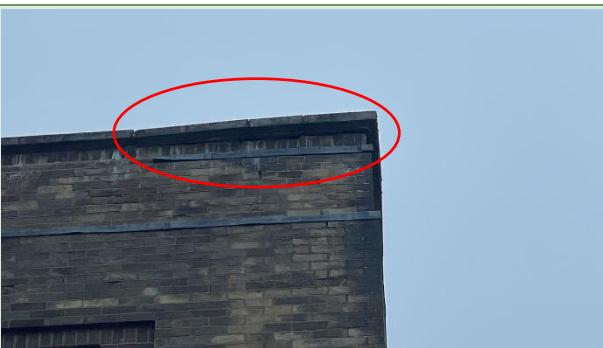
Low
External Façade			
F004	<p>Gap in mortar under concrete eave on the southwest corner with a northwest aspect.</p> <p>Feature is likely to be superficial and</p>

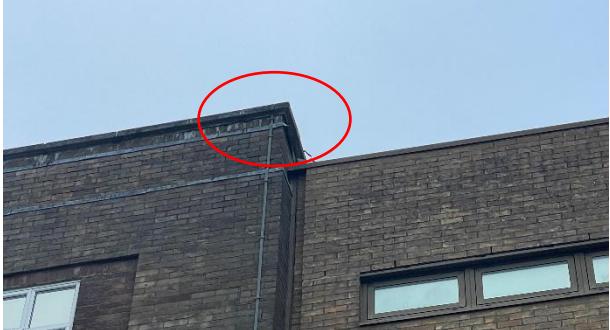
PRF No.	PRF Description	Photograph	Suitability
	lack a large cavity space. Is likely to be thermally unstable.		
F005	Crack in brickwork directly below the concrete eave on the southern aspect at roof level. Unlikely to provide a large cavity space and is likely to be exposed and thermally unstable.

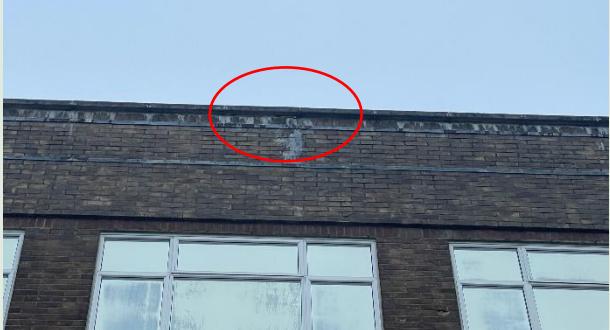
Low
F006	Crack in mortar under concrete eave above the 5th window on the south-western aspect at roof level. It is unlikely to provide a large cavity space and is likely to be thermally unstable.

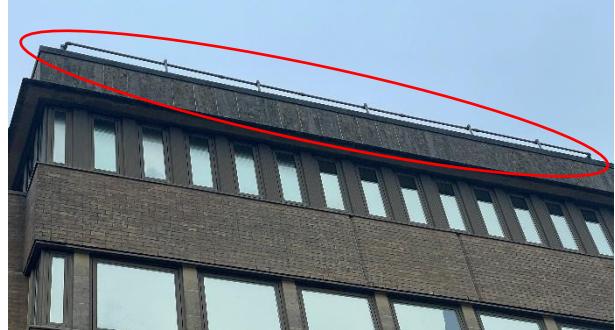
PRF No.	PRF Description	Photograph	Suitability
F007	Gap between metal parapet and concrete wall on eastern aspect at roof level, likely to be thermally unstable.

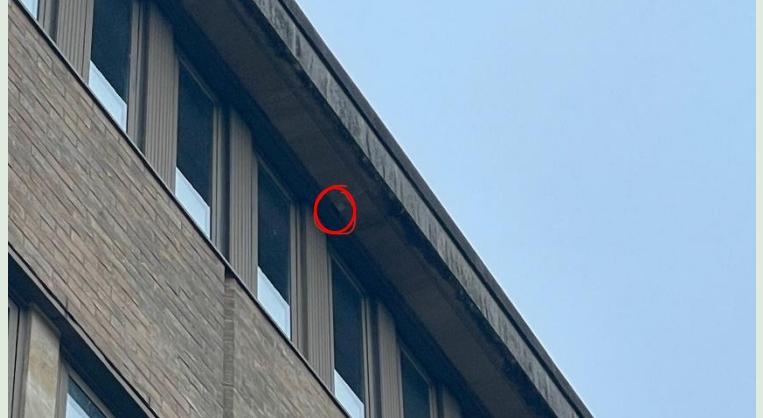
Low
F008	Hole in concrete eave on the northeastern aspect. Unlikely to provide a large cavity space and is likely to be thermally unstable.

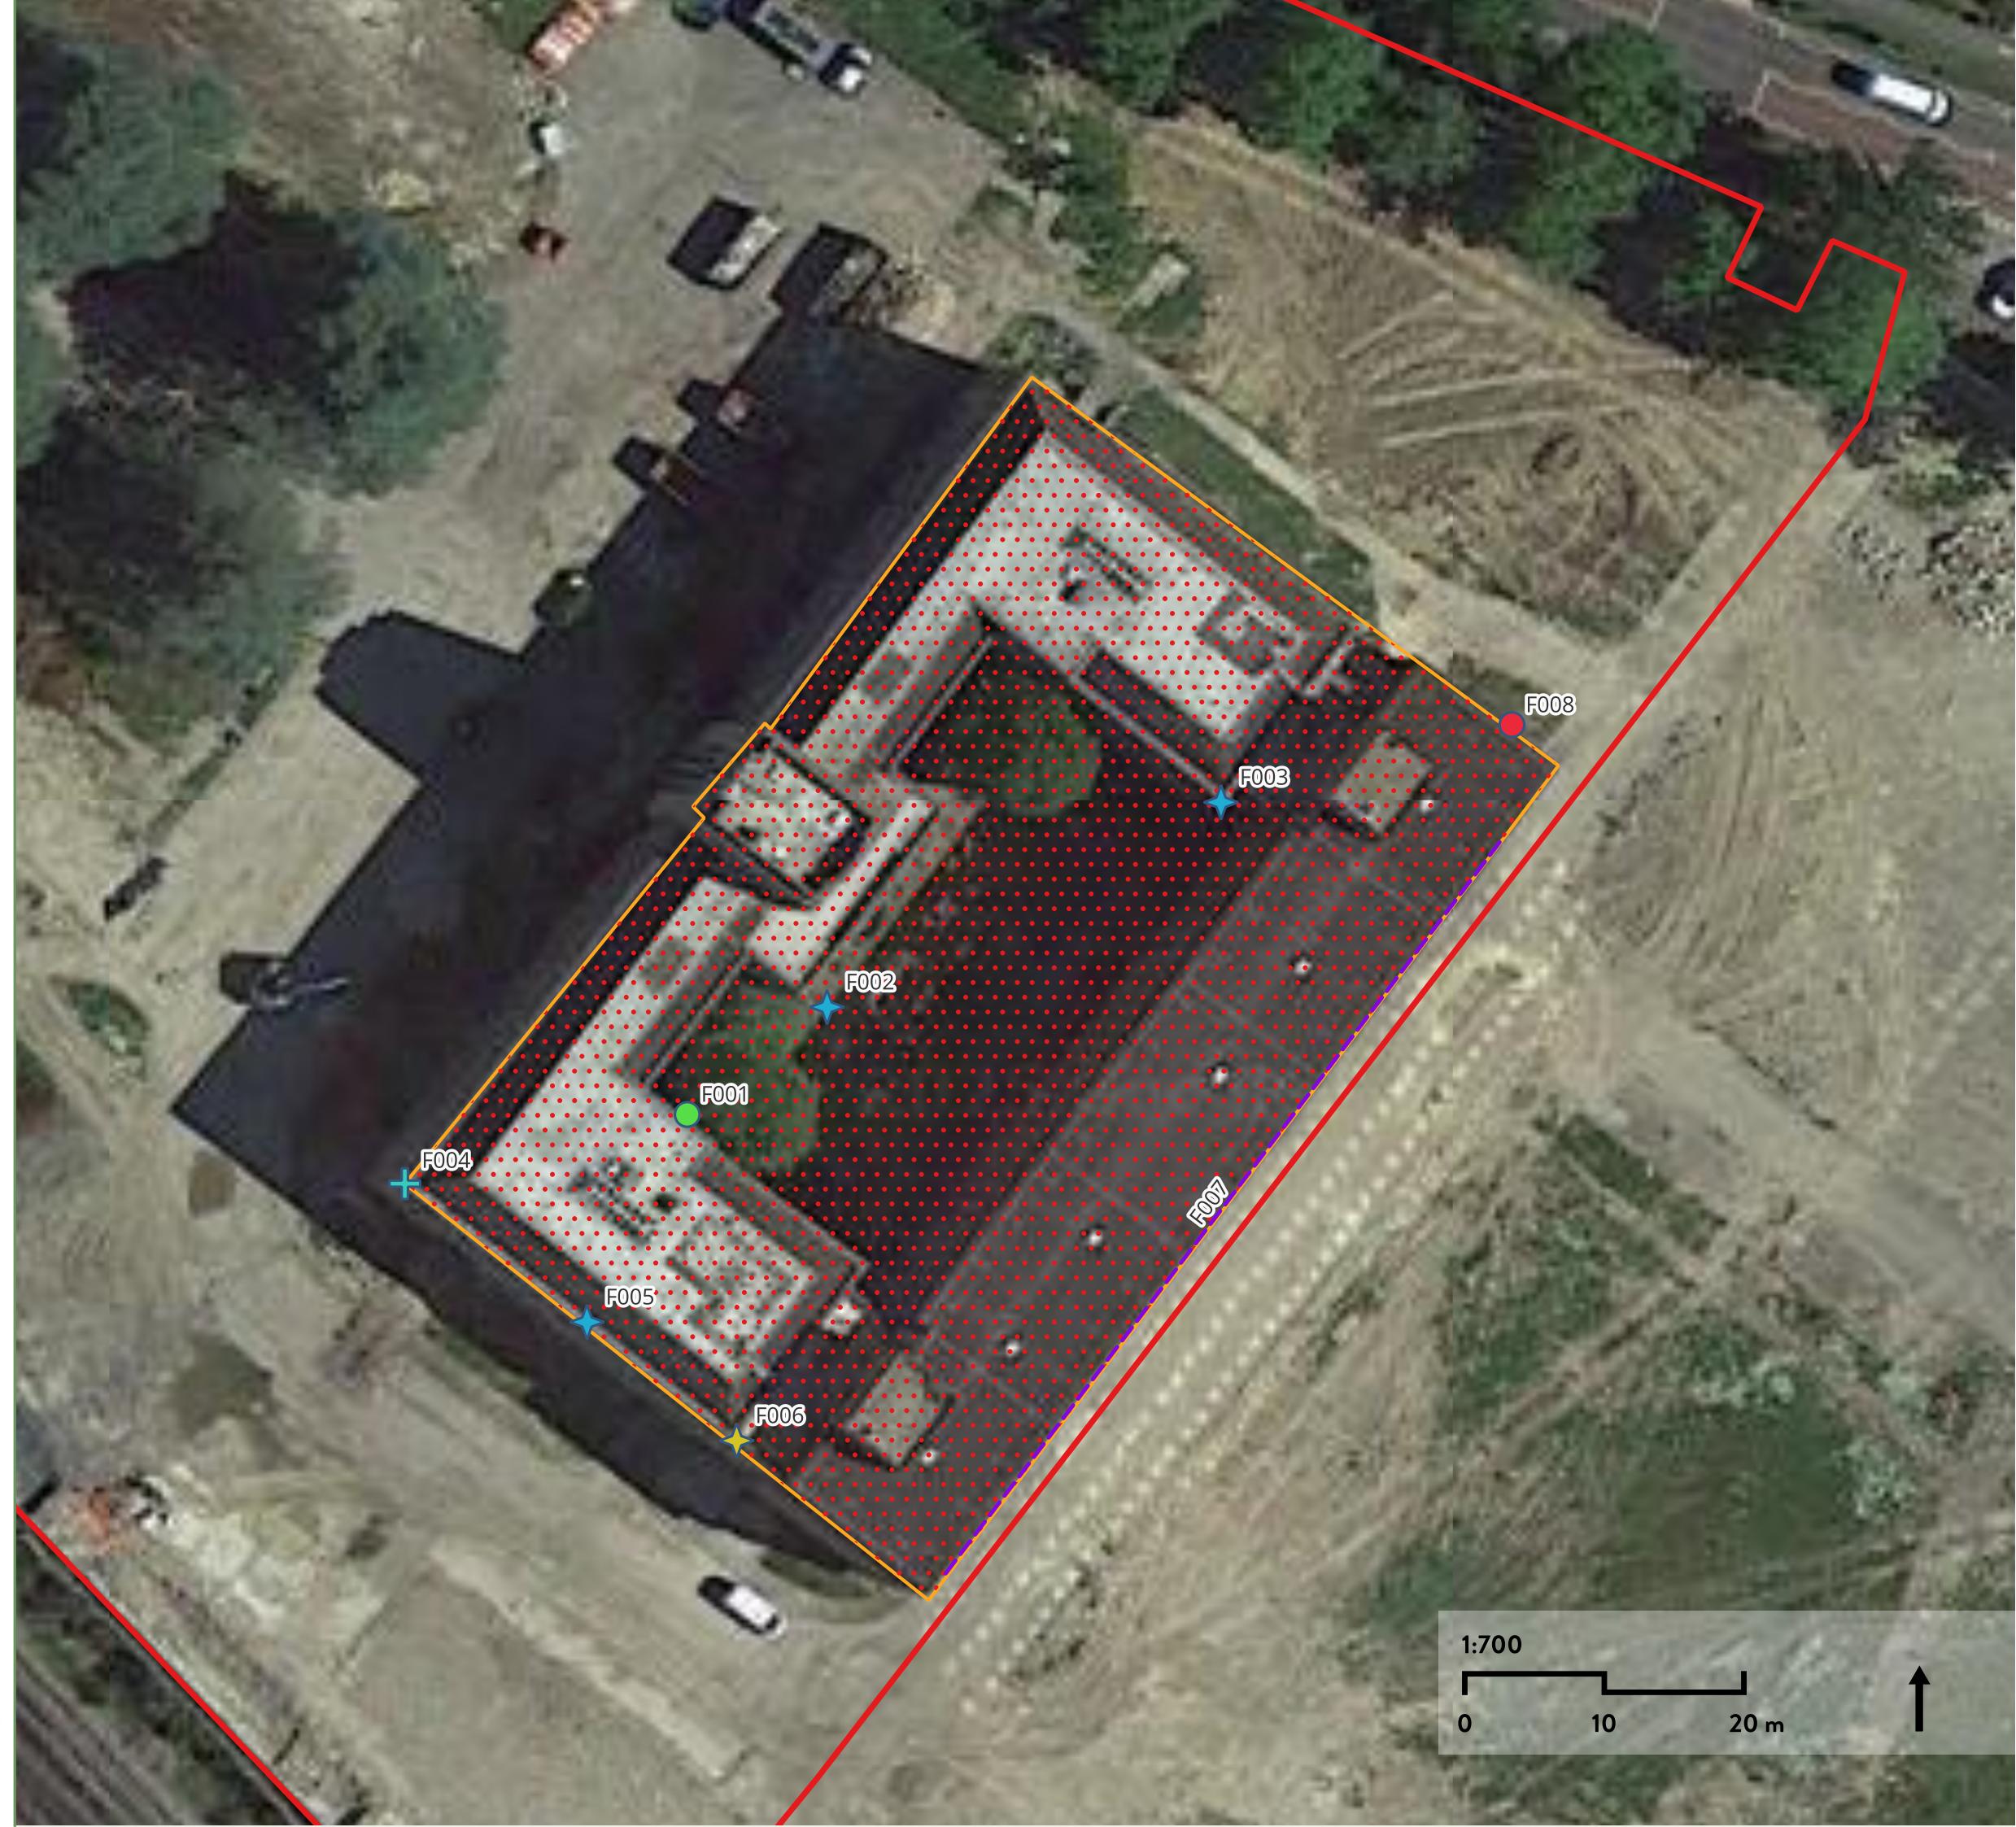
Title: Figure A.1 PRA Survey Results

A PRA was undertaken in daylight on 5th February during cool (3- 5°C), sunny and dry conditions. The evaluation of bat suitability comprised a detailed systematic internal and external assessment of B1 (Figure A.1), that aimed to identify suitable PRFs. In accordance with the Bat Conservation Trust's (BCT) Good Practice Guidelines⁵ consideration was given to:

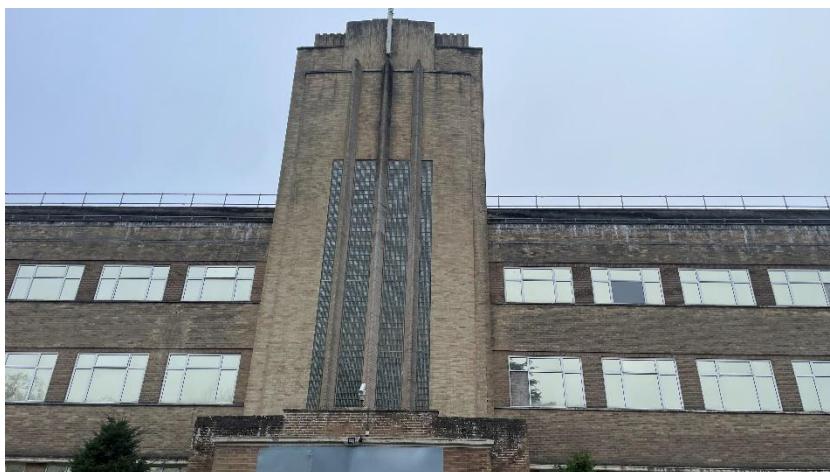
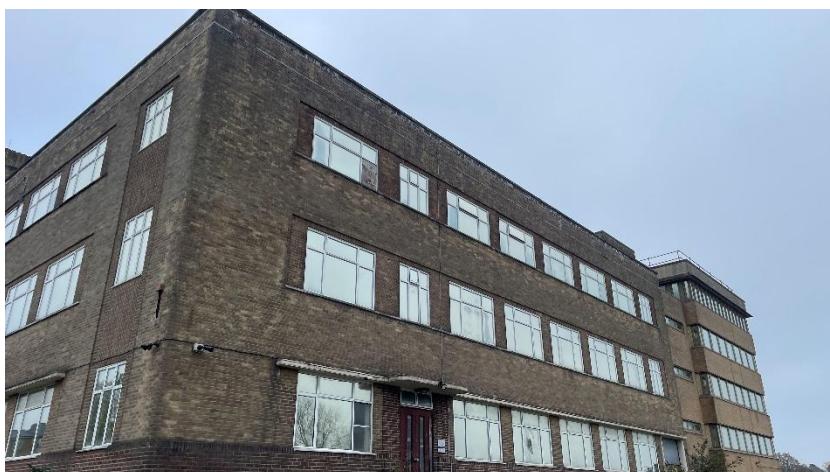
B1 is a brick constructed building that is derelict. The western half of the building was constructed 1910 - 1960 and has an absence of a cavity wall (see Plate B.2 to Plate B.3), with the eastern half of the building (see Plate B.4 to Plate B.5) likely constructed 1960 to present. There is a flat roof present with pitched roof with clay tiles (see Plate B.6). The tiles are in good condition, with no damage or decay noted. Lead flashing is present. The building has an absence of soffits or fascia's, however, concrete eaves are present. The building brickwork and roof structure is in good condition overall.

Plate B.2 *Western aspect of B1*

Plate B.3 *Southern aspect of B1*

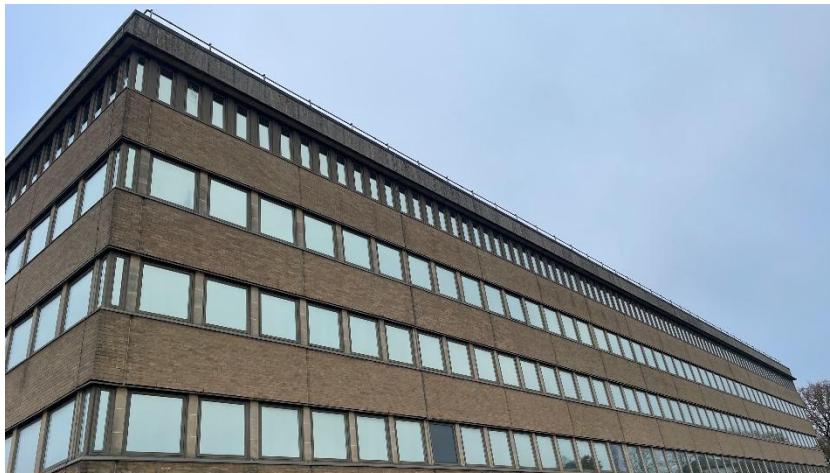
Plate B.4 *Eastern aspect of B1*

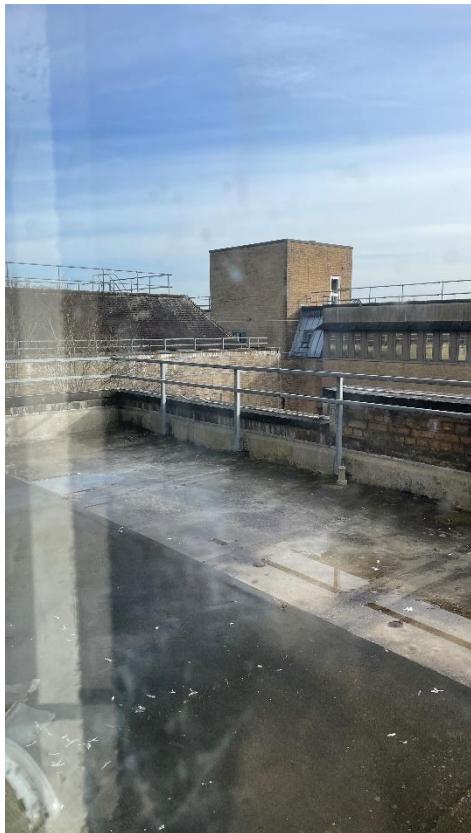
The roof of B1 could not be accessed during the survey. This is not considered a significant limitation as the roof tiles were clearly visible with the use of binoculars from ground level.

Plate B.6 *Flat roof (inaccessible)*

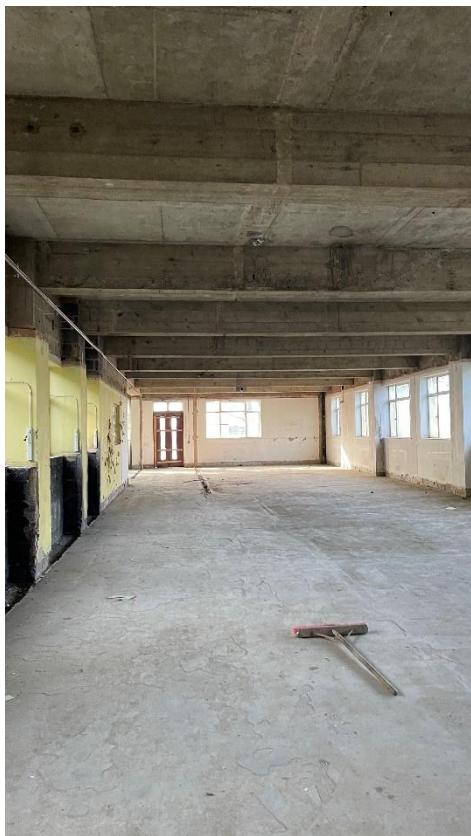
There were minor surface cracks within the concrete ceilings on the basement and middle floors (see Plate B.9), providing space for low numbers of bats on an opportunistic basis which could provide low suitability PRFs for roosting bats. The lift shafts around the stairwells may contain damaged brickwork/concrete breeze blocks (see Plate B.10), however no PRFs were noted within the areas that could be inspected (due to health and safety reasons) and would lack the presence of a large cavity space suitable for large numbers of roosting bats due to the absence of cavity walls.

Plate B.9 *Middle floor*

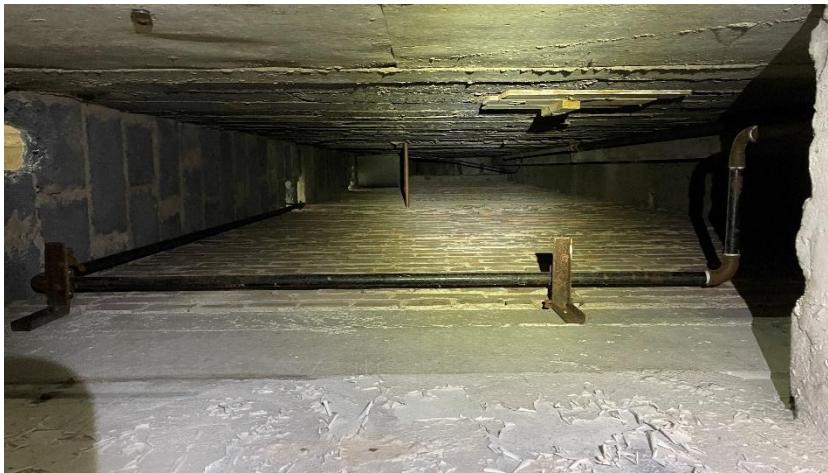
Voids from the lift shafts around the stairwells could not be fully inspected due to the height of the void. Shafts where pipework entered the building within the basement could not be access due to health and safety reasons. This is not a significant limitation as the voids were fairly well sealed, constructed of brick wall/concrete breeze blocks with no suitable crevices. The accessible areas were searched for

Plate B.10 Void adjacent to lift shaft looking upwards from basement level

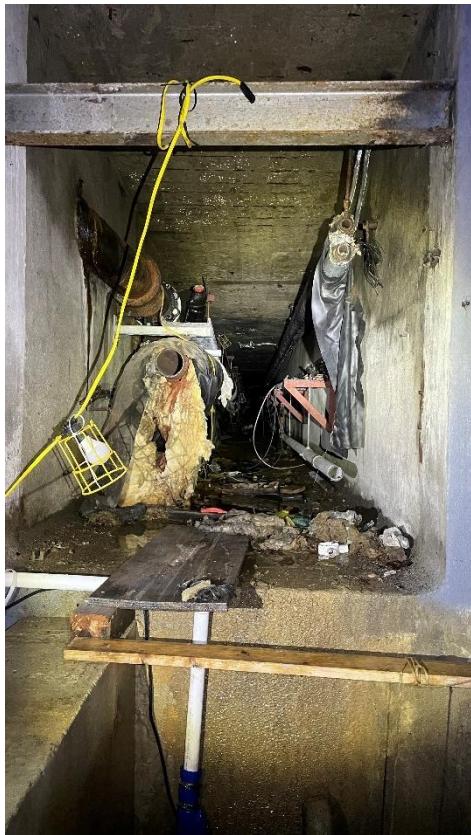
Within the southwestern section of the basement is lower section of the building that was dark, cool and humid, with water droplets present on the high ceilings. This area contained a shaft (see Plate B.12) that extended southwest outside of the building that contained water pipes approximately 20m in length. The shaft was made of concrete and no apparent cracks or crevices were noted from the entrance, the shaft could not be inspected fully due to health and safety concerns. The humidity within this area was high, thermally stable and cool providing good conditions for hibernating bats. The basement of the building and pipework shafts were therefore assessed with high hibernation suitability.

No signs of bats or bats themselves were noted during the hibernation assessment. The basement area of the building was assessed with high suitability for hibernating bats.

Plate B.12 Shaft within basement (high hibernation suitability area)

Further hibernation survey should comprise one further survey in February/March during suitable cool conditions (overnight temperatures below 5°C). During the survey B1, including the basement will be physically searched for presence of hibernating bats utilising torches, mirrors and endoscopes. Evidence of roosting bats as well as evidence of bat activity (e.g. droppings) should be recorded during the survey.

This survey information will be supplemented with data collected by deploying static detectors in B1 between February and March. Static detectors will record any calls of bats active during this time and the data will be analysed in the office to identify bat calls and species present. The result of the further hibernation survey will outline any specific mitigation measures and recommendations for hibernating bats.
