Horsham Enterprise Park
Consideration of Building 3 Paper

Introduction and background

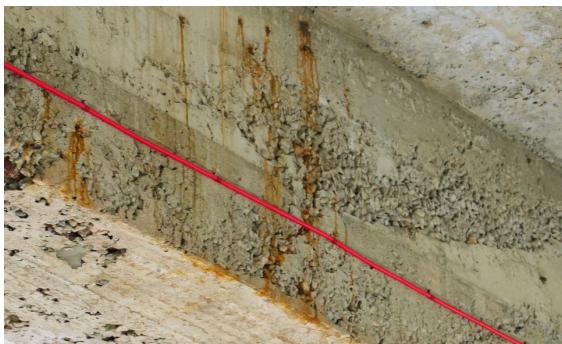
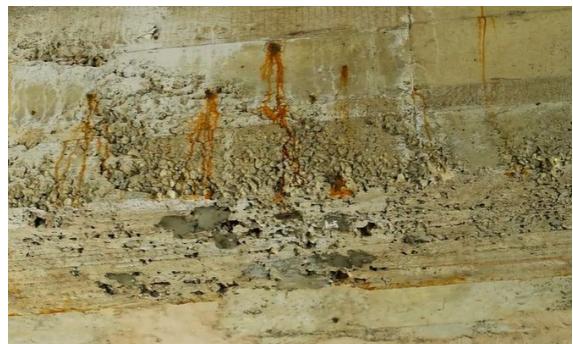
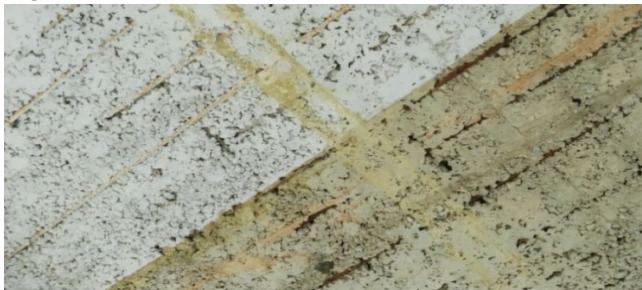
The structural report (Appendix B) issued by Arch Associates summarises there is widespread carbonation and areas of low compressive strength suggesting the concrete has experienced long-term environmental degradation, likely accelerated by inadequate cover and poor original construction practices. There are localised areas of good core integrity and adequate strength, but the following defects would need to be addressed to ensure the appropriate building design life:

1. Honeycombing and Carbonisation of Concrete

Figs 3 - 5 - Photographs show honeycombed and carbonised concrete with exposed rusting rebar.

Proprietary concrete repair systems will need to be specified to reinstate the voided concrete and restore the necessary reinforcement cover. Protective coatings and corrosion inhibitors should be applied to reinforcement. This is extensive throughout large areas of the building wings.

Guidance from the Building Research Establishment's Digest 444 and Concrete Society's Technical Report Number 38 would need to be followed for carbonation repairs. This can include the need to remove carbonated concrete, treatment of rebar and then reinstatement of new surface concrete to provide suitable concrete cover.

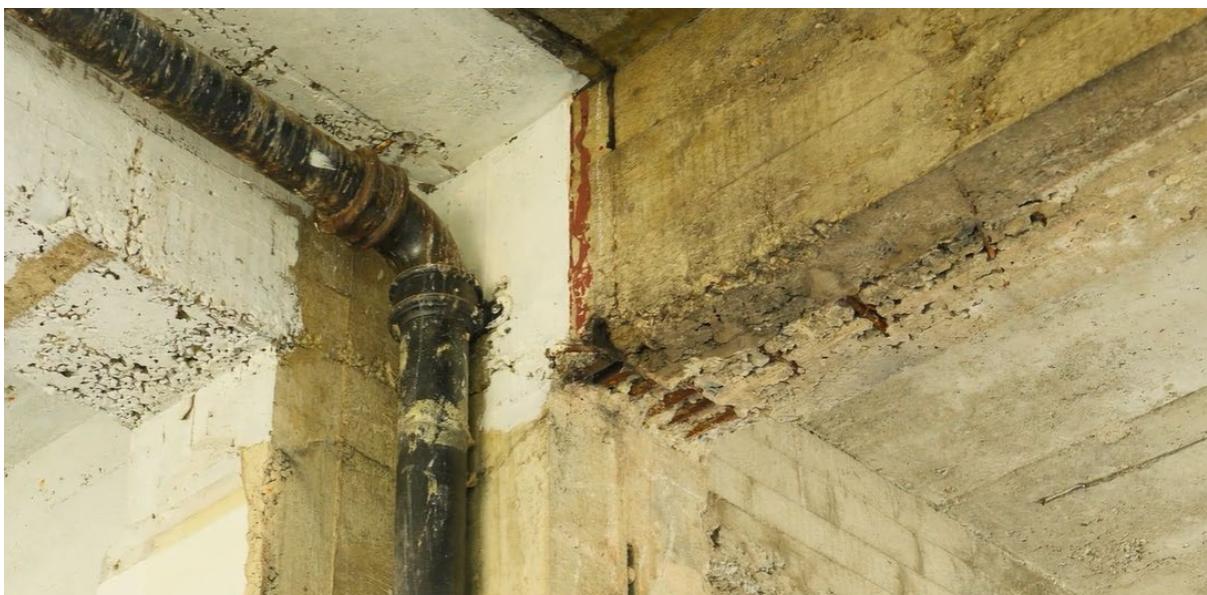
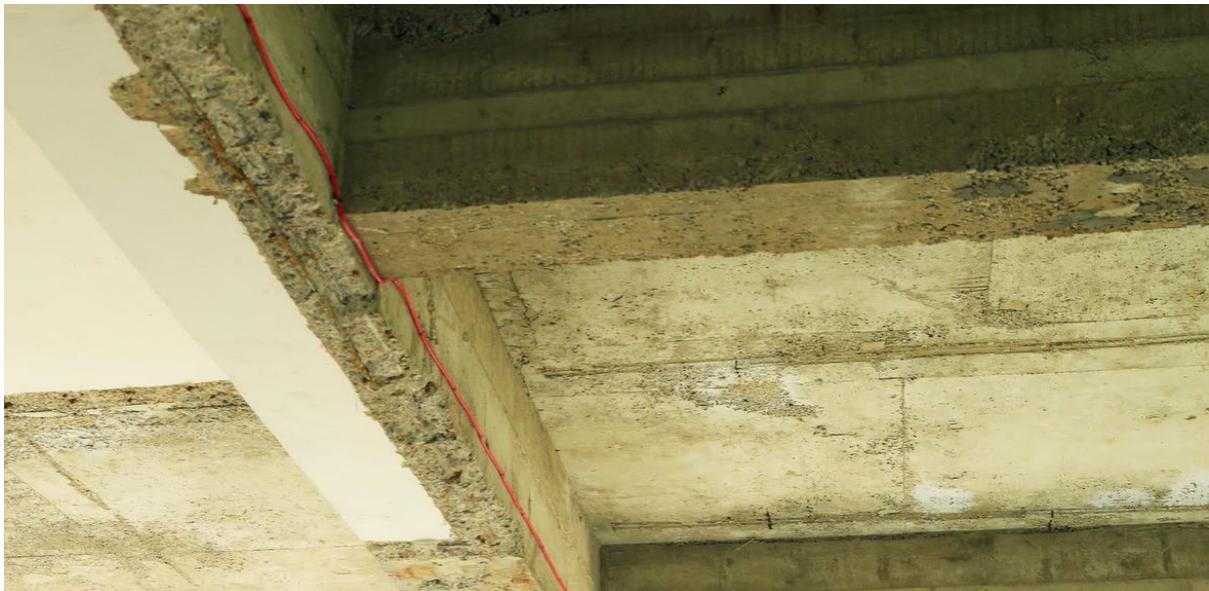
Fig 6

2. Lack of structural fire resistance due to exposed rebar/lack of suitable concrete cover

Proprietary products would be required to be applied to reinstate the appropriate fire protection of the concrete elements. This demonstrates the lack of concrete cover that provides fire resistance to the building.

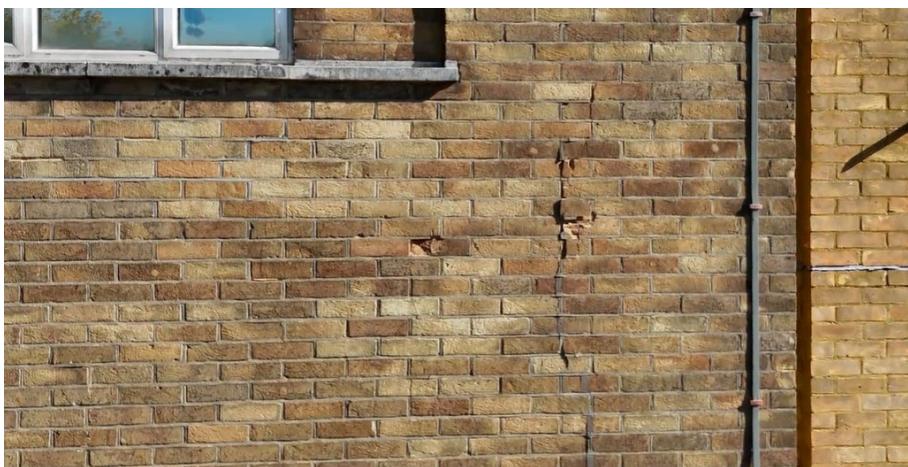
3. Corroded wall ties and lintels within external brickwork

Due to corroded wall ties and lintels, there is a risk of potential collapse of the masonry outer leaf and further damage to the structure. So, in any eventuality, the external brickwork cladding needs to be completely removed.

Fig 7 – evidence of corroded wall ties

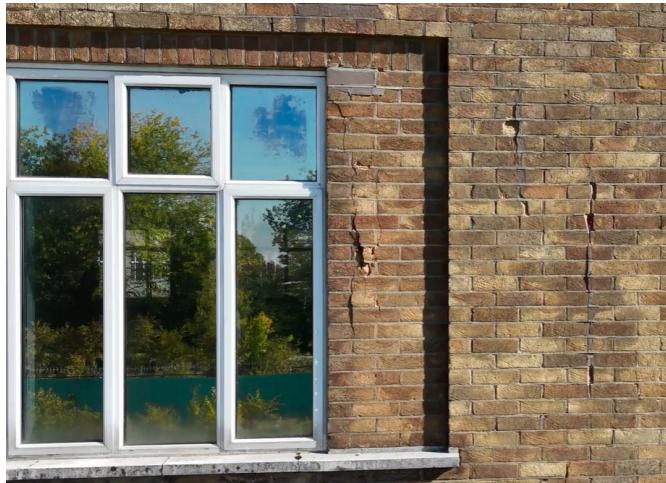
4. Cracking within external brickwork

The external brickwork has instances of severe cracking and damage. Remediation would require the removal and repair using crack injection and stitching. However, because the wall ties and lintels all need to be removed the cracking would be remediated when the brickwork is rebuilt.

Fig 8 – cracking to external walls

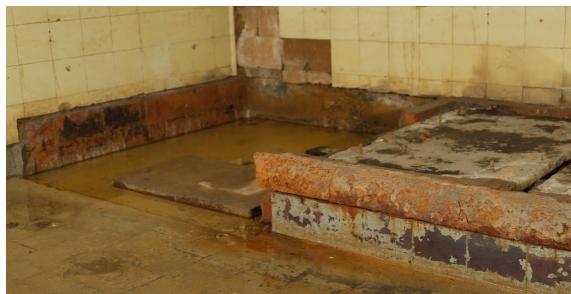
During on-site testing in the summer, the basement was pumped out to establish the extent of the water ingress. Within 24 hours the basement became flooded again, it is now anticipated to be over 2 metres deep, in a period of relatively dry weather conditions. It is likely that this ongoing water ingress is further damaging the concrete including its reinforcement.

Fig 10 shows water damage and concrete degradation due to water ingress

The basement of the building is flooded and has done so for a significant number of years. In a refurbishment scenario this would need to be pumped out to allow a waterproofing system to be retrofitted. Suitable measures for draining of water should be provided and maintenance strategies will also be required to ensure the waterproofing system remains effective.

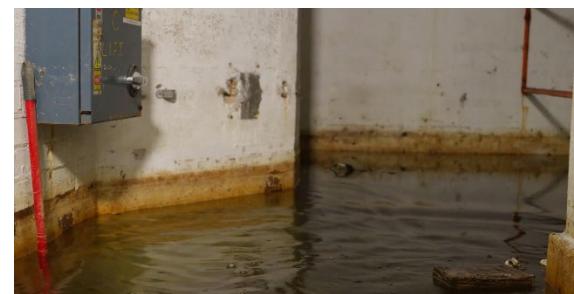
Fig 11 shows extensive water ingress from unknown source

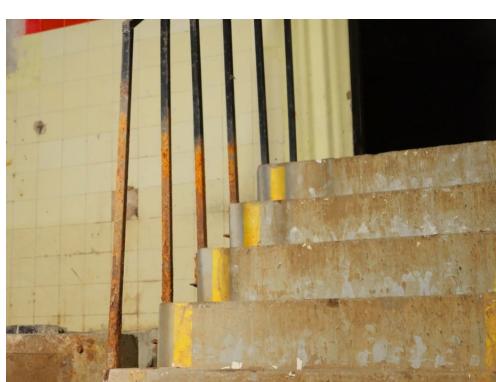
Fig 12 shows extensive and prolonged water damage in the basement (tideline on railings)
