**BELLWAY HOMES LTD**

**WOODFORDS, SHIPLEY ROAD**

**DRAINAGE TECHNICAL NOTE**

**REPORT REF.  
2108061\_B-ACE-XX-XX-RP-C-0001**

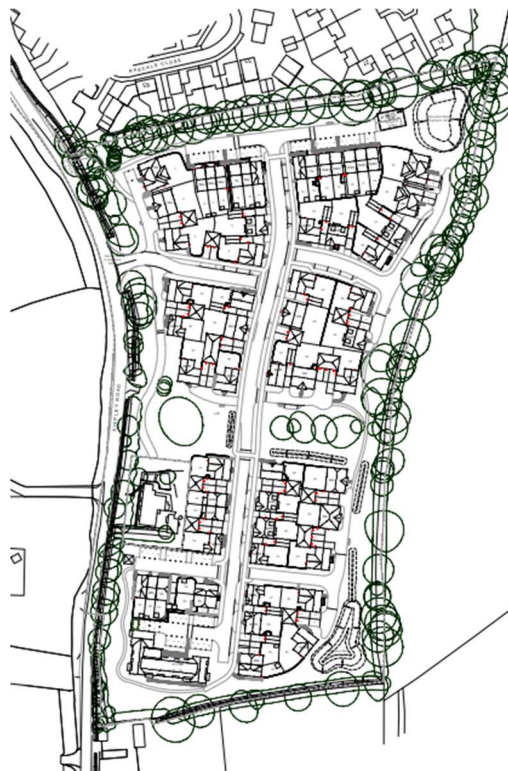
**Figure 1-1 DHA Site Layout**

- 1.3. Reserved matters application for the erection of up to 73 no. dwellings, open space and child play provision, residential parking facilities and associated infrastructure, including access arrangements following outline application DC/21/2180.
- 1.4. An extract of the proposed site plan from DHA is shown in **Figure 1-1** and the full site plan, ref. 102108-BEL-SL-01, is shown in **Appendix A**.

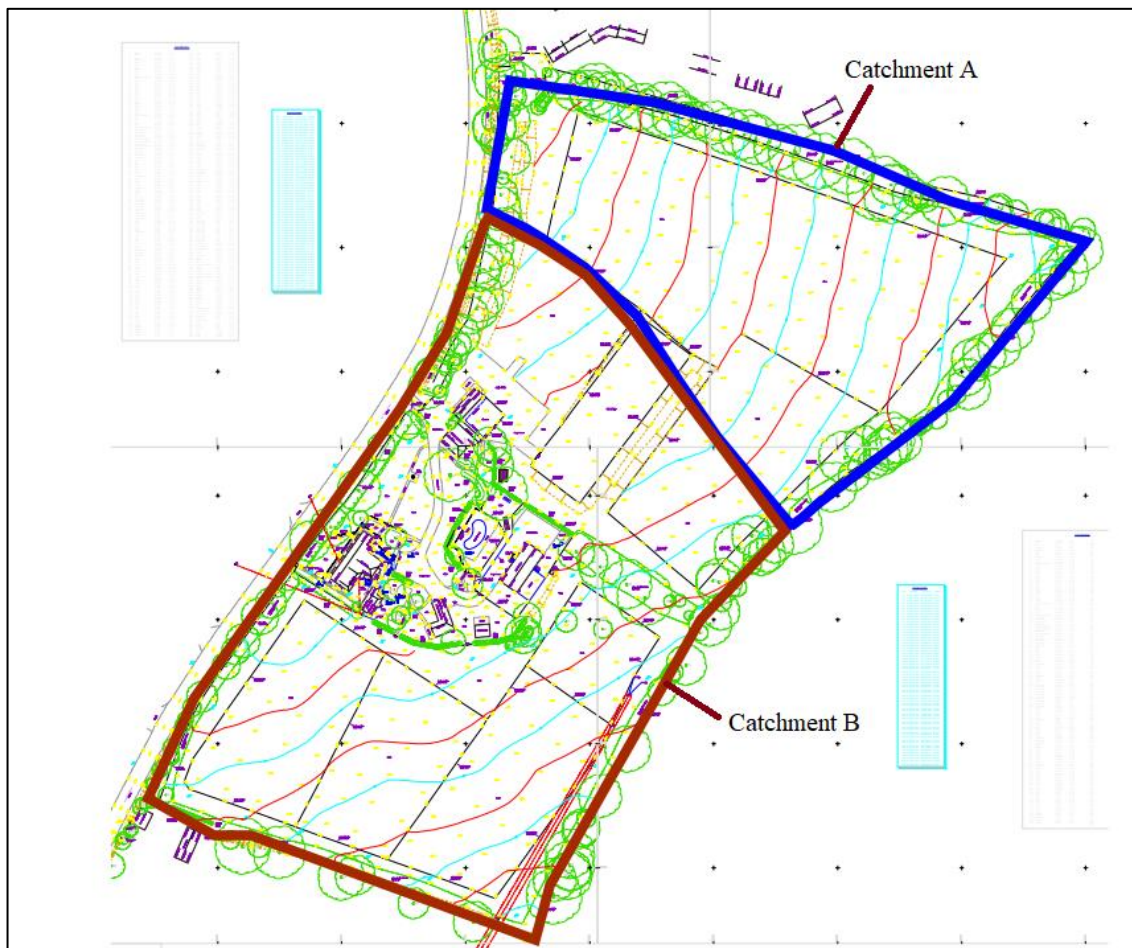
Figure 2.1 Catchment boundaries

- 2.2 A topographical survey of the existing site was undertaken by Hook Survey Partnership in July 2019, which is provided in [Appendix C](#) of this report.
- 2.3 The topography demonstrates that the site has two catchments known as Catchment A and Catchment B as illustrated in Figure 2.1 below. Catchment A falls towards the ordinary watercourse which runs along the eastern site boundary with ground levels ranging from 50.56 metres Above Ordinance Datum (mAOD) to 43.62 mAOD. Catchment B fall towards the ordinary watercourse which runs along the southern site boundary with ground levels ranging from 50.12 mAOD to 43.26 mAOD.

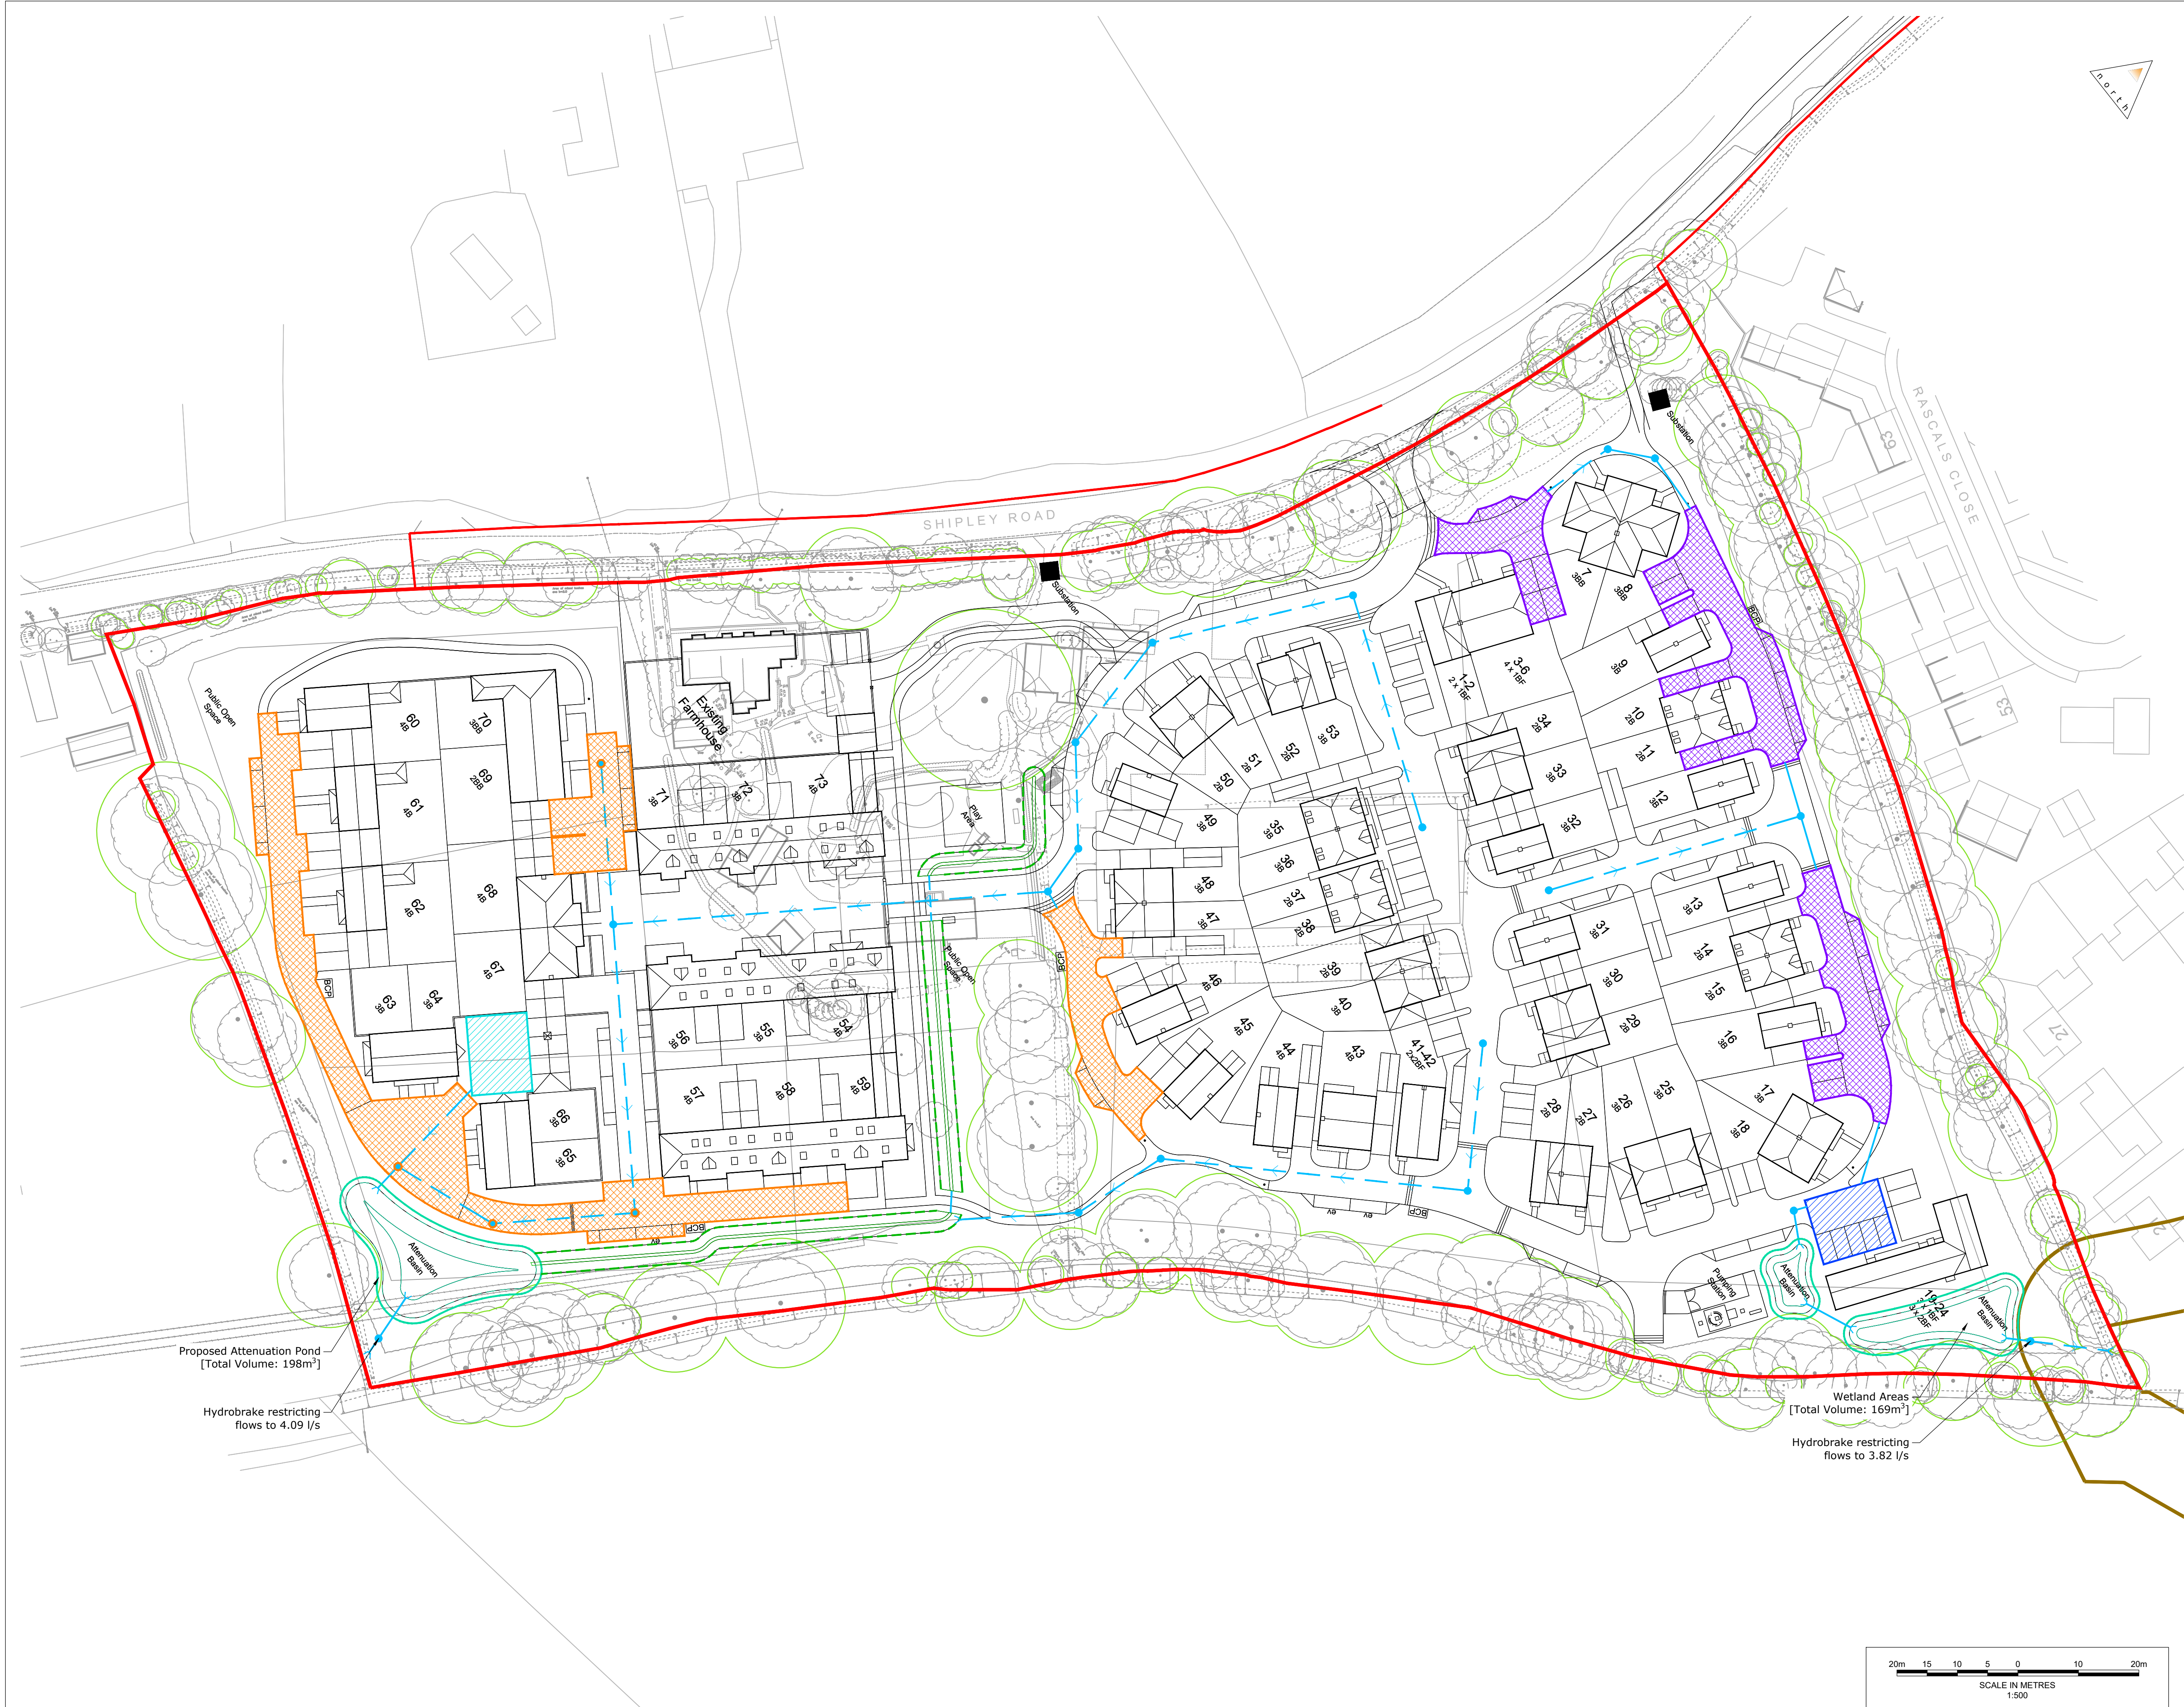
Drainage Strategy

- Proposed Permeable Paving - 450mm deep Type 4 Open Graded Sub-base, 30% Void Ratio [Total Volume: 203m<sup>3</sup>]
- Proposed Permeable Paving - 450mm Permeable Storage Crates, 95% Void Ratio [Total Volume: 403m<sup>3</sup>]
- Proposed Attenuation Storage Tank - 400mm deep [Total Volume: 52m<sup>3</sup>]
- Proposed Attenuation Storage Tank - 800mm deep [Total Volume: 99m<sup>3</sup>]
- Proposed Surface Water Sewer
- Proposed Surface Water Manhole / Inspection Chamber
- Proposed Headwall
- Proposed Ponding Area - Refer to Main Drawing for Area Type
- Proposed Swale - 500mm deep [Total Volume: 144m<sup>3</sup>]

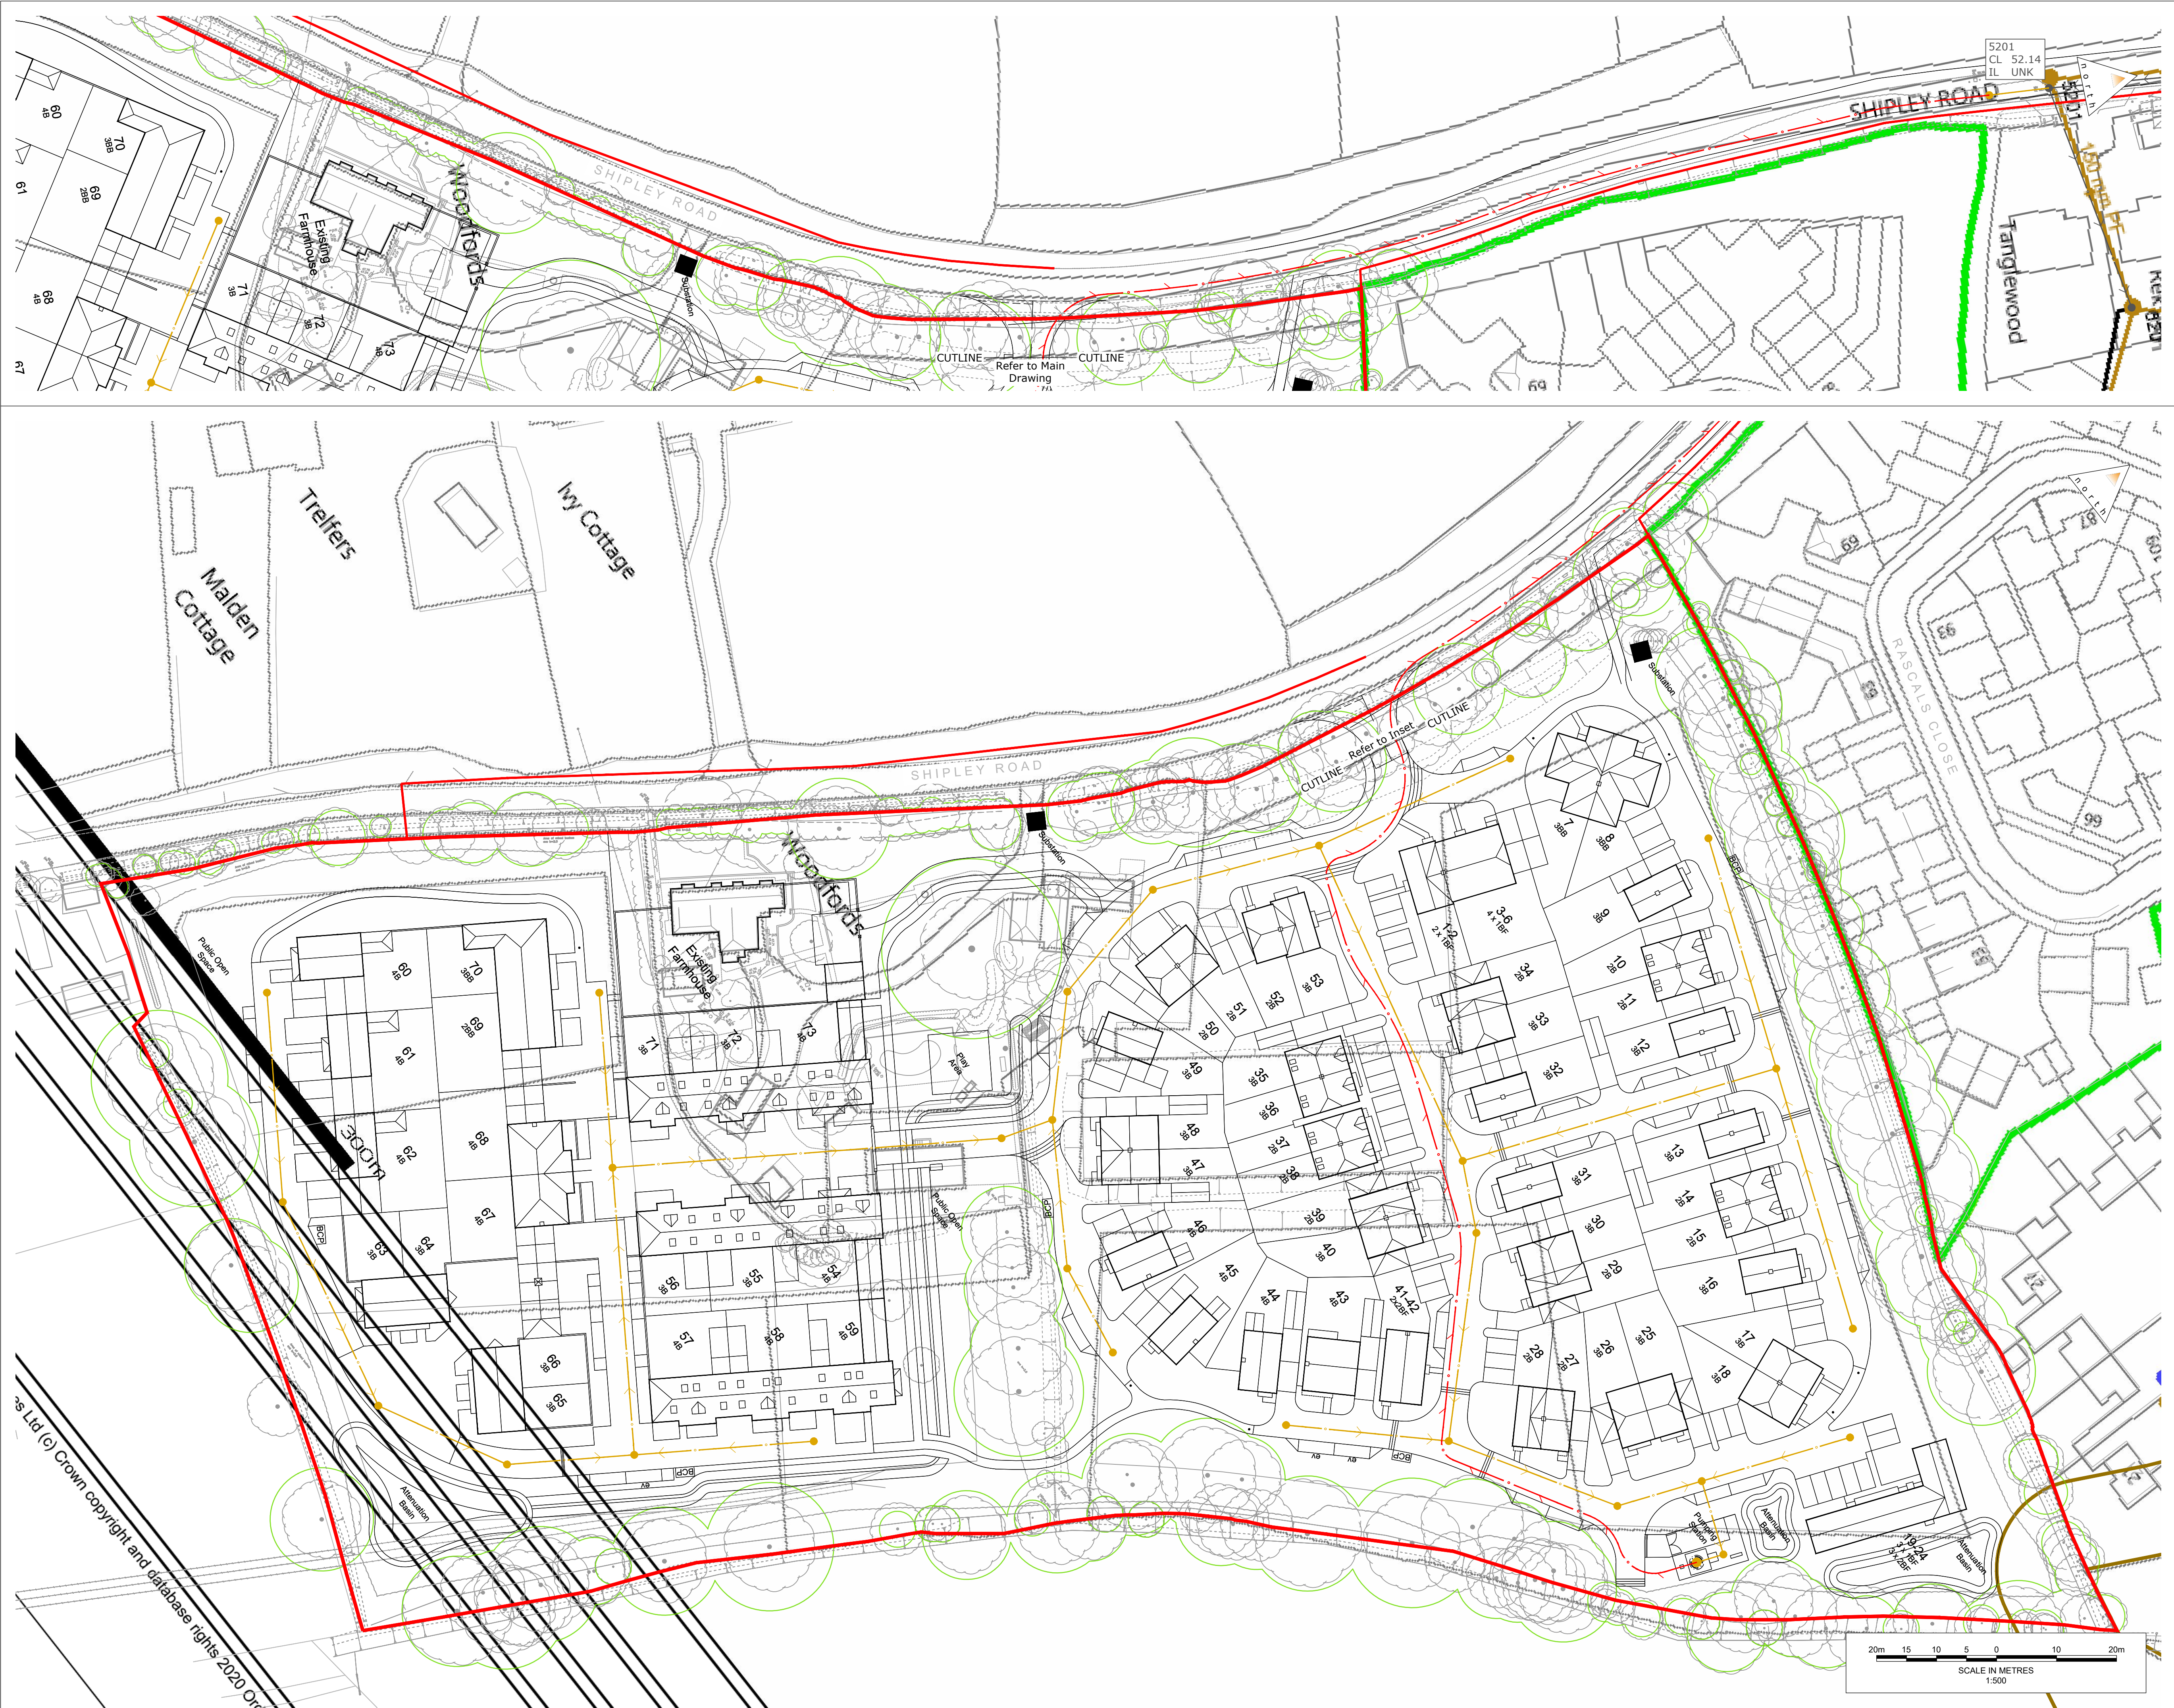
- Proposed Foul Sewer
- Proposed Foul Manhole / Inspection Chamber
- Proposed Foul Rising Main
- Existing Southern Water Foul Sewer

4.1. The foul network will drain, via pumping station, to existing Southern Water manhole 5201. The outline drainage strategy can be found in **Appendix D**.

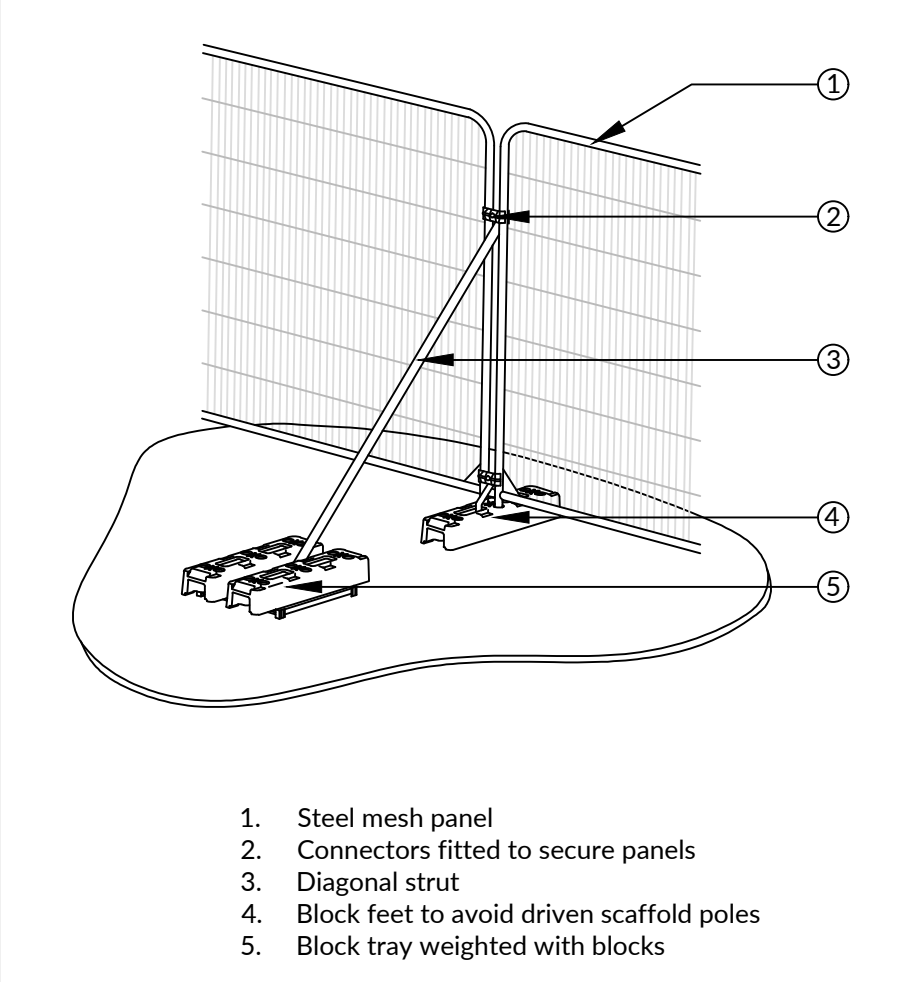
Figure 1: Example of a protective barrier

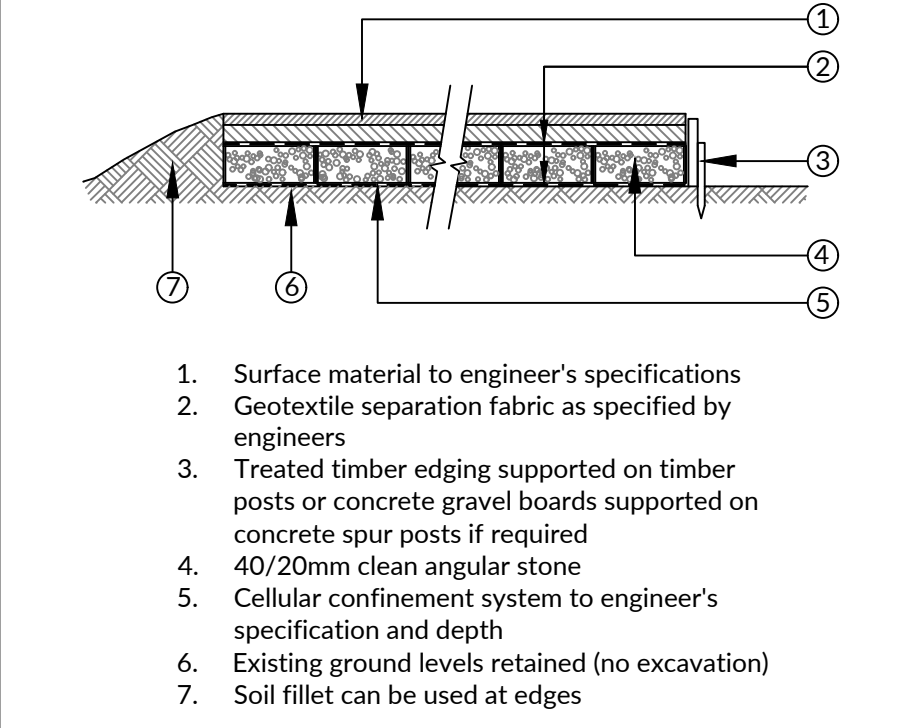
Figure 3: Typical detail of 'no-dig' surfacing
