# Bat Emergence Survey Report

Stables

Holdings

31<sup>st</sup> May 2025

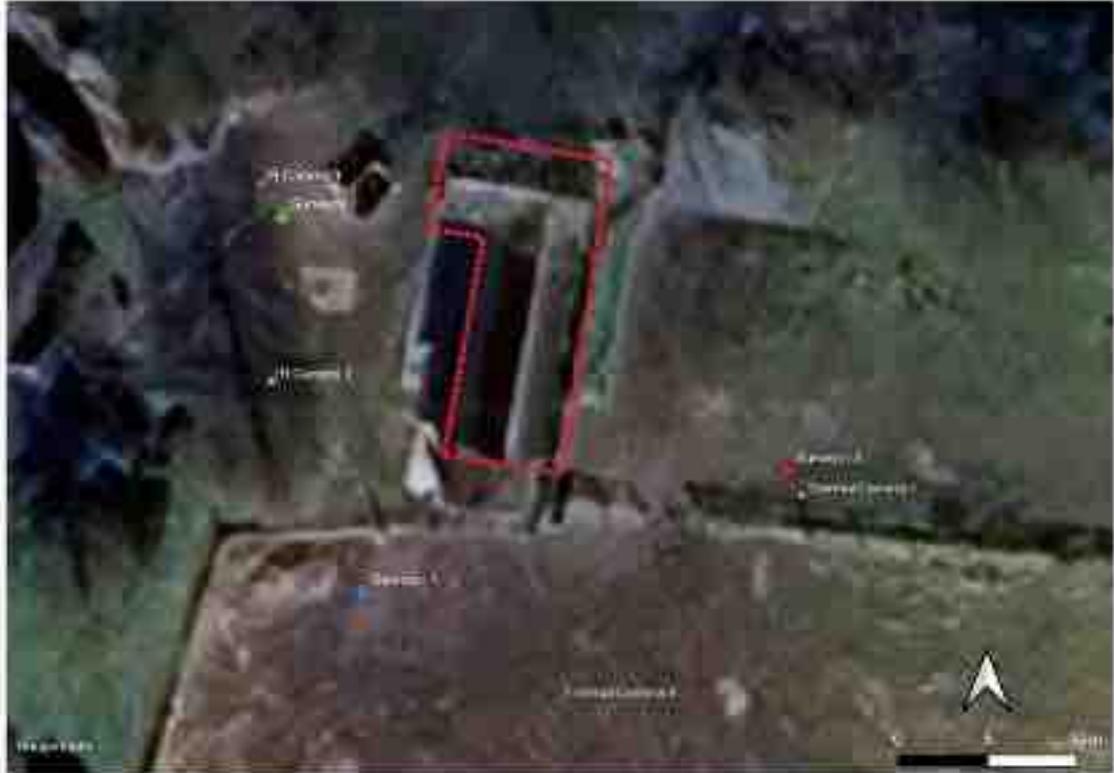
3.5 **Figure 2: Surveyor and Camera Positions**

- 3.3 Echometer Pro 2 bat detector with iPad processor unit and Bat Box Duet detectors were used to detect bat echolocation. A mixture of night vision equipment was used including: Sionyx Aurora IR camera, a Pulsar Axion and Telios thermal imaging cameras. Calls were analysed, when required, identifying species following Russ (2021).
- 3.4 The night vision observation equipment gave a view of the features of the building surveyed that was not possible with the naked eye, enabling effective observation to continue in the dark. The cameras were installed on tripods, which enabled the surveyor to work normally without having to hold the camera steady. The Axion and Telios enable a live feed to be viewed and recorded directly through a

suitable tablet, which in this incidence was an iPad Pro. The Sionyx Aurora IR camera provide a wide angled view which is also recorded and fixed throughout the survey.

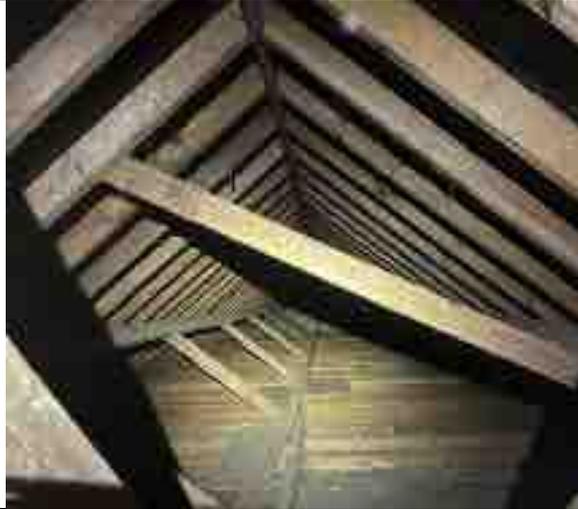
**Plate 7: Roof Void on North- South Axis**

4.5 Externally, the building exhibited features commonly associated with bat roosting potential, including raised tiles, unsealed eaves, and vertical timber joints. A loft hatch gave access to an extensive roof void, which extended the full length of the ridge and remained largely undisturbed. The roof void was tall and narrow with exposed wooden rafters and no lining or insulation between the timbers. The roof covering was lined with traditional black bitumen-based sarking felt, a material known to be more

suitable for bats compared to modern breathable membranes which can pose an entanglement risk. The internal void was dry and stable, with low light levels and a relatively constant microclimate, all of which are favourable to bat roosting.

5.5 A mitigation licence is required as it is predicted that there will be disturbance of the roost as a result of the works a mitigation licence is required from Natural England. The licence would require the production of a method statement of works, which would include measures such as hand removal of the roof tiles and any cladding under the supervision of a licenced ecological consultant and the use of bitumen felt, rather than a semi-breathable membrane, under any tiles, so to avoid causing injury or death to bats through entanglement.

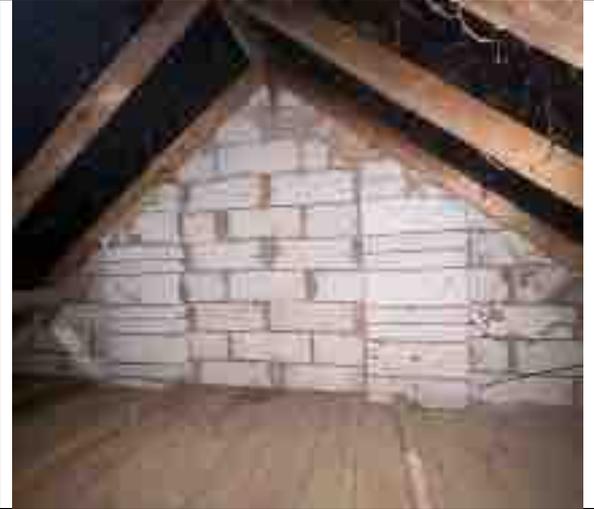
**Plate 8: Eastern Gable End**

4.9 An emergence survey undertaken at the stable building recorded a confirmed emergence of a common pipistrelle at 20:59 from the gable end of the eastern apex, specifically from between the roof edge halfway down the left side. This is considered direct evidence of a day roost feature within the roof structure (see Plate 5, Section 7). Additional common pipistrelle activity was recorded between 21:34 and 21:48, with multiple foraging passes observed along the western treeline and around the adjacent building, indicating the surrounding habitat supported feeding activity. Two noctule passes were detected overhead at 21:22 and 22:01, consistent with high-level commuting behaviour.

4.11 A single common pipistrelle was observed emerging at 21:17 from the gable end of the eastern apex of the stable building, specifically from between the roof edge halfway down the left side (see Plate 5, Section 7). This confirmed the presence of an active day roost within the roof structure. Additional common pipistrelle activity was recorded between 21:38 and 21:56, with multiple foraging passes observed along the treeline to the west and around the adjacent building, indicating that the surrounding habitat supported feeding activity. A single noctule pass was recorded overhead at 21:22, consistent with high-level commuting behaviour. These findings confirm the presence of a small day roost within the building and demonstrate the use of the wider site by both common pipistrelle and noctule for foraging and commuting.

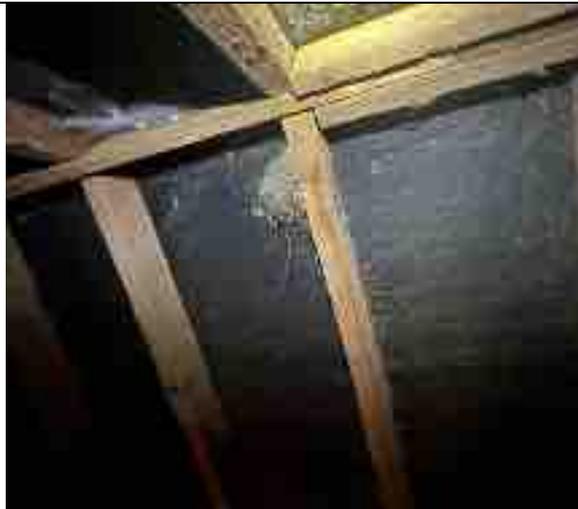
**Plate 9: Swift Nest**

4.7 An active swift (*Apus apus*) nest was observed within the loft space, affixed to the underside of the roof lining. The nest was constructed from mud and plant material, typical of the species, and there was clear evidence of recent or ongoing use. Swifts are a migratory Schedule 1 species under the Wildlife and Countryside Act 1981 (as amended), and their active nests are legally protected from disturbance.

5.10 To compensate for the loss of one existing swift nest, it is recommended that one integrated or external swift boxes be installed on or near the original structure (at a 1:2 ratio), ideally as close to the previous nesting location as possible. Swift boxes should be installed as high as possible from ground level in a shaded or sheltered location, away from direct sunlight and prevailing wind. The boxes must have a clear flight path with no obstructions such as wires, pipes, or vegetation in front of the entrance

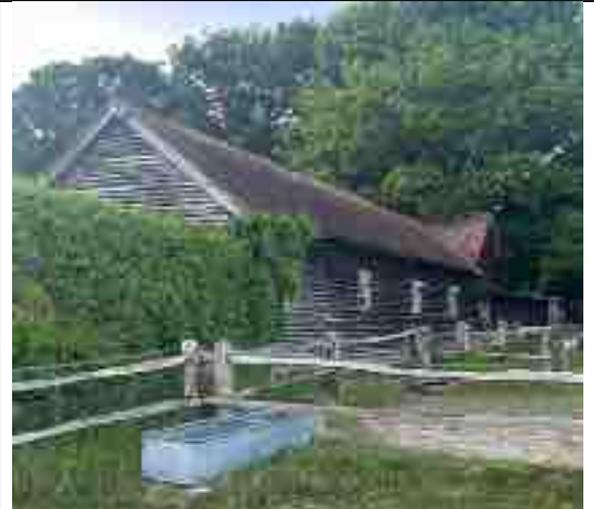
**Plate 12: Eastern View with Emergence Location**

5.1 A single common pipistrelle bat was observed emerging from the gable end of the roof on the eastern side of the building. Bat activity within the wider site was relatively low, with common pipistrelle foraging activity to the west, close to the main building and around the gardens. Very occasional noctule passes were recorded, likely to be commuting overhead.

5.6 Two bat boxes would be installed prior to the works. These could be installed in the adjacent trees and could consist of types that would be specific to the bat species present. For common pipistrelle, these would take the form of a Schwegler 2F general purpose bat box installed within adjacent trees. Should any bats be found during the works, then they can be relocated to these.
