LAND NORTH WEST OF SOUTHWATER, HORSHAM

Preliminary Ground Appraisal Report

PRELIMINARY GROUND APPRAISAL REPORT

**LAND NORTH-WEST OF SOUTHWATER,
HORSHAM, WEST SUSSEX, RH13 9BH**

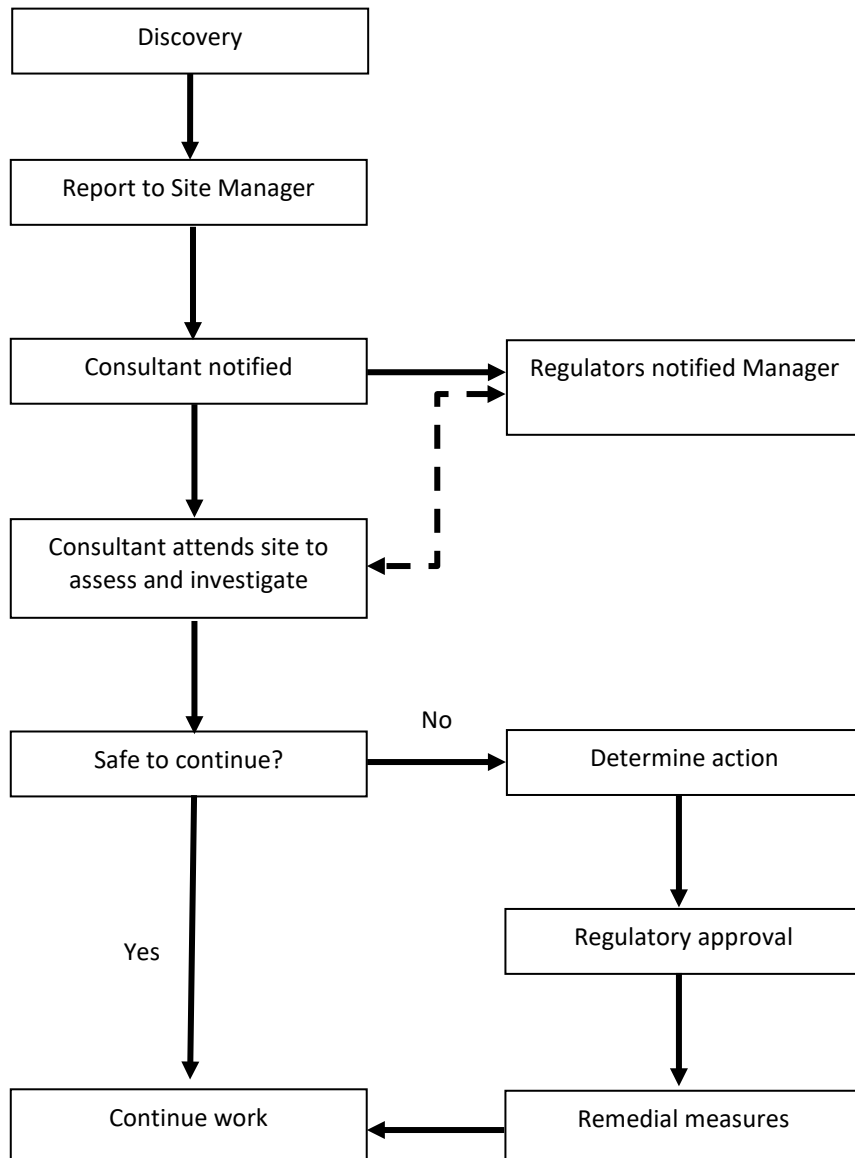
Chart 1 Discovery Strategy Flowchart

The process is shown below.

- Where remedial action is required, regulatory consultation and approval will be sought.
- A record will be produced by the Consultant and held on site (with copies held by the Consultant, Client, and Local Authority), detailing the discovery, assessment works undertaken, findings thereof, confirmation either of no action required or detailing the remedial action taken and validation thereof.
