Arboricultural impact appraisal and method statement

Campsfield, Southwater, Horsham, West Sussex RH13 9FW

Phillip Brophy HNDArb MArborA CEnv MICFor RCArborA

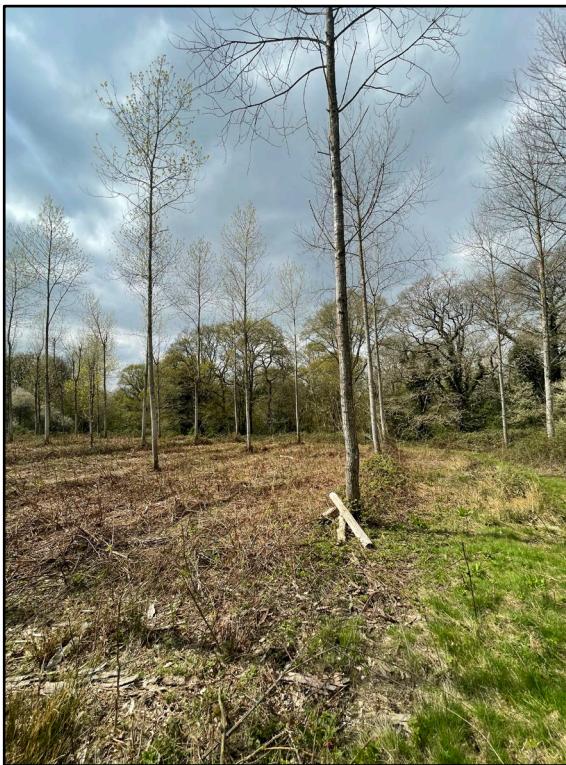
Photograph 1: View of western extents of group G6 highlighting plantation context and structural form.

These two groups of poplar trees have been established in plantation style rows. Individually within the group the trees range up to height of approximately 15 m with stem diameters not generally exceeding 30 cm. Due to their observed vitality and structural form (multiple occurrences of storm damage were observed – limb and whole stem failure), it is reasonable to advance that they are low quality trees with limited levels of sustainability.

Additionally, given their monocultural plantation context they can be held to be incongruous to the landscape character of the area and therefore of limited value from a visual landscape perspective. Their removal to enable the proposed development will not result in a significant adverse impact on visual amenity or landscape character.

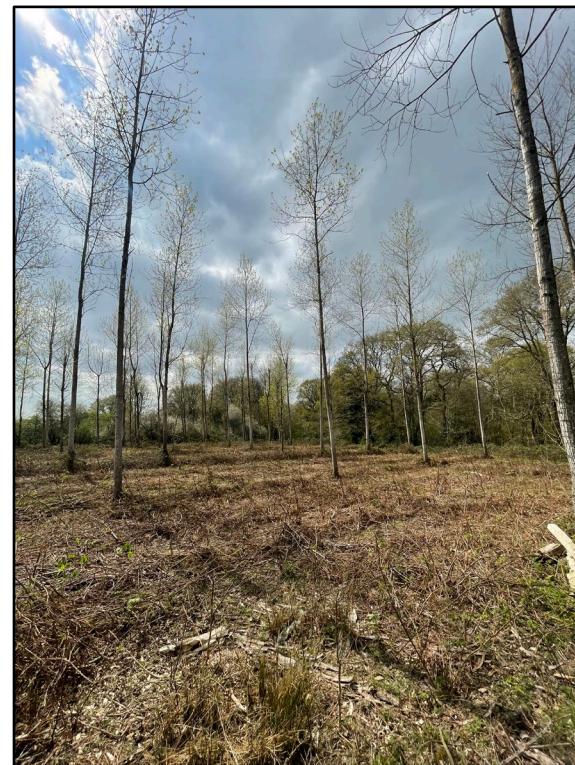
Photograph 2: View of character and form of plantation context of trees within groups G6 and G23.
