# Additional Investigation & Remediation Strategy

## Millfields Farm, Rusper

**BRD4518-OR1-A**

**July 2025**

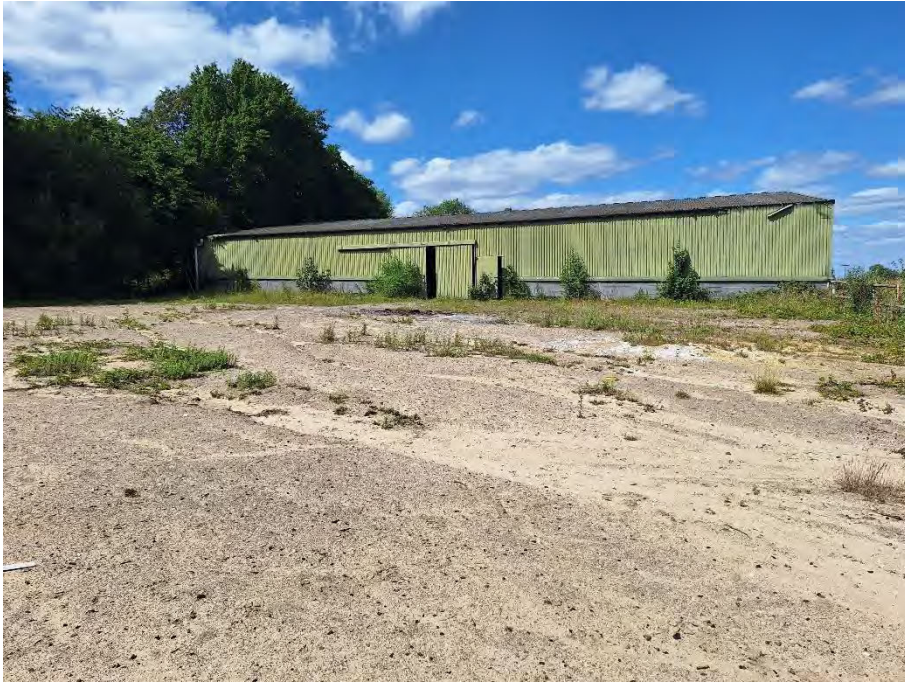
Plate 3: Existing large commercial style barn building at the southern end of the farmyard with southern manège in the foreground.

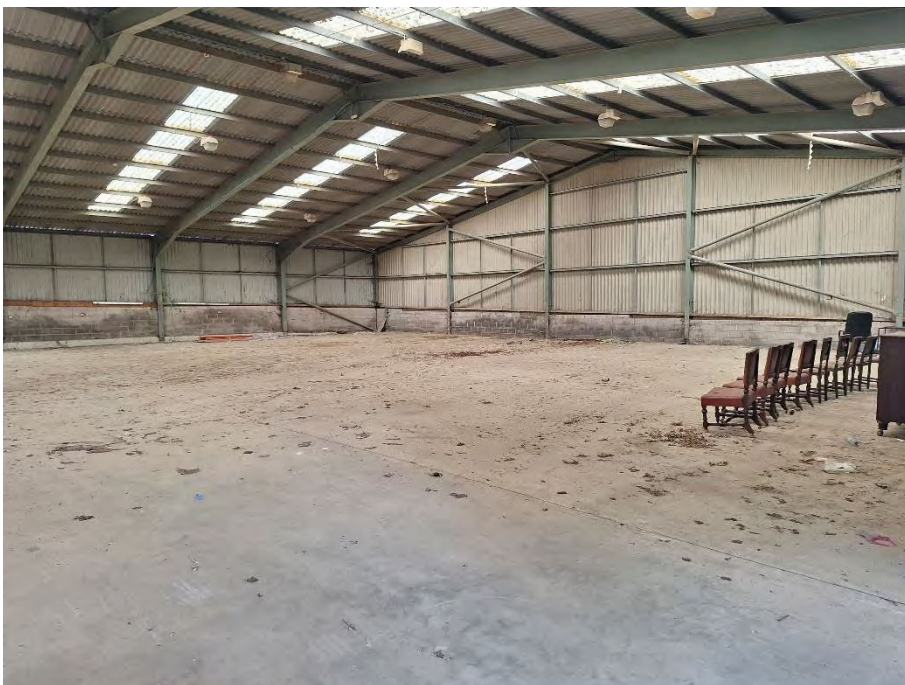
Plate 4: Inside the large barn building. Contrart to IDOM report, no evidence of a borehole having been drilled inside the building.

- MBH102 is shown to have been drilled inside the building footprint, but the soil log shows topsoil over clay soils. An inspection of the floor slab in this building did not identify any areas to have been broken out for the drilling of a borehole. There were also no spoil mounds that would have been generated from drilling. The borehole has therefore clearly been drilled outside of this building.
- MBH101 recorded Made Ground soils to 0.7m bgl in the middle of a field. Whilst possible, it is considered that this is more likely a consequence of some Made Ground in the farmyard area.
- MWS104 and MTP103 were forwarded inside a building. Again, there is no evidence of any holes in these locations and access to the stated locations is very limited.

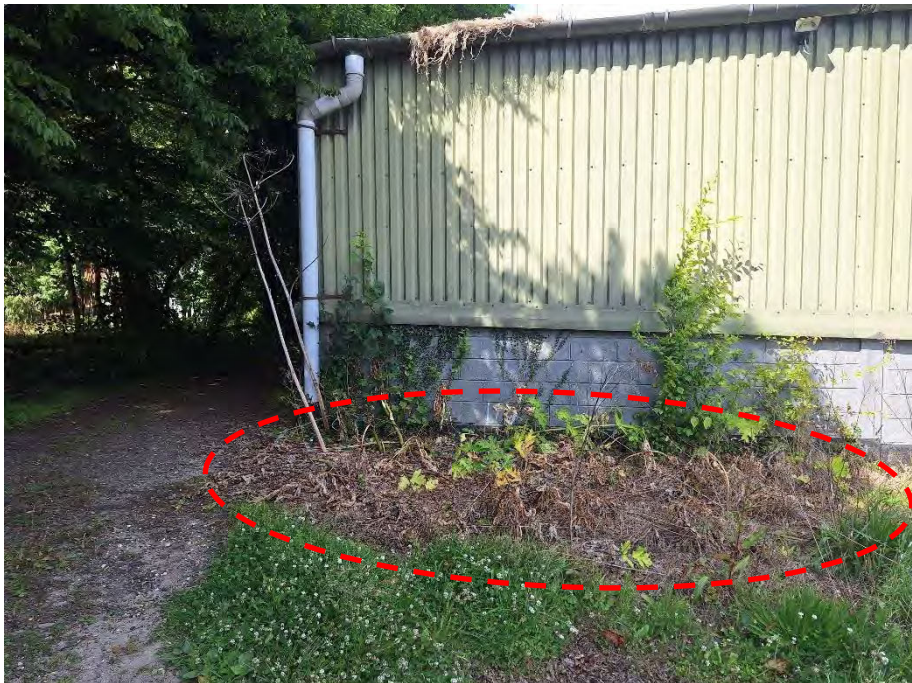
The Giant Hogweed infestation was identified by BRD during the recent site investigation works and a limited survey of the site has identified that the Giant Hogweed is growing in the southwestern area of the site. The main growth is adjacent to the large commercial style building but it has also spread to the southeast into a horse training manège and an area of overgrown vegetation. Several plants have also been observed growing in the garden of the neighbouring property to the northwest in this area of the site.

Based on the BRD site observations, there was evidence of chemically treated plant in some areas of the site, but healthy plant in others. Two of the plants were also noted to be flowering which could result in further spread this growing season. It is considered that the infestation has been present for a number of growing seasons as evidenced by the presence of dead plant canes. As a result, viable seeds could be present in the soils across a larger area than that observed to date.

Plate 5: Giant hogweed infestation.

To manage the identified infestation and protect persons during any current and future works on the site, it is recommended that a Giant Hogweed Management Plan is developed by an appropriately trained invasive weed specialist and the recommendations detailed in this plan actioned prior to the commencement of any further works in this area of the site.

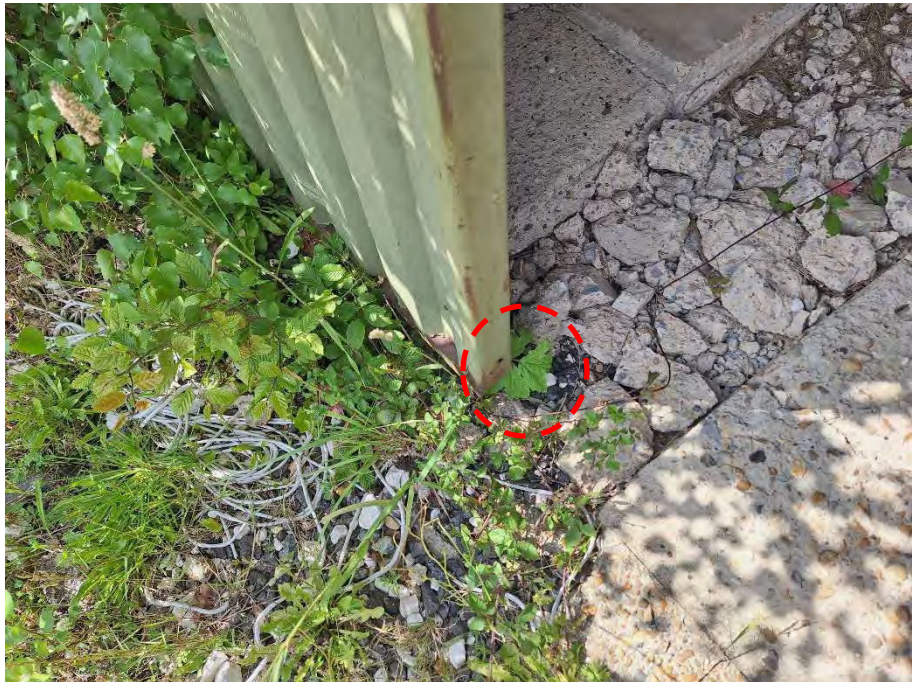
Plate 6: Giant hogweed plan growing adjacent to the door of the large southern building.

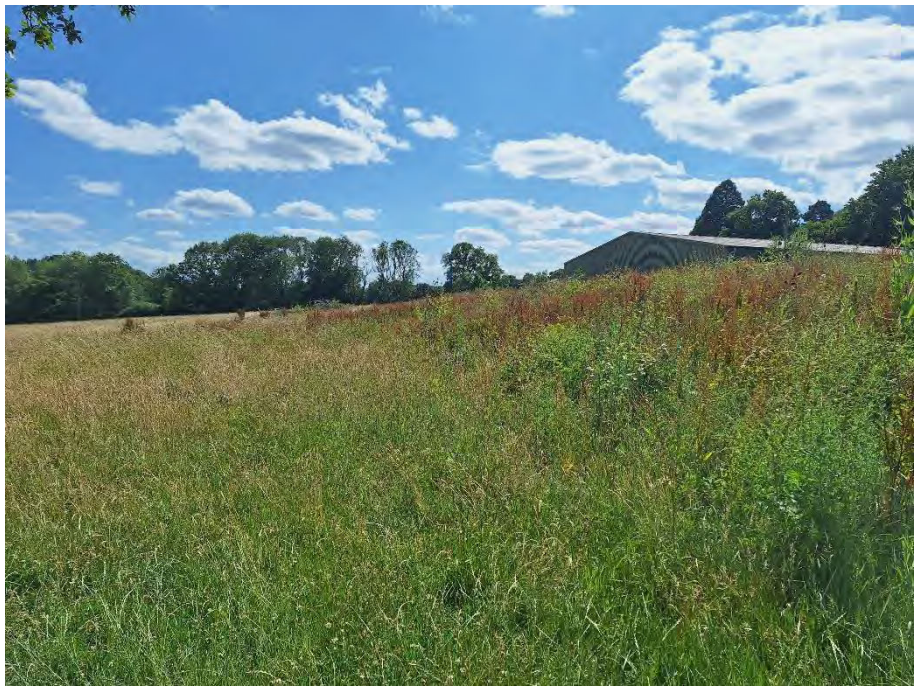
The ground conditions encountered during the investigation works were generally in keeping with those encountered by the previous investigations with mostly shallow Made Ground identified in the farmyard area alongside Made Ground Topsoil and Topsoil in the field areas. Deeper Made Ground soils were identified where the soils have been imported to artificially raise levels in the southeastern part of the farmyard.

Plate 7: Area of raised ground artificially raised by imported soils

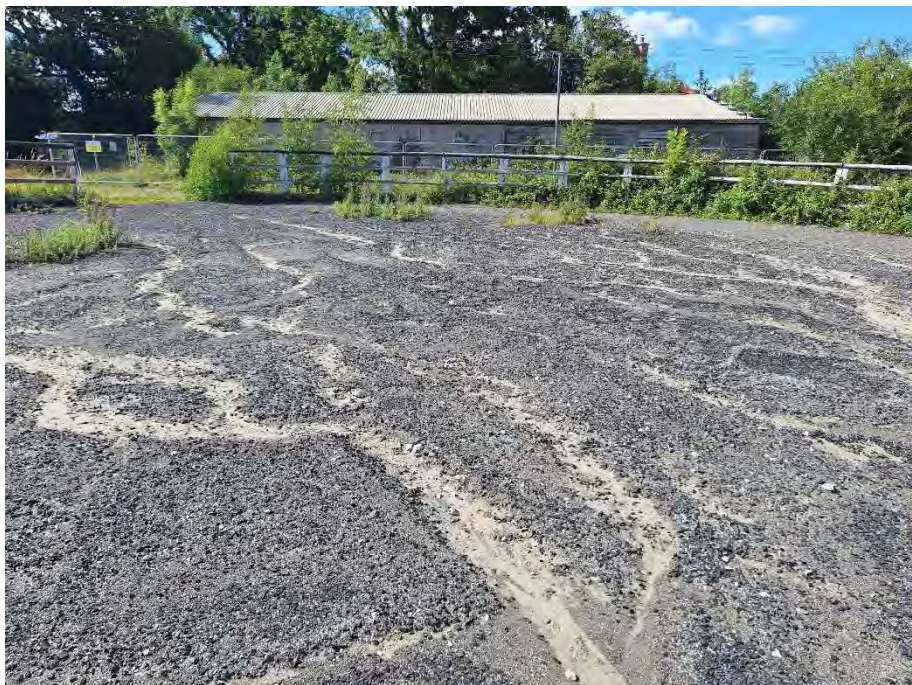
In the circular area, the surface soils were described as a 'Loose light brown gravelly sand. Gravel of fine to coarse subangular to subrounded flint with fragments of plastic and rubber tyre'. These soils were also 0.1m in thickness and were underlain by a sandy gravel of flint and granite to 0.2m bgl and then a 'Firm grey organic silty clay with slight organic odour' to 0.3m bgl.

Plate 8: Surface materials in the central manège.
