Client  
**BELLWAY HOME LTD (STRATEGIC LAND)**

Project  
**FORMER THAKEHAM MUSHROOM SITE, THAKEHAM**

Title  
**TREE PROTECTION PLAN**

Drawing Number  
**2142-KC-XX-YTREE-TPP01RevE**

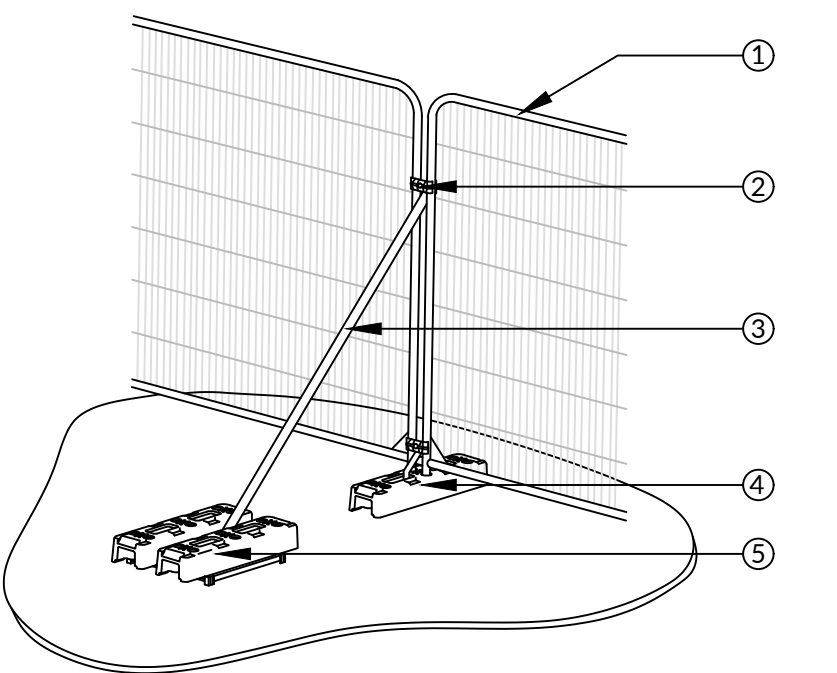
Figure 1: Example of a protective barrier

1. Steel mesh panel
  2. Connectors fitted to secure panels
  3. Diagonal strut
  4. Block feet to avoid driven scaffold poles
  5. Block tray weighted with blocks
- © Keen Consultants

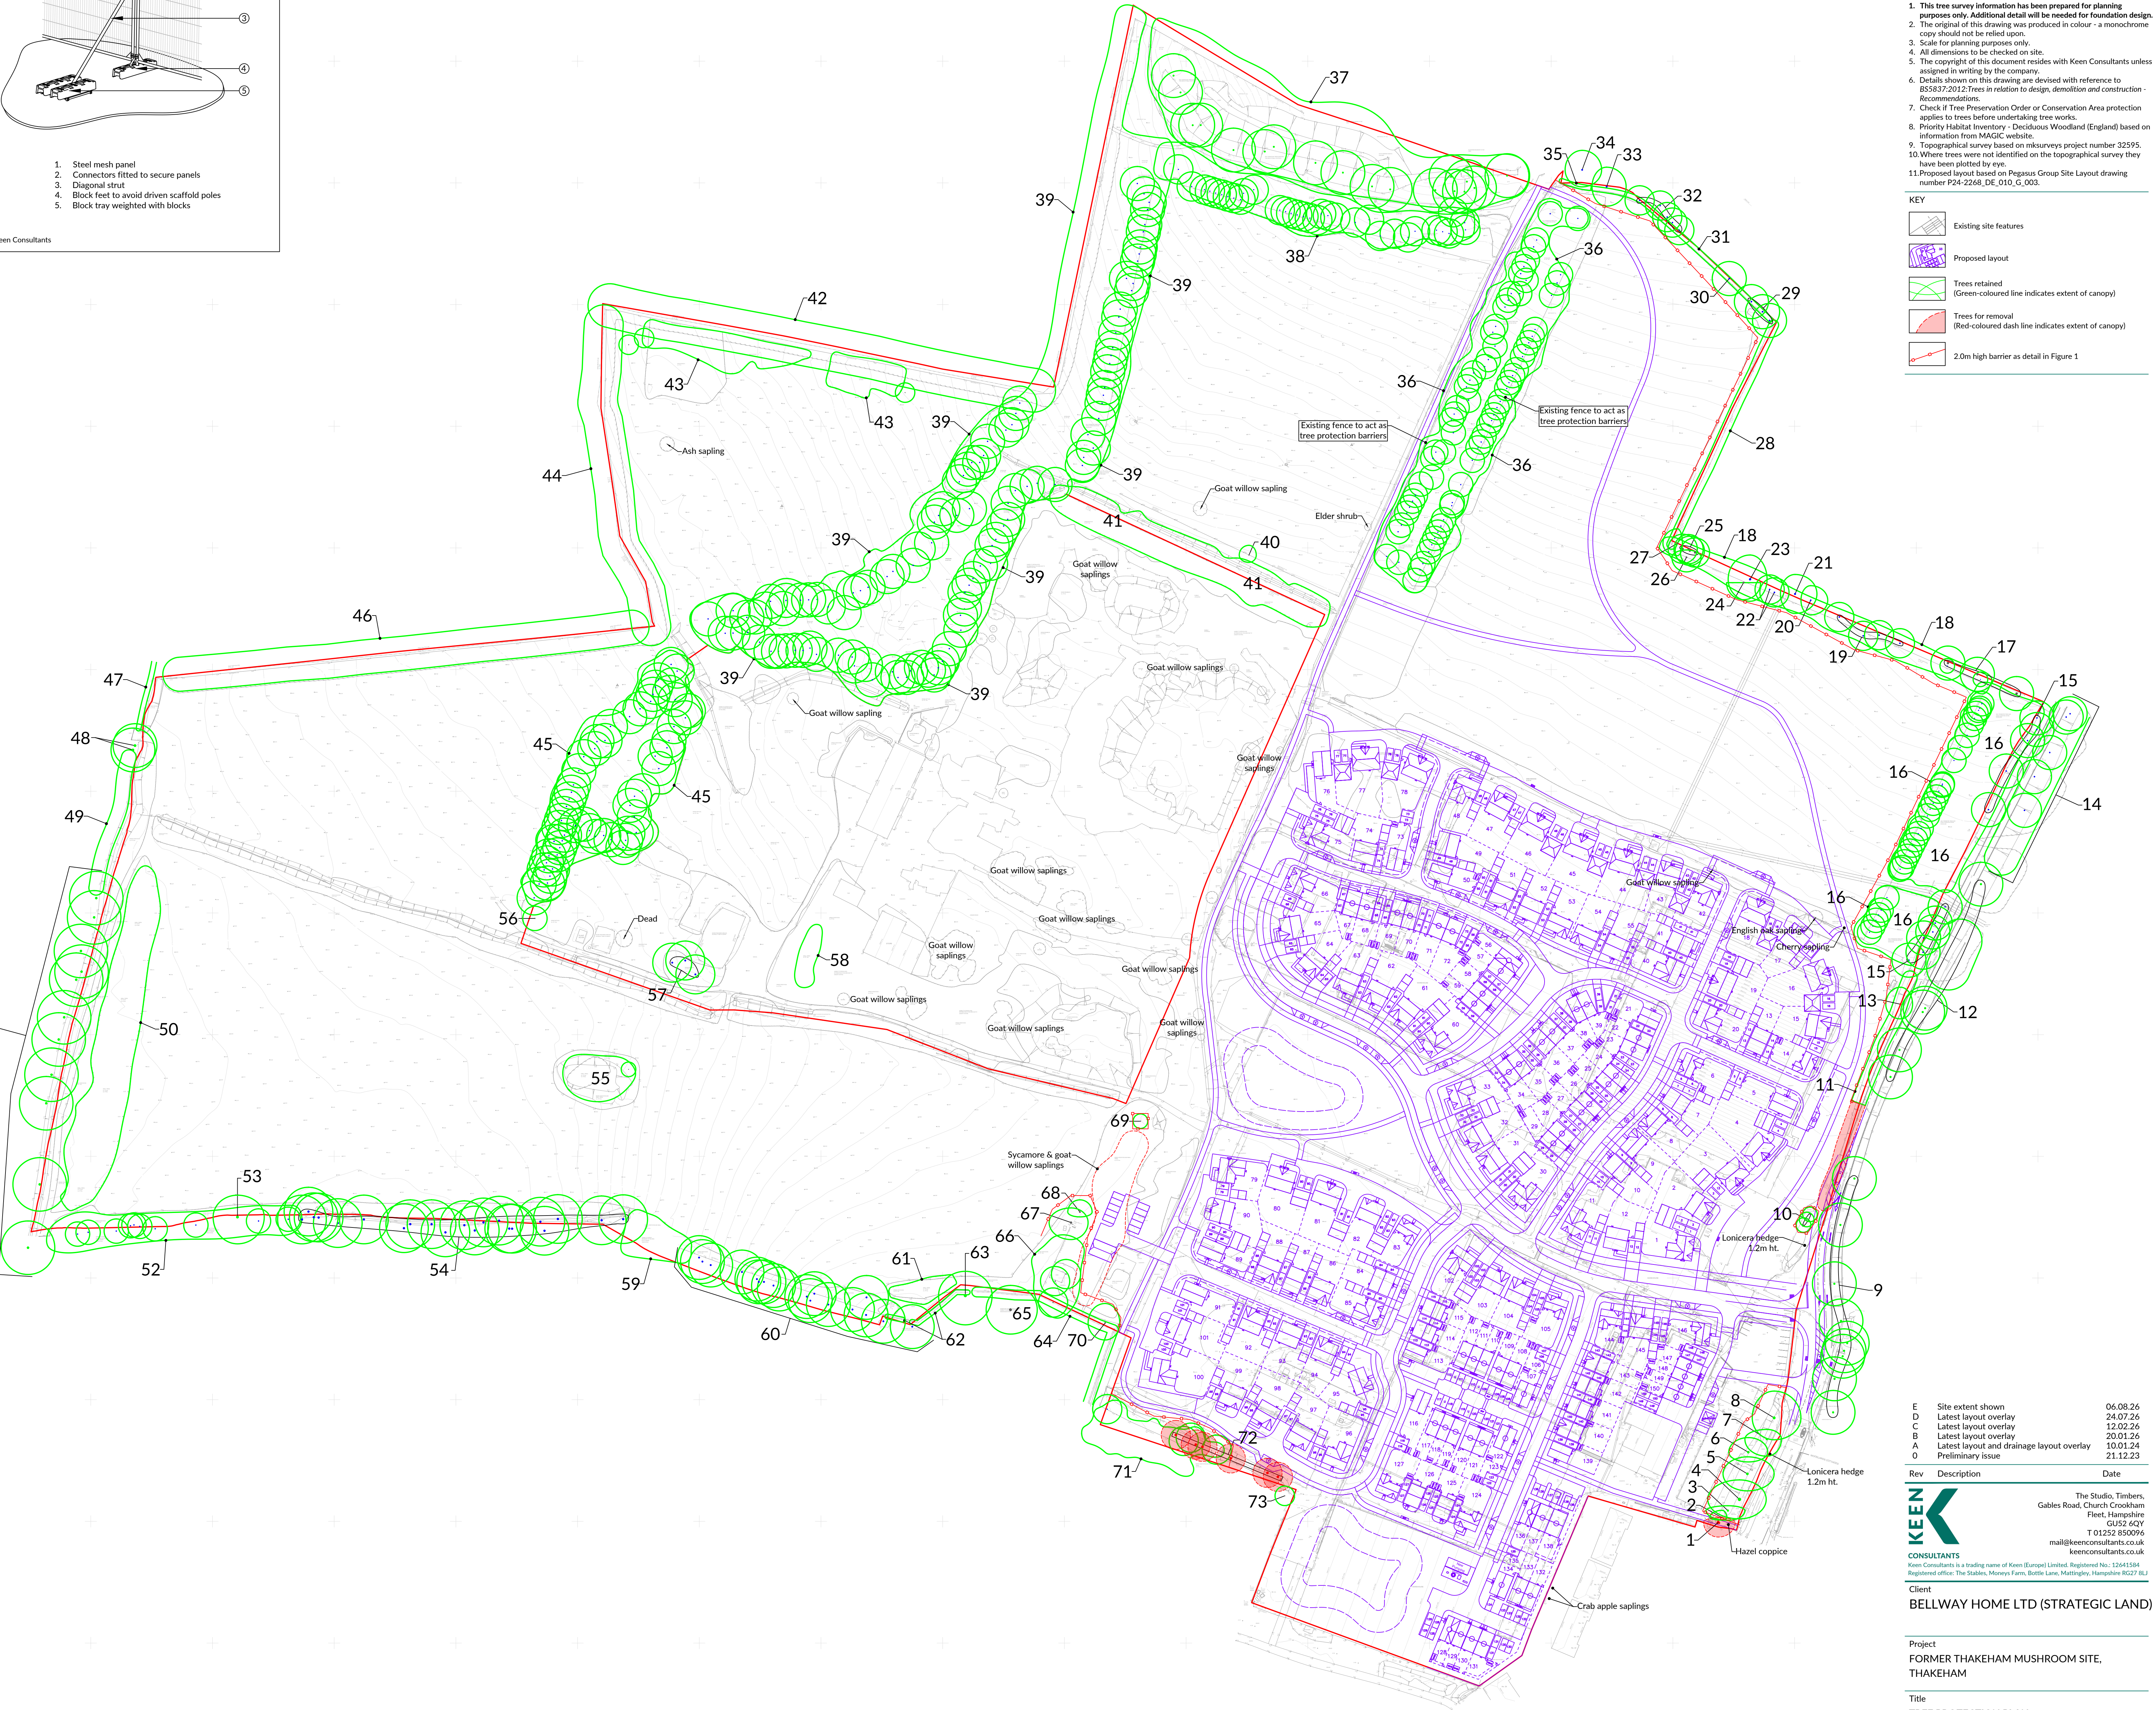
- KEY
- Existing site features
  - Proposed layout
  - Trees retained (Green-coloured line indicates extent of canopy)
  - Trees for removal (Red-coloured dash line indicates extent of canopy)
  - 2.0m high barrier as detail in Figure 1

| Schedule of trees at former Thakeham Mushroom Site, Thakeham | | | | | | | | | | | | | | | | | | | | | | | | |
|---|---|---|---|---|---|---|---|---|---|---|---|---|---|---|---|---|---|---|---|---|---|---|--|--|
| 1 | Ash | 18 | 2 | 7 | 6 | 6 | | 50c | 50c | 60c | | | | 7 | 7S | E | U | <10 | Suppressed by adjoining oak. Showing signs of Ash Dieback. One stem has failed in the past. All stems covered in ivy. | Remove. | 11.13 | 389 | | |
| 4 | English oak | 18 | 8 | 11 | 8 | 13 | 120c | | | | | | | 3 | 3S | M | A2 | <40 | Forms part of a group of similar sized trees along Storrington Road. Main stem and limb structure smothered in ivy. Broad spreading form. No significant decay pockets or defects. | | 14.40 | 652 | | |
| 5 | English oak | 18 | 7 | 11 | 7 | 10 | 90c | | | | | | | 5 | 5W | M | A2 | <40 | Lower stem partially smothered in ivy. Some deadwood within crown. Some damage to buttress roots. Forms part of a group of similar sized trees along Storrington Road. | Remove deadwood in excess of 25mm diameter. | 10.80 | 366 | | |
| 17 | Group of Lombardy poplar | 23av | | | | | 80av | | | | | | | 4 | 4S | E | C2 | <10 | Group of tall trees growing on field margin. All attaining proportions where they are liable to stem failure. | | 9.60 | 290 | | |
| 44 | Leyland cypress hedgerow | 11av | | | | | 20av | | | | | | | 0 | - | E | C2 | <10 | Established but outgrown hedgerow. If allowed to continue to grow the hedge will reach proportions where stems is likely to fail. | | 2.40 | 18 | | |
| 47 | Ash | 15 | 6 | 7 | 7 | 9 | 67 | | | | | | | 2 | 2NW | E | C1 | <10 | Showing signs of Ash Dieback. One stem has failed and rotting in adjoining tree. Unsuitable to long term retention. | | 8.04 | 203 | | |
| 52 | Row of Lombardy poplar | 26av | | | | | 90av | | | | | | | 0 | - | M | U | <10 | Large examples of species and attaining a size where they are vulnerable to failure. Tree second from eastern end of row has failed and fallen through the adjoining industrial building. Trees unsuitable to long term retention. | Remove. | 10.80 | 366 | | |
