**MONKS FARM, OAK WOOD HILL,  
DORKING RH5 5QA  
PHASE I GEO-ENVIRONMENTAL  
ASSESSMENT  
MR STEPHEN FLAVIN  
19<sup>TH</sup> DECEMBER 2025  
LS8796.1**

| <b>Title:</b> | <b>PHASE I GEO-ENVIRONMENTAL ASSESSMENT</b> | |
| <b>Project:</b> | <b>BARN CONVERSION TO DWELLING WITH GARDEN</b> | |

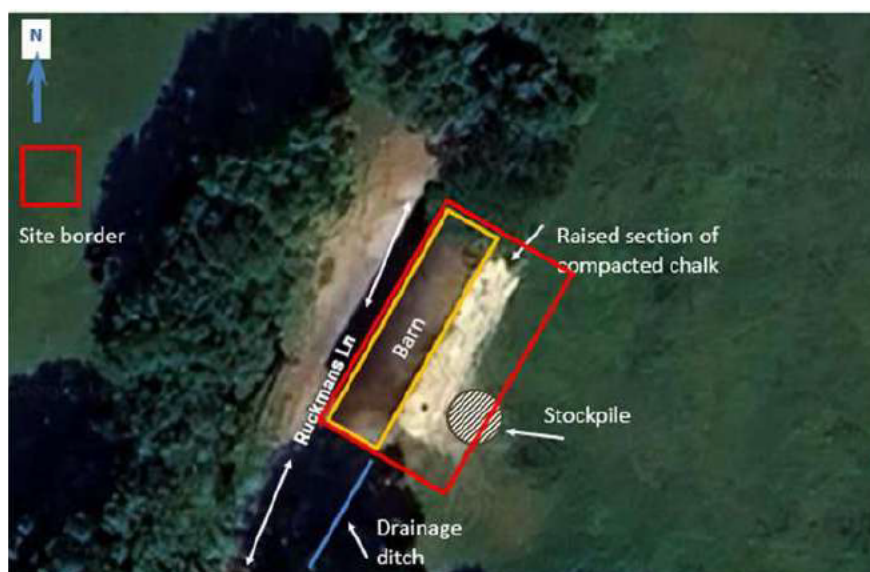
Stored materials inside the barn included several pieces of old farming plant/equipment with rusty metal frames, tyres, an engine and small hand/electric tools, three Heras feet and construction fencing. Also, inside the barn were paper/plastic bags and containers: two motor oil, paint, concrete powder and road salt. Fly tipping noted included three vehicle batteries, several paint aerosols and a gas cylinder. Surface litter included rare plastic, metal, ceramic tile, textile and glass fragments.

Dumped wastes including domestic rubbish, hand tools and plant/equipment etc. were noted. An allowance should be made for removing such items as part of site preparation works.

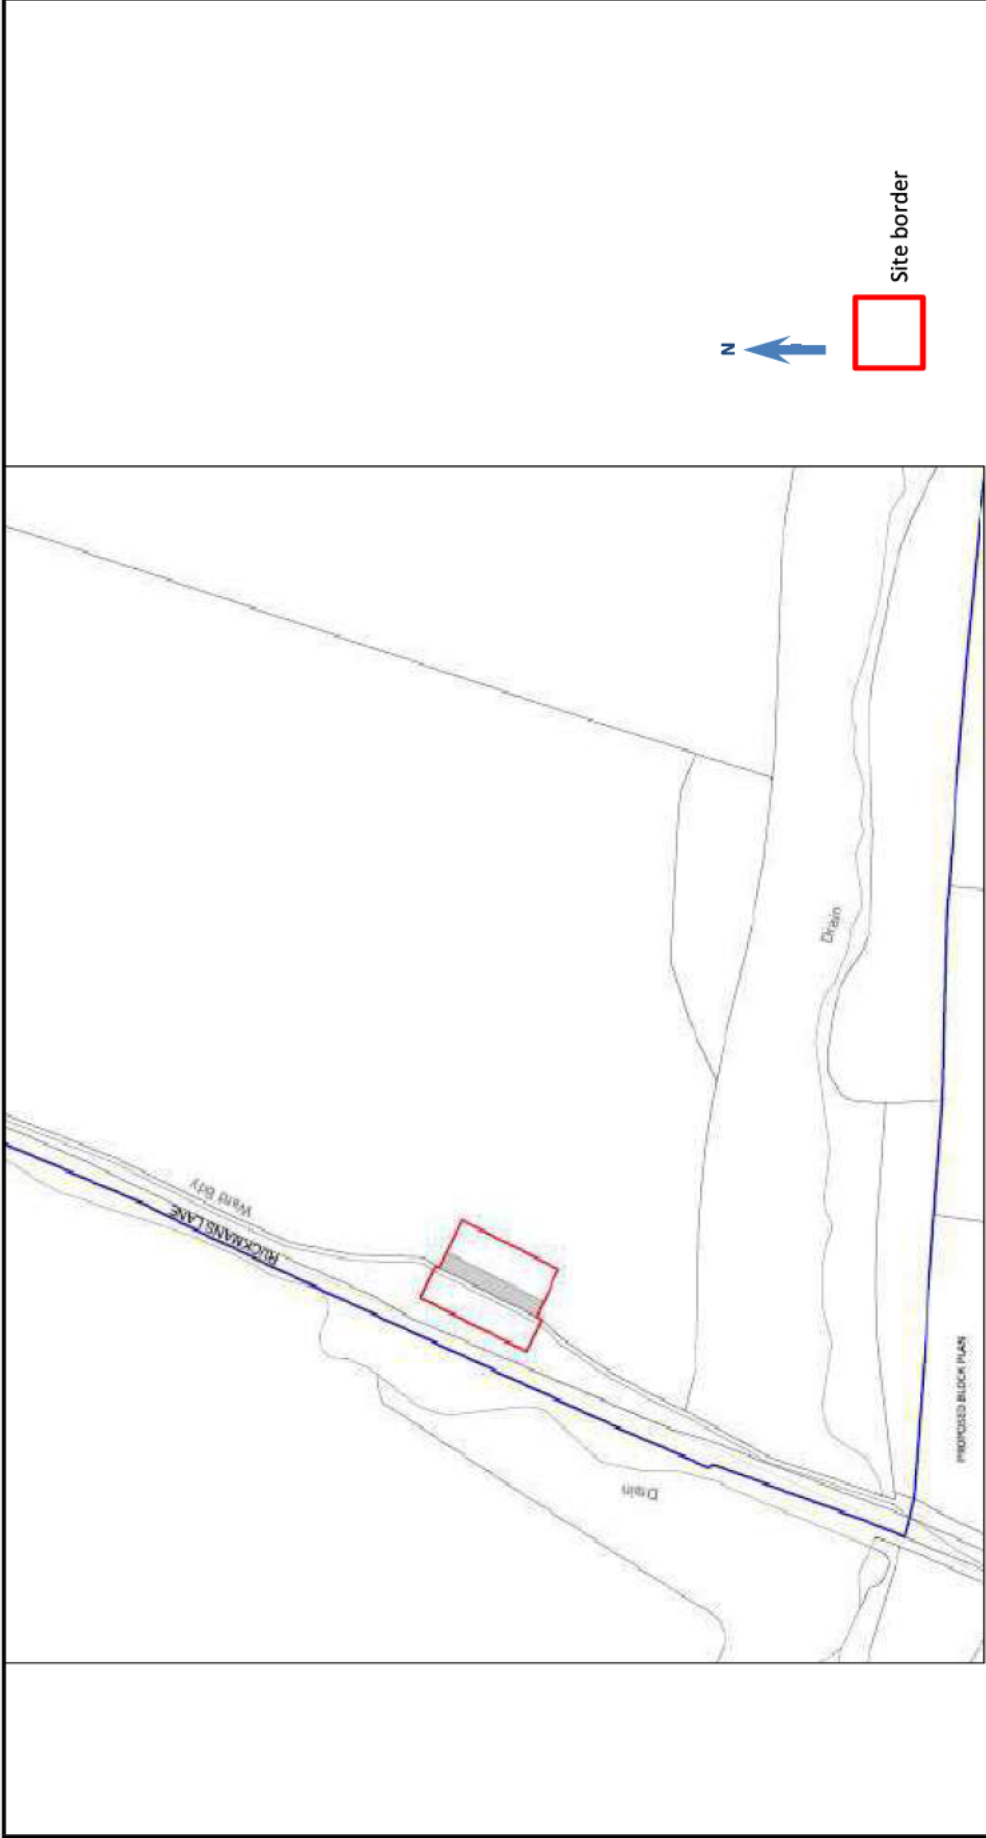
| PROJECT: | Monks Farm, Oakwood Hill, Dorking RH5 5QA | FIGURE: | 2 | CHECKED: | MR |

| TITLE: | Site Layout Plan | REF: | LS8796 | PREPARED: | JM |

The area under investigation comprised a steel-framed barn with a strip of land to the east. The layout is indicated on Figure 2, and a walkover survey is presented in section 2.0. The area was approximately 0.03 hectares.
