## Arboricultural Method Statement

Toat Café, Staines Cottage & Staines Farm

Client: Antonio Avenue Ltd.

Date: March 2026

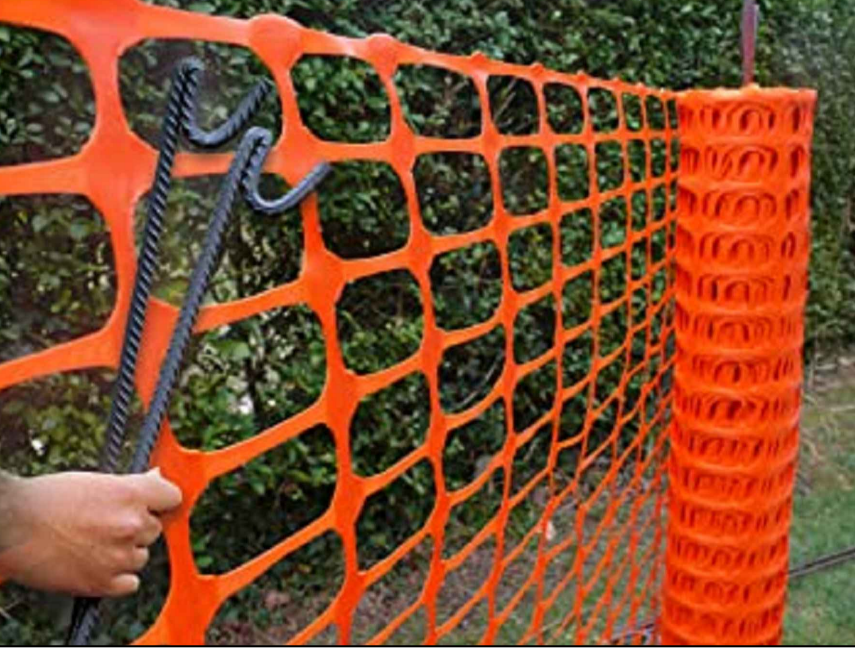
PROTECTIVE FENCING

Subject to agreement with the LPA tree officer, protection of the boundary hedges and lower category groups will comprise plastic mesh temporary barrier fencing, supported on steel road pins or similar, driven into the ground at 1.5-2m centres. The locations where plastic mesh fencing may be used are denoted by continuous bold orange lines on the TPP. If the LPA tree officer deems the mesh fencing as insufficient protection, the trees will be protected with heras panels as detailed below.

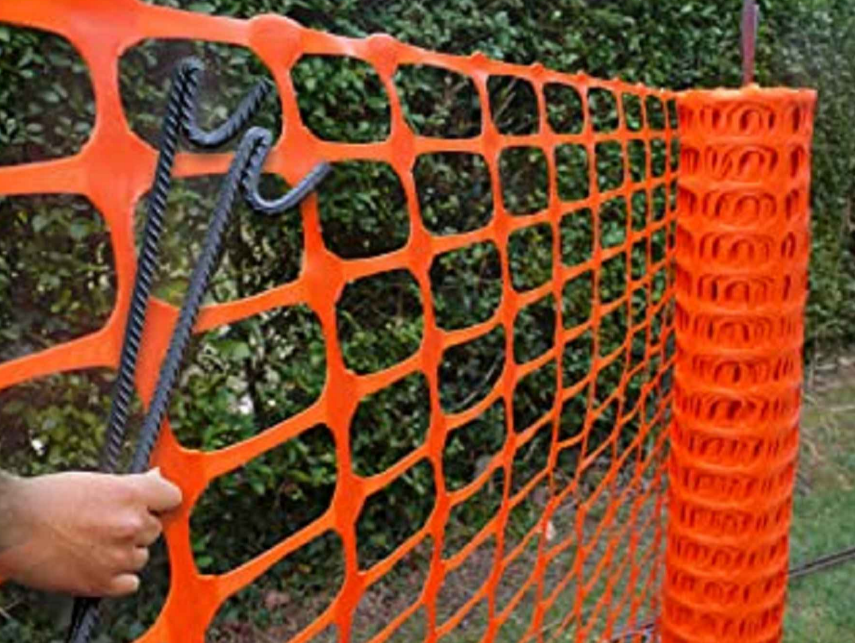
PROTECTIVE FENCING

Subject to agreement with the LPA tree officer, protection of the boundary hedges and lower category groups will comprise plastic mesh temporary barrier fencing, supported on steel road pins or similar, driven into the ground at 1.5-2m centres. The locations where plastic mesh fencing may be used are denoted by continuous bold orange lines on the TPP. If the LPA tree officer deems the mesh fencing as insufficient protection, the trees will be protected with heras panels as detailed below.
